SENATOR HARRY REID READINESS & TRAINING CENTER

Site Number: 9920 STATE OF NEVADA PUBLIC WORKS DIVISION FACILITY CONDITION ANALYSIS

Report distributed in January 2022

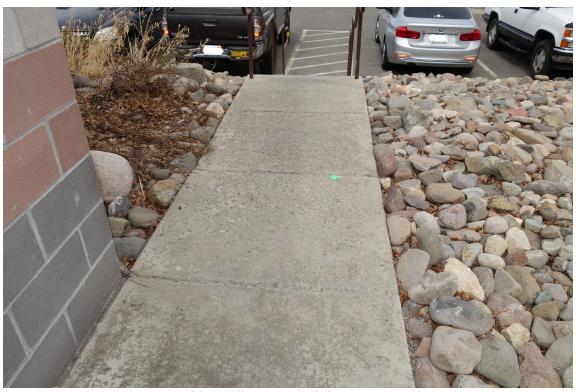
The Washoe County Armory site in Stead is over 20 years old and is in need concrete walkway replacement. The project will upgrade the accessible paths of travel and replace failing and heaved concrete.

Sen. Harry Reid Readiness & Training Center - Site #9920 Description: Sidewalk Replacement Needed.

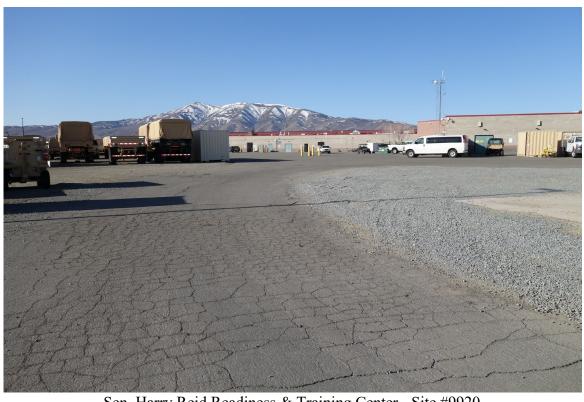
It is important to maintain the asphalt concrete paving on the site. This project would provide for minor replacement of deteriorated paving, minor crack filling and slurry sealing of the paving site wide. Striping is included in this estimate. This project should be scheduled on a 5 year cyclical basis to maintain the integrity of the paving and prevent premature failure. 1,150,000 square feet of asphalt area was used to generate this estimate.

Sen. Harry Reid Readiness & Training Center - Site #9920 Description: Pavement Patch, Crack & Slurry Seal Site Paving Needed.

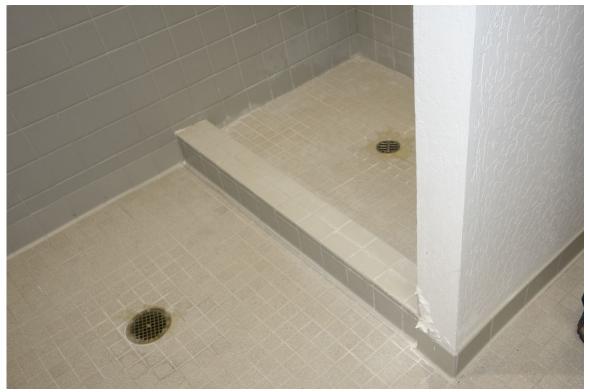
The vanities in the Men's and Women's restroom are not accessible and should be replaced with an ADA accessible countertop, sink, faucet and plumbing jacket. There are also showers present which are not compliant. This project also includes remodeling both showers into ADA compliant showers including fixtures. IBC - 2018, ICC/ANSI A117.1 and Americans with Disabilities Act Accessibility Guidelines (ADAAG) were referenced for this project. This project or a portion thereof was previously recommended in the FCA report dated 07/17/2008. It has been amended accordingly to reflect conditions observed during the most recent survey date of 04/07/2021.

OSA Flight Detachment 45 - Building #2408 Description: ADA Restroom & Shower Remodel Needed.

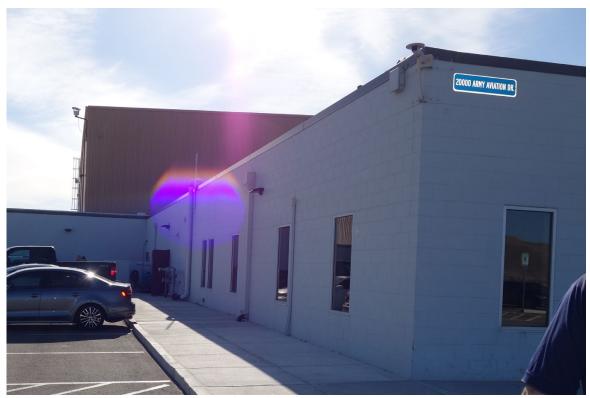
The windows are original to the building and have reached the end of their useful life. These older windows are drafty and not energy efficient. This project recommends replacing the windows with dual pane, higher efficiency units. This estimate is for the replacement of 30 units. Removal and disposal of the existing windows is included in this estimate.

Army Aviation Support Facility - Building #2045 Description: Window Replacement Recommended.

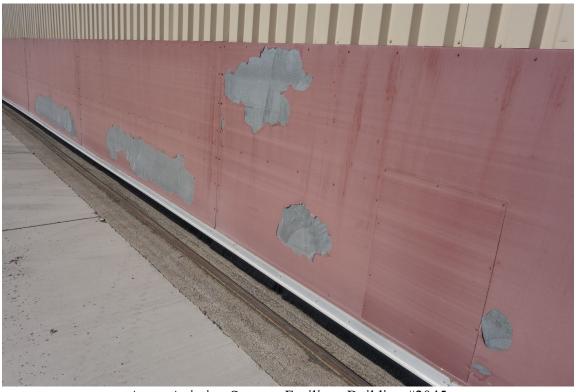
The exterior finishes were in poor condition. It is important to maintain the finish, weather resistance and appearance of the building. This project recommends work to protect the exterior building envelope, other than the roof, including painting, staining, sealing or other applied finishes, and caulking around windows, flashing, fixtures, and other penetrations to maintain the building in good, weather tight condition. It is recommended that this project be implemented in the next 2 - 4 years and is recommended on a cyclical basis based on environmental conditions.

Army Aviation Support Facility - Building #2045
Description: Exterior Finishes – Repaint Exterior Including Hangar Doors.

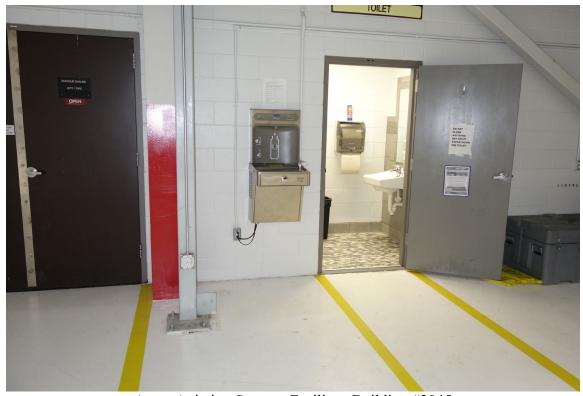
Army Aviation Support Facility - Building #2045 Description: Dual Level Drinking Fountains Needed.

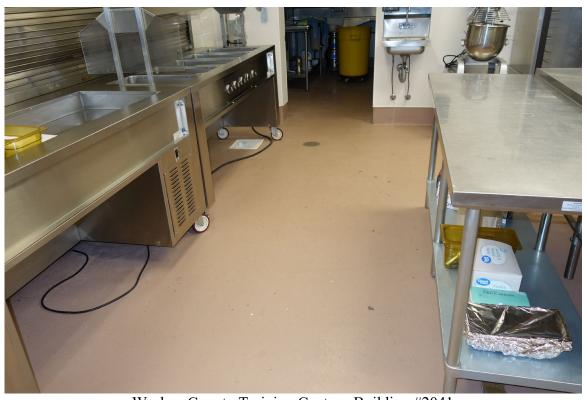
Washoe County Training Center - Building #2041 Description: Flooring Replacement Needed.

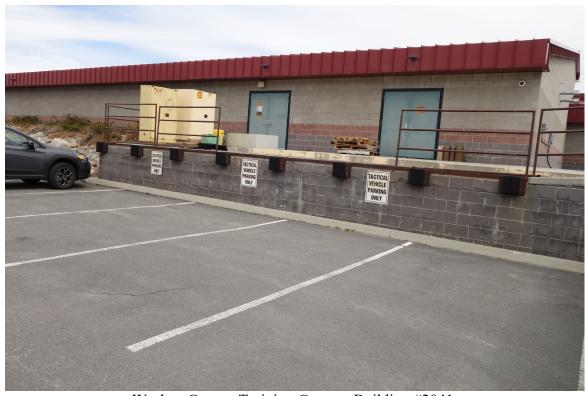
Washoe County Training Center - Building #2041 Description: Loading Dock Replacement Recommended.

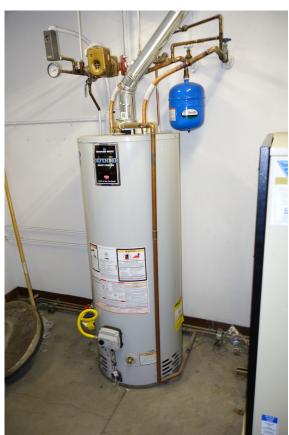
Field Maintenance Shop A - Building #2040 Description: Water Heater Seismic Restraints Needed.
