# FORT CHURCHILL STATE PARK

**Site Number: 9921**  
**STATE OF NEVADA PUBLIC WORKS DIVISION**  
**FACILITY CONDITION ANALYSIS**

Report distributed in October 2021

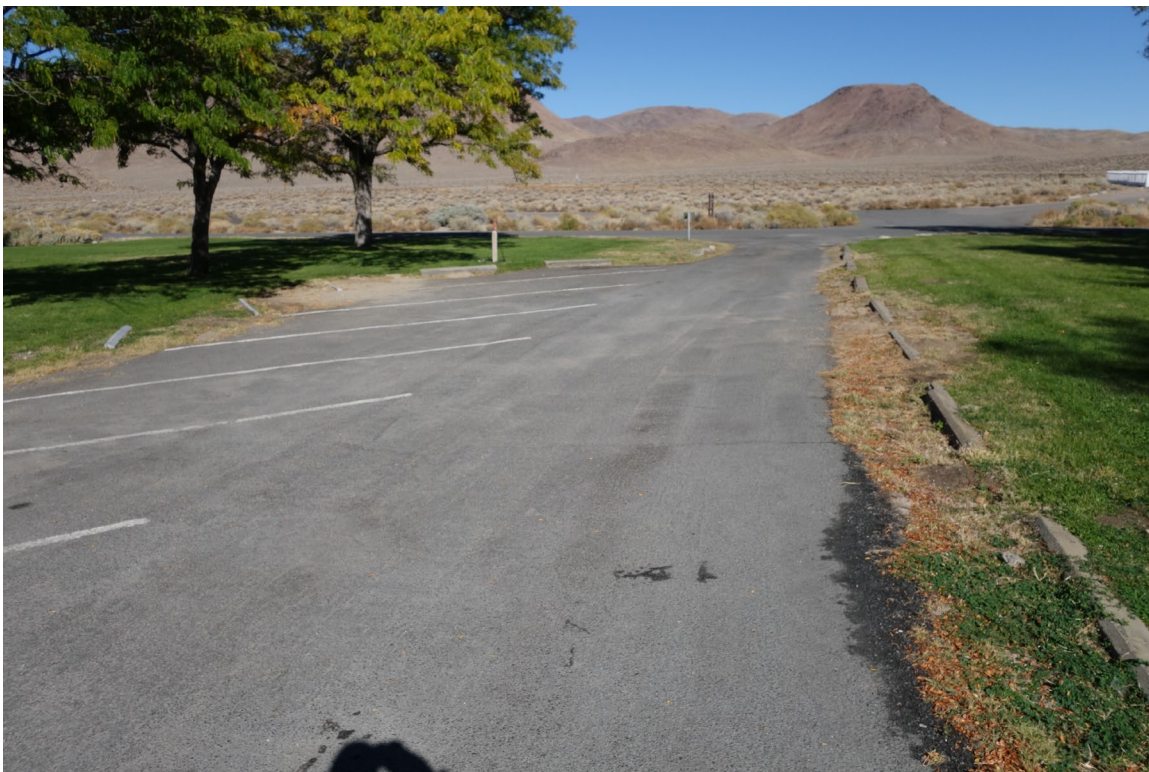
Fort Churchill State Park - Site #9921  
Description: Reseal Asphalt Parking and Roads.

It is important to maintain the asphalt concrete paving on the site. This project would provide for minor crack filling and slurry sealing of the paving site wide including access roads and parking areas. Striping is included in this estimate. This project should be scheduled on a 5 year cyclical basis to maintain the integrity of the paving and prevent premature failure. 400,000 square feet of asphalt area was used to generate this estimate.

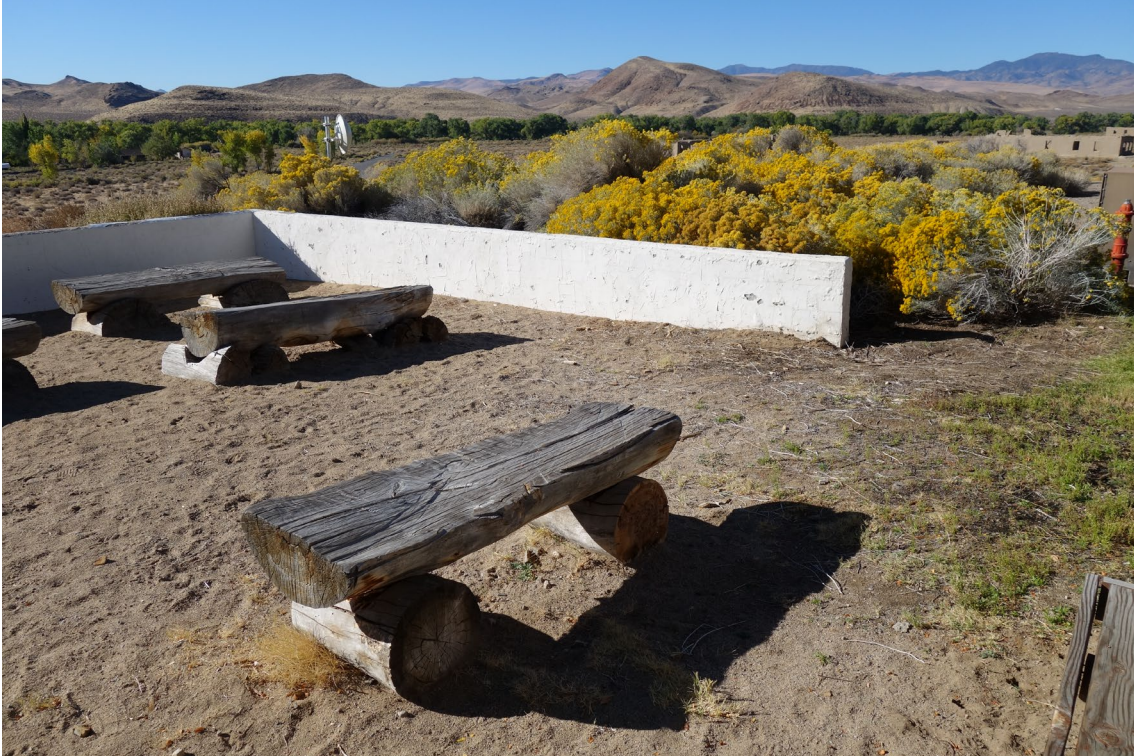
The ruins viewing area west of the Museum has reached the end of its useful life. The CMU perimeter pony walls are spalling and cracking and need to be removed. This project would provide funding for the removal of the low walls, regrading and compacting, installation of a new concrete patio and guard rails as required. The cost estimate also includes demolition and disposal of the existing materials.

Fort Churchill State Park - Site #9921  
Description: Viewing Area Needing Upgrade to Concrete.

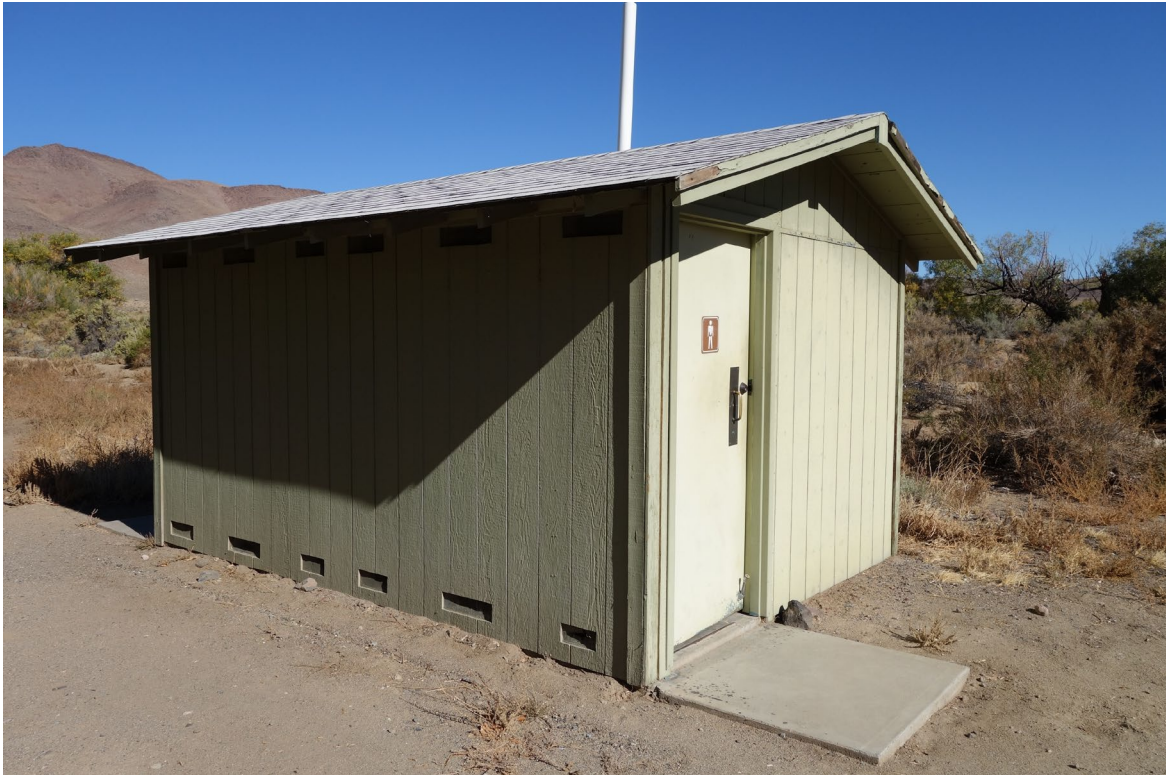
Comfort Station #1 – Group Camp - Building #0486  
Description: Exterior of the Building – Needing Replacement.

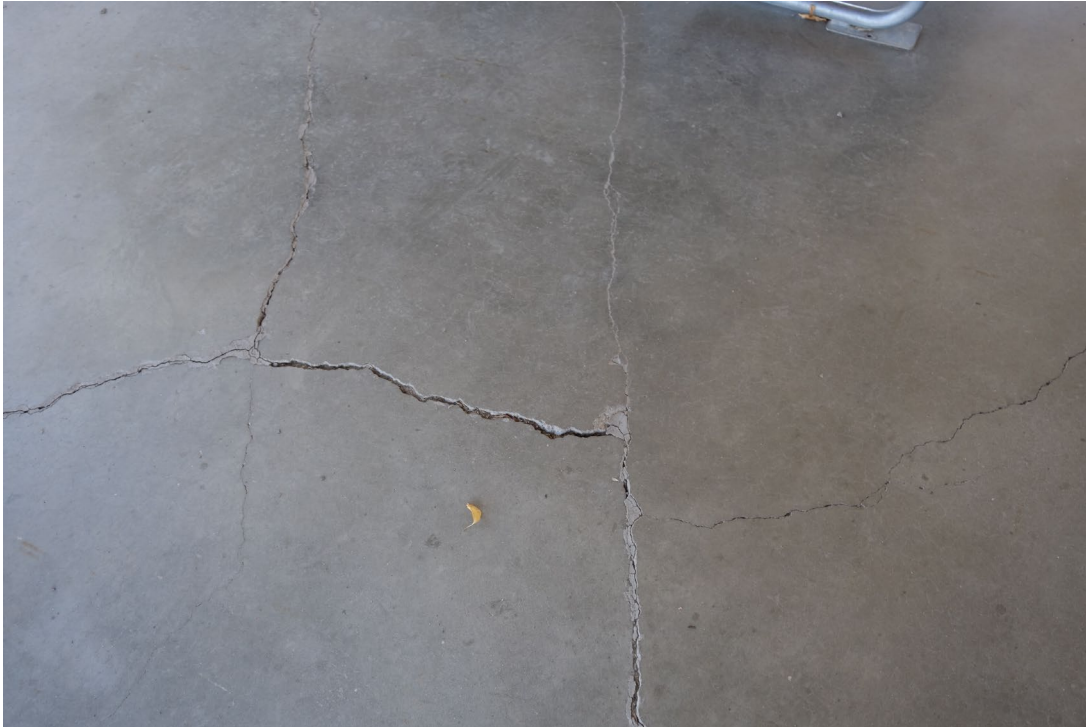
Group Ramada - Building #0490  
Description: Concrete Slab Needing Replacement.

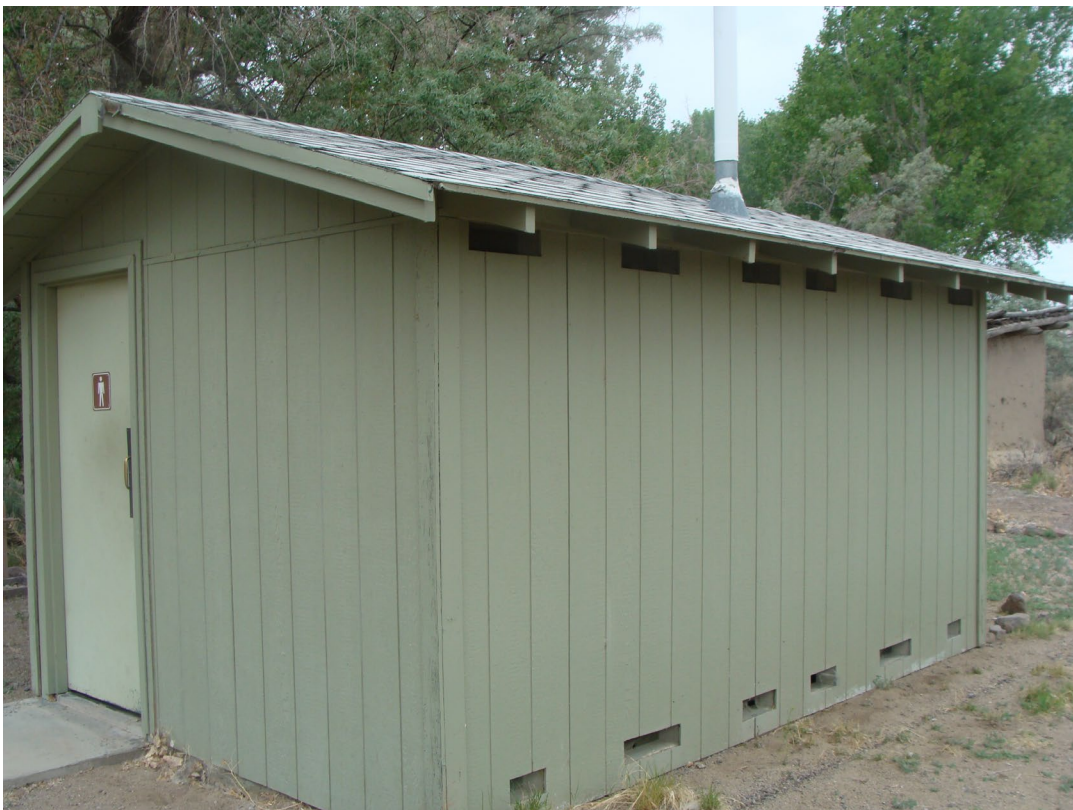
Comfort Station #2 - Campground - Building #0491  
Description: Exterior of the Building – Needing Replacement.

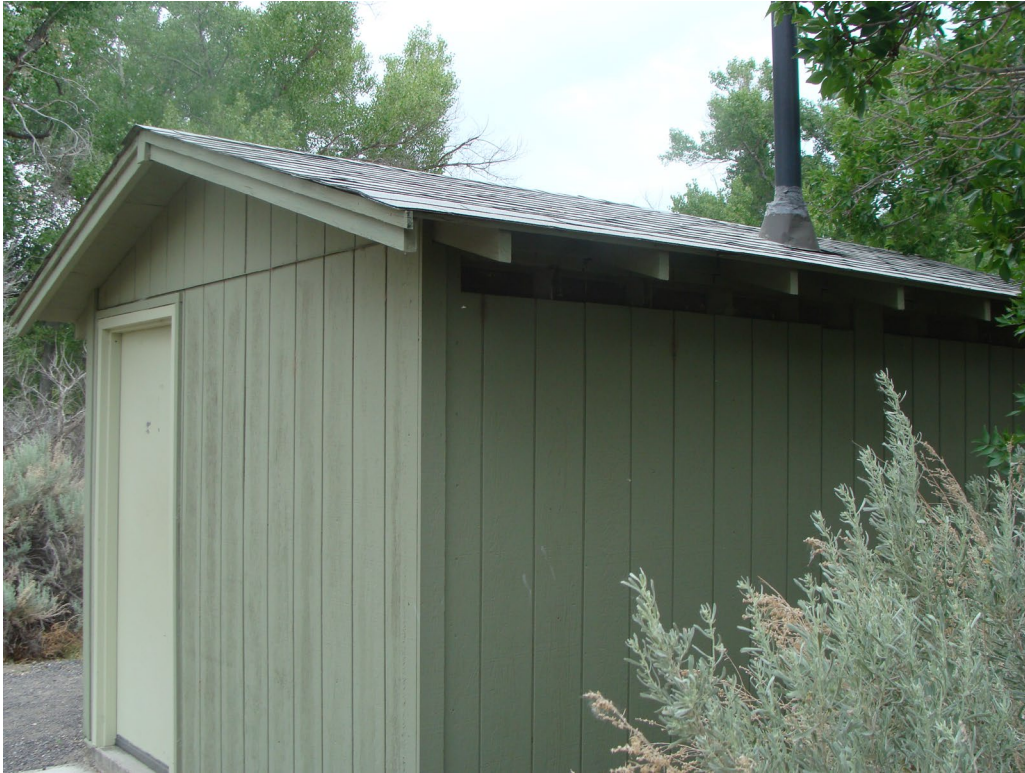
Comfort Station #3 - Campground - Building #0492  
Description: Exterior of the Building – Needing Replacement.

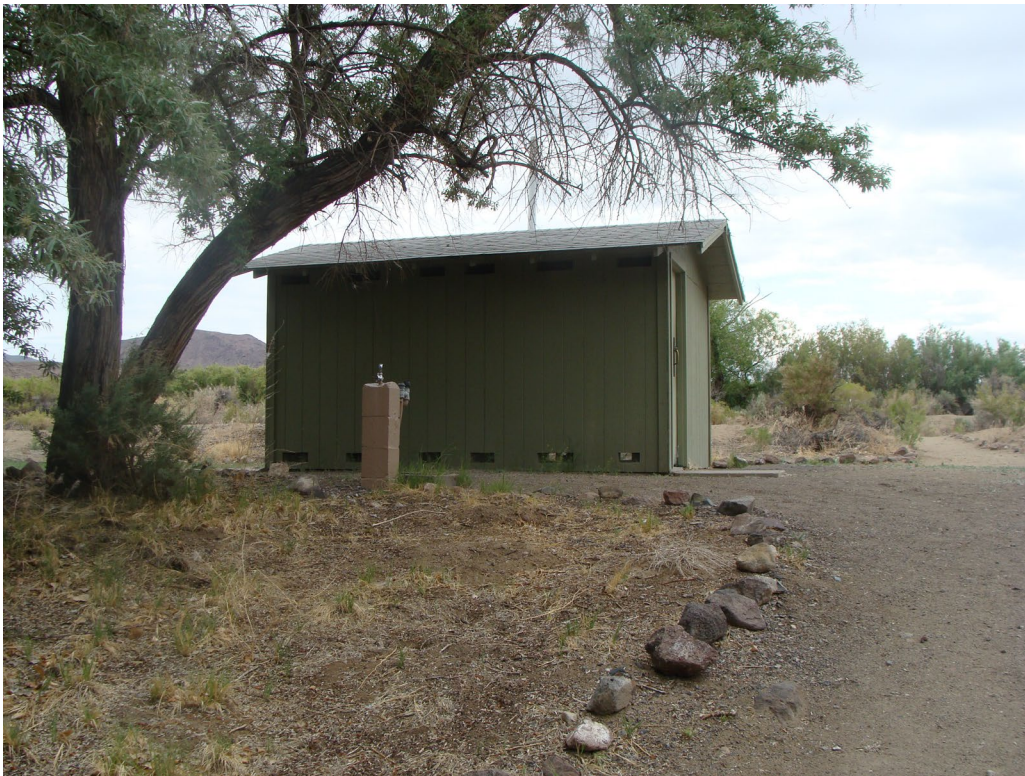
Comfort Station #4 - Picnic - Building #0500  
Description: Exterior of the Building – Needing Replacement.

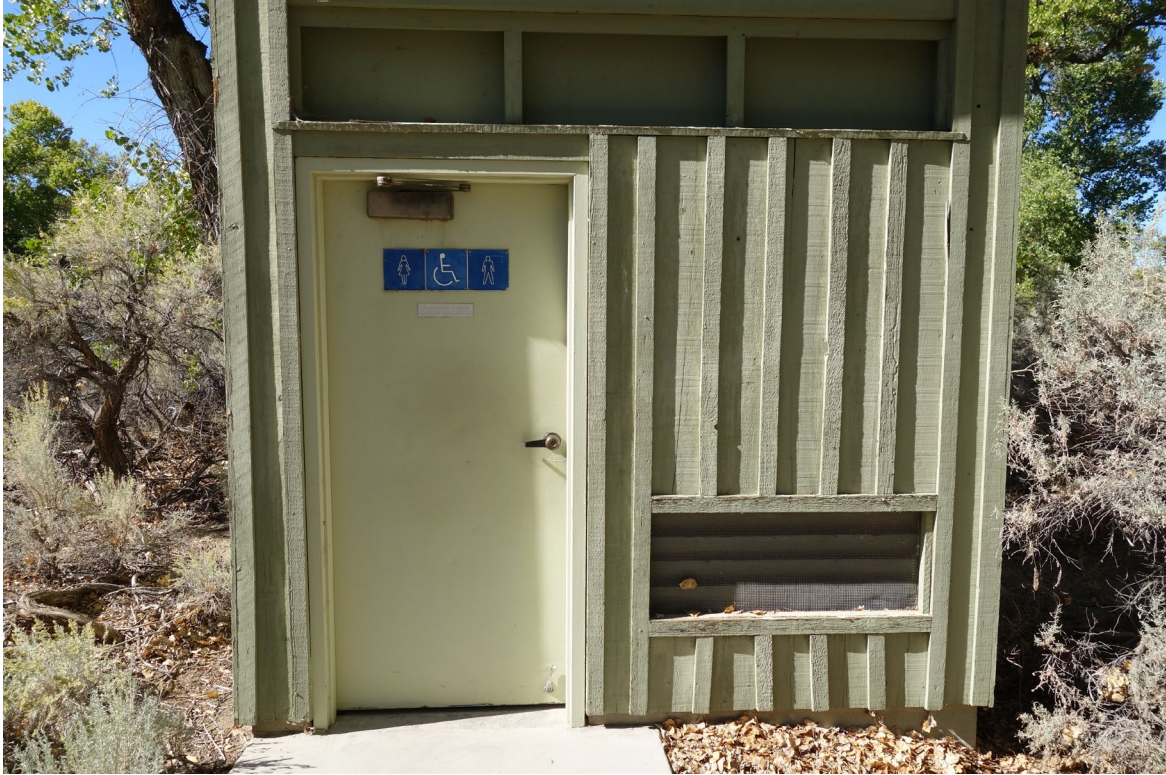
ADA Accessible Comfort Station #1 - Building #0501  
Description: Exterior of the Building – Needing Replacement.

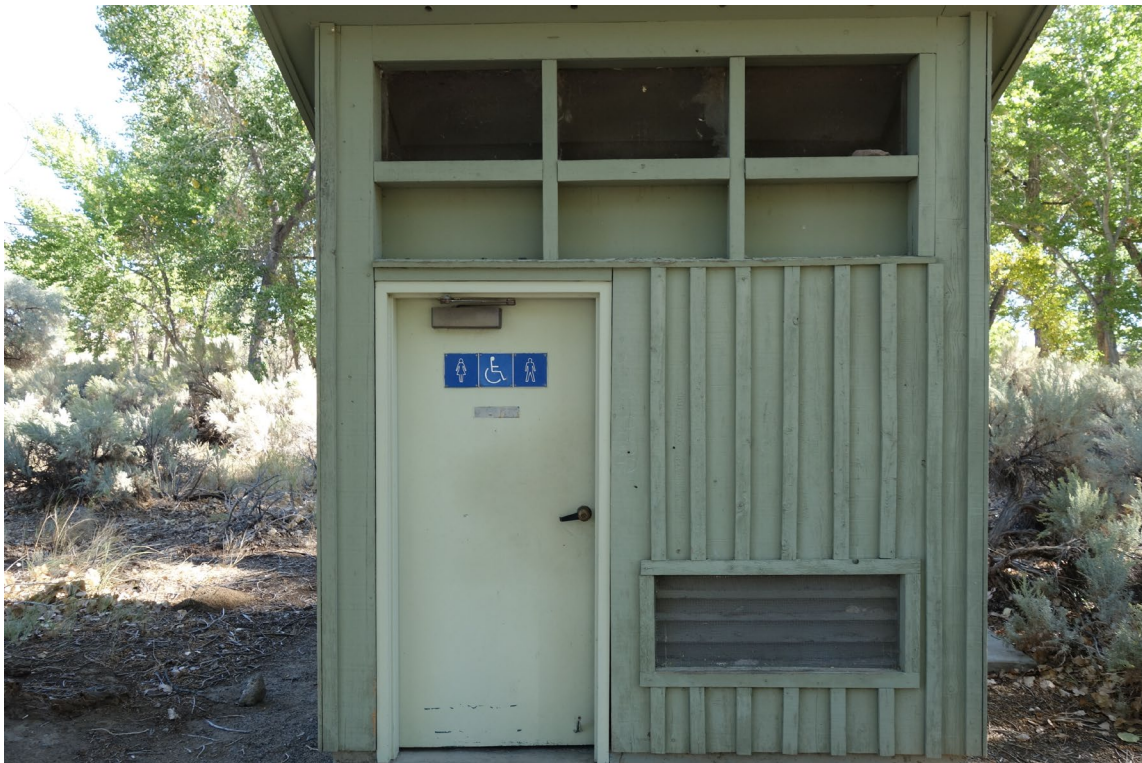
ADA Accessible Comfort Station #2 - Building #0502  
Description: Exterior of the Building – Needing Replacement.

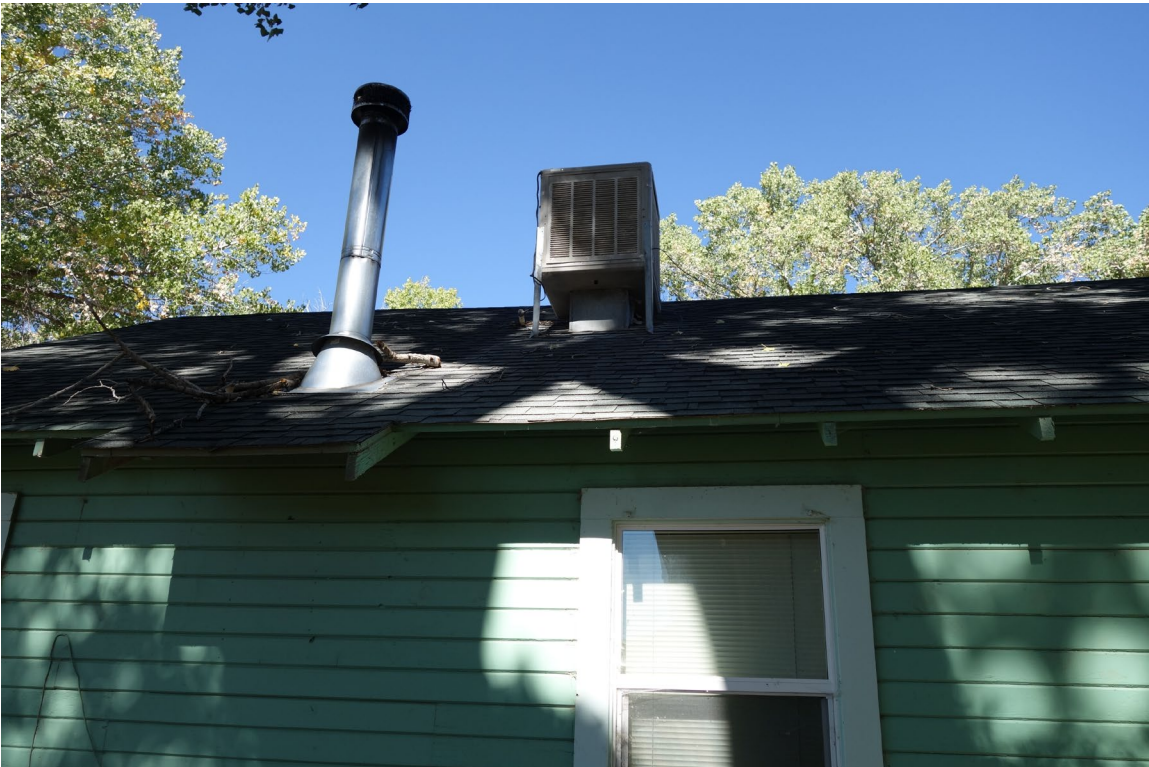
Residence #5 – Ghiglia Ranch - Building #0539  
Description: Evaporative Cooler Replacement.

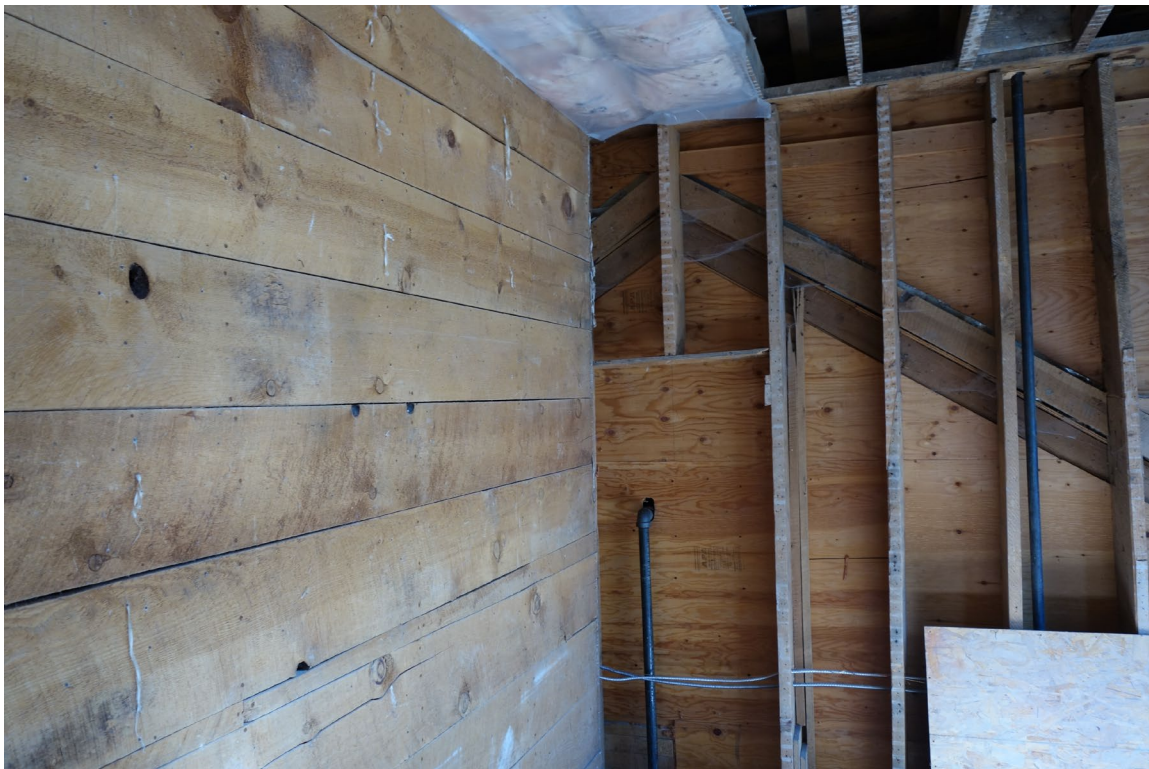
Buckland Station Historic Building - Building #0541  
Description: Building Insulation Needed.

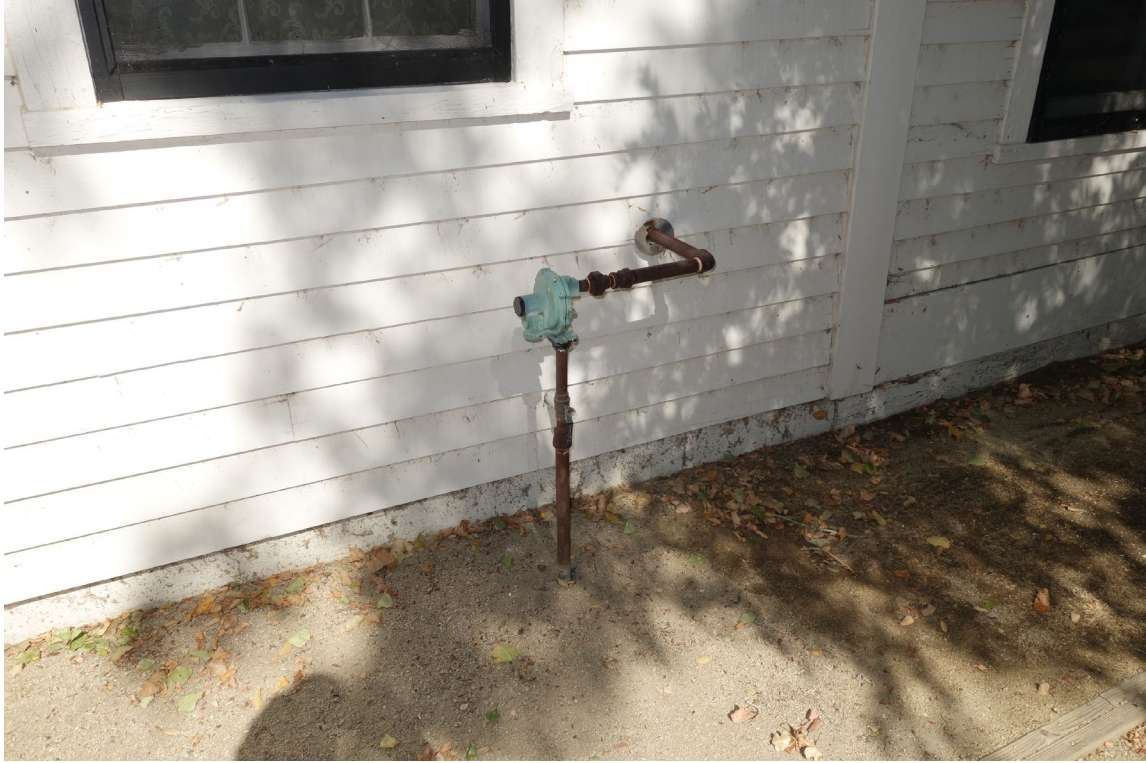
Buckland Station Historic Building - Building #0541  
Description: Seismic Gas Valve Needed.

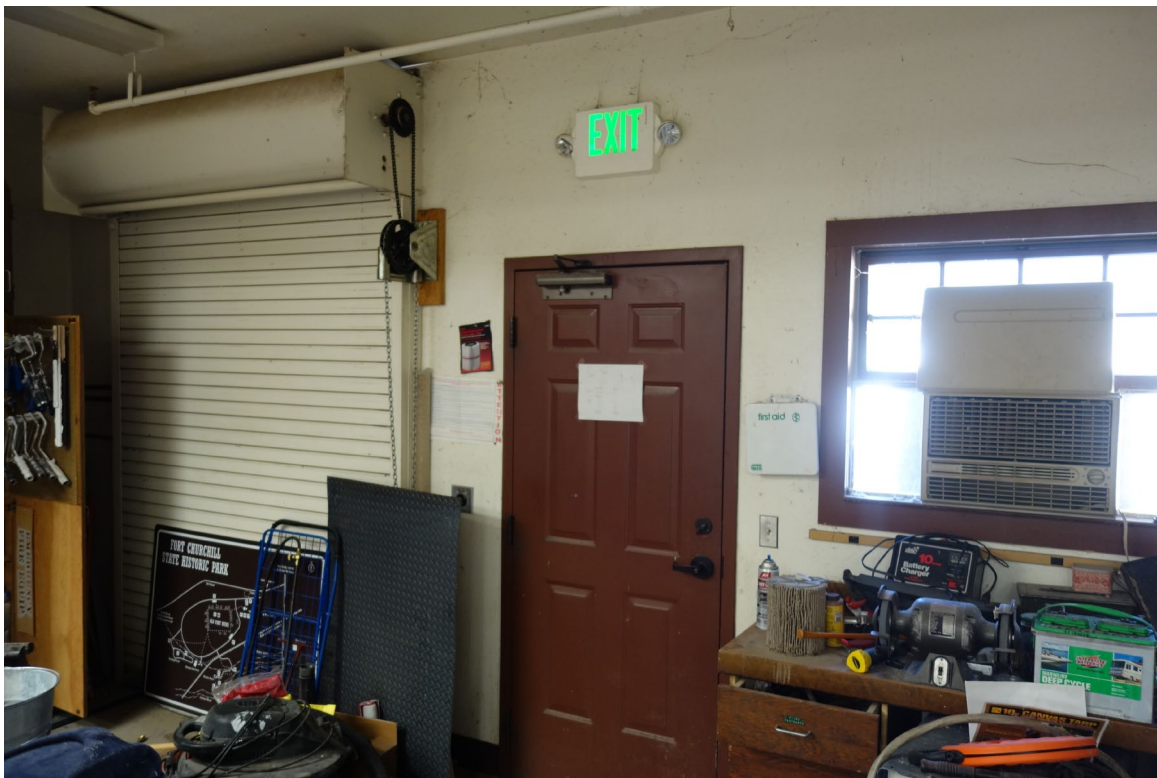
Park Shop / Office - Building #1165  
Description: Interior of the Shop & A/C Upgrade Needed.

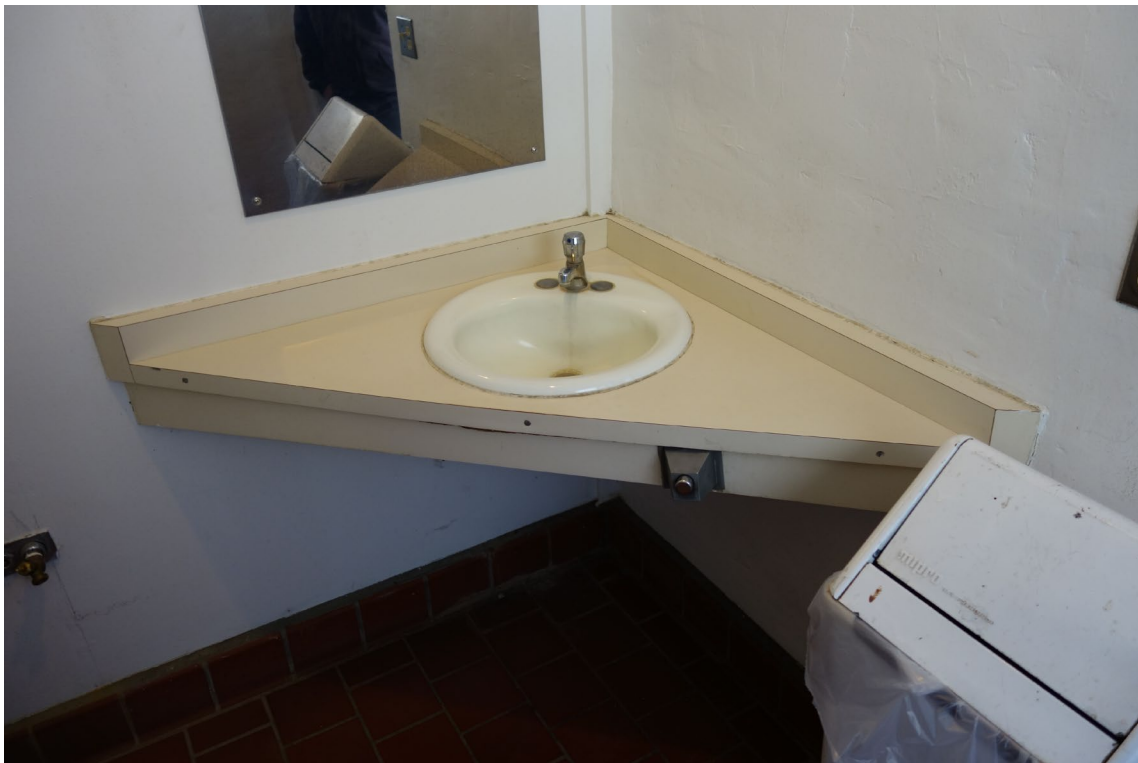
The Shop/Public Restroom building is a wood framed structure with a wood shingle roofing system on a concrete foundation. The building has a new wood shake roofing system installed in 2021. The shop area is now used mostly for storage. The restroom portion contains the designated public restrooms which are not fully ADA compliant and are in need of an upgrade.

Shop / Public Restroom Building - Building #1318  
Description: ADA Restroom Upgrade Needed.

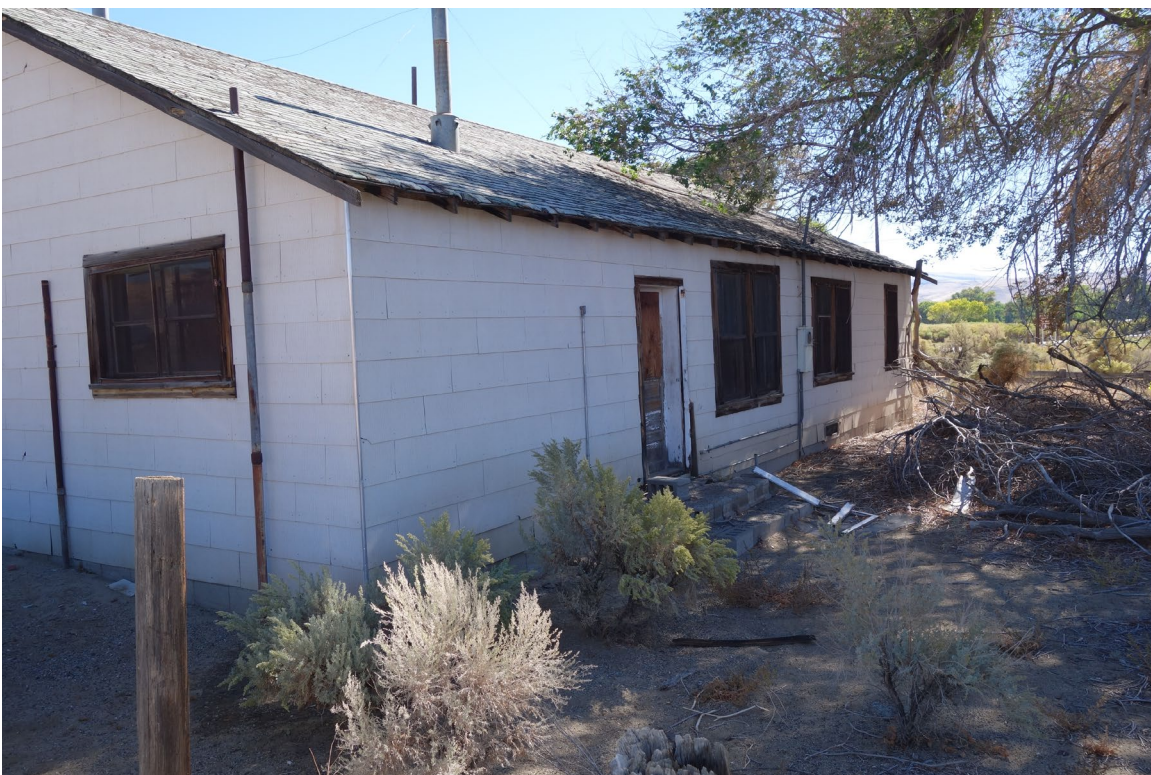
The Robert Depaoli Ranch was constructed in 1935 and is located about 200 yards Northwest of the Buckland Station on the West side of Highway 95A. The unoccupied residence is a single story structure on an unreinforced CMU foundation with a composition roof. All utilities have been or never were connected. The building is currently used for storage and is in poor condition.

The residence contains numerous code and safety issues including, but not limited to an upper level exterior door without a deck or stairway, rodent infestation, broken or missing doors and windows, possible asbestos contamination and broken or missing electrical fixtures. This project recommends that the residence be secured by boarding up exterior openings and weather proof the exterior to prevent further damage. The electrical service should be disconnected and the public/personnel should not be allowed to enter or use this building.

Residence #4 – Depaoli Ranch - Building #1474  
Description: Exterior of the Building.

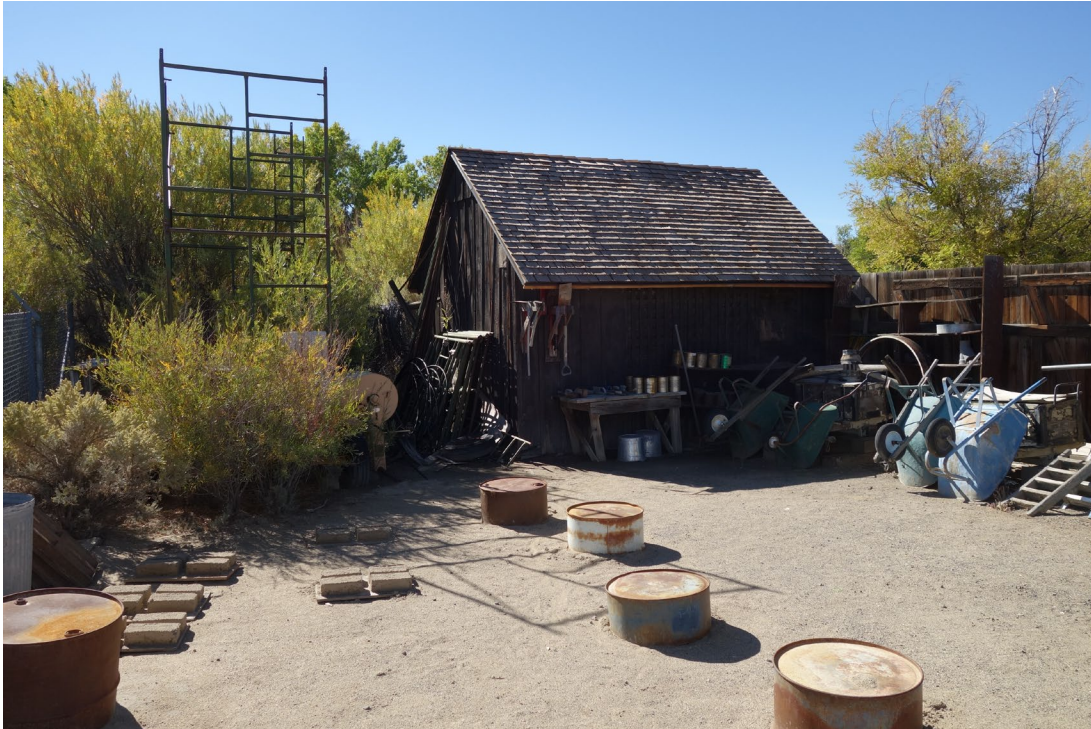
The Blacksmith Shop is an old wood framed structure with a wood shingle roofing system installed in 2017 with a 30 year warranty. It is located near the adobe brick storage structure. The building has numerous items relating to blacksmithing operations and is in poor condition.

The wood structure is approaching 100 years old and there are numerous areas where the wood is splitting, warping and deteriorating. This is also an exhibit for the park and requires maintenance time to display the artifacts and maintain the signage. This project would provide for sealing the wood, caulking the flashing, fixtures and windows, replacing wood shake roof shingles as needed, replacing wood siding as needed and maintaining the exhibit in a state of arrested decay. This project should be coordinated with the Nevada State Historical Preservation Office for possible restrictions or requirements which are not included in this estimate. It is recommended that the work be done in the next 2-3 years and that this project be scheduled on a cyclical basis to maintain the integrity of the structure.

Blacksmith Shop - Building #2386  
Description: Exterior of the Building.
