# RENO NHP HEADQUARTERS SITE

357 Hammill Lane Reno, Nevada 89511

## Site Number: 9923 STATE OF NEVADA PUBLIC WORKS DIVISION FACILITY CONDITION ANALYSIS

Report distributed in November 2021

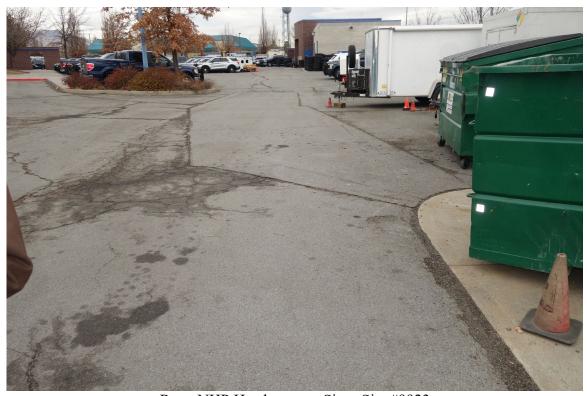
Reno NHP Headquarters Site - Site #9923
Description: AC Paving Patch, Crack & Slurry Seal Needed.

It is important to maintain the asphalt concrete paving on the site. This project would provide for minor crack filling and sealing of the paving site wide including access roads, parking areas and driving test areas. Striping is included in this estimate. This project should be scheduled on a 5 year cyclical basis to maintain the integrity of the paving and prevent premature failure. 60,000 square feet of asphalt area was used to generate this estimate.

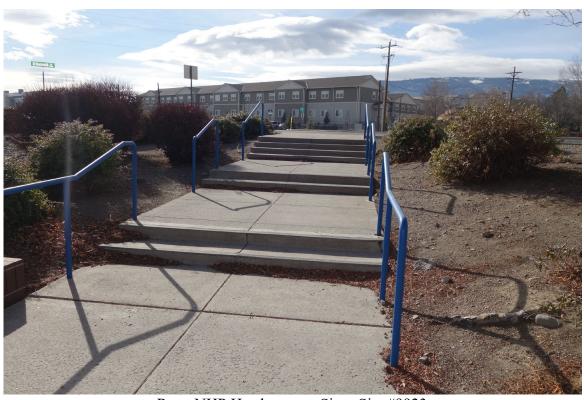
Reno NHP Headquarters Site - Site #9923
Description: ADA Route of Travel from Public Way Needed.

The Americans with Disabilities Act (ADA) provides for accessibility to sites and services for people with physical limitations. A path of travel from the public street to the accessible public entrance of the building is necessary to comply with ADA accessibility requirements. This project would provide for a concrete walkway from the existing sidewalk to the building. This will require regrading, placement of P.C. concrete, installing a ramp with compliant handrails, signage, striping and any other necessary upgrades. The 2018 IBC, ICC/ANSI A117.1 and the most current version of the Americans With Disabilities Act Accessible Guidelines (ADAAG) were used as a reference for this project. This project or a portion thereof was previously recommended in the FCA report dated 05/19/2011. It has been amended accordingly to reflect conditions observed during the most recent survey date of 01/12/2021.

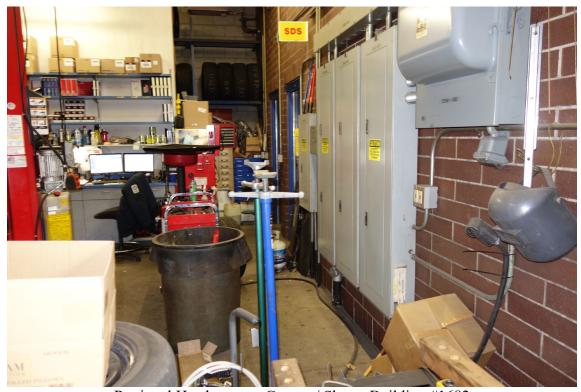
Regional Headquarters Garage / Shop - Building #1682 Description: Arc Flash & Coordination Study Needed.

An arc flash and electrical coordination study has not been performed or is more than 5 years since the last coordination study. The latest electrical code requires coordination studies be verified and performed every 5 years and arc flash labeling on all electrical panels to provide the safety requirements for maintenance personnel. This project will perform the required coordination study, evaluation, adjustments and labeling for the building electrical distribution system.

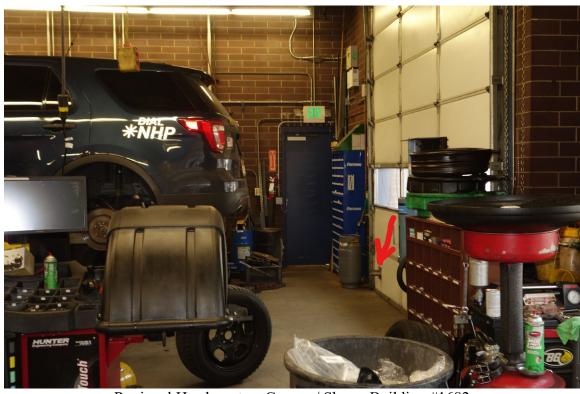
Regional Headquarters Garage / Shop - Building #1682 Description: Inadequate Vehicular Exhaust System (Red Arrow).

The vehicle maintenance garages have no exhaust extraction system to remove toxic exhaust fumes. In enclosed areas where motor vehicles operate, mechanical ventilation shall be provided per the 2018 IBC 406.6.3 and UMC 502.14. This project would provide for the purchase and installation of a vehicle exhaust extraction system in two garage bays including, hoses, automatic shut off, electrical connections and roof mounted exhaust fans and equipment as provided and / or required by the manufacturer.

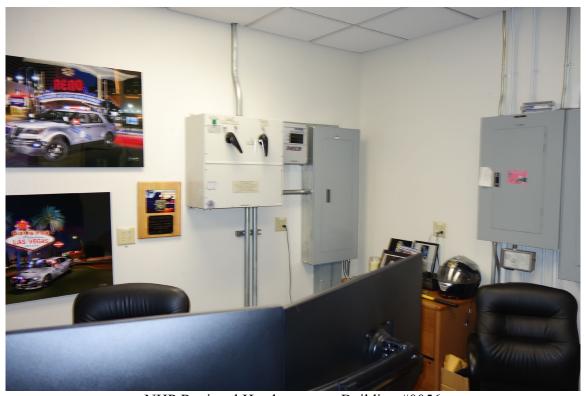
NHP Regional Headquarters - Building #0056 Description: Arc Flash & Coordination Study Needed.

An arc flash and electrical coordination study has not been performed or is more than 5 years since the last coordination study. The latest electrical code requires coordination studies be verified and performed every 5 years and arc flash labeling on all electrical panels to provide the safety requirements for maintenance personnel. This project will perform the required coordination study, evaluation, adjustments and labeling for the building electrical distribution system.

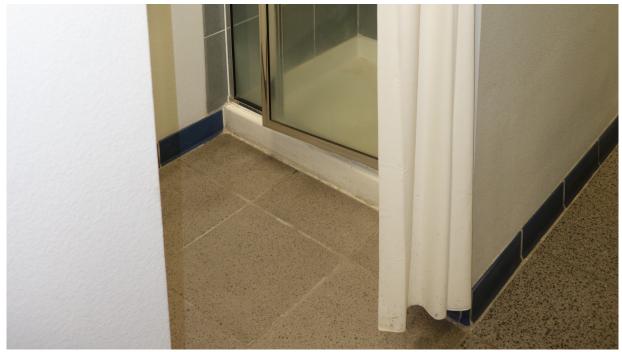
NHP Regional Headquarters - Building #0056 Description: ADA Shower in Locker Room Needed.

The Men's and Women's restrooms each contain at least one shower. The existing showers are not ADA accessible. This project would provide for an ADA compliant shower for each restroom including access, compliant plumbing fixtures and shower seats. NRS 338.180, IBC - 2018, ICC/ANSI A117.1 and the most current version of the Americans with Disabilities Act Accessible Guidelines (ADAAG) were used as a reference for this project.

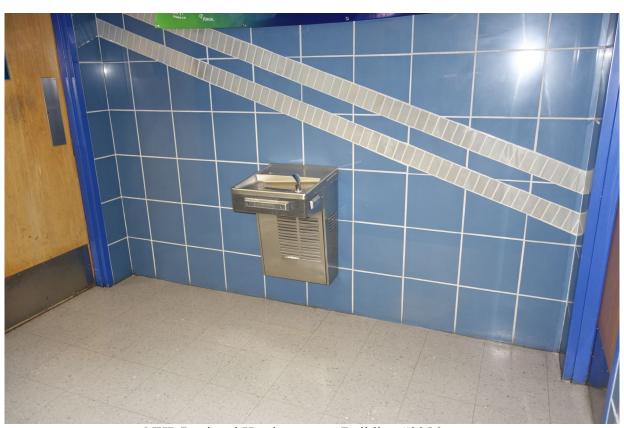
NHP Regional Headquarters - Building #0056 Description: Dual Level Drinking Fountain Needed.

This building contains a water fountain. The 2018 IBC Section 1109.5 states where a water fountain is provided, at least half should be accessible. This project would provide funding for the purchase and installation of a new accessible fixed high/low ADA drinking fountain.
