MORMON STATION STATE HISTORIC PARK SITE

Site Number: 9925
STATE OF NEVADA PUBLIC WORKS DIVISION
FACILITY CONDITION ANALYSIS

Report distributed in December 2021

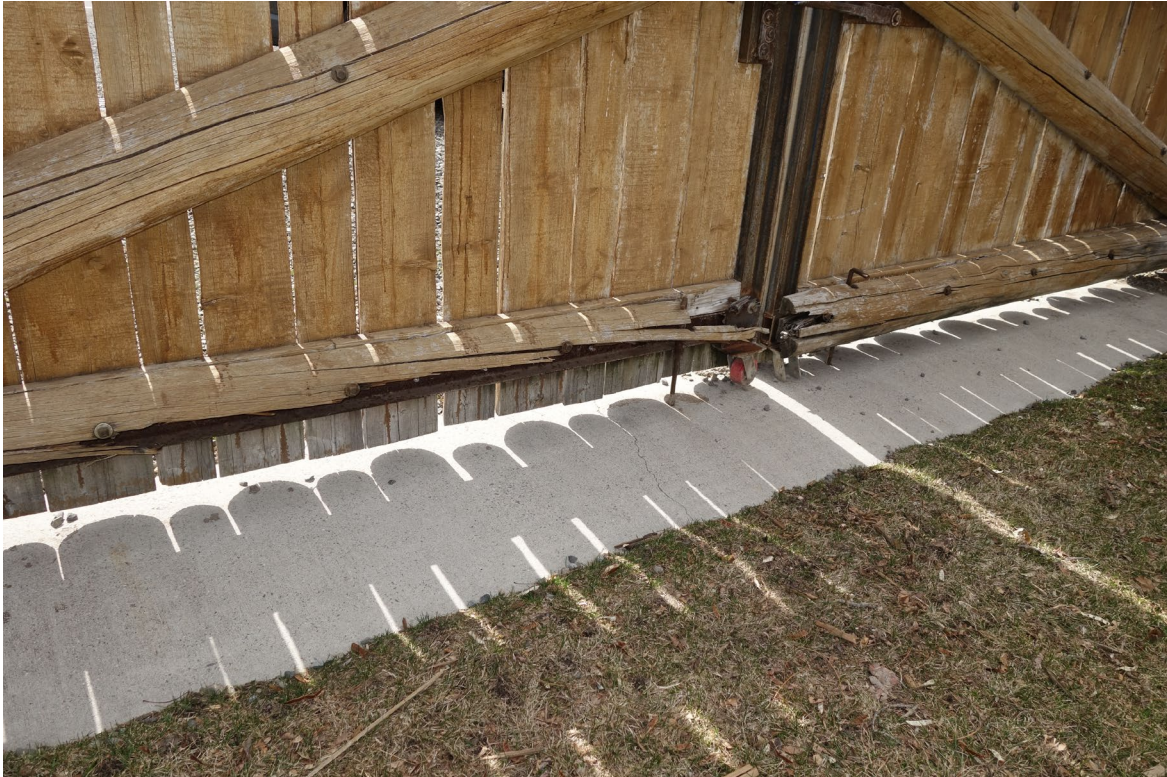
The stockade gate on the south side of the stockade fence is in need of modifications to allow the gate to open properly. This project would provide for the modification of the gate including but not limited to adding sturdy wheels and hardware for ease of operation and stability.

Mormon Station State Historic Park Site – FCA Site #9925
Description: Stockade Gate Repairs Needed.

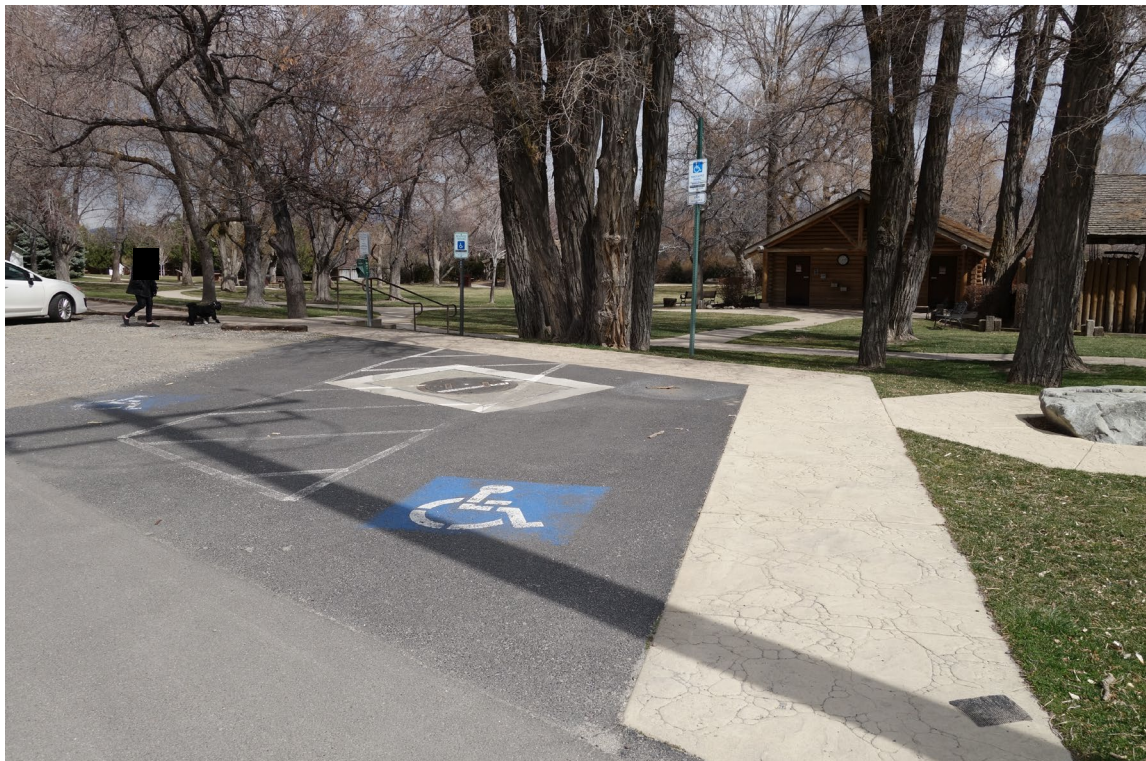
The site currently has only a portion of the parking area paved. The area paved is where the ADA accessible parking is located. The rest of the parking area is loose compacted soil and gravel. This project would provide for 3" of asphalt concrete paving over 6" of compacted base. The length of the parking area used for this estimate is 300 feet and the width 25 feet.

Mormon Station State Historic Park Site – FCA Site #9925
Description: View of ADA Parking and Adjacent Gravel Public Parking.

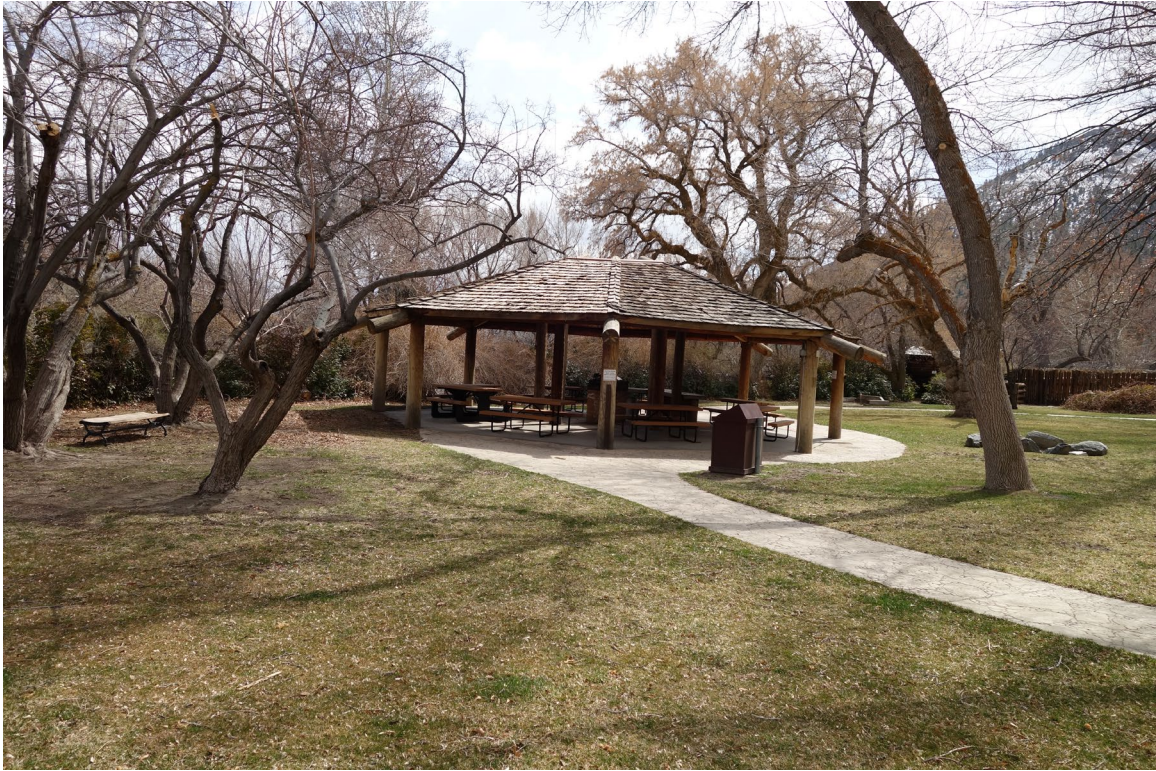
The Group Ramada was built in 1977 and the current wood shake roofing system is weathered, has reached the end of its useful life and is in need of replacement. Due to its historic nature of the park, the structure should be re-roofed with fire retardant-treated wood shakes and underlayment. It is recommended that this project be coordinated with the Nevada State Historical Preservation Office (SHPO) for possible restrictions or additional requirements. This project will fund the replacement of the wood shingle roofing systems. This estimate includes removal and disposal of the old roof. This project or a portion thereof was previously recommended in the FCA report dated 02/18/2015. It has been amended accordingly to reflect conditions observed during the most recent survey date of 03/25/2021.

Group Ramada – FCA Building #1333
Description: Exterior of the Ramada.

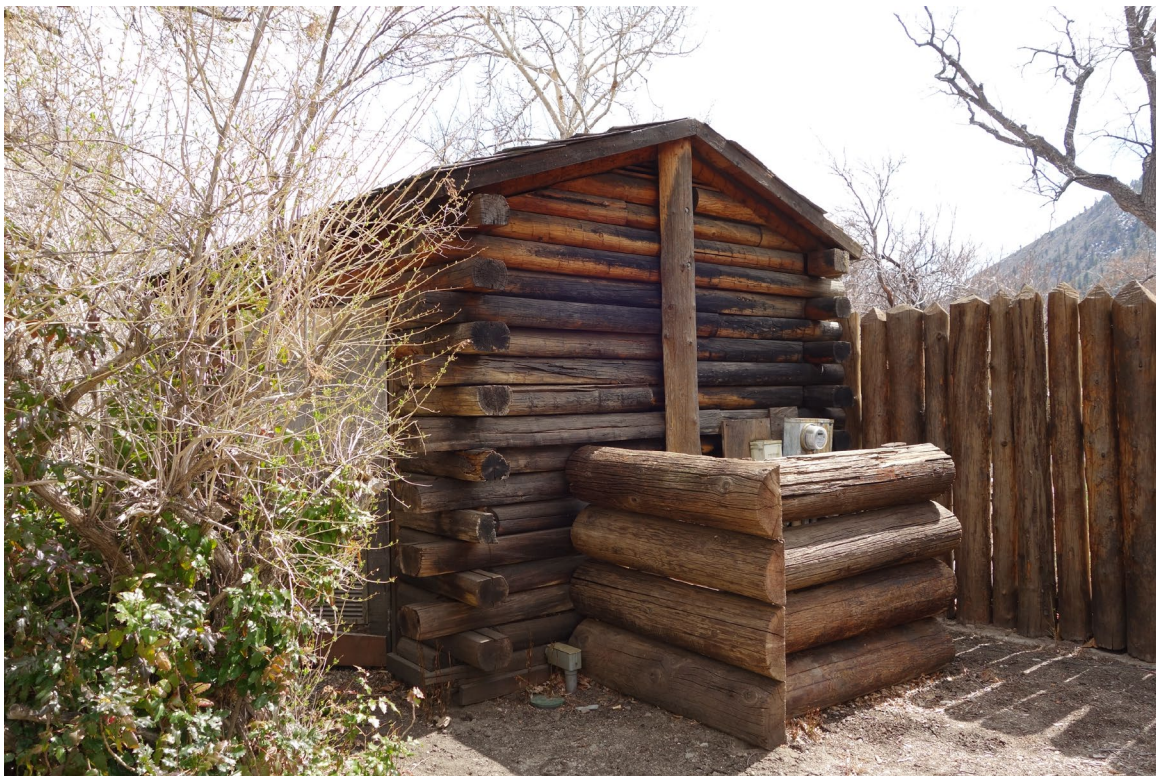
The exterior door to the pump house is in poor shape and is delaminating due to excess moisture and age. This project would provide for a new exterior door/frame assembly including door hardware. A paintable metal door system was used for this estimate and will help reduce maintenance costs related to wood. This door should be replaced in the next two years.

The interior / exterior condition was in poor condition. The cyclical treatment of the building interior and exterior is very important to help maintain the finish, weather proofing, integrity and appearance of the building. This treatment does not include the roofing material itself but it should include everything that has to do with weather proofing the building envelope including painting or staining, sealing, repairing the chinking and caulking where applicable. This project should be scheduled on a cyclical basis. Interior and exterior chinking maintenance is also part of this project.

Irrigation Pump House – FCA Building #1335
Description: Exterior of the Pump House.

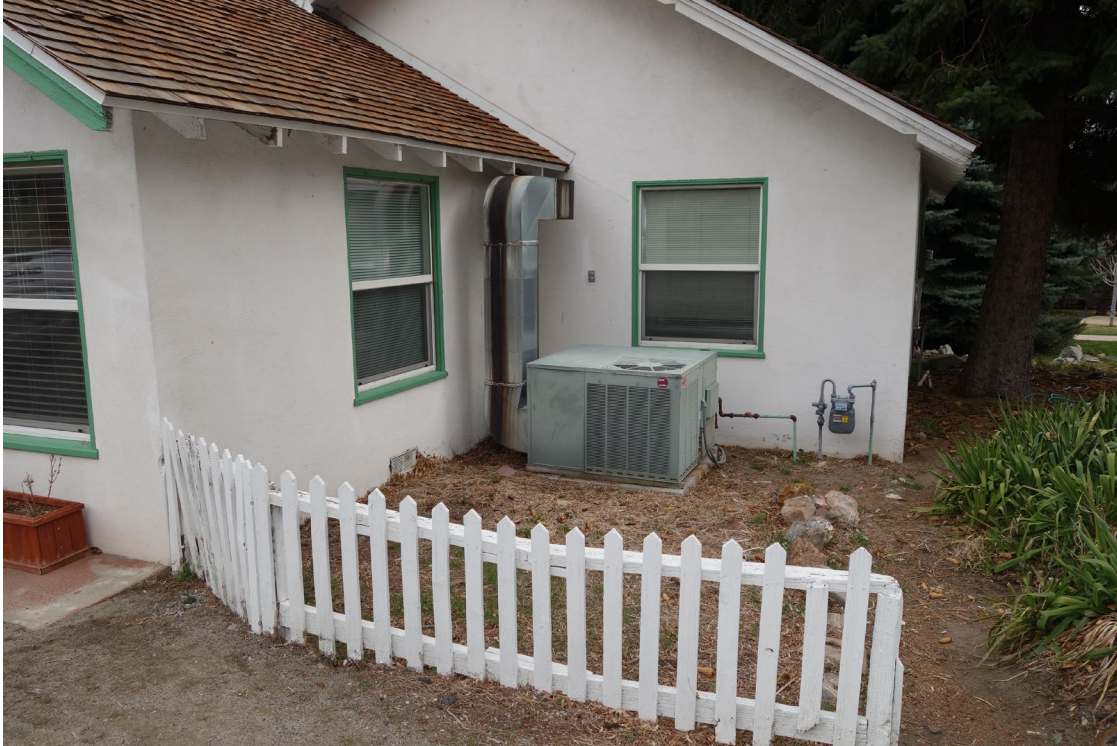
The HVAC system was manufactured in 2001 and should be planned for replacement. It is not energy efficient and is reaching the end of its expected and useful life. The R-22 refrigerant in the cooling system is no longer EPA compliant and its production is mandated to be phased out completely by January 1, 2020. This project would provide for installation of a new HVAC system and cleaning of the existing duct work and grilles. This project includes removal and disposal of the existing HVAC system and all required connections to utilities.

Campbell House – Park Office – FCA Building #2682
Description: HVAC Upgrade & Seismic Gas Valve Installation Needed.

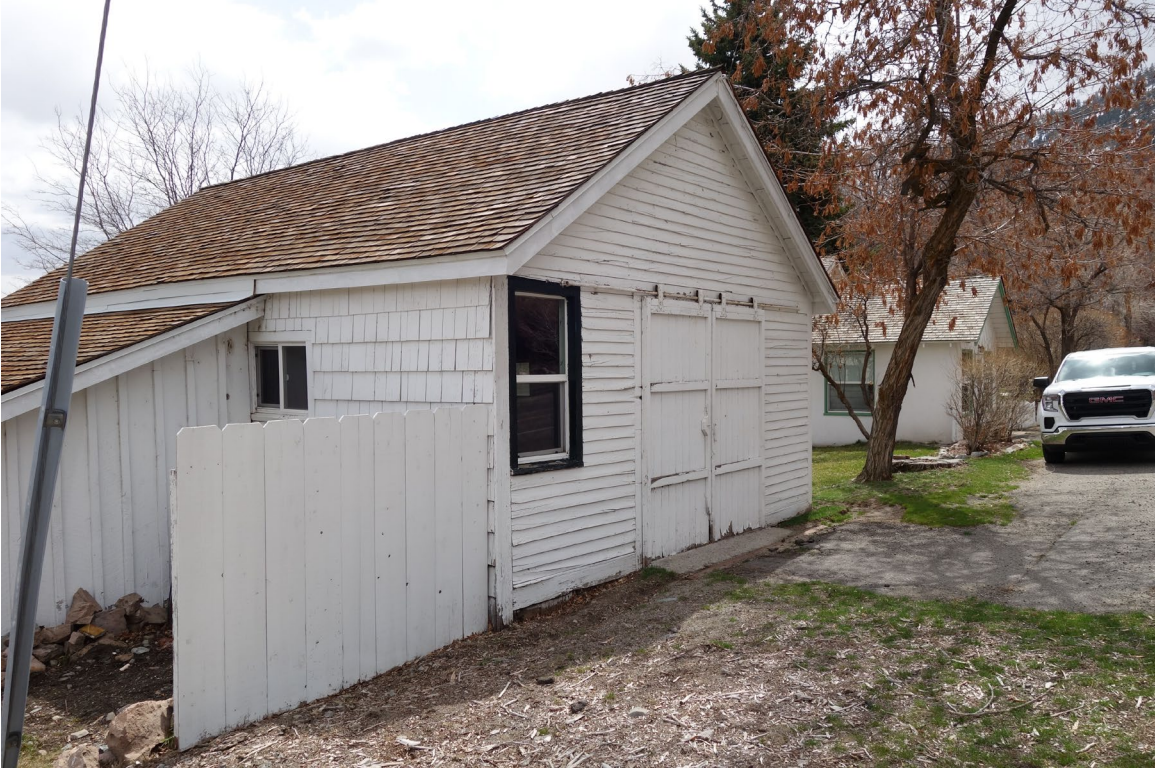
The exterior finishes were in poor condition. It is important to maintain the finish, weather resistance and appearance of the building. The exterior finish on the building is starting to peel and blister and some of the wood siding is damaged. This project would provide funding to protect the exterior building envelope, other than the roof, including painting, staining, or other applied finishes, and caulking around windows, flashing, fixtures, and other penetrations to maintain the building in good, weather tight condition. Additional monies are included to replace damaged siding as needed. This building should be painted in the next 2 - 3 years.

Blacksmith Shop – FCA Building #2684
Description: Exterior of the Building.

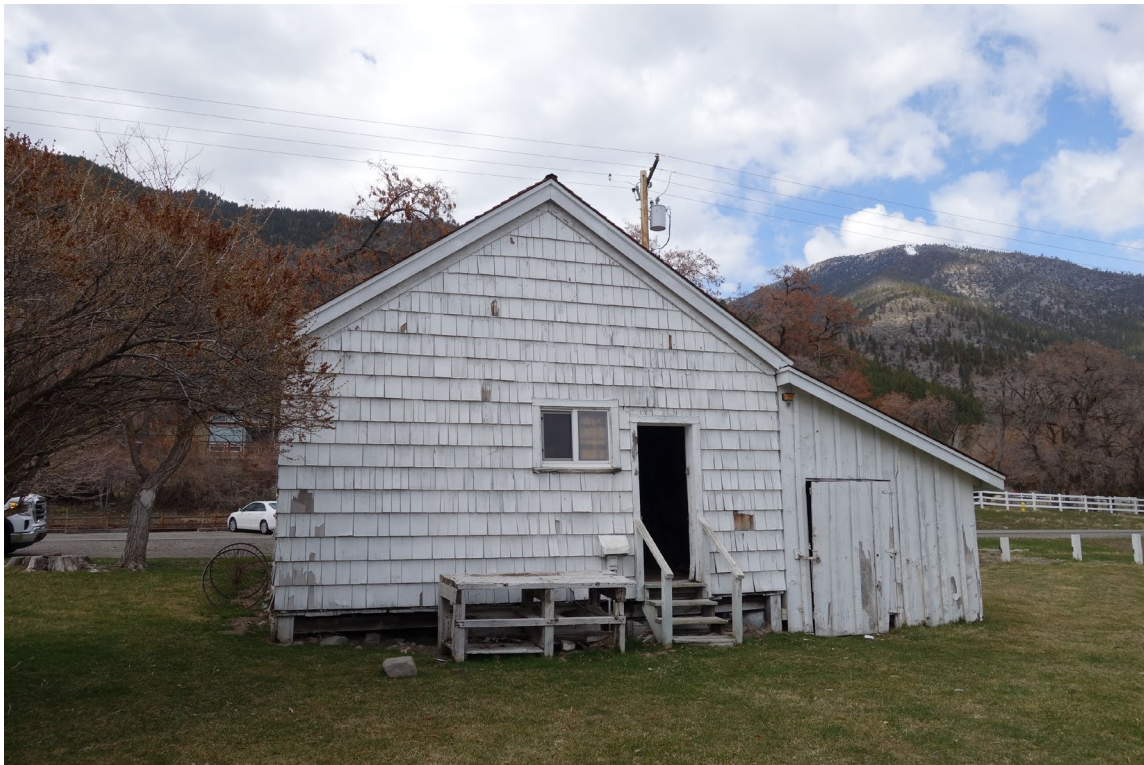
There is an exterior stairway leading to the entrance which is in poor condition and does not have a landing at the bottom of the stairway. This does not comply with 2018 IBC Section 1011 which describes the requirements for stairs and landings including that the width of the landing shall not be less than the width of the stairway. This project will fund the installation of a new stairway with handrails, landing and sidewalk to accessible path of travel. Removal of the existing stairway is included in this project.

Blacksmith Shop – FCA Building #2684
Description: Exterior Stair, Landing and Access to Sidewalk Needed.
