LAKE TAHOE NEVADA STATE PARK CAVE ROCK

Cave Rock
Douglas County, Nevada

Site Number: 9926
STATE OF NEVADA PUBLIC WORKS DIVISION
FACILITY CONDITION ANALYSIS

Report distributed in December 2021

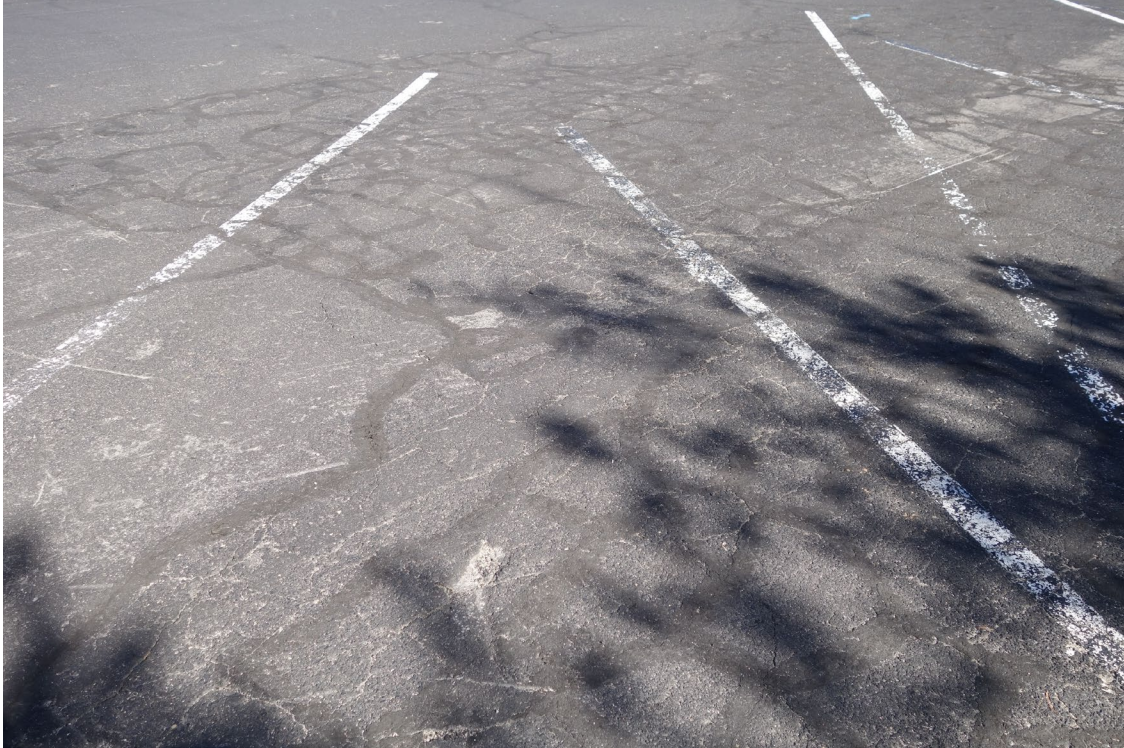
The existing AC paving is in fair condition; however, there are significant areas of alligatoring and at least three locations of complete failure. This project would provide for patching, crack fill, slurry seal, and striping of the paved areas at Cave Rock including the entrance road. This project should be scheduled on a cyclical basis based on environmental conditions and should be implemented in the next two years.

Lake Tahoe Nevada State Park – Cave Rock Site – FCA Site #9926
Description: Paving Crack Fill & Seal.

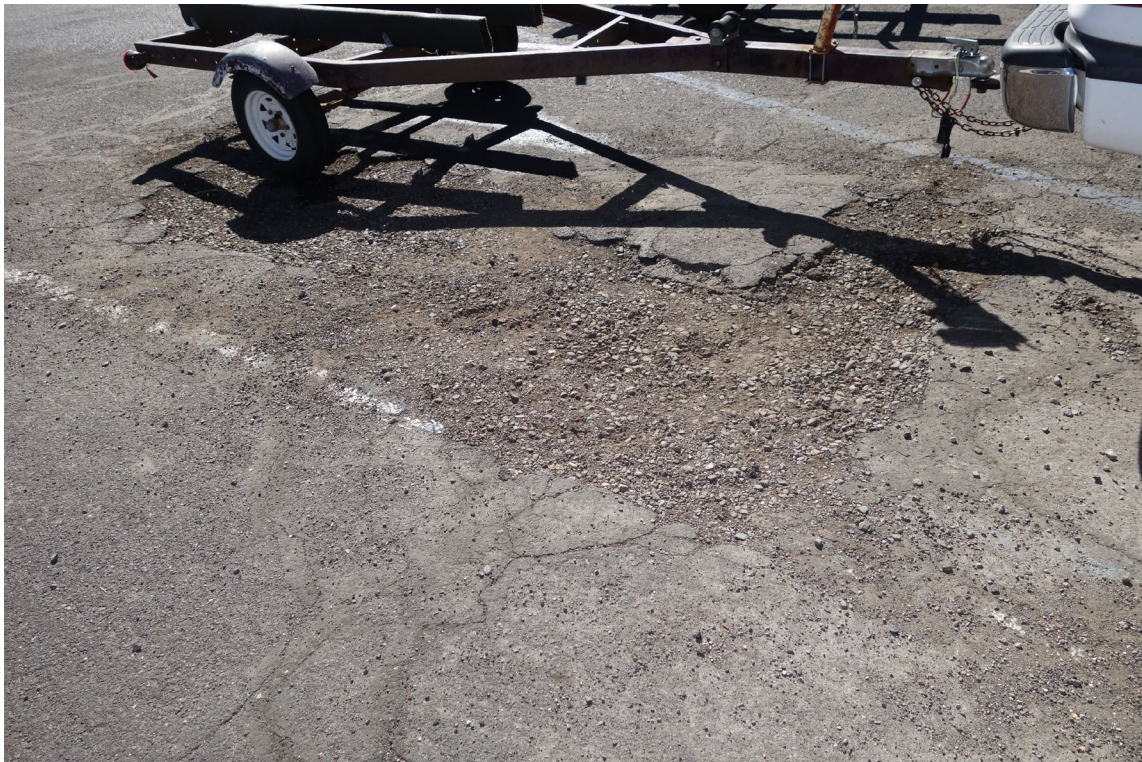
Lake Tahoe Nevada State Park – Cave Rock Site – FCA Site #9926
Description: Crack Fill & Seal - Paving Repair.

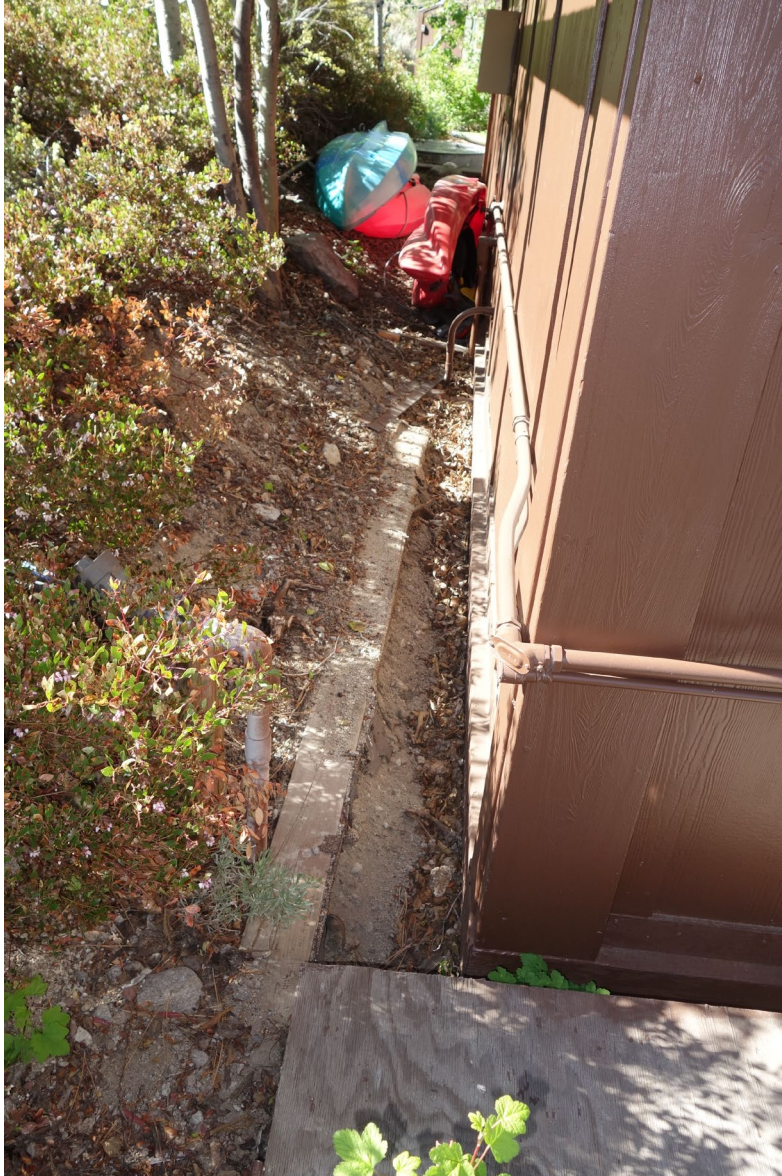
The grade does not slope away effectively from the east side of the Comfort Station. It is recommended per IBC 1804.4 grading the ground immediately adjacent to the foundation shall be sloped away from the building at a slope of not less than one vertical unit in 20 units horizontal (5-percent slope). It is recommended that the grading be completed within 2 - 3 years.

Cave Rock Comfort Station – FCA Building #0597
Description: Site Drainage Upgrades.

This project should be implemented concurrently with the EROSION / SLOPE MITIGATION project.

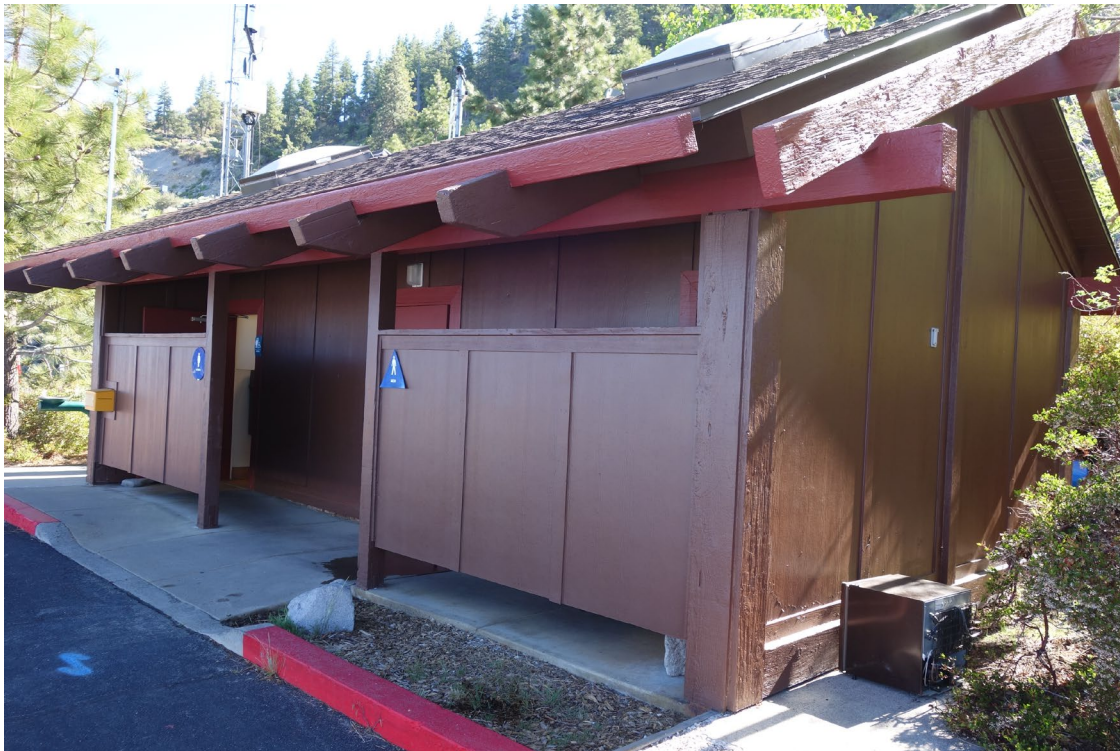
The existing Men's and Women's restrooms are not fully ADA compliant. This project would provide for modifications to the entrance into the restrooms including reworking the concrete ramp and privacy walls, installing the wall mounted dispensers at the proper location, and other improvements as required. ADA signage is also included in this estimate. The 2018 IBC, ICC/ANSI A117.1, NRS 338.180 and the most current version of the ADA Standards For Accessible Design were used as a reference for this project.

Cave Rock Comfort Station – FCA Building #0597
Description: Non-ADA compliant entrance.

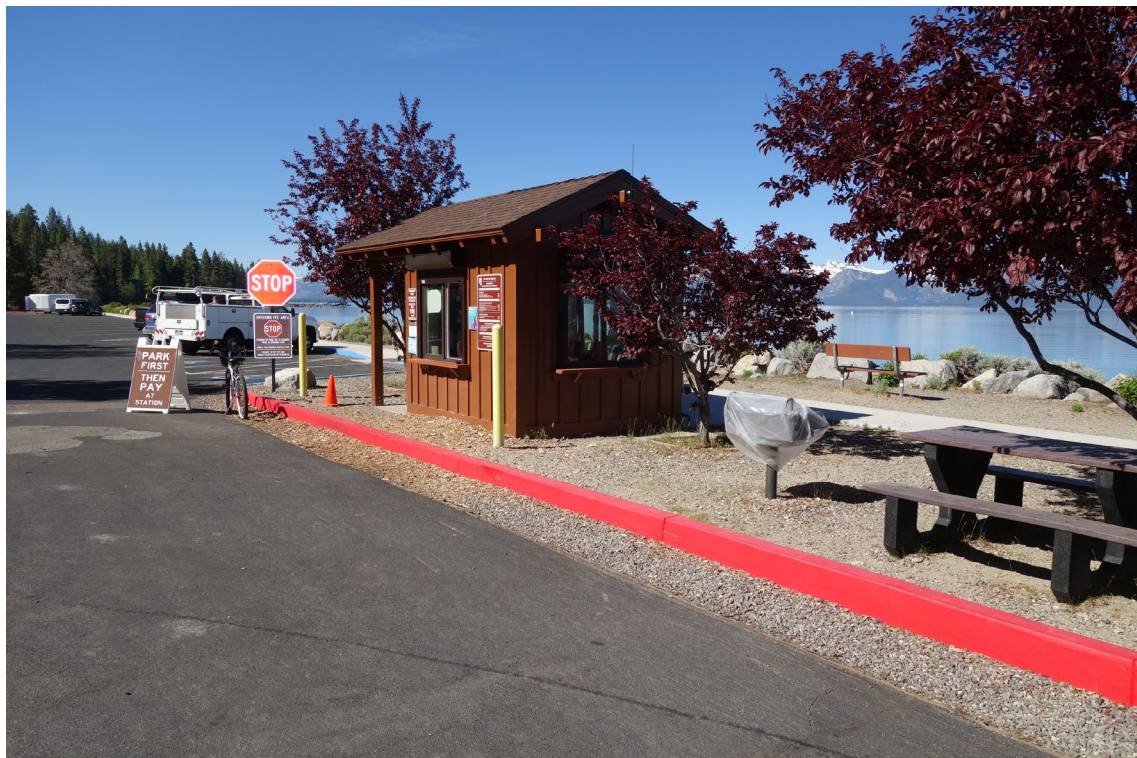
The exterior is in good condition. It is important to maintain the finish, weather resistance, and appearance of the building. This project would provide funding to protect the exterior of the building excluding the roof. Included in the cost is painting the doors, wood siding and trim, and caulking of the door frames, wood siding and trim as needed, flashing, fixtures and all other penetrations. It is recommended that the building be painted and caulked in the next 8 - 9 years and that this project be scheduled on a cyclical basis to maintain the integrity of the structure.

Cave Rock Fee Station – FCA Building #0588
Description: Exterior of the building.

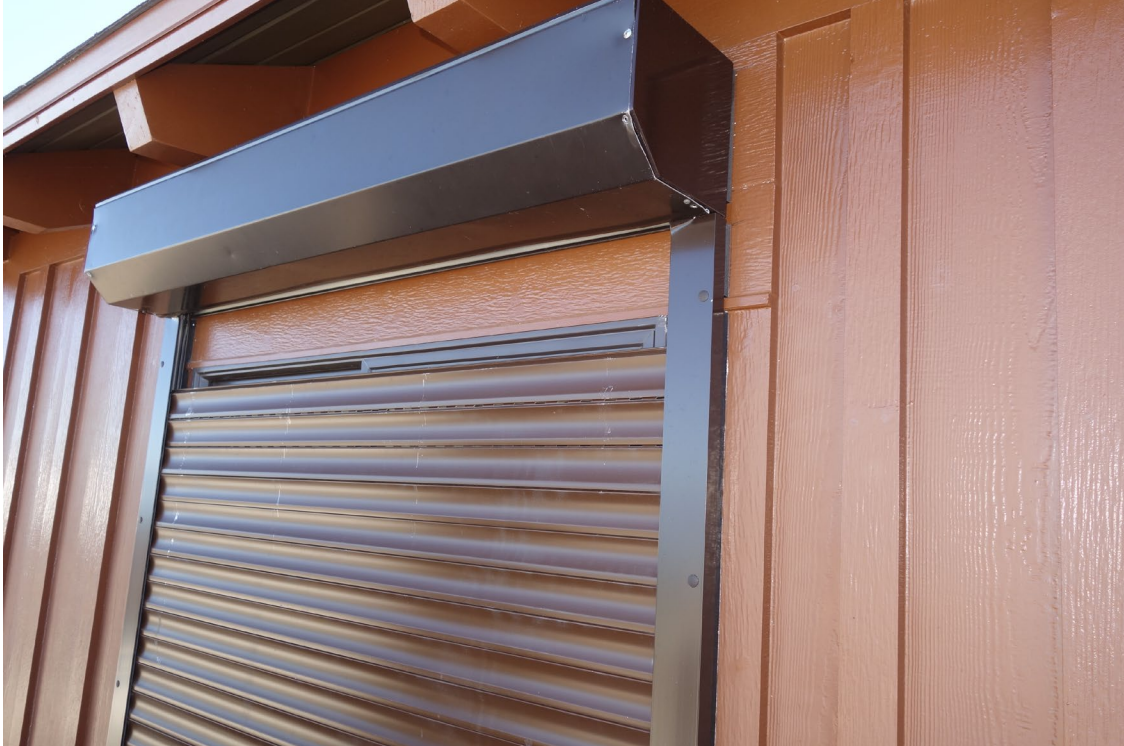
There are three overhead coiling window security sashes on the building one of which is damaged and does not function properly. It is original to the building and should be scheduled for replacement. This project would provide for the removal and disposal of one manually operated overhead coiling sash and replacement with a new manually operated overhead coiling sash. Removal and disposal of the existing door is included in this estimate.

Cave Rock Fee Station – FCA Building #0588
Description: Security Window Sash Repair.
