LAKE TAHOE NEVADA STATE PARK SAND HARBOR

2005 State Highway 28
Incline Village, Nevada

Site Number: 9927
STATE OF NEVADA PUBLIC WORKS DIVISION
FACILITY CONDITION ANALYSIS

Report distributed in December 2021

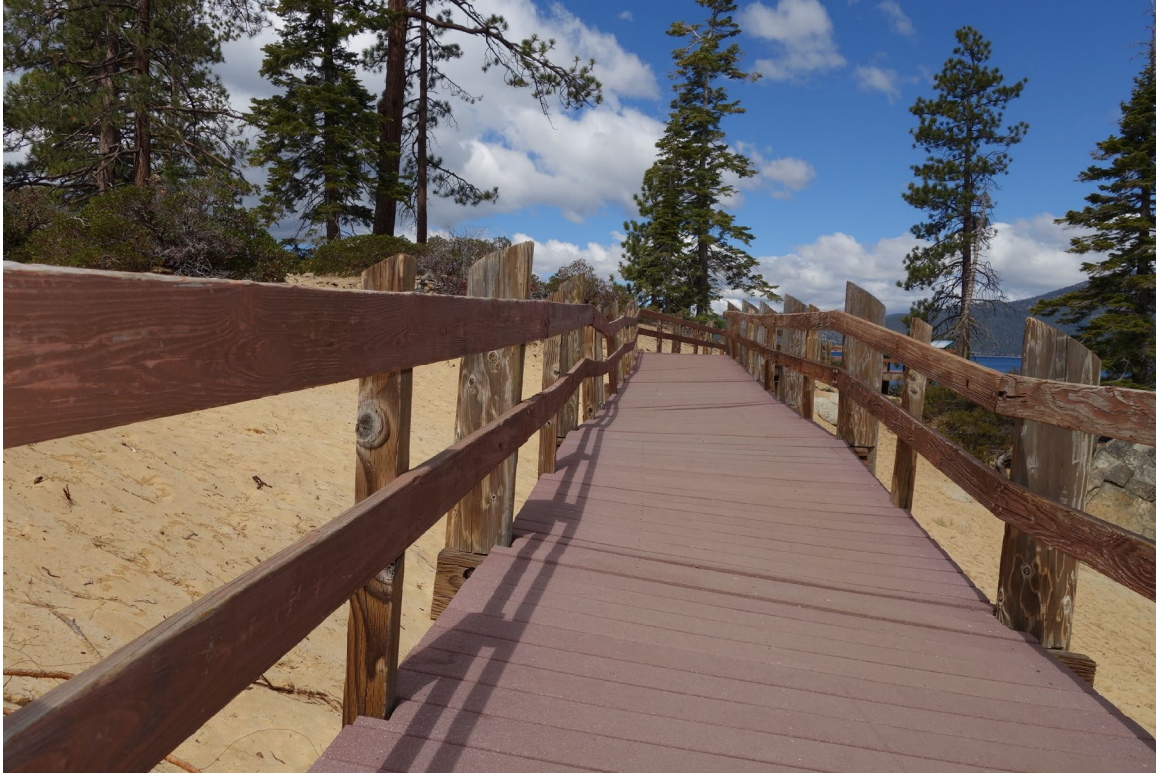
A wooden walkway originating at the Fee Booth and extending west along the north side of Sand Point is failing at the elevated portion along the beach frontage. Vertical support posts appear to be settling creating an uneven walking surface. This project addresses removal and replacement of the existing elevated walkway as needed and installation of new guards and handrails as required. 100 lineal feet of walkway replacement was used for this estimate.

Sand Harbor State Park Site – FCA Building #9927
Description: Sand Point Elevated Walkway in Need of Repairs.

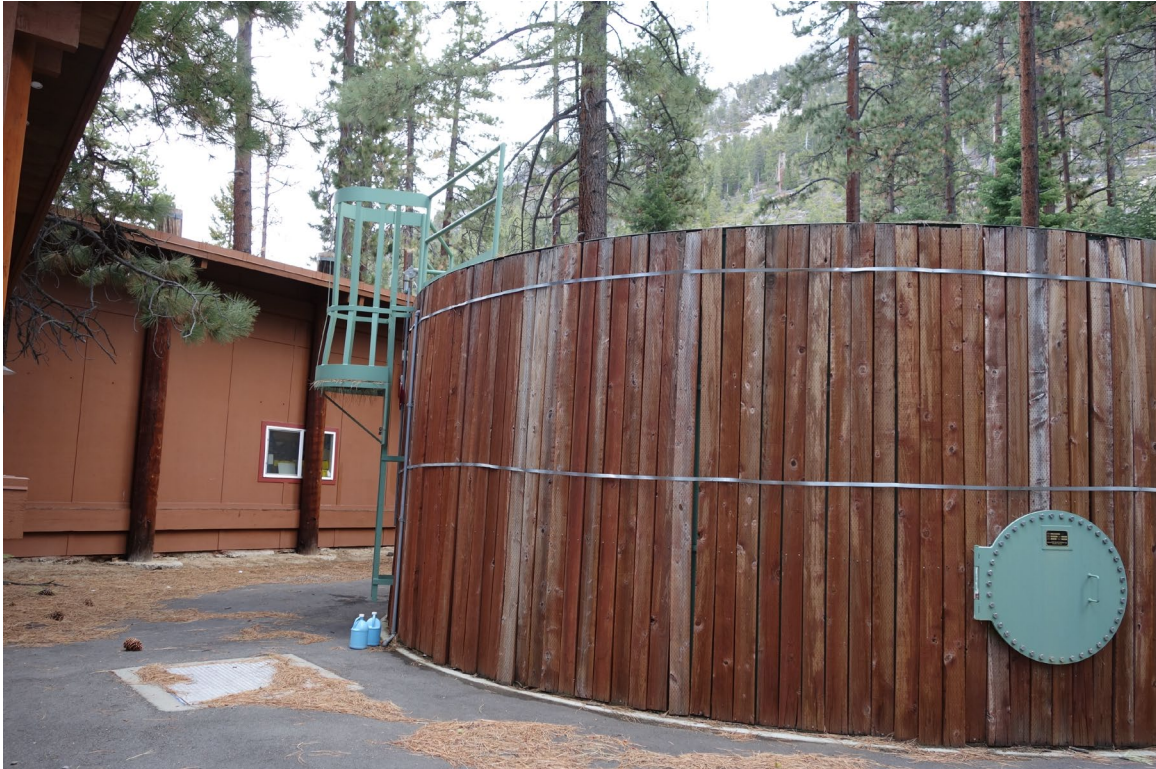
The exterior finishes were in fair condition. It is important to maintain the finish, weather resistance and appearance of the water tank. This project would provide for the painting of the water tank and the fence surrounding it to maintain it in a good, weather tight condition. It is recommended that this project be implemented in the next 4 - 6 years and is recommended on a cyclical basis based on environmental conditions. The square footage used is the area of the water tank walls (1,120 s.f.) plus the area of the top of the tank (700 s.f.) plus the area of the fence (1,120 s.f.).

Water Tank – FCA Building #2905
Description: Exterior of Structure.

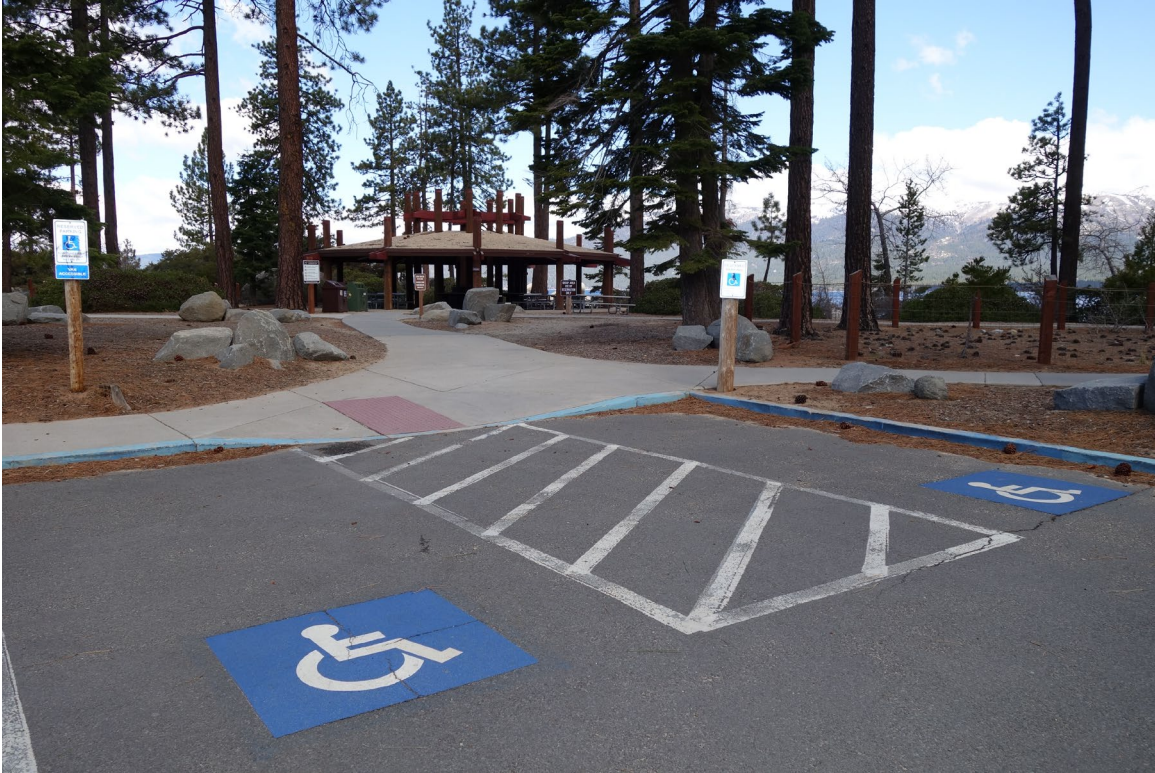
Group Use Ramada – FCA Building #2376
Description: View of Path of Travel and Accessible Parking to Structure.

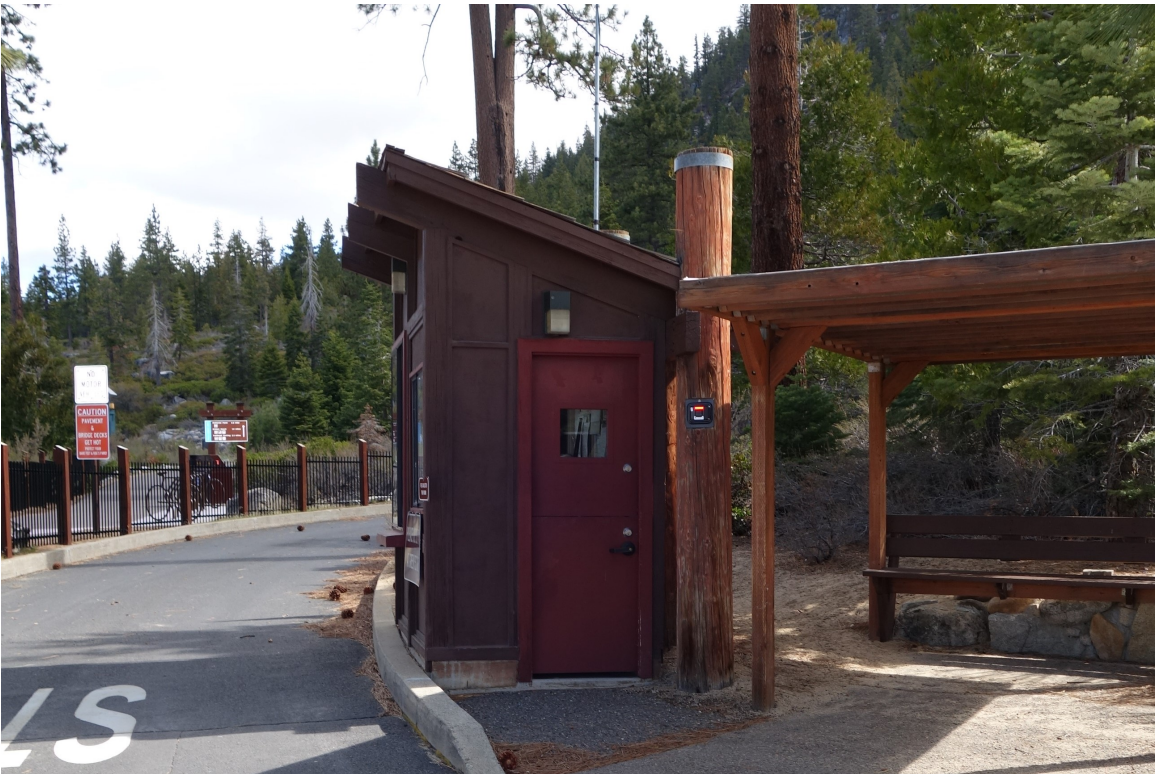
The design of the building has proven to be inadequate in both size and location. The staff regularly sits outside of the building to collect fees stating that the building is too small and uncomfortable to stay inside. The building is also too close to the access road and has been hit by vehicles, trailers and boats on many occasions. This project would provide for moving the entire structure back from the road and adding 50 square feet of floor area. A new roof should be included for the entire structure.

Boat Ramp Fee Station – FCA Building #1603
Description: Exterior of Building.

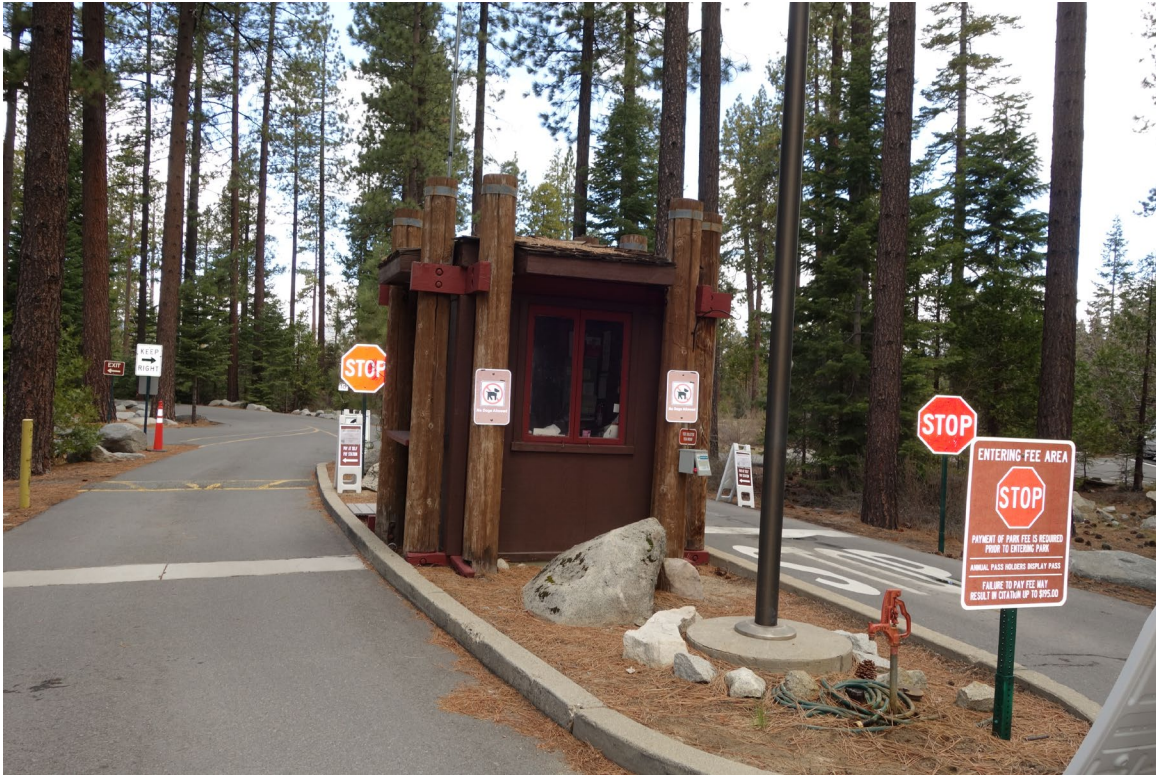
The existing exterior wood door appears to be original to the building. It is damaged from age and general wear and tear. This project would provide for the replacement and installation of a new metal door, frame and hardware. Removal and disposal of the existing door and painting of the new door is included in this estimate.

The exterior finishes were in poor condition. It is important to maintain the finish, weather resistance and appearance of the building. This project would provide funding to protect the exterior of the building, excluding the roof. Included in the cost is sanding, priming, painting and caulking of the windows, flashing, fixtures and all other penetrations. It is recommended that the building be painted in the next 2 - 3 years and that this project be scheduled on a cyclical basis to maintain the integrity of the structure.

The wood flooring in the Fee Station is damaged and reaching the end of its useful life. This project would provide for removal and disposal of the wood flooring and the installation of a new subfloor and 12x12 VCT with a 6" base.

Main Fee Station – FCA Building #1599
Description: Exterior of the Building.
