State of Nevada  
Department of Wildlife  
Ely Wildlife Old Field Office  
Facility Condition Analysis

# **ELY WILDLIFE OLD FIELD OFFICE**

**Site Number: 9933**  
**STATE OF NEVADA PUBLIC WORKS DIVISION**  
**FACILITY CONDITION ANALYSIS**

Report Printed in November 2011

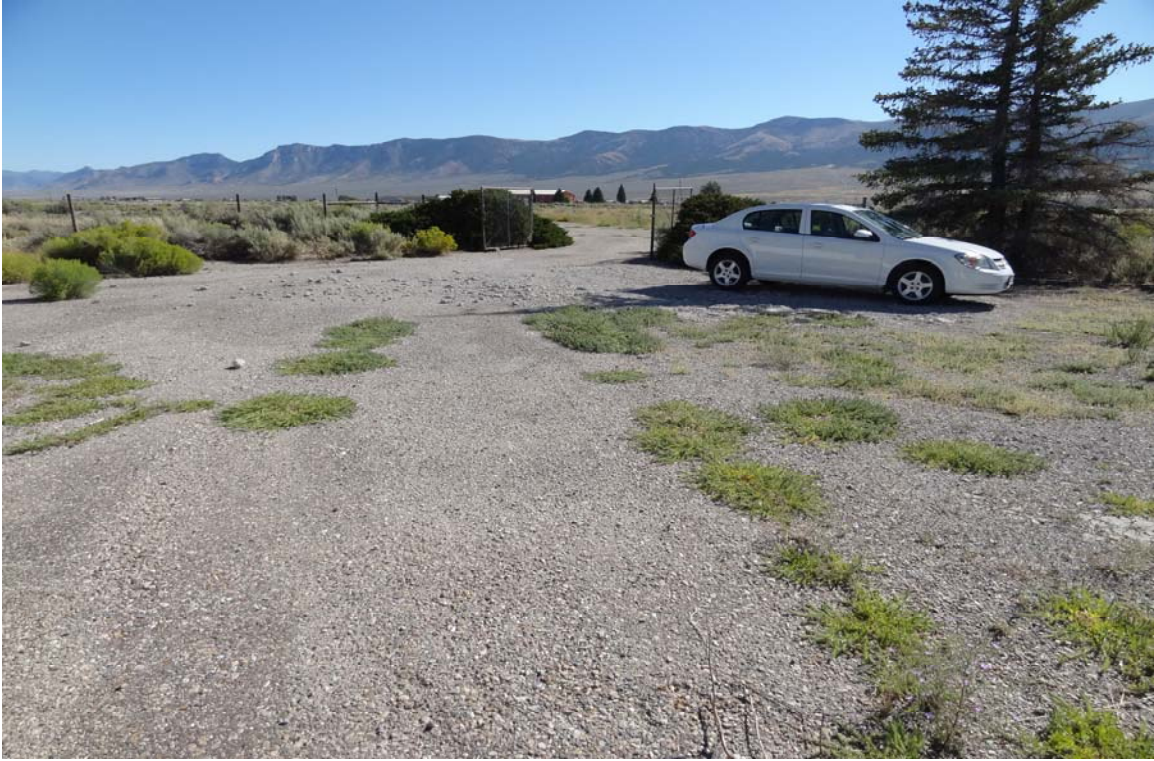
The access road and parking areas on the site are not paved. Any existing concrete or asphalt paving has deteriorated to the point of complete failure. This project would provide asphalt cement paving for a 20' wide access road and parking spaces. The estimate includes grading, 6" base, compaction and installation of 4" thick asphalt cement paving.

Ely Wildlife Old Field Office Site - Site #9933  
Description: Parking area.

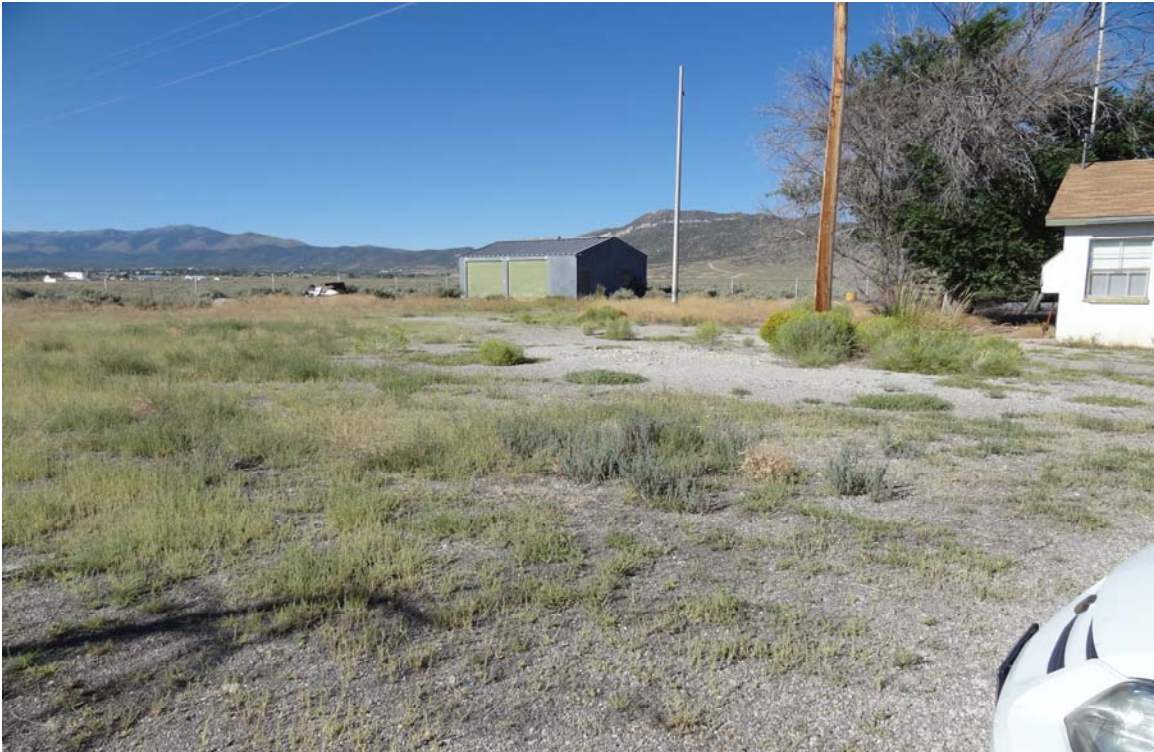
Most of the site is covered with weeds. This project would provide for the removal and disposal of the weeds on the site and treatment of the area with an herbicide to control future weed growth.

Ely Wildlife Old Field Office Site - Site #9933  
Description: Yard in need of weed abatement.

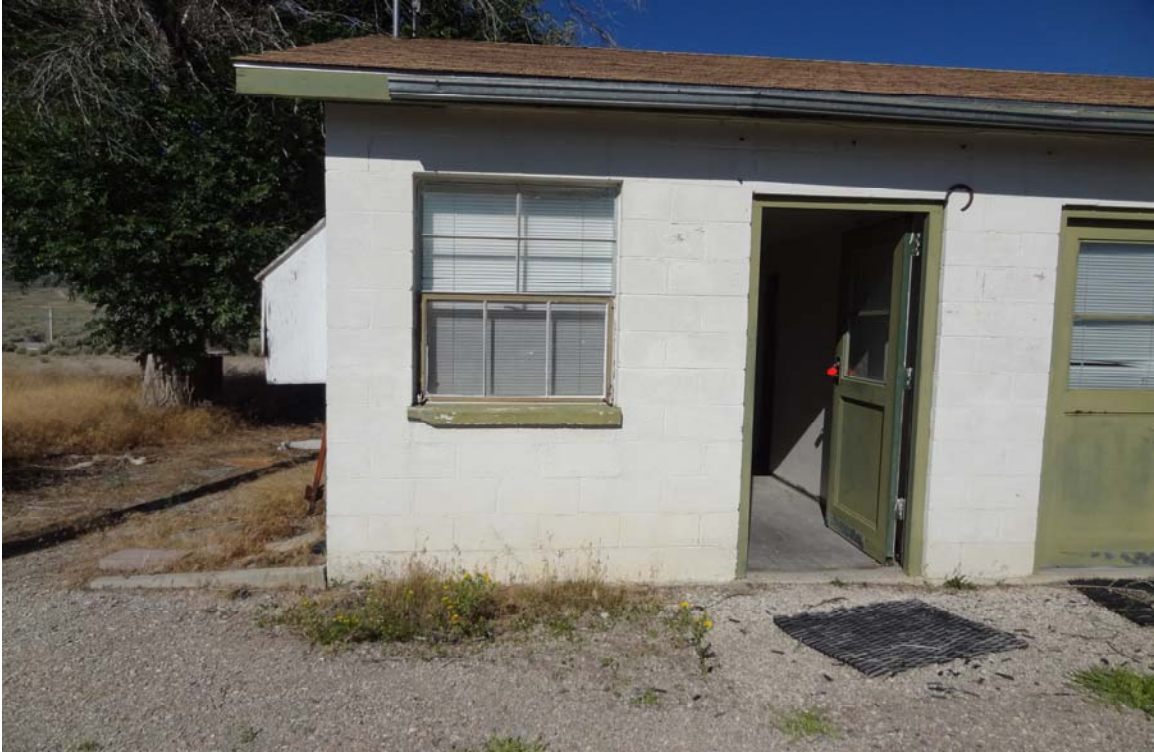
Ely Wildlife Old Field Office - Site #0635  
Description: Main entrance into office.

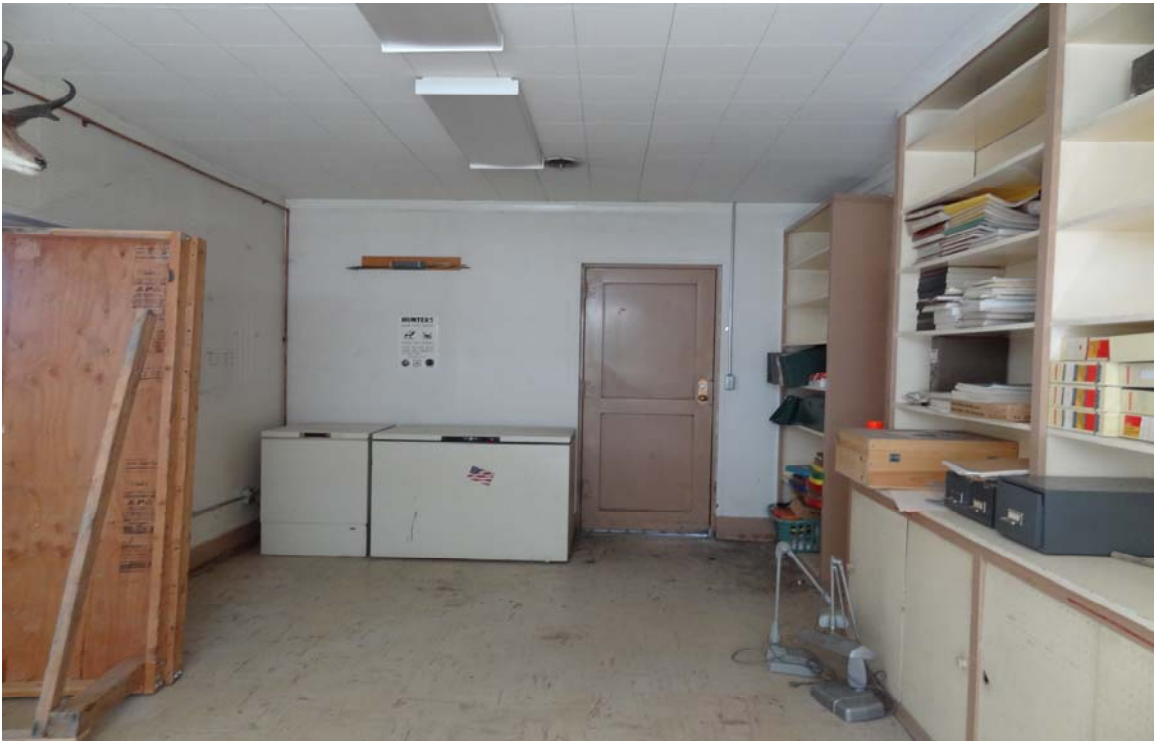
Ely Wildlife Old Field Office - Site #0635  
Description: Interior of the old office.

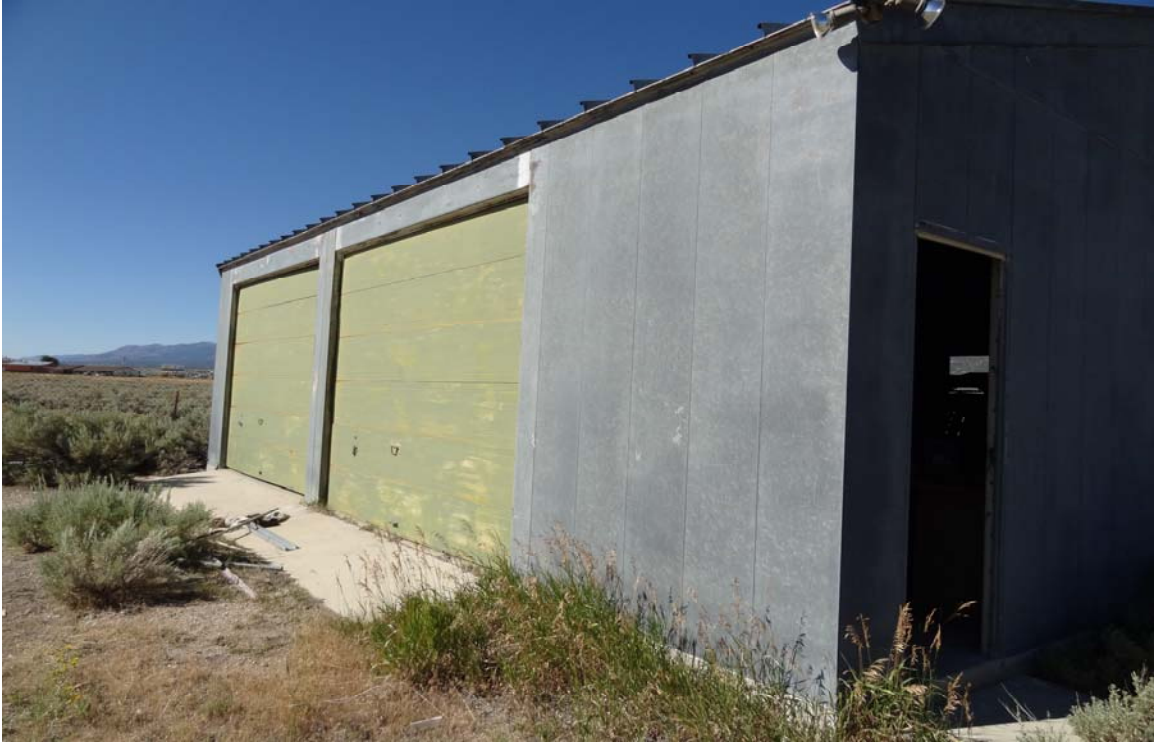
Wildlife Storage / Garage - Site #0636  
Description: Exterior of the building.

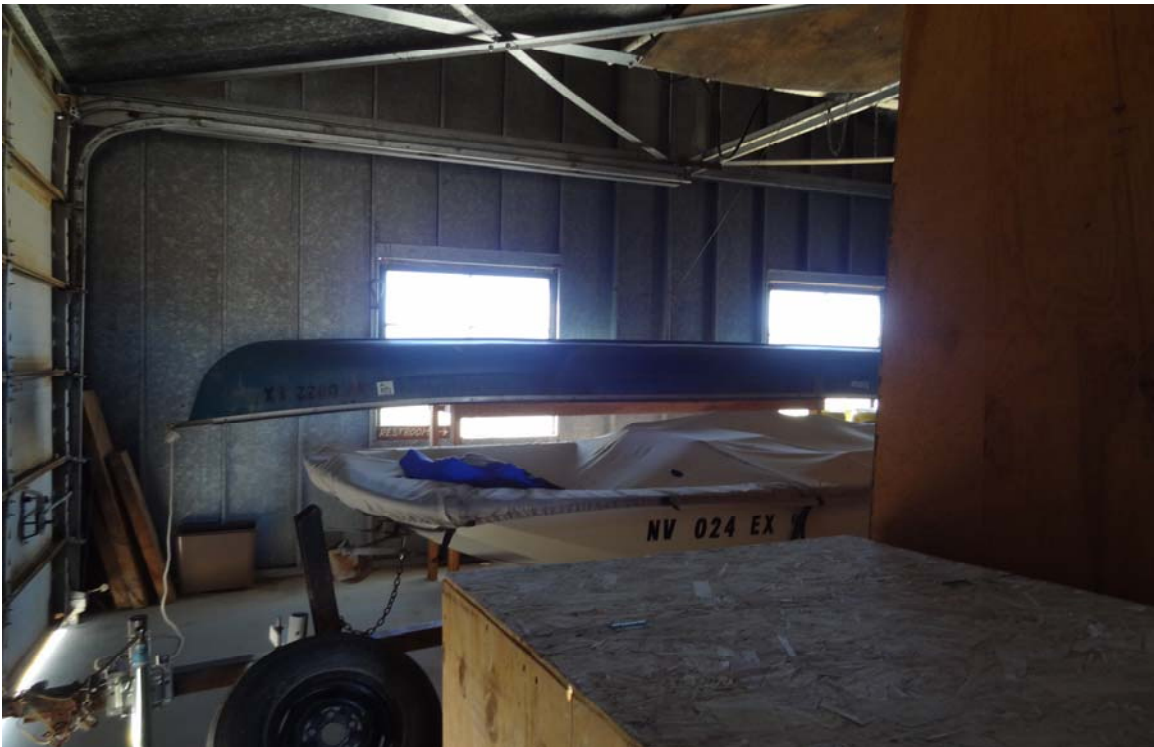
Wildlife Storage / Garage - Site #0636  
Description: Interior of the building.
