Department of Conservation and Natural Resources
Division of State Parks
Wild Horse State Recreation Area
Facility Condition Analysis

WILD HORSE STATE RECREATION AREA

Site Number: 9935 STATE OF NEVADA PUBLIC WORKS DIVISION FACILITY CONDITION ANALYSIS

Survey Date: 7/23/2014

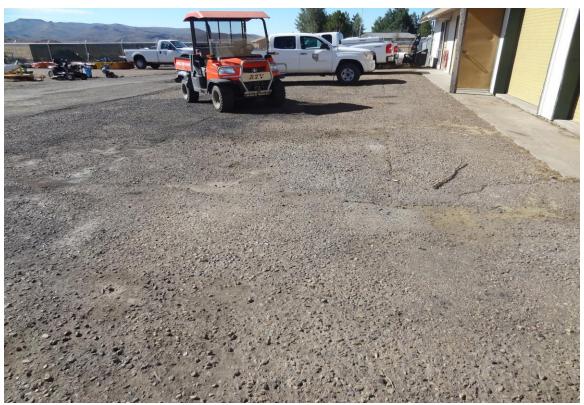
The AC paying behind the visitors center has failed and is in need of replacement. This project would provide for the removal of the damaged paving and installation of new 3" thick AC paving over a compacted base. It may be possible to grind in place the damaged paving and use for base which could reduce project cost.

Wild Horse State Recreation Area Site – FCA Site #9935 Description: AC paving in need of removal and replacement.

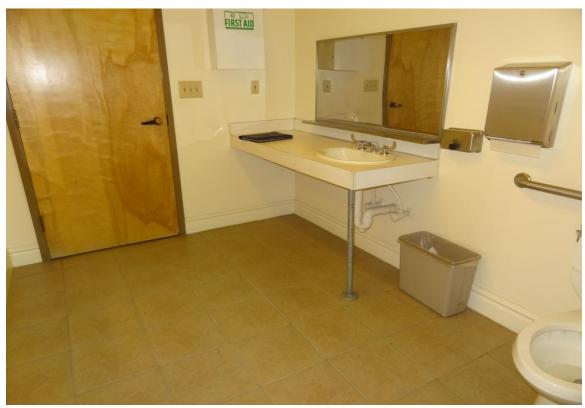
Park Office / Shop – FCA Building #1315 Description: View of the restroom.
