State of Nevada
Department of Health & Human Services
Division of Child & Family Services
Nevada Youth Training Center
Facility Condition Analysis

NEVADA YOUTH TRAINING CENTER

100 Youth Center Road
Elko, Nevada 89801

Site Number: 9938
STATE OF NEVADA PUBLIC WORKS DIVISION
FACILITY CONDITION ANALYSIS

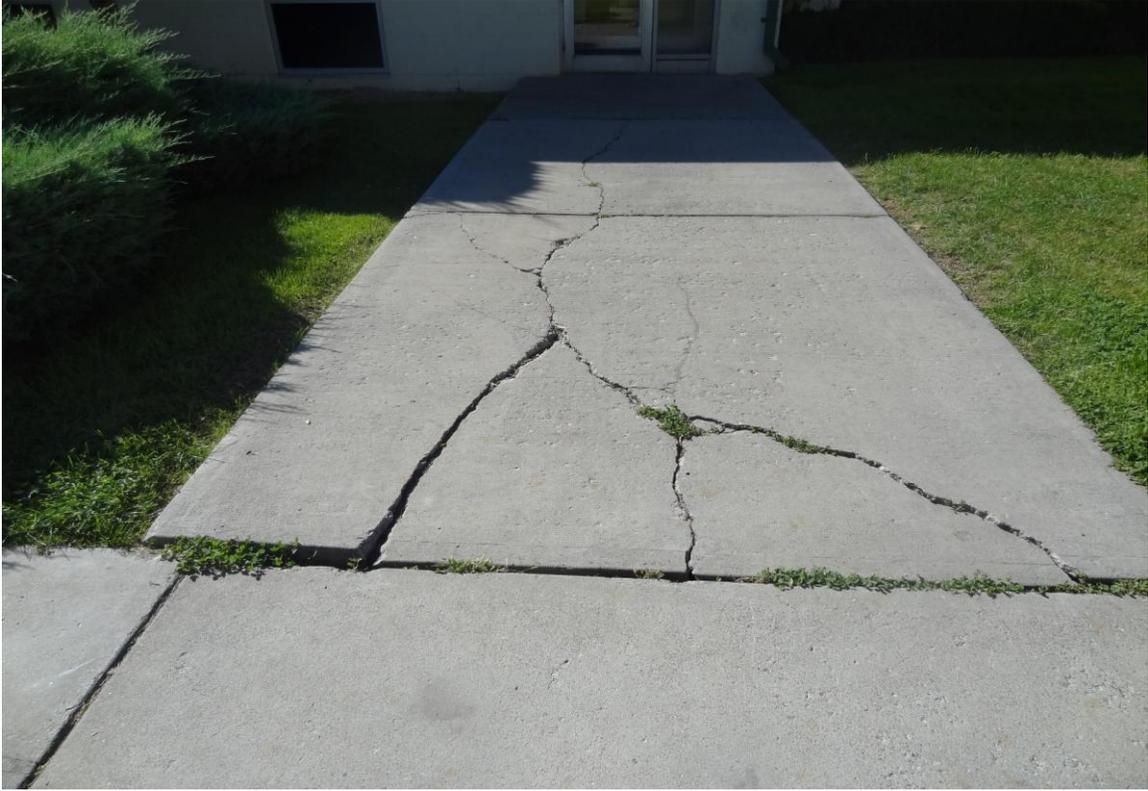
The site has several areas of damaged concrete sidewalks that have not been replaced recently. These areas pose tripping hazards from heaving and settling and the cracks will continue to grow from freeze/ thaw impacts. This project would provide for the removal and replacement of the damaged concrete sidewalks. 5,000 SF of 4" thick concrete sidewalk was used for this estimate.

Nevada Youth Training Center Site – FCA Site #9938
Description: Damaged concrete walkway at entrance to housing unit.

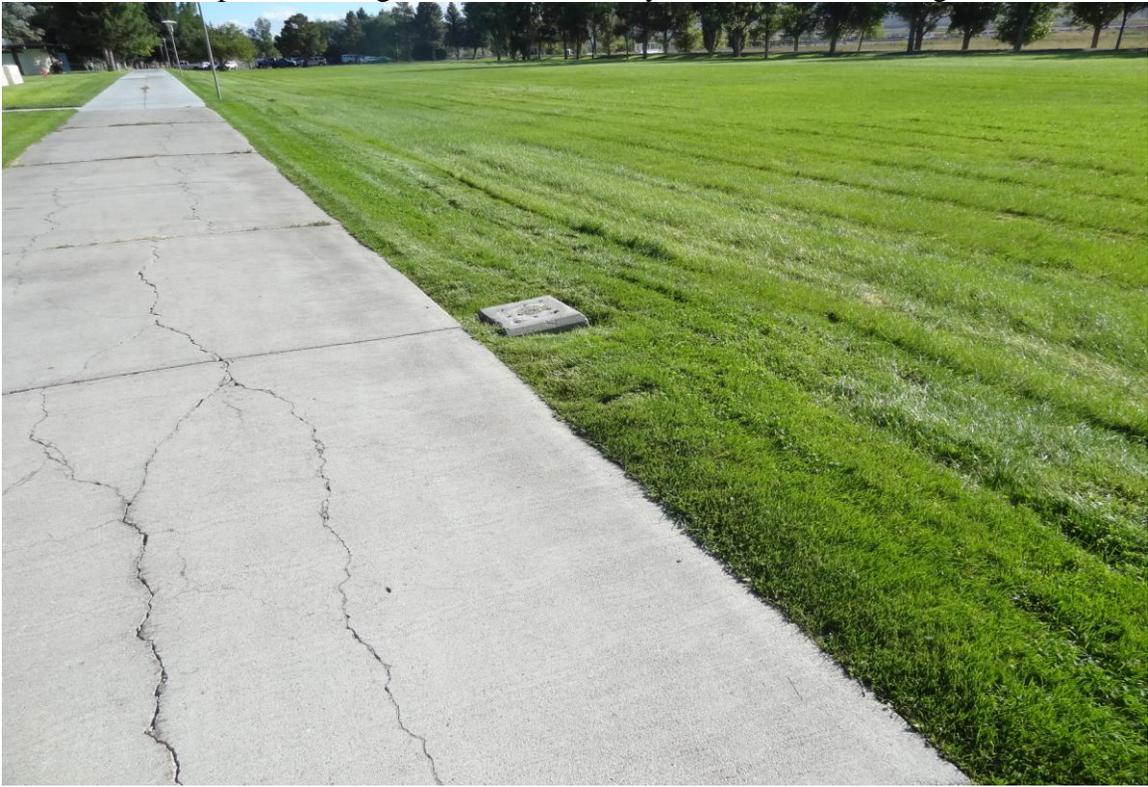
There many existing light poles around the site which have caused continuous maintenance problems and some are not working. Problems include failing contactors, unavailable replacement parts, failing conduits and rusted metal poles. Due to insufficient lighting and cracked and heaving concrete sidewalks, there have been tripping hazards and complaints from individuals on the campus. This project would provide for the installation of 35 solar powered LED exterior light fixtures, 20 foot tall poles and 30" diameter raised concrete bases. This installation will eliminate the need for trenching and installing new electrical connections.

Nevada Youth Training Center Site – FCA Site #9938
Description: Damaged concrete walkway and missing site pole light.
