State of Nevada
Department of Conservation and Natural Resources
Division of State Parks
Facility Condition Analysis

KERSHAW-RYAN STATE PARK

Site Number: 9944
STATE OF NEVADA PUBLIC WORKS DIVISION
FACILITY CONDITION ANALYSIS

Report distributed in April 2017

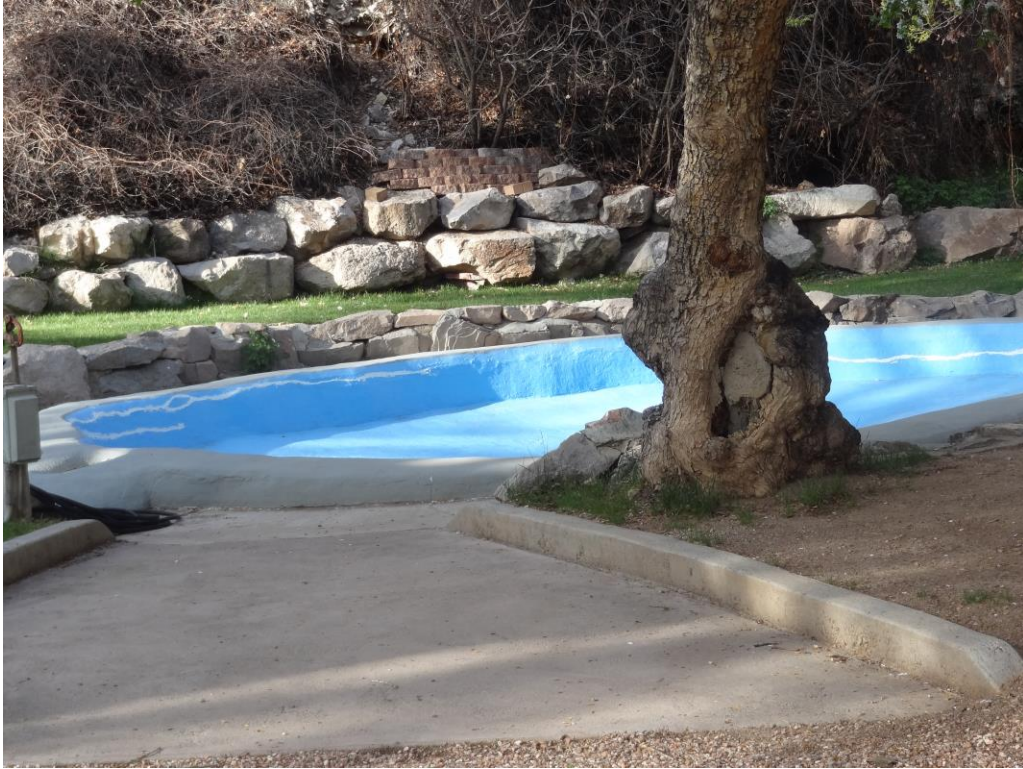
Kershaw-Ryan State Park Site - Site #9944
Description: Outdoor wading pool in need of ADA Upgrades.

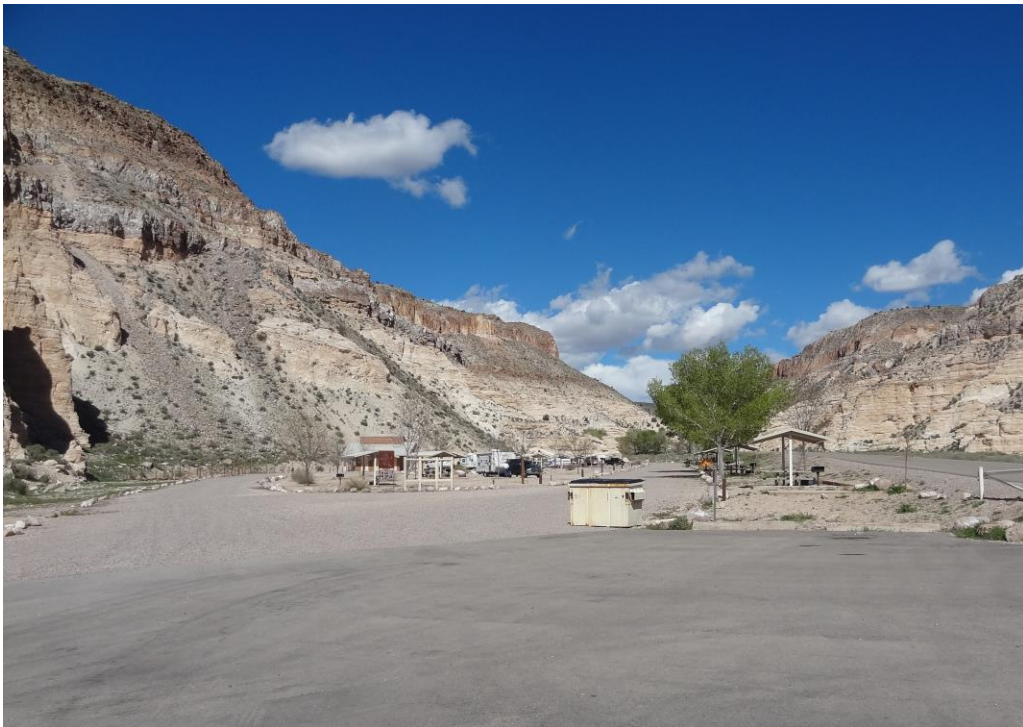
Kershaw-Ryan State Park Site - Site #9944
Description: New campground with shade ramadas and a comfort station.

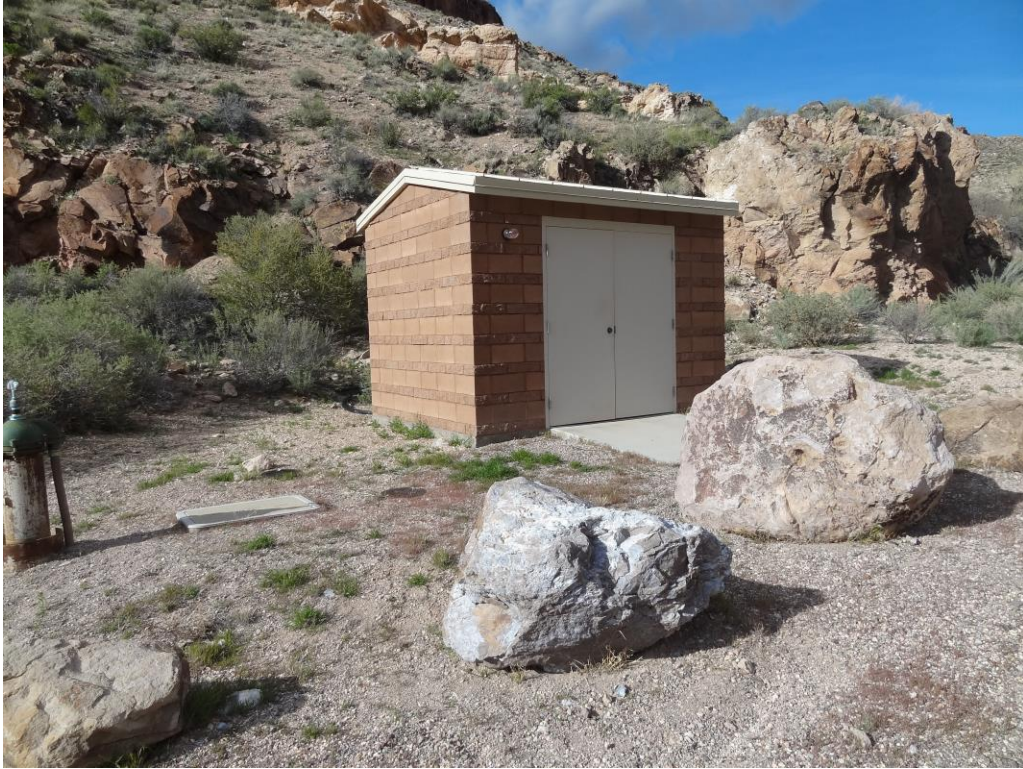
Pump House - Building #3716
Description: Exterior finishes.

It is important to maintain the finish, weather resistance and appearance of the building. This project would provide funding to protect the exterior of the building excluding the roof. Included in the cost are cleaning and sealing the concrete masonry units and caulking the flashing, fixtures and all other penetrations. It is recommended that the building be sealed and caulked in the next 4-5 years and that this project be scheduled on a cyclical basis to maintain the integrity of the structure.

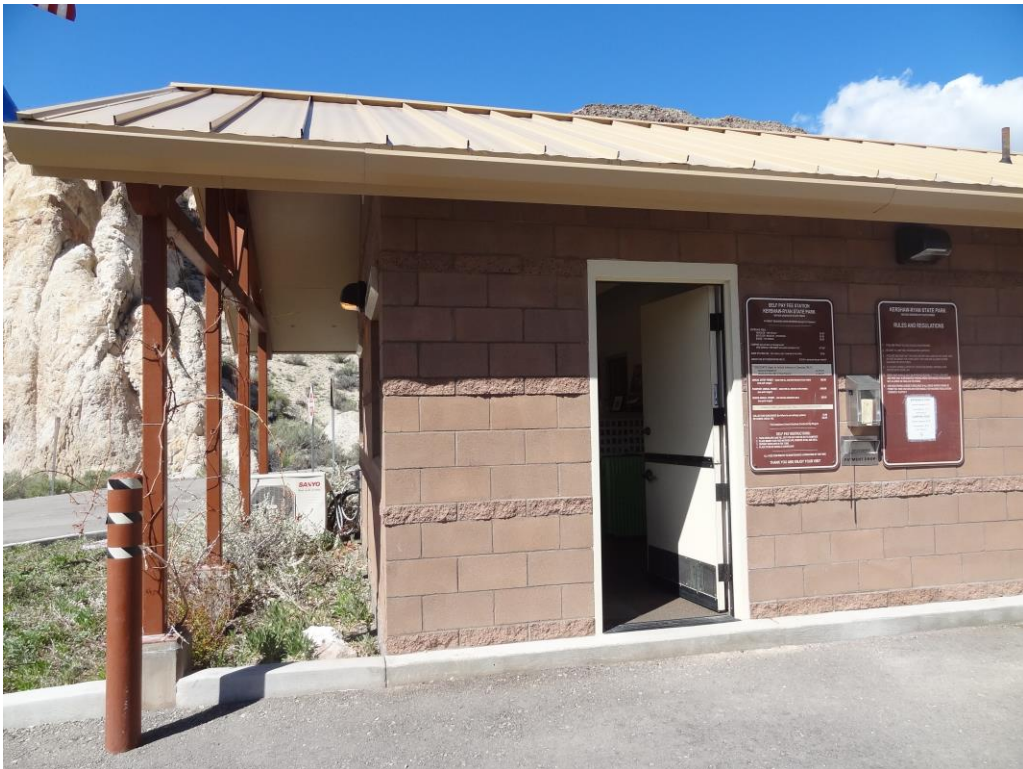
Entrance Fee Station - Building #3715
Description: Exterior finishes.

It is important to maintain the finish, weather resistance and appearance of the building. This project would provide funding to protect the exterior of the building excluding the roof. Included in the cost are cleaning and sealing the concrete masonry units and caulking of the windows, flashing, fixtures and all other penetrations. It is recommended that the building be sealed and caulked in the next 4-5 years and that this project be scheduled on a cyclical basis to maintain the integrity of the structure.

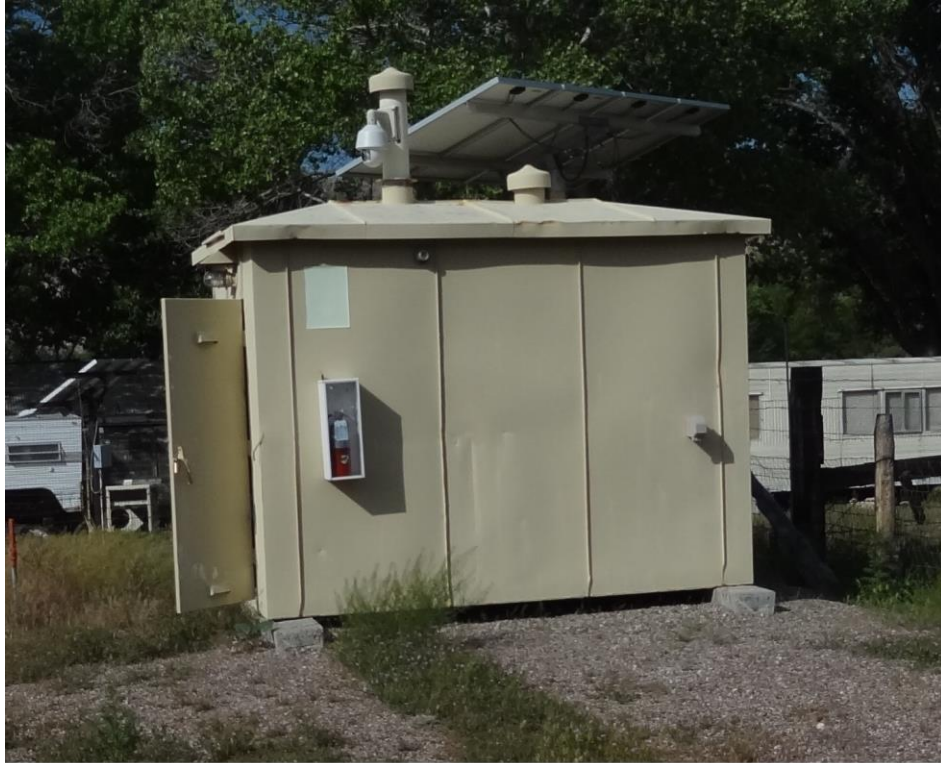
Generator Building - Building #3685
Description: Exterior finishes.

It is important to maintain the finish, weather resistance and appearance of the building. This project would provide funding to protect the exterior of the building excluding the roof. Included in the cost is the caulking and sealing of the doors, flashing, fixtures and all other penetrations. It is recommended that the building be caulked and sealed in the next 4-5 years and that this project be scheduled on a cyclical basis to maintain the integrity of the structure.

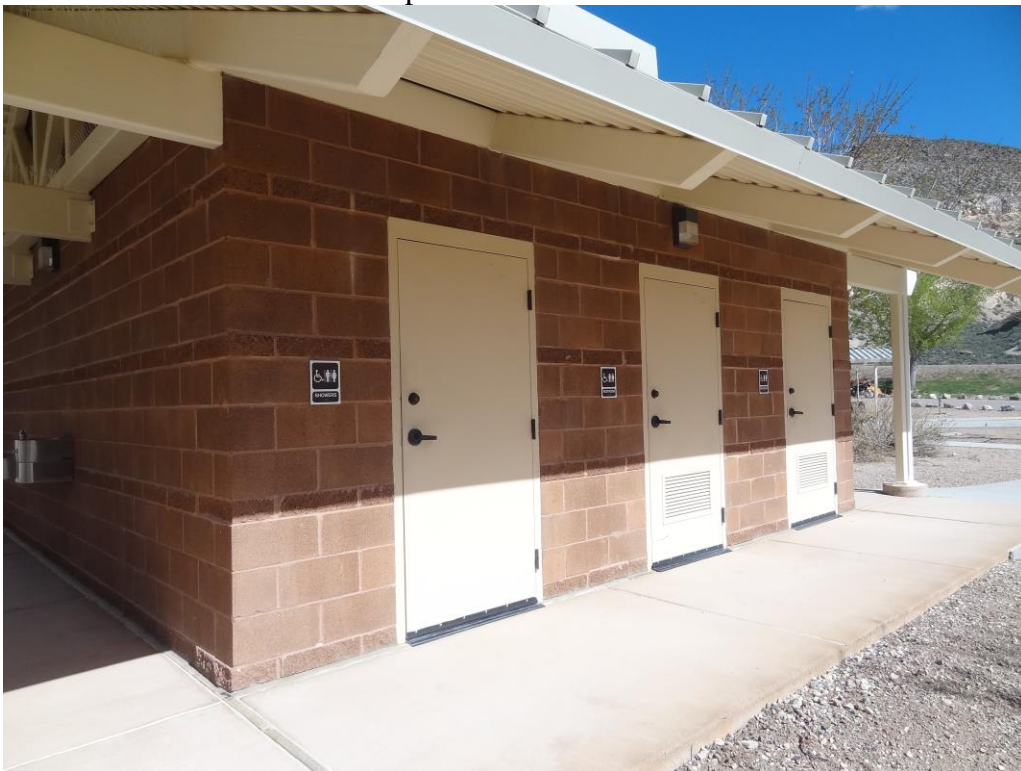
Comfort Station #2 - Lower - Building #2934
Description: Exterior finishes.

It is important to maintain the finish, weather resistance and appearance of the building. This project would provide funding to protect the exterior of the building excluding the roof. Included in the cost are cleaning and sealing the concrete masonry units and caulking of the windows, flashing, fixtures and all other penetrations. It is recommended that the building be sealed and caulked in the next 2-3 years and that this project be scheduled on a cyclical basis to maintain the integrity of the structure.

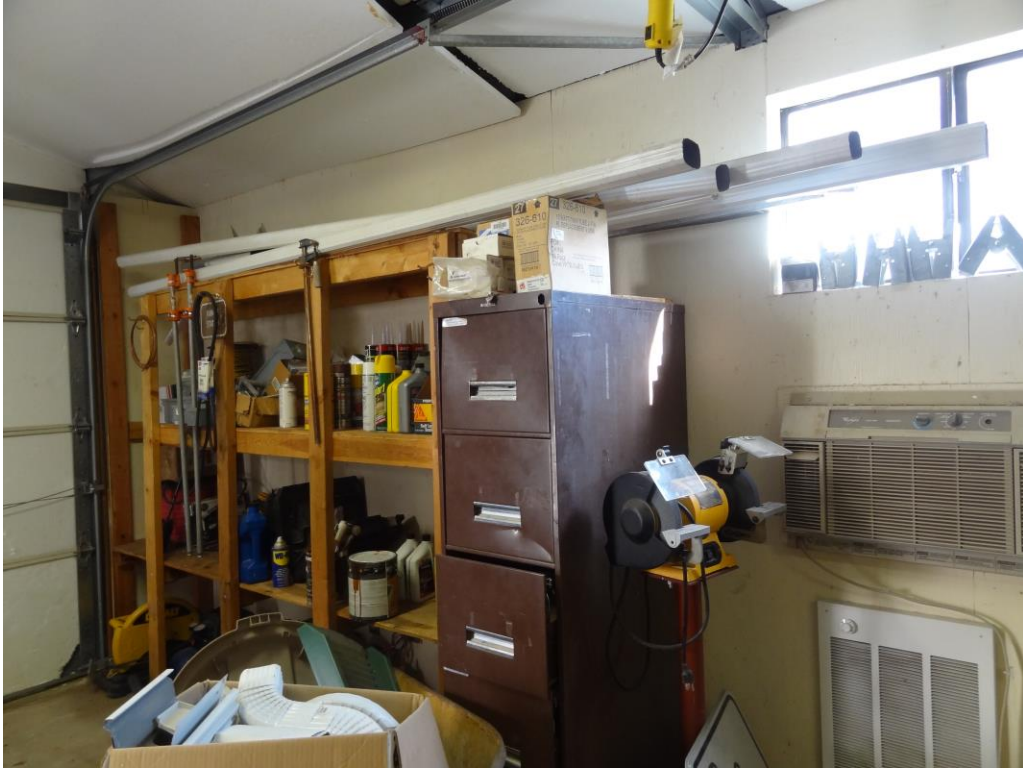
Park Maintenance Building - Building #2930
Description: Interior finishes.

It is recommended that the interior walls and ceilings be painted at least once in the next 2-3 years and every 5-7 years thereafter to maintain the integrity of the interior of the building. Prior to painting, all surfaces should be repaired and prepped. An epoxy-based paint should be utilized in wet areas for durability. This project or a portion thereof was previously recommended in the FCA report dated 09/16/2008. It has been amended accordingly to reflect conditions observed during the most recent survey date of 04/12/2016.

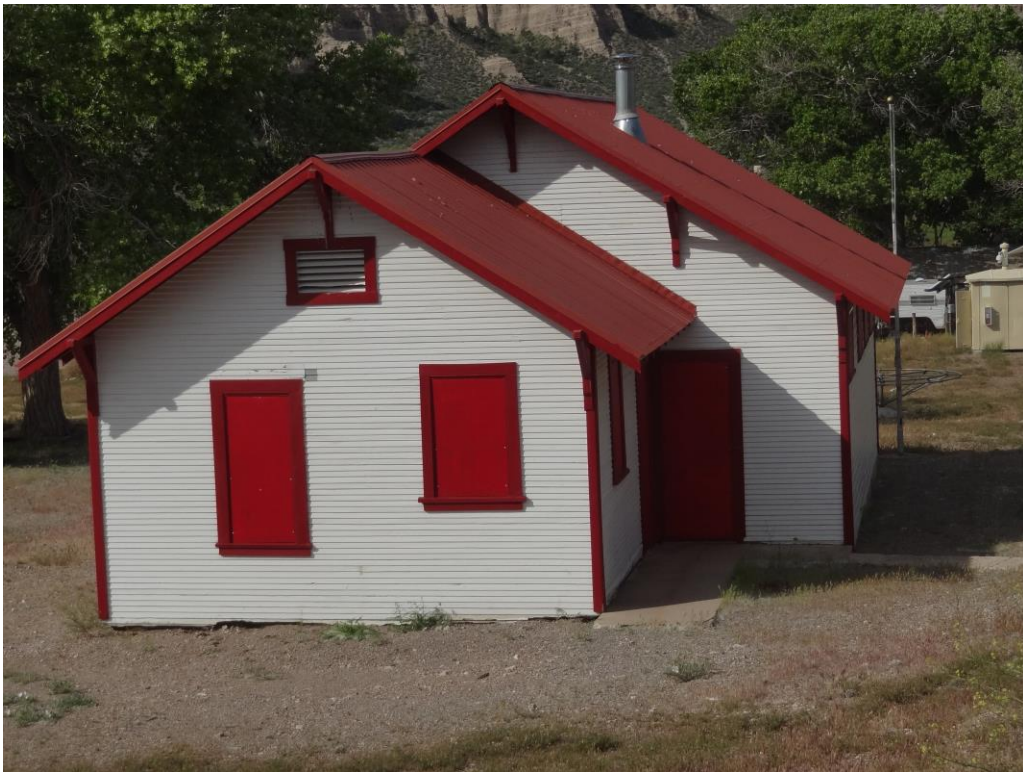
The addition to the backside of the Elgin Schoolhouse has wood to earth contact. This can lead to wood rot and insect infestation. Per 2012 International Building Code (IBC) Section 2304 wood siding, clearance between wood siding and earth on the exterior of the building shall not be less than 6 inches; wood shall be protected from decay and termites. This project will remove the addition on the backside of the Elgin Schoolhouse. A concrete foundation will be poured and the addition will be installed on top of the new concrete foundation.

Elgin School House - Building #2537
Description: Rear addition in need of a concrete foundation.

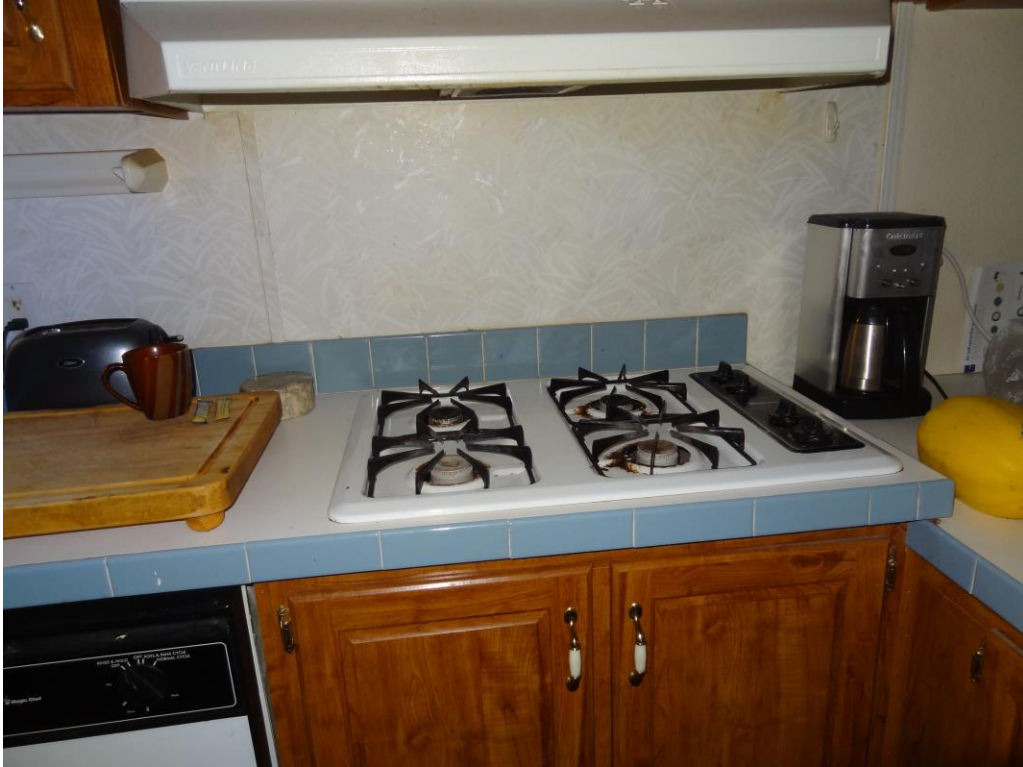
Park Residence - Building #2252
Description: Residential kitchen due for a remodel.

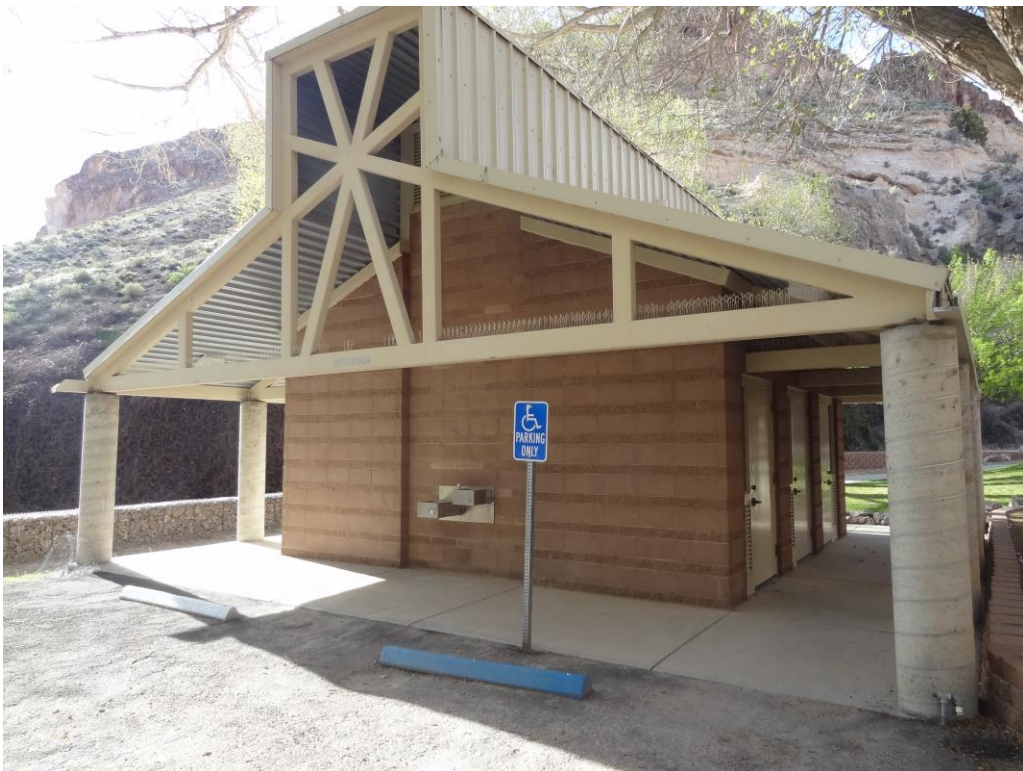
Comfort Station #1 - Upper - Building #0552
Description: Exterior finishes and ADA parking space.

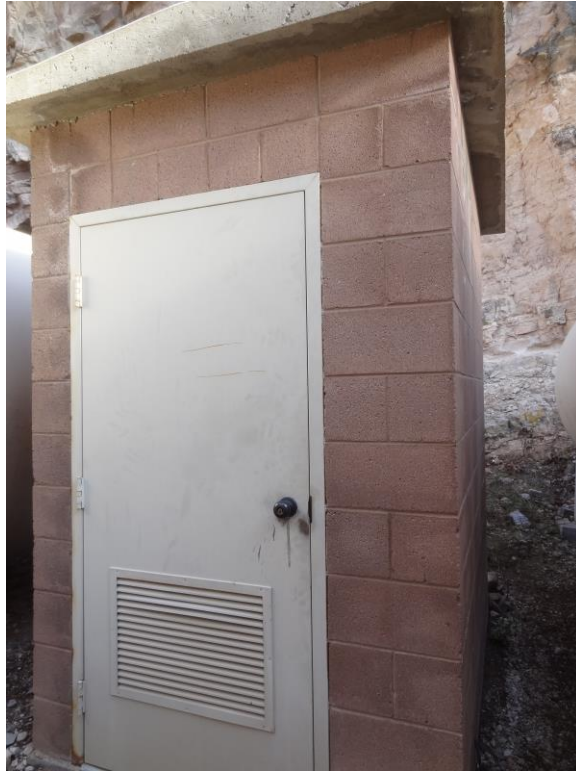
Brick Pump House - Building #0529
Description: Exterior finishes.
