CATHEDRAL GORGE STATE PARK

Site Number: 9947
STATE OF NEVADA PUBLIC WORKS DIVISION
FACILITY CONDITION ANALYSIS

Report distributed in May 2021

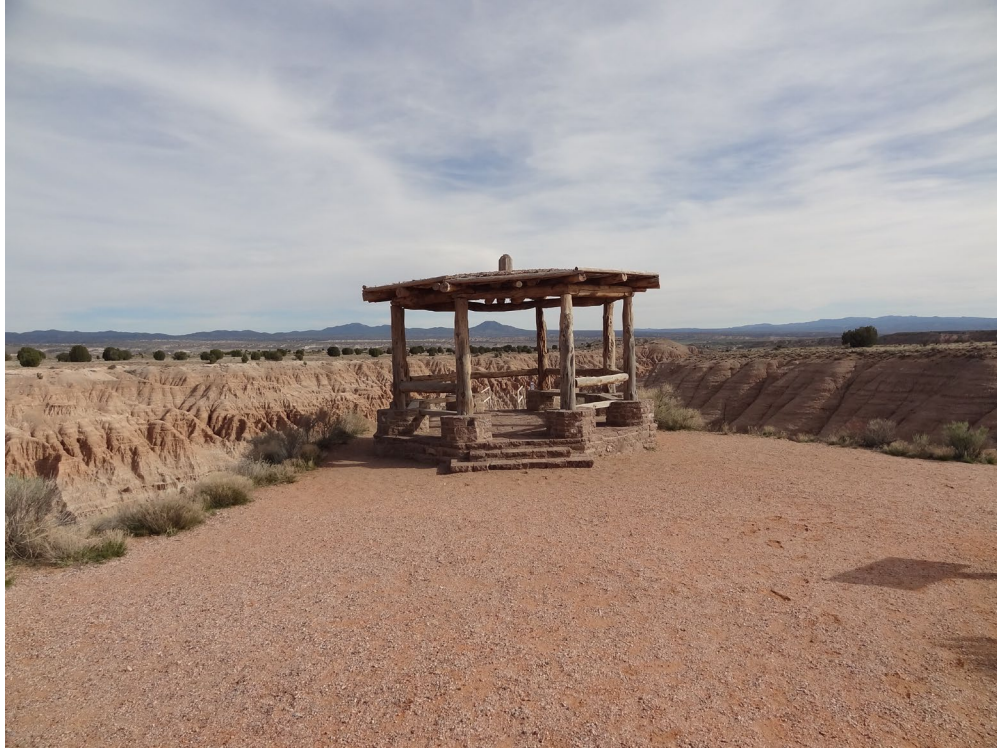
At the Miller Point Overlook, there are no sidewalks or handrails. This is creating a safety hazard due to erosion. This project recommends for the installation of erosion control, new handrails, sidewalks, ramps and for the proper returns and supports to be installed. The 2018 IBC, ICC/ANSI A117.1 - 2009, NRS 338.180 and the most current version of the ADA Standards for Accessible Design were used as references for this project.

Cathedral Gorge State Park - Site #9947
Description: Miller Point Sidewalk, Handrail & Erosion Control Project.

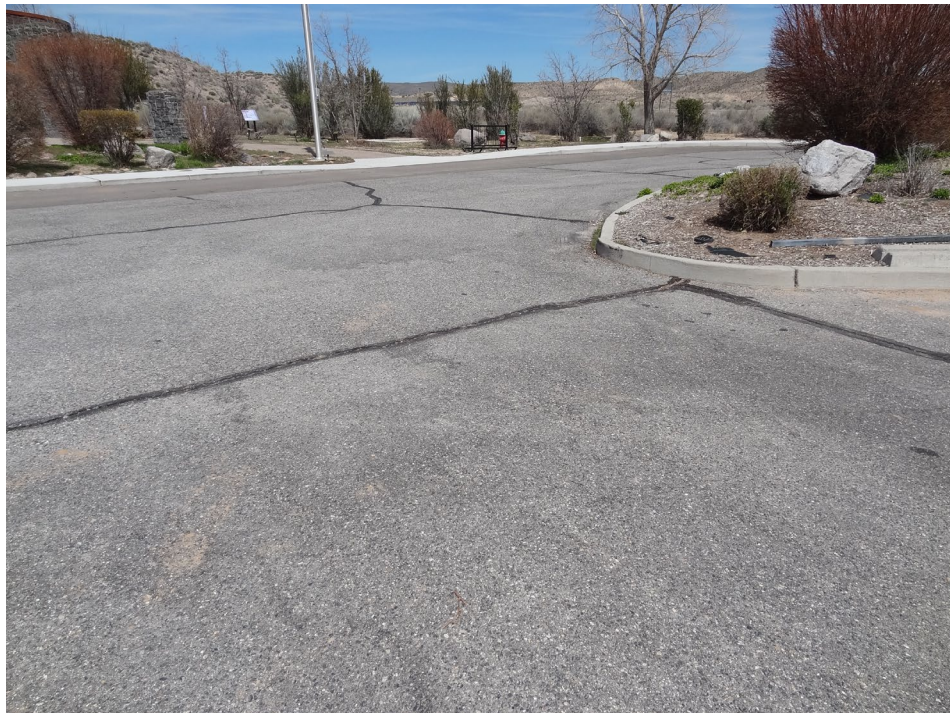
It is important to maintain the asphalt cement paving on the site. This project would provide for minor crack filling and slurry sealing of the paving site wide including access roads, parking areas and the maintenance yard. Striping is included in this estimate. This project should be scheduled on a 5 year cyclical basis to maintain the integrity of the paving and prevent premature failure. 172,500 square feet of asphalt area was used to generate this estimate.

Cathedral Gorge State Park - Site #9947
Description: Slurry Seal Asphalt Paving.

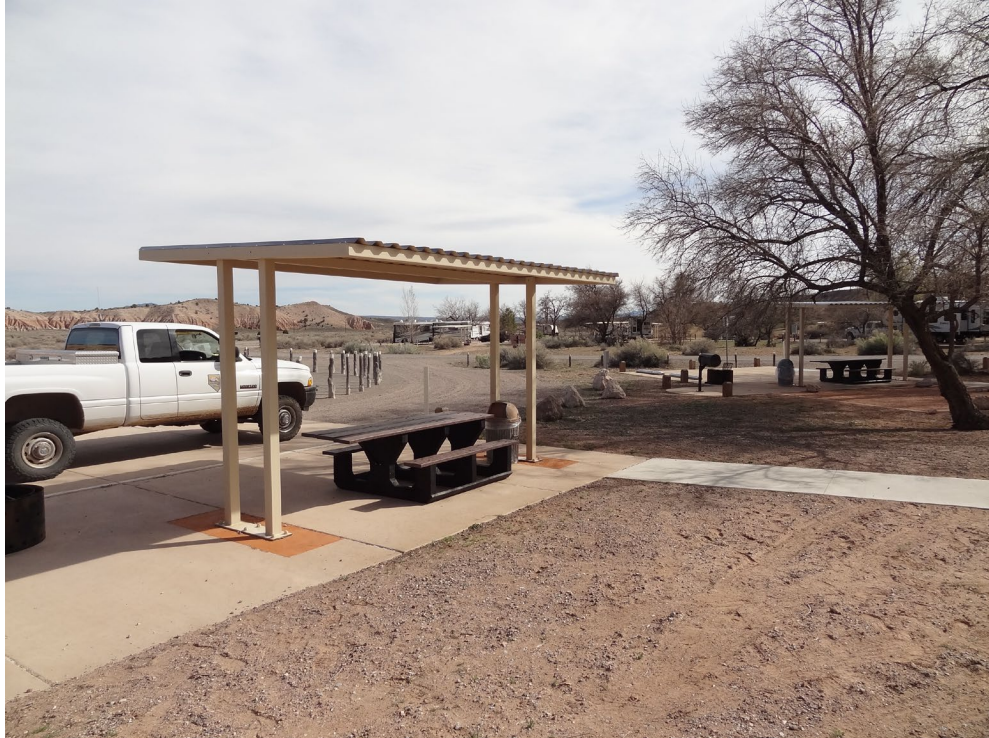
There are 28 steel shade ramadas in different locations throughout the site which are 151 s.f. each for a total of 4,228 square feet. It is important to maintain the finish, weather resistance and appearance of the structures. This project would provide for painting of the structures and it is recommended that this project be scheduled on a cyclical basis to maintain the integrity of the structures.

Cathedral Gorge State Park - Site #9947
Description: Exterior Finishes of Typical Shade Ramadas.

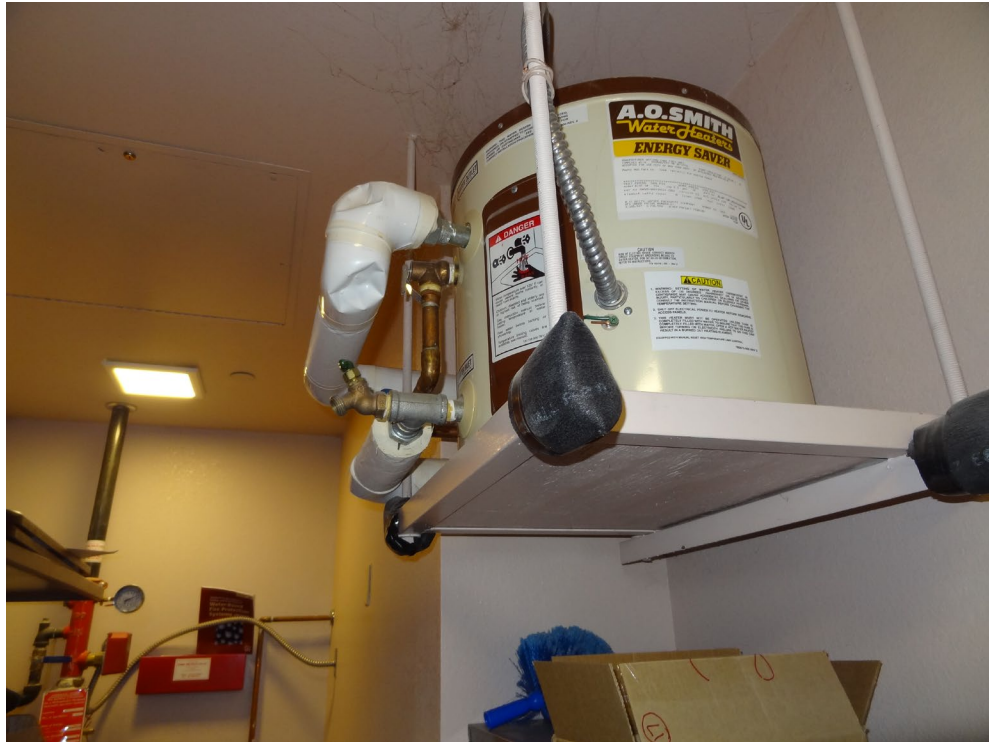
Regional Information Center - Building #0273
Description: Water Heater Replacement.

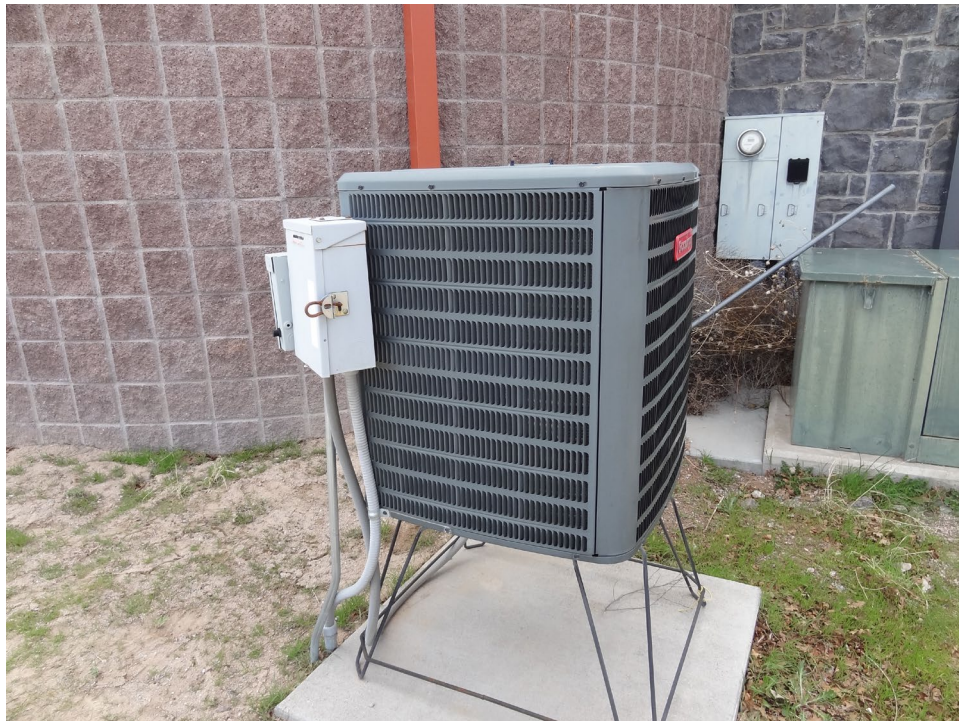
Regional Information Center - Building #0273
Description: HVAC Equipment Replacement.

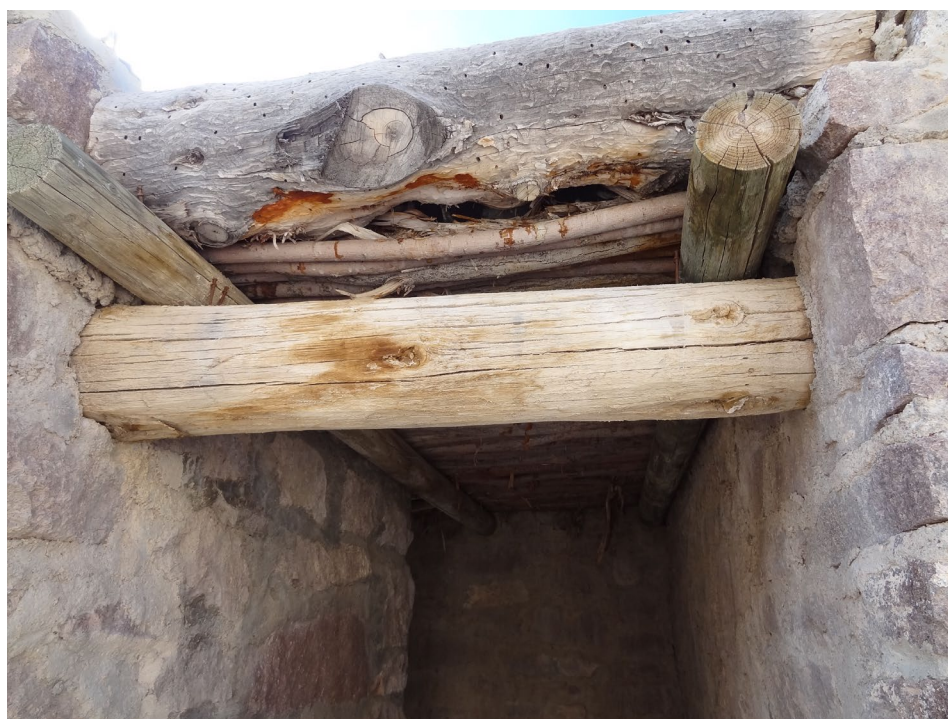
Comfort Station #1 - CCC - Building #1036
Description: Structural Retrofit.

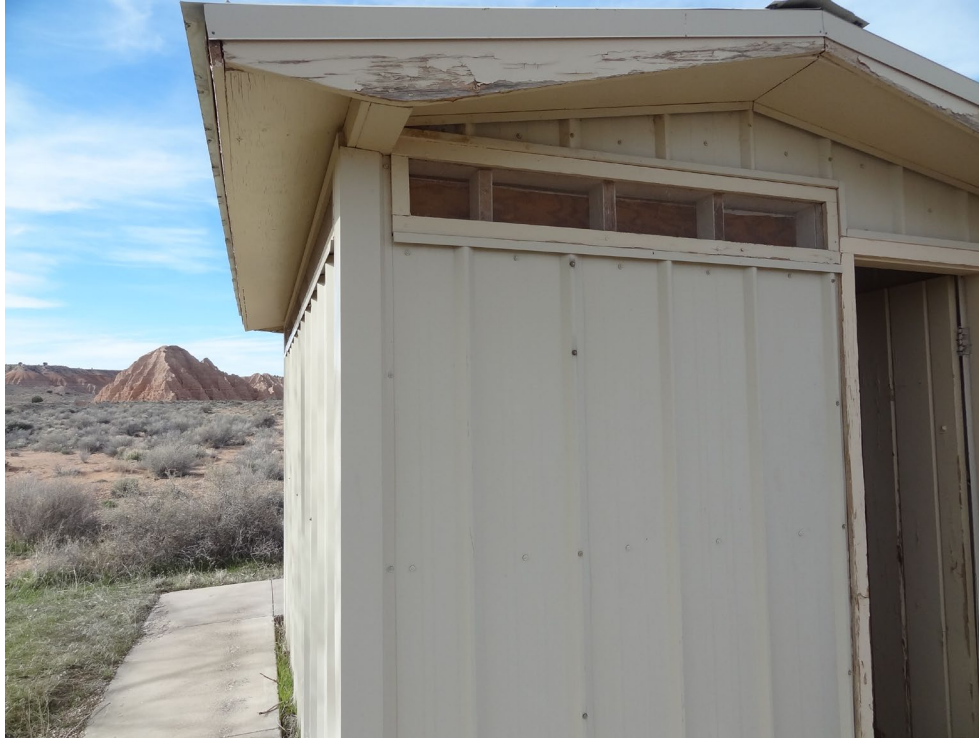
Campground Storage - Building #1037
Description: Exterior Finishes of the Building.

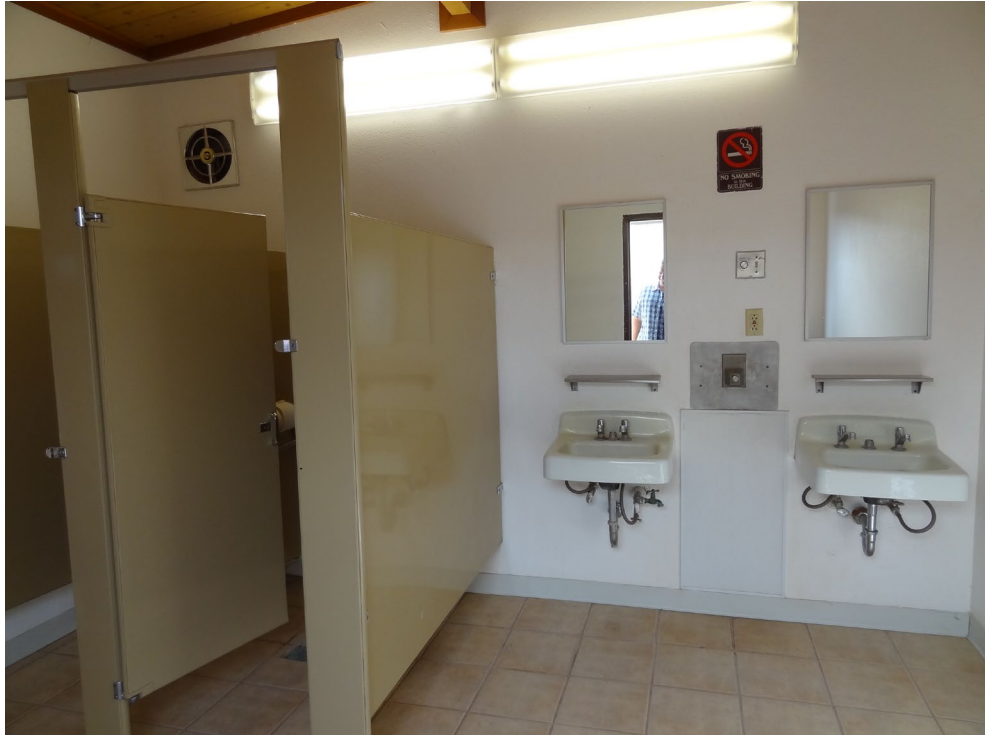
Comfort Station #4 - Campground - Building #1039
Description: ADA Restroom Upgrade.

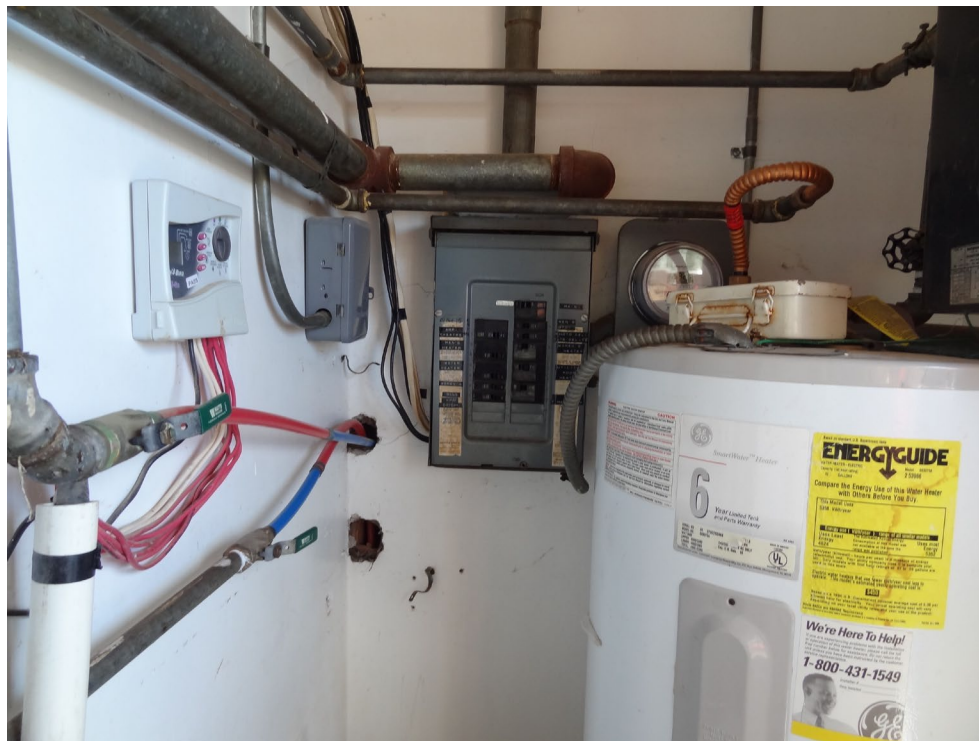
Comfort Station #4 - Campground - Building #1039
Description: Water Heater Replacement.

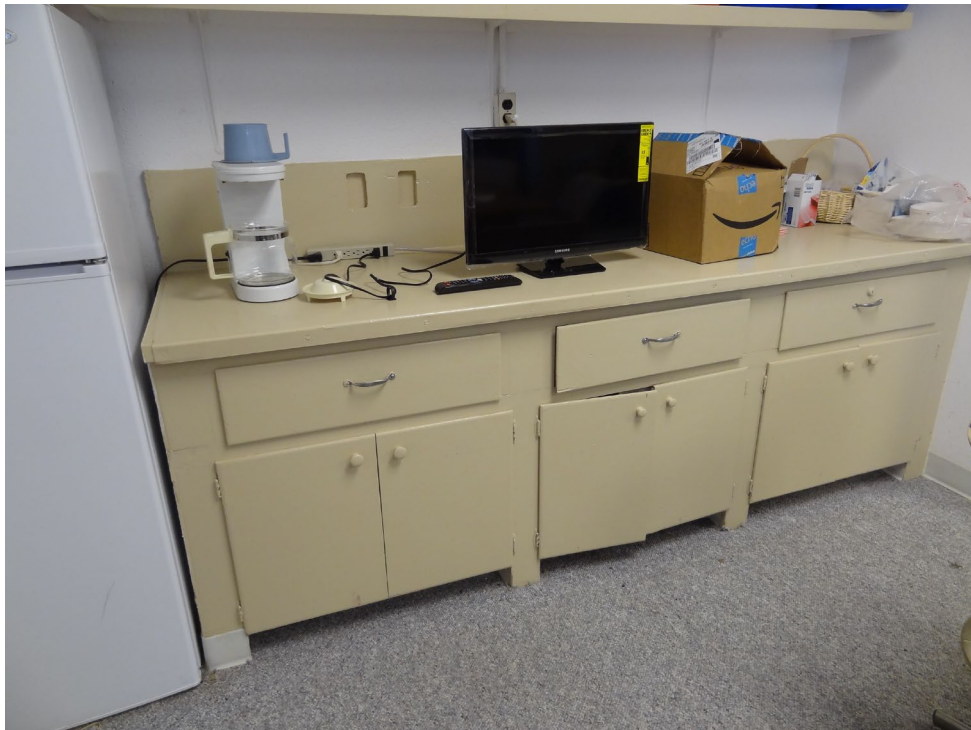
Maintenance Office / Shop - Building #1040
Description: Break Room Remodel.

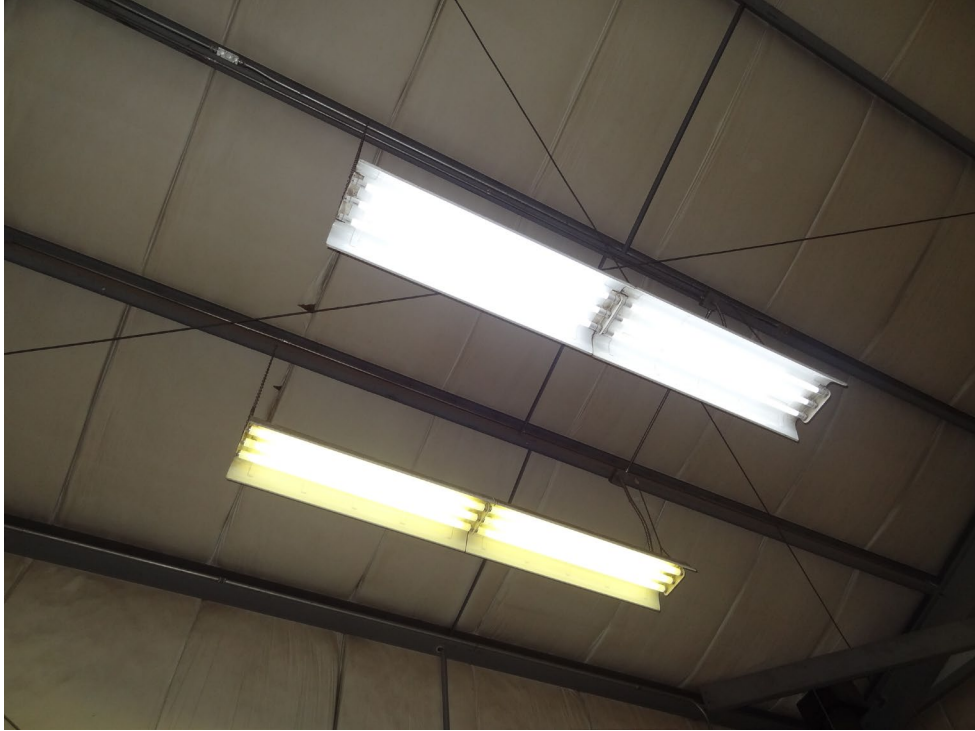
Maintenance Office / Shop - Building #1040
Description: Lighting Upgrade.

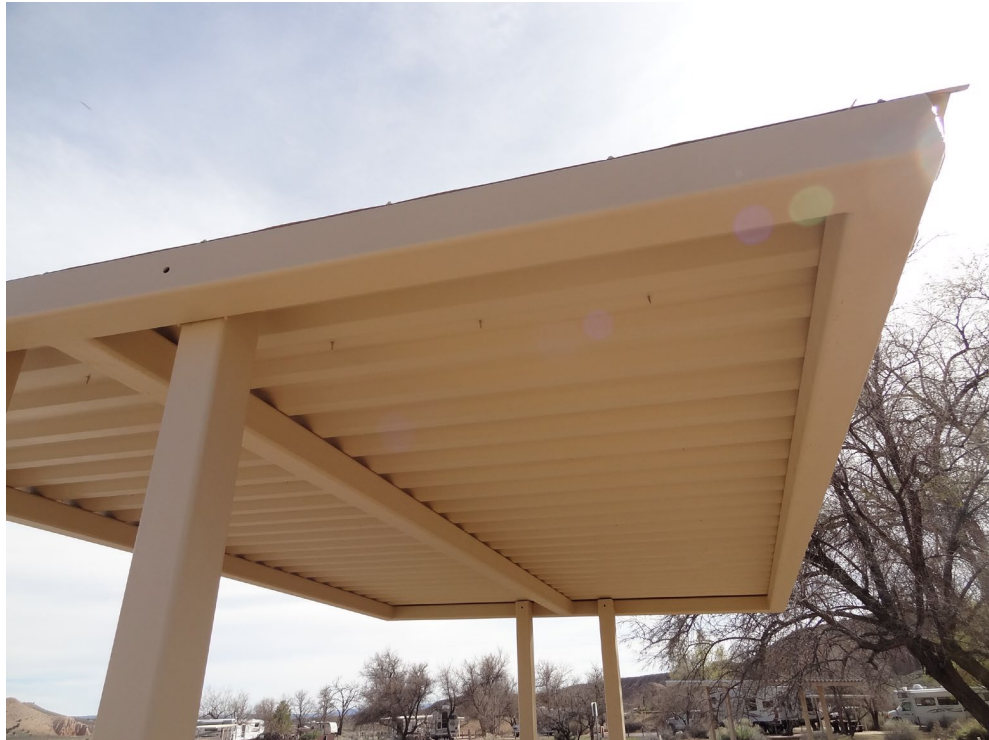
Typical Campground Ramadas
Description: Finish of the Structures.

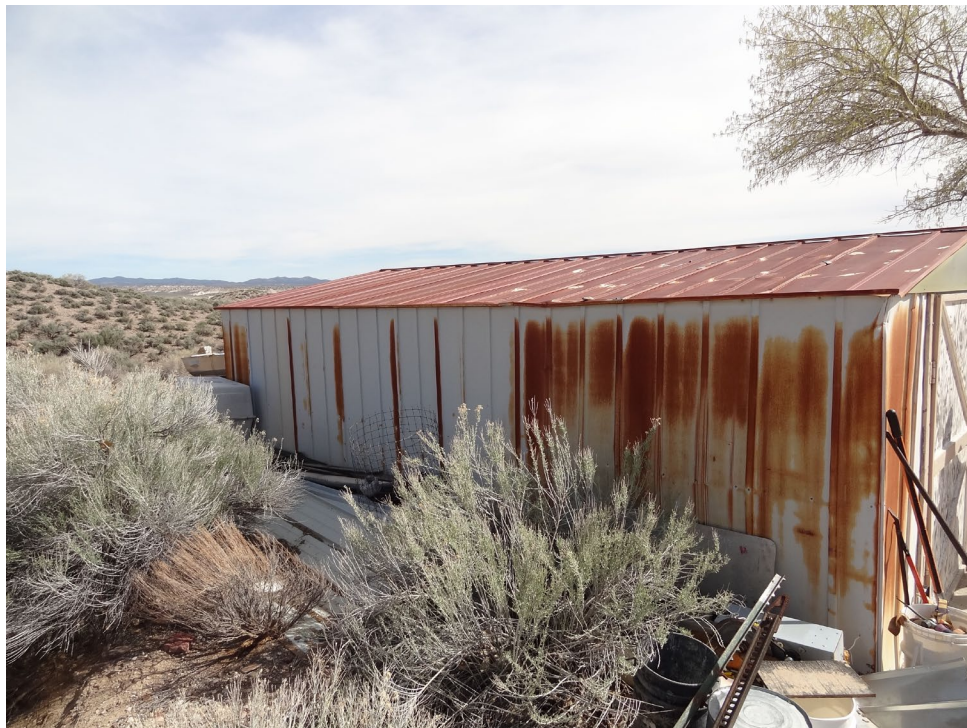
The metal storage shed is in extremely poor condition and the roof is damaged. This project would provide for the demolition of the structure including debris removal.

Metal Storage Shed #4 - Building #1057
Description: Exterior of the Building.

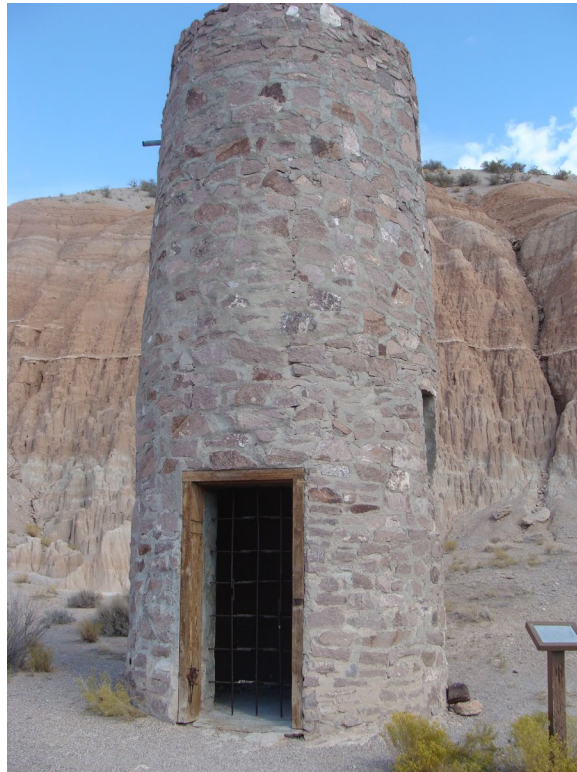
CCC Water Tower - Building #1060
Description: View of Water Tower.

In order to preserve the building for future rehabilitation and reuse, this project recommends mothballing it in accordance with the U. S. Department of Interior Recommended Guidelines in Preservation Brief 31. Costs related to removing water in the basement or crawlspace, providing drainage away from the building to prevent future water accumulation, pest control and removal of accumulated waste are included. Windows and doors will be secured or covered, and some will include louvers to permit ventilation of the structure.

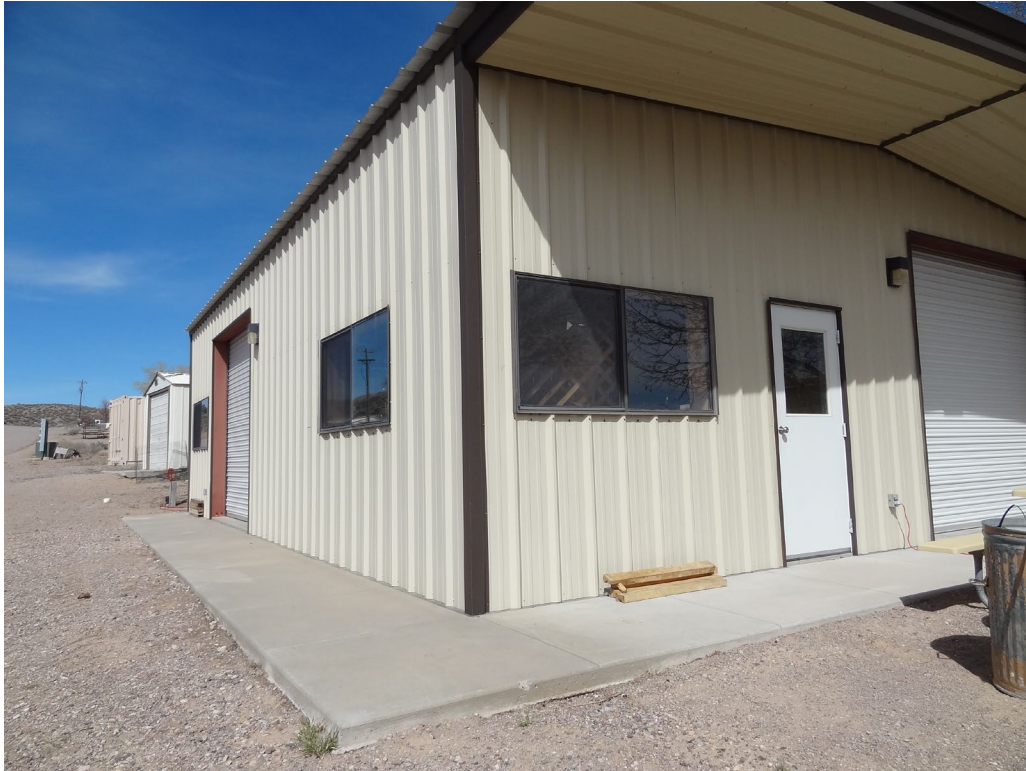
Wood Shop - Building #2939
Description: Exterior of the Building.

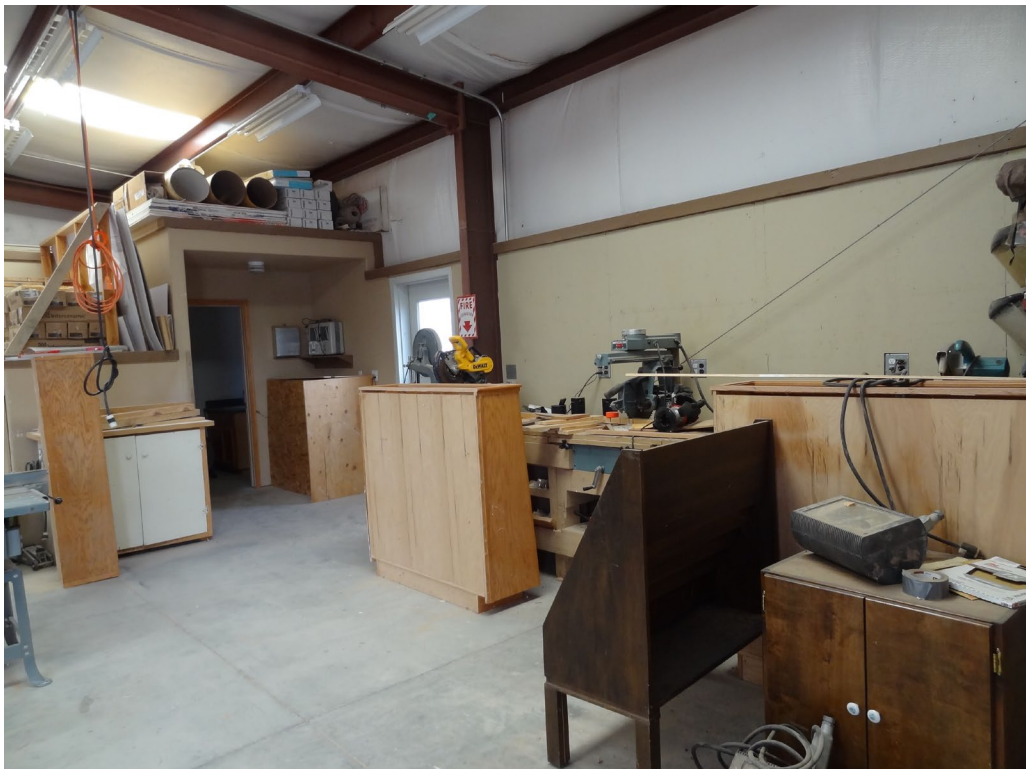
The building has a woodshop which has an inoperative dust collection system. The existing exhaust fan is undersized for the equipment being used. This project recommends the replacement of the dust collection system with a higher capacity system, including the fan, motor and ducting to each piece of equipment.

Wood Shop - Building #2939
Description: Interior of the Building.

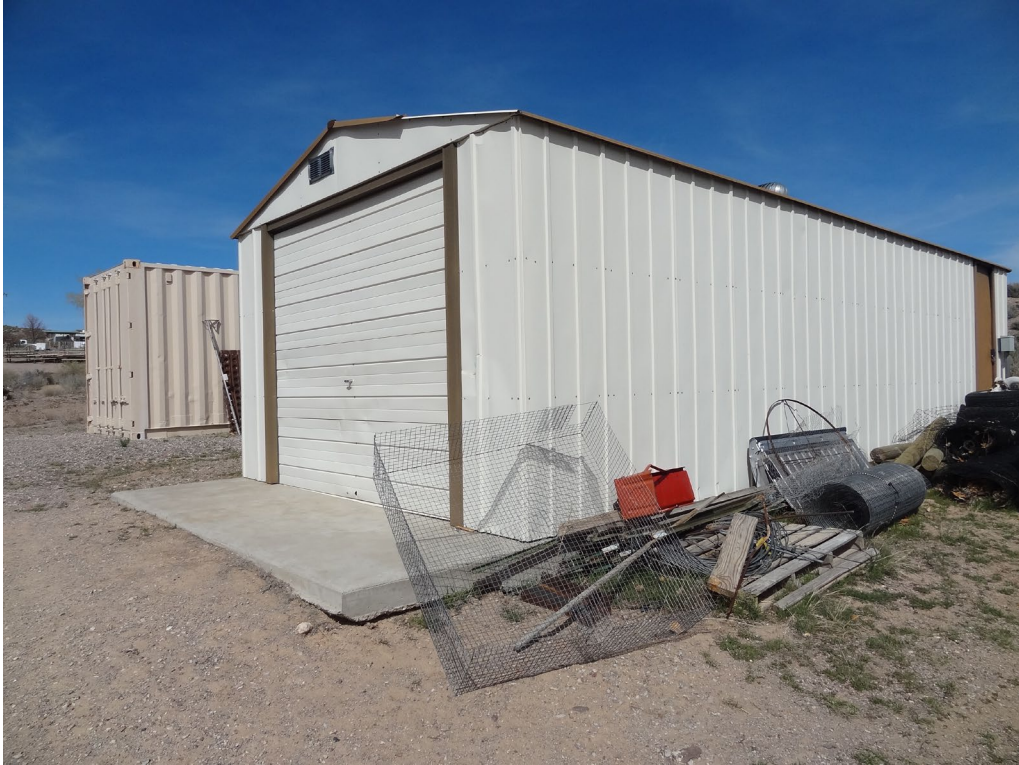
The garage door is constructed of metal and is original to the building. It has deteriorated from weather exposure over time. It is recommended that a new garage door be installed. This estimate includes the removal and the disposal of the existing garage door.

The corrugated metal roof on this building was in poor condition at the time of the survey. It is recommended that this building be re-roofed in the next 4-5 years with a standing seam metal roofing system. This estimate includes the removal and the disposal of the old roof.

NDOW Storage Shed - Building #2940
Description: Exterior of the Building.
