BEAVER DAM STATE PARK SITE

Site Number: 9948
STATE OF NEVADA PUBLIC WORKS DIVISION
FACILITY CONDITION ANALYSIS

Report distributed in March 2021

SPWD Facility Condition Analysis - 9948

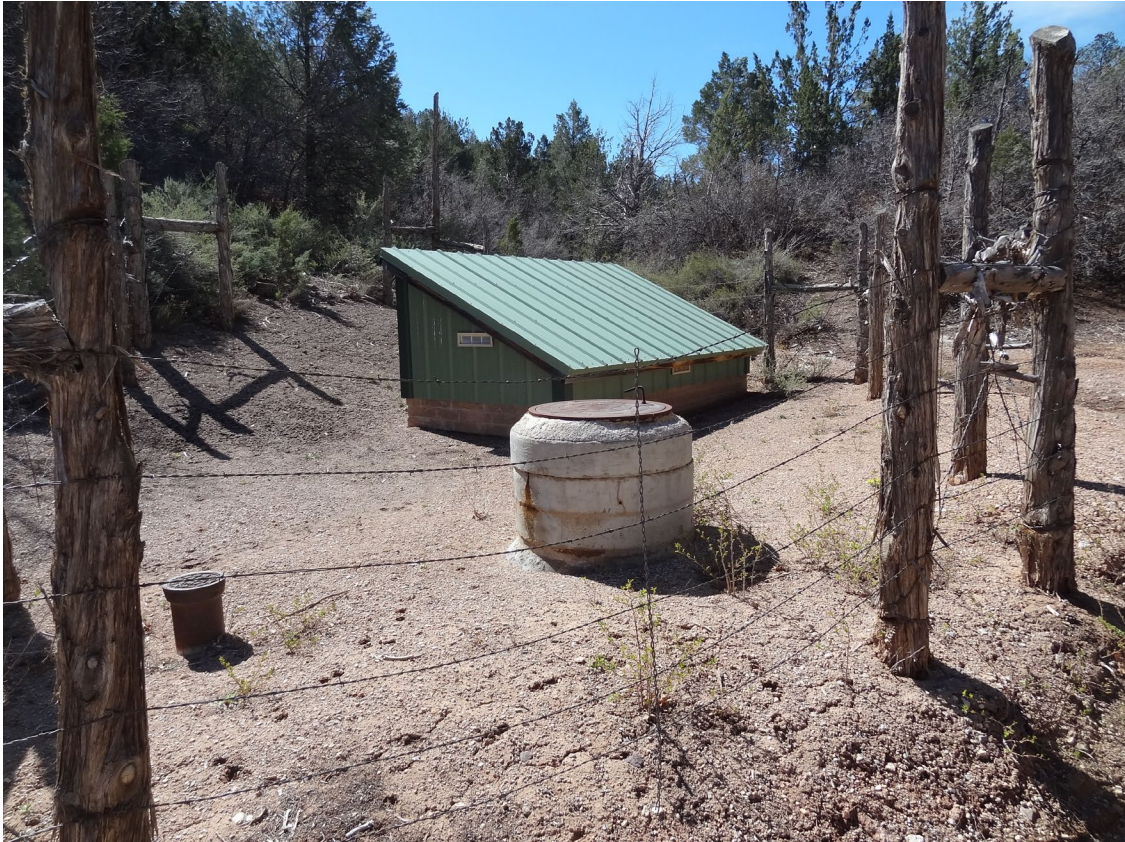
BDSP Spring House - Building #3085
Description: Exterior of the Building.

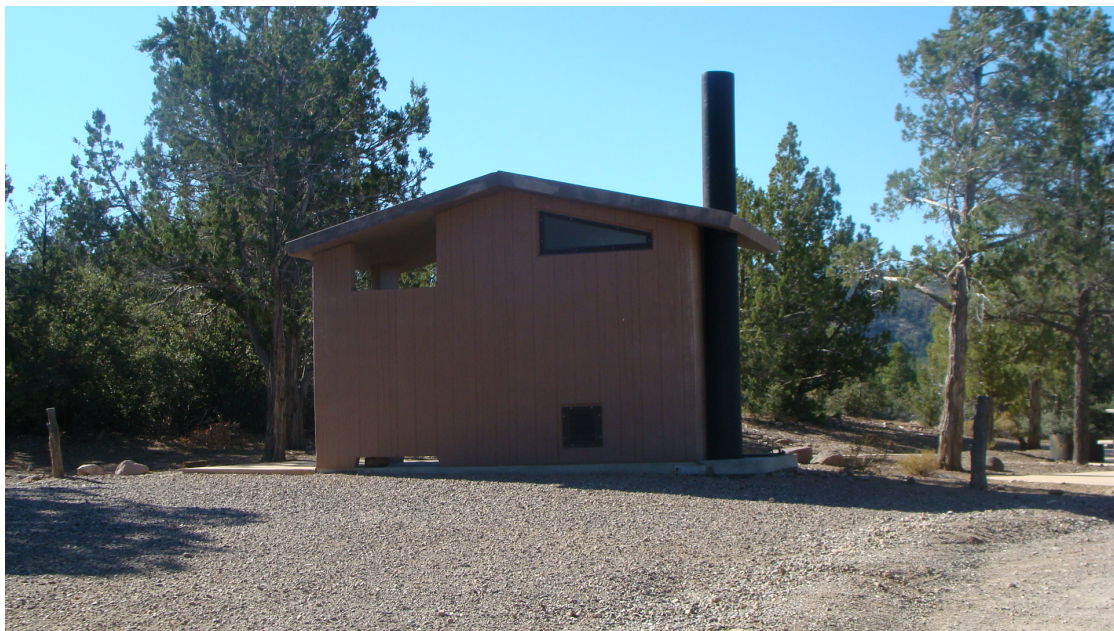
BDSP ADA CXT Toilet #3 – Loop B - Building #2255
Description: Exterior of the Building.

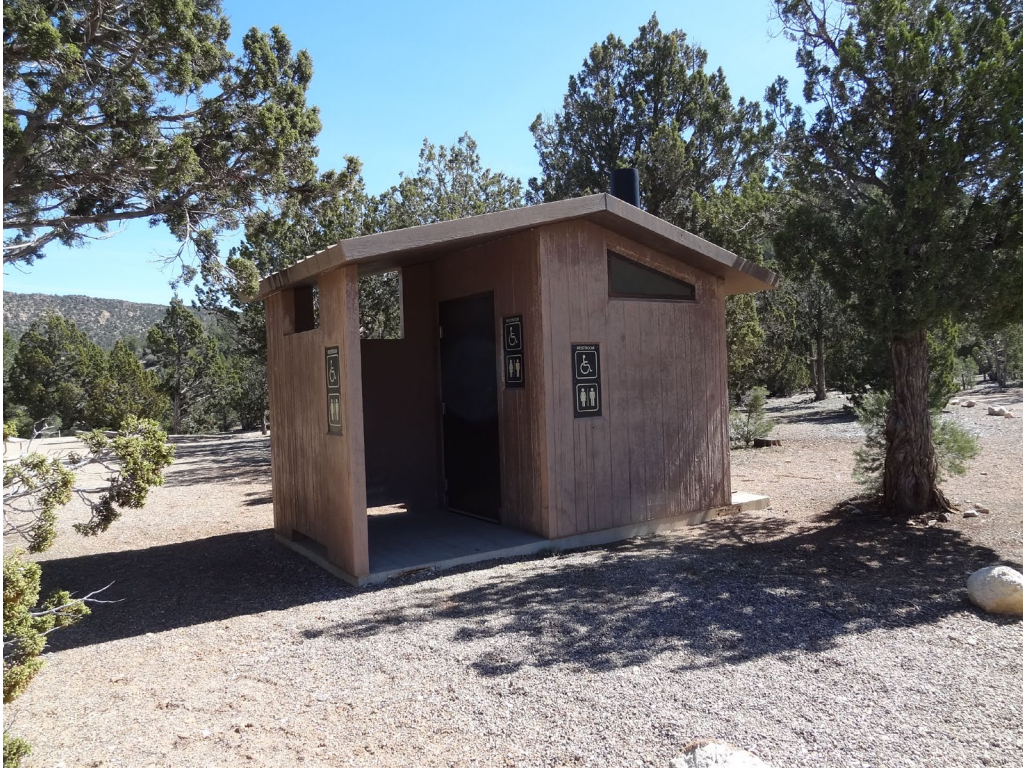
BDSP CXT Toilet #2 – Loop B - Building #2254
Description: Exterior of the Building.

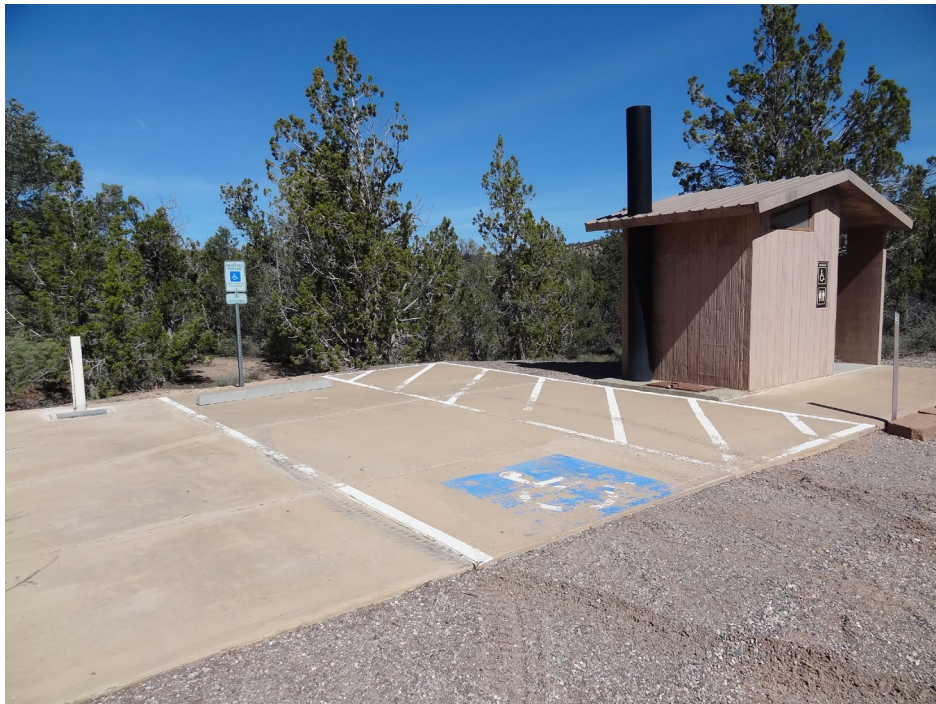
BDSP ADA CXT Toilet #1 – Loop A - Building #2253
Description: Exterior of the building.

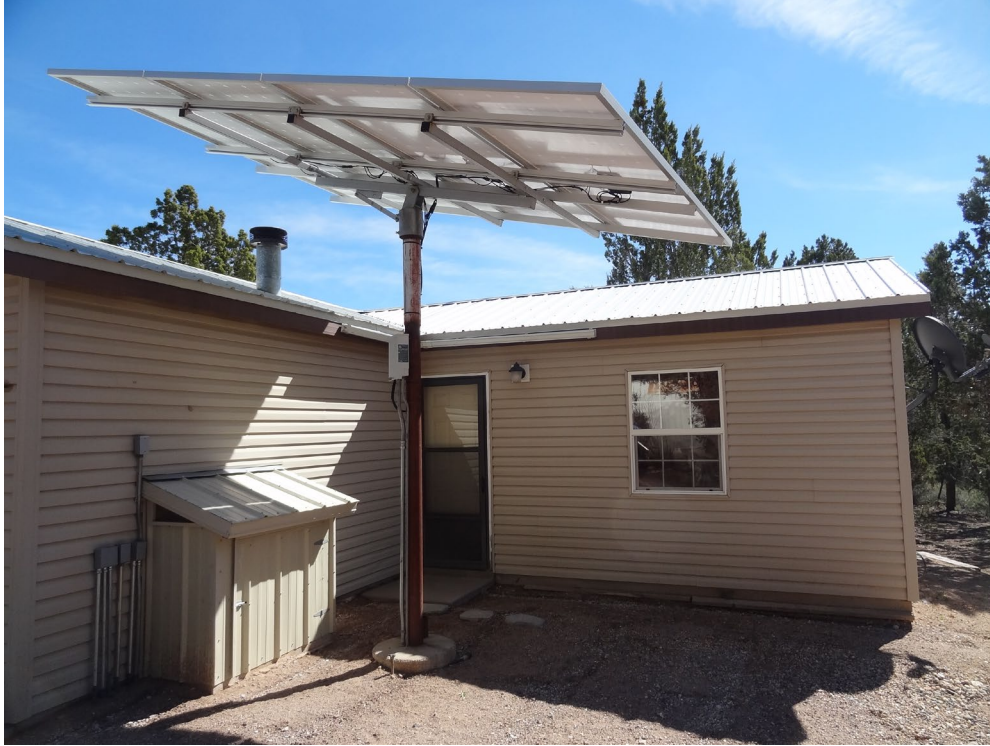
BDSP Park Residence - Building #0997
Description: Exterior of the Building.

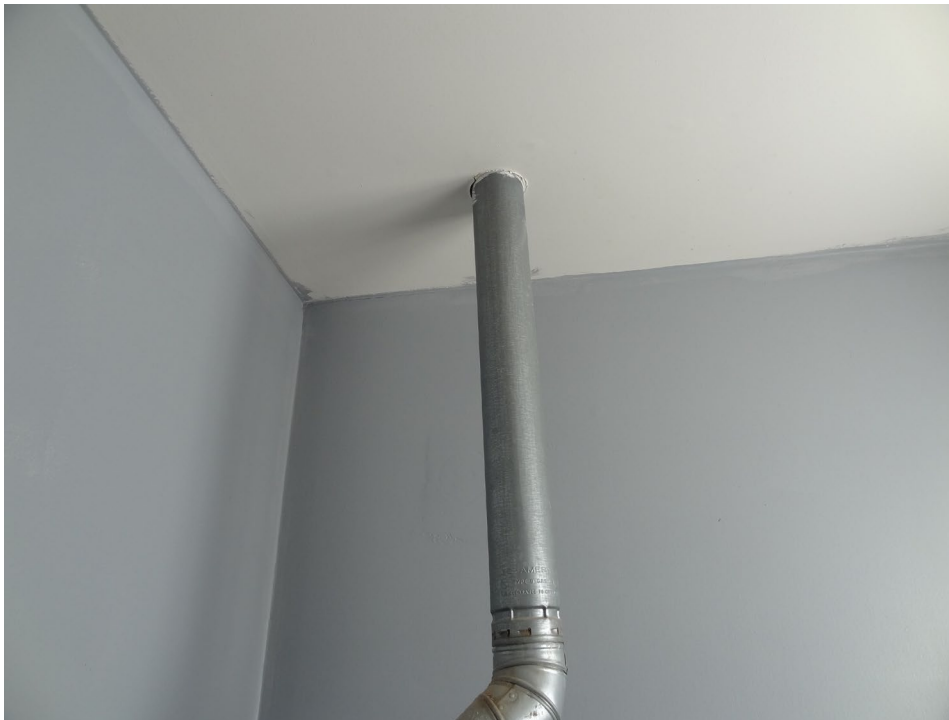
There is a water heater flue in the building that does not comply with UMC 2018 chapter 8, chimneys and vents. The flue is close to combustibles and does not have the proper clearances per UMC 2018. This is a fire hazard. It is recommended that the flue in the building meet the proper clearances per UMC 2018 and the manufacture's specifications. The flue should be installed by a licensed contractor.

BDSP Park Residence - Building #0997
Description: Water Heater Flue Clearance to Combustible Project.

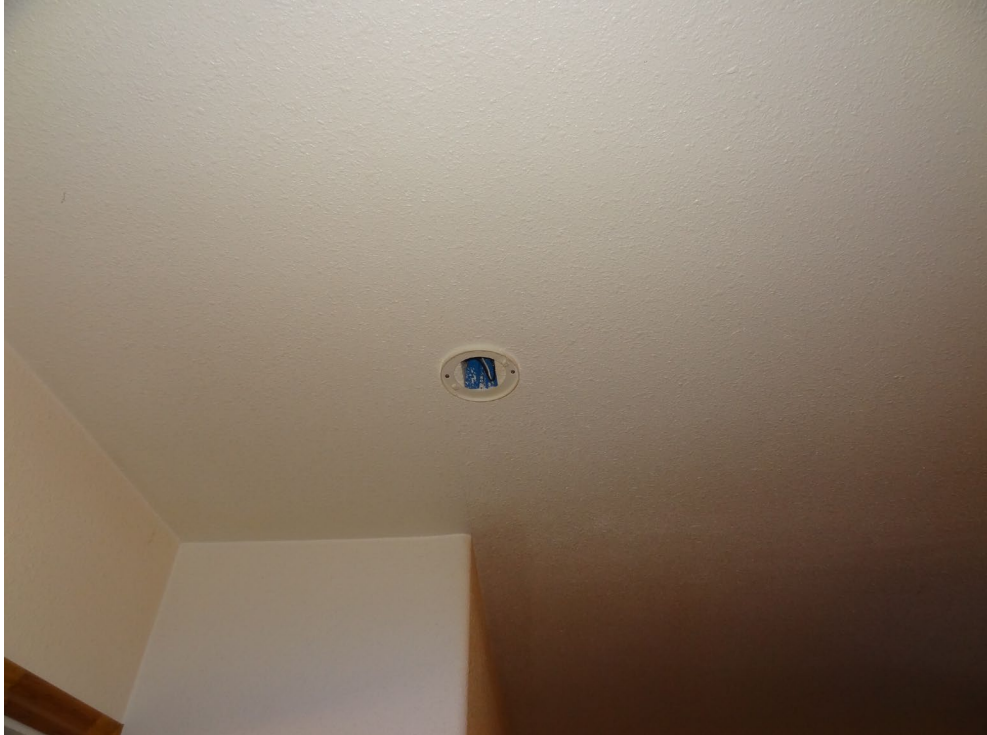
IRC 2018 Section R314 and R315.3 explains the requirements for smoke alarms in dwelling units. This includes: installing and maintaining smoke alarms in each sleeping room; having a carbon monoxide and smoke detector on the ceiling or wall outside of each sleeping area; in the immediate vicinity of bedrooms when an alteration, repair or addition requiring a permit occurs. IRC 2018 requires that smoke detectors and carbon monoxide alarms be UL rated. State Fire Marshal NAC 477.915 (3) requires that smoke detectors be connected to the wiring in a building and include a battery for emergency backup power. This project would provide funding for the purchase and installation of smoke alarms and carbon monoxide alarms in accordance with IRC and NAC laws.

BDSP Park Residence - Building #0997
Description: Smoke Alarm Installation Project.

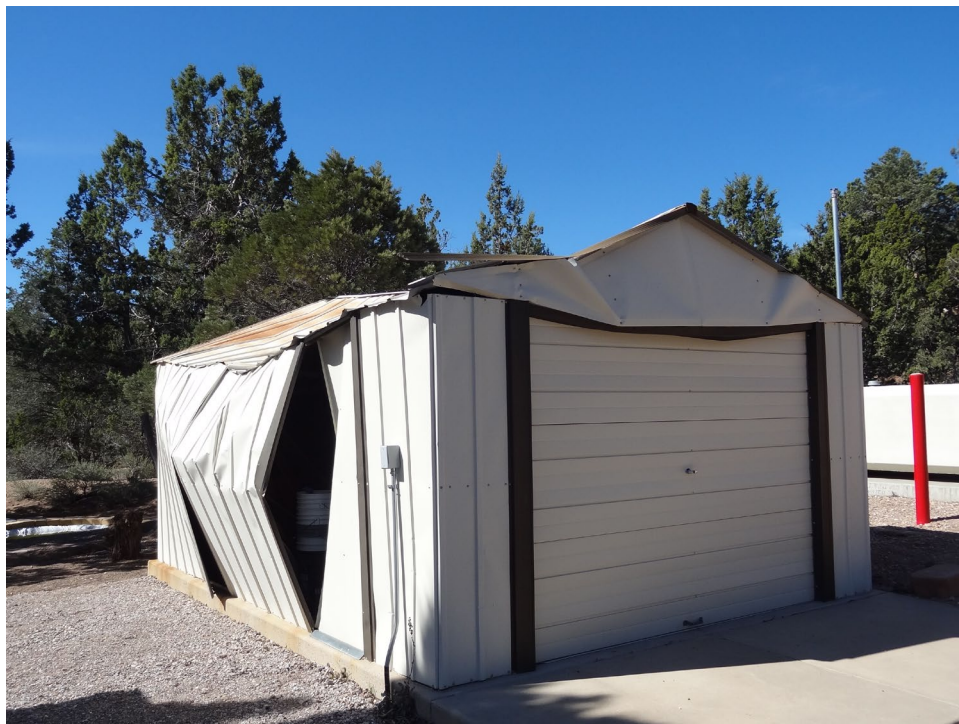
The building is an old storage shed that is no longer in use and is severely damaged. It is recommended that this structure be demolished and for the pit below to be filled-in, per the guidelines of the Nevada State Division of Environmental Protection and any local requirements.

BDSP Storage Shed - Building #0506
Description: Exterior of the Building – Demolish Structure.

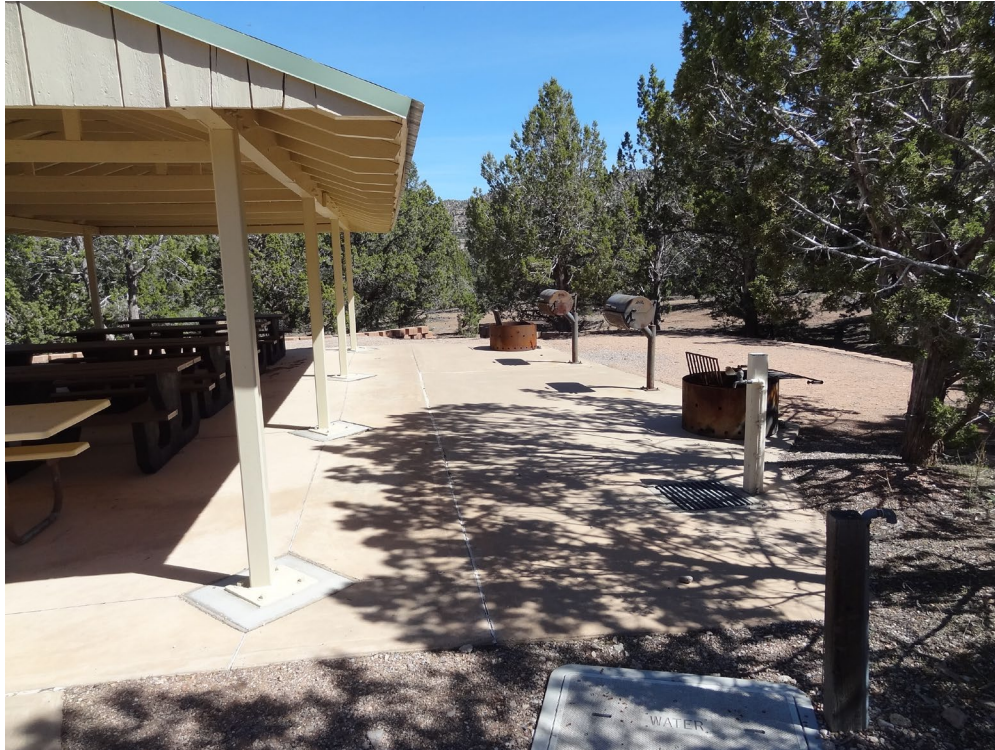
BDSP Shade Ramada – Loop B - Building #0466
Description: Exterior of the Building.

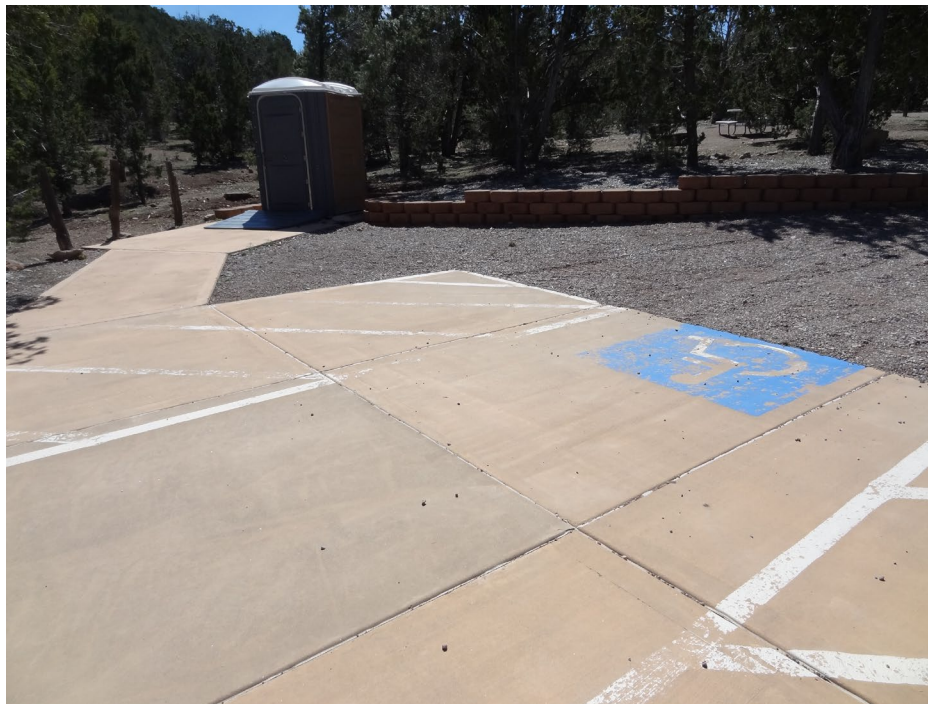
BDSP Shade Ramada – Loop B - Building #0466
Description: ADA Parking & Accessible Portable Toilet.

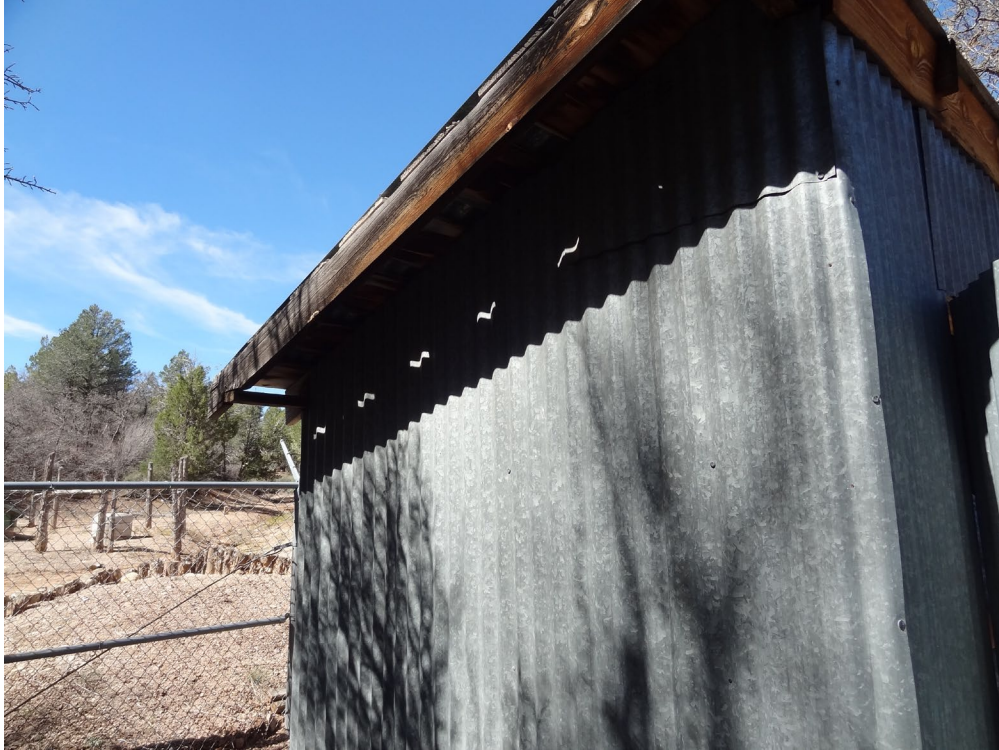
BDSP Pump House - Building #0465
Description: Exterior of the Building.

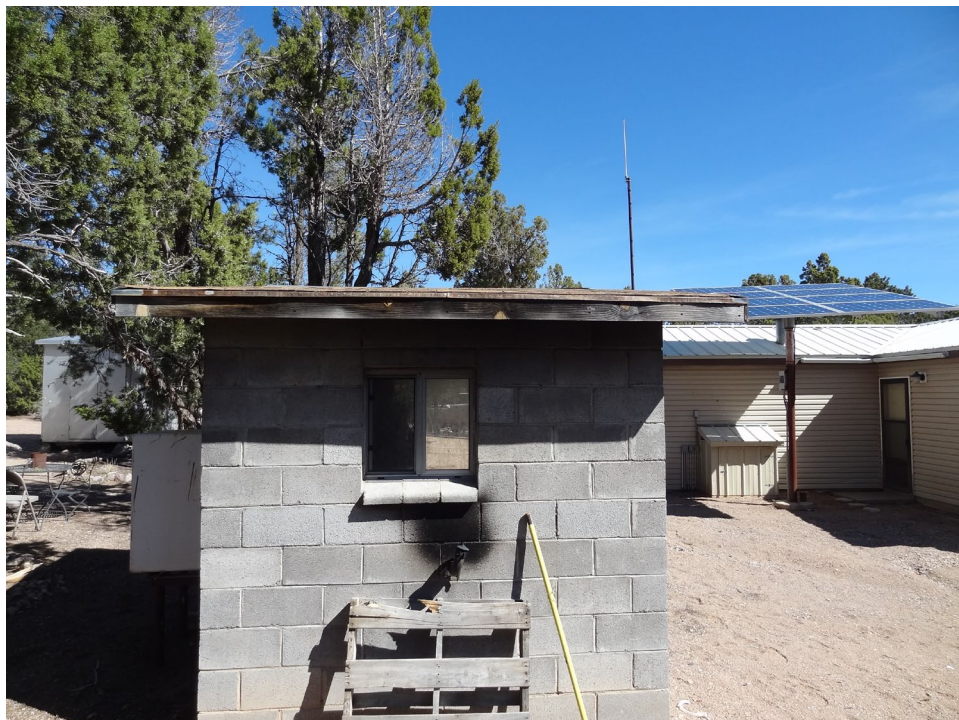
BDSP Generator Building - Building #0460
Description: Exterior of the Building.
