State of Nevada  
Cultural Affairs  
Facility Condition Analysis

# BOULDER CITY RAILROAD MUSEUM

**Site Number: 9951**

**STATE OF NEVADA PUBLIC WORKS DIVISION  
FACILITY CONDITION ANALYSIS**

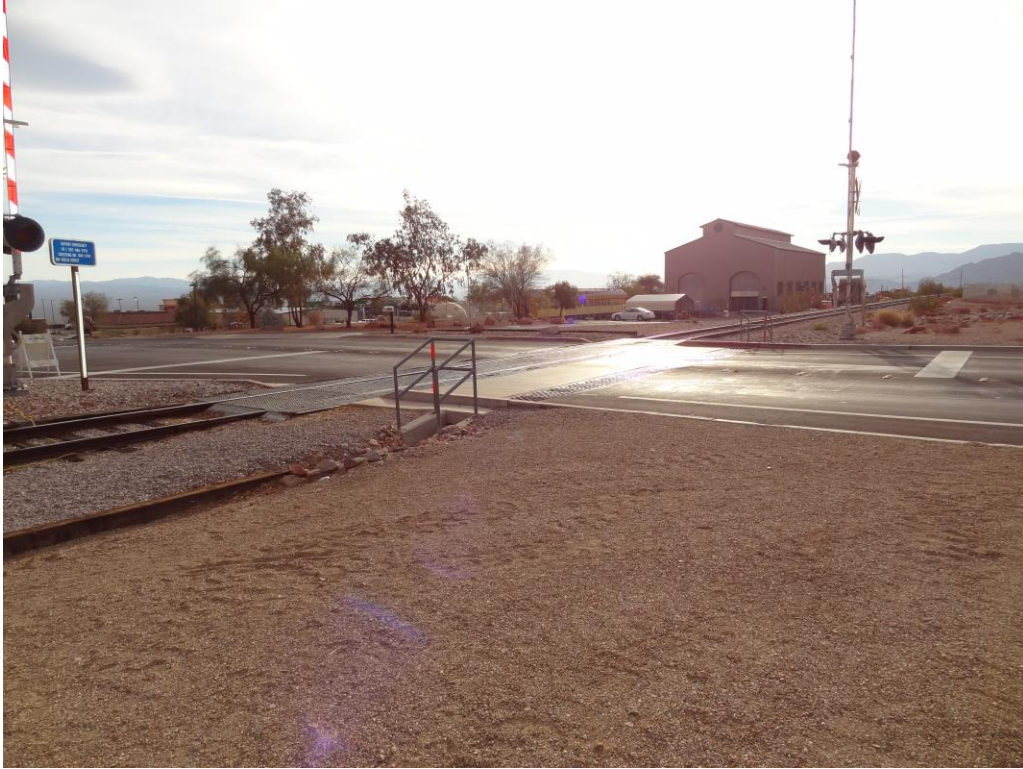
Boulder City Railroad Museum - Site #9951  
Description: Exterior site lighting installation needed.

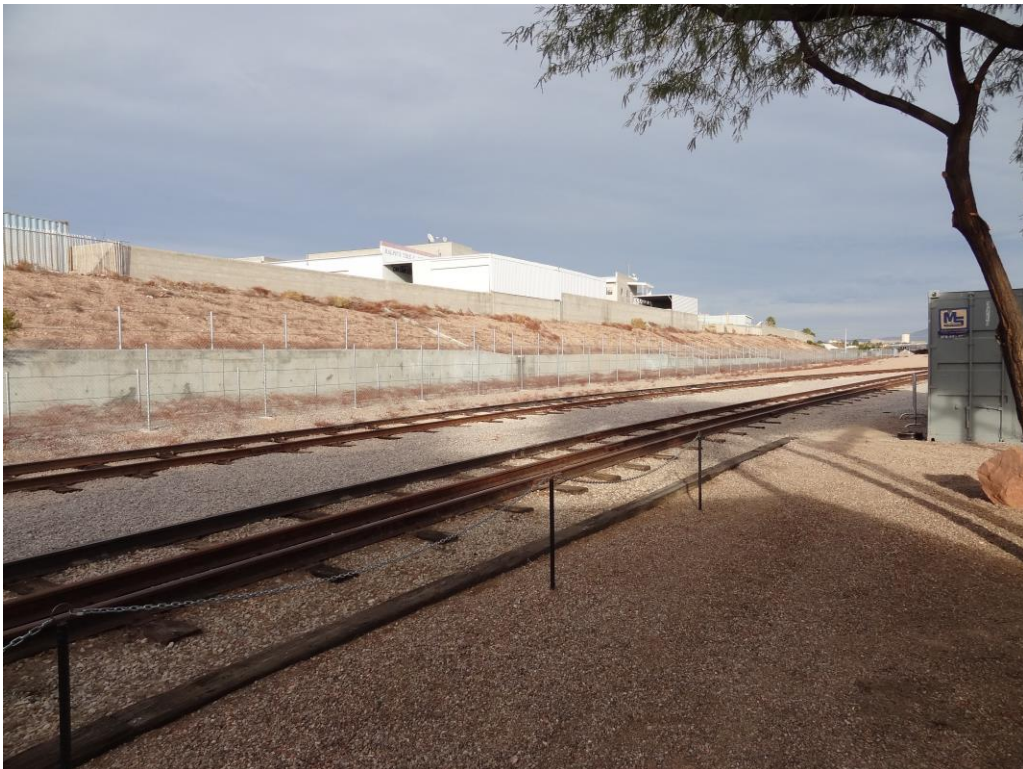
The site has 5 miles of railroad tracks that were in poor condition and were not in compliance with Federal standards at the time of the survey. This project would remove and replace the existing railroad tracks and replace them with new tracks that meet or exceed the Federal Railroad design standards.

Boulder City Railroad Museum - Site #9951  
Description: Railroad track replacement needed.

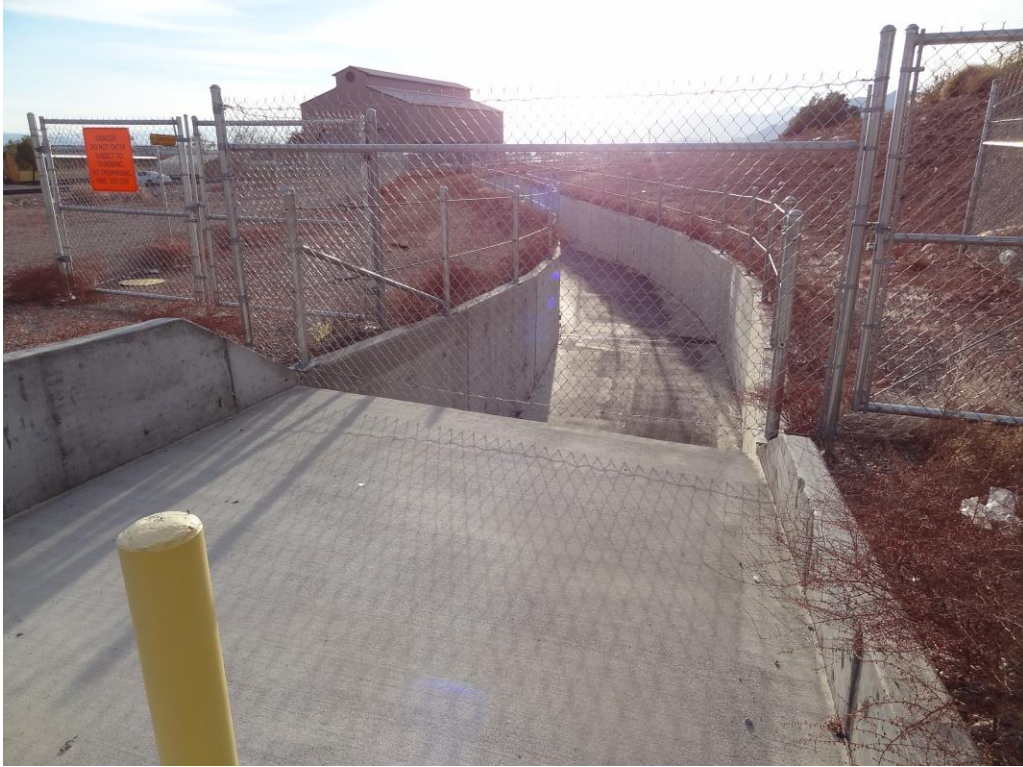
Boulder City Railroad Museum - Site #9951  
Description: Site Drainage.

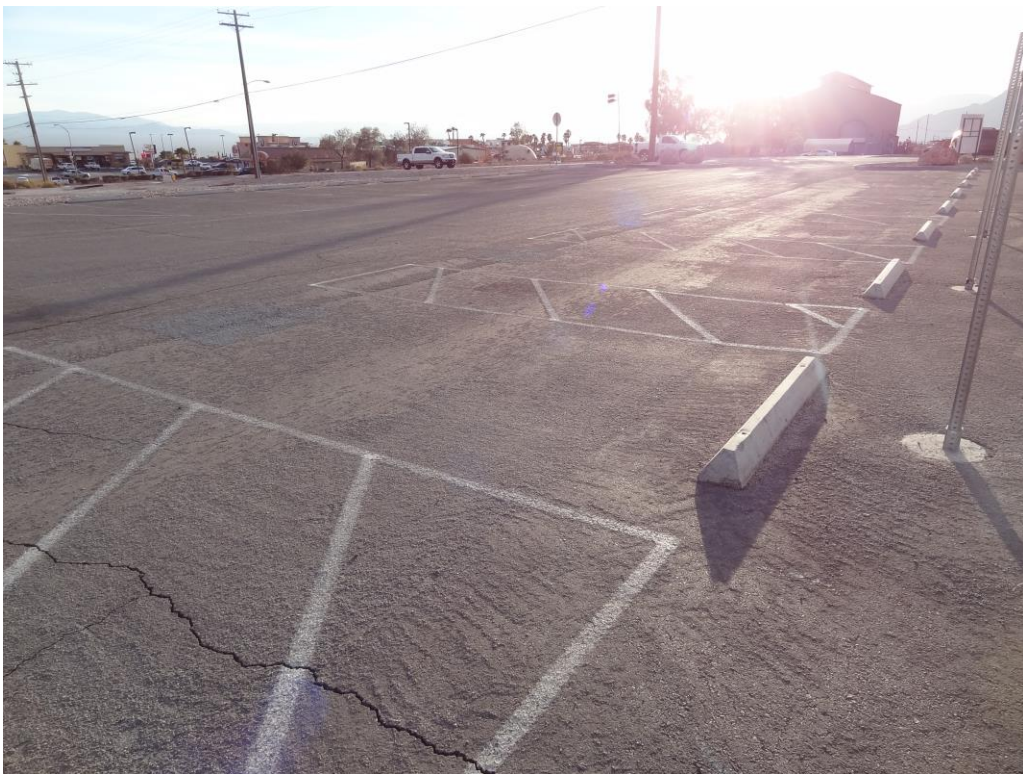
It is important to maintain the asphalt concrete paving on the site. This project would provide for minor crack filling and slurry sealing of the paving site wide including access roads, parking areas and the maintenance yard. Striping is included in this estimate. This project should be scheduled on a 5 year cyclical basis to maintain the integrity of the paving and prevent premature failure. 32,000 square feet of asphalt area was used to generate this estimate.

Boulder City Railroad Museum - Site #9951  
Description: Slurry seal asphalt paving needed.

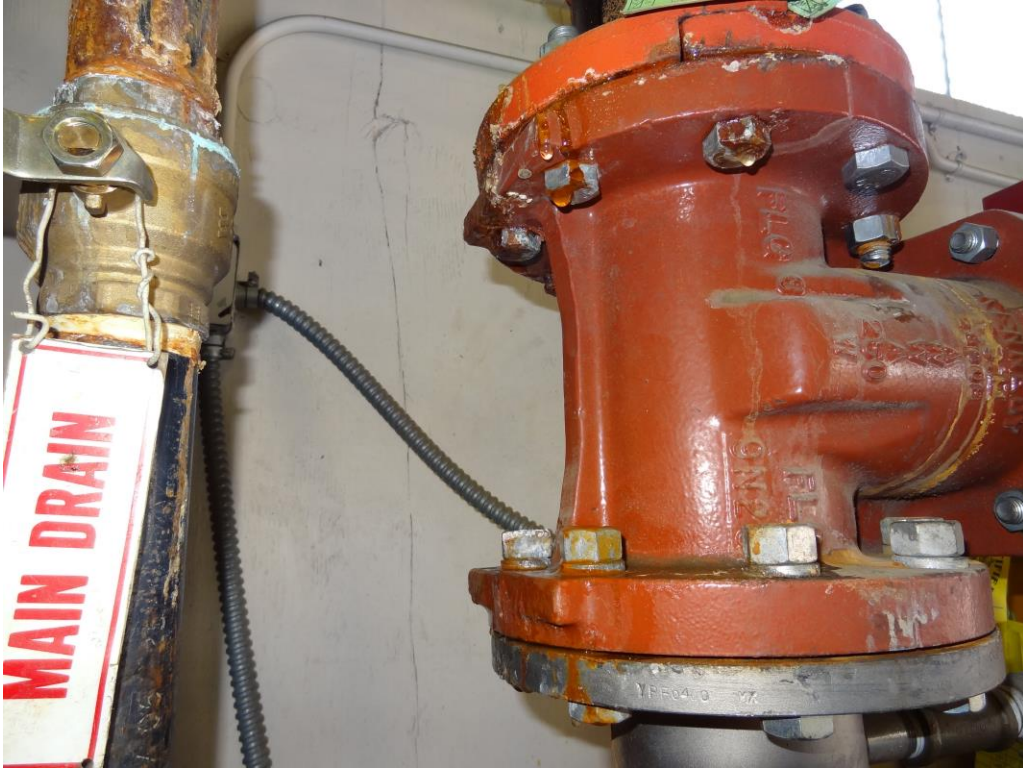
The fire suppression system is a wet system and the corrosive water is causing damage. With each annual test, the corrosion is accelerated and has recently caused failures in some of the valves and pipes. The system is about 21 years old. It is recommended to perform a five year flush on the system with an inspection of the sprinkler heads at the cost of about \$3,500. Should the inspection deem it necessary, a full flush and replacement of the heads would follow at the cost of about \$6,500. The five year flush should be scheduled every five years thereafter to maximize the lifecycle of the system.

Boulder City Museum Maintenance - Building #0841  
Description: Fire suppression system maintenance needed.

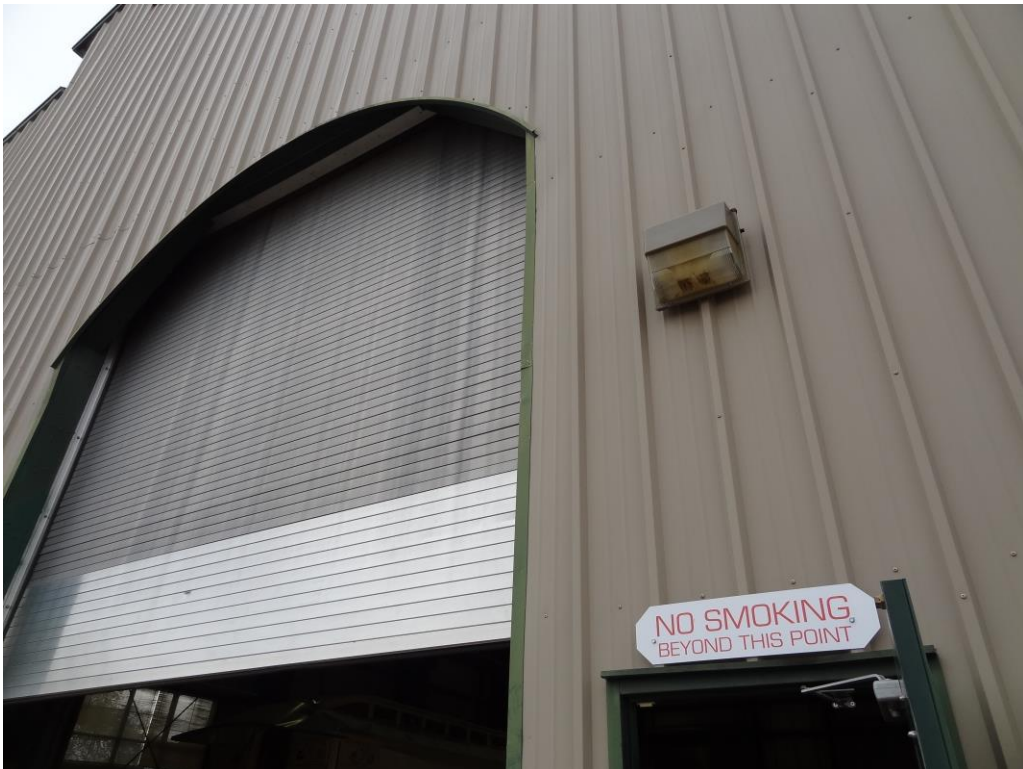
Boulder City Museum Maintenance - Building #0841  
Description: Overhead door replacement needed.

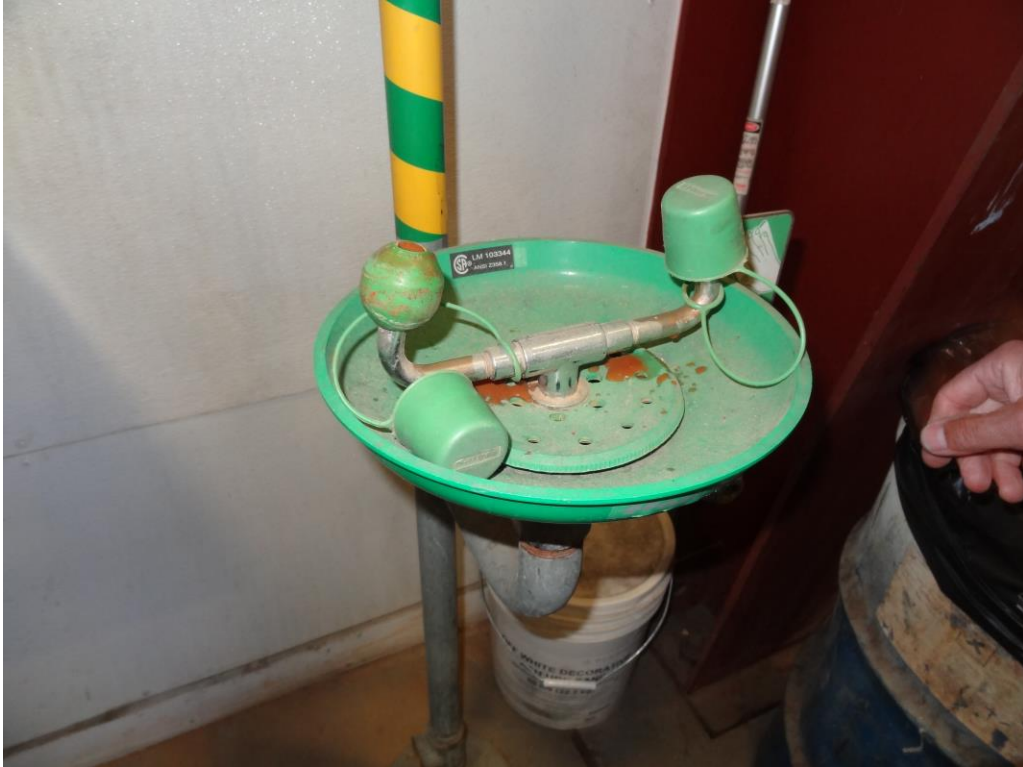
The emergency eye wash station is original to the building and the domestic water supply piping should be scheduled for replacement. The galvanized pipe is rusting on the inside and contaminating the water rendering the station useless. This project would provide for the removal of the existing piping and installation of new copper domestic water supply.

Boulder City Museum Maintenance - Building #0841  
Description: Emergency eye wash station refurbishment needed.

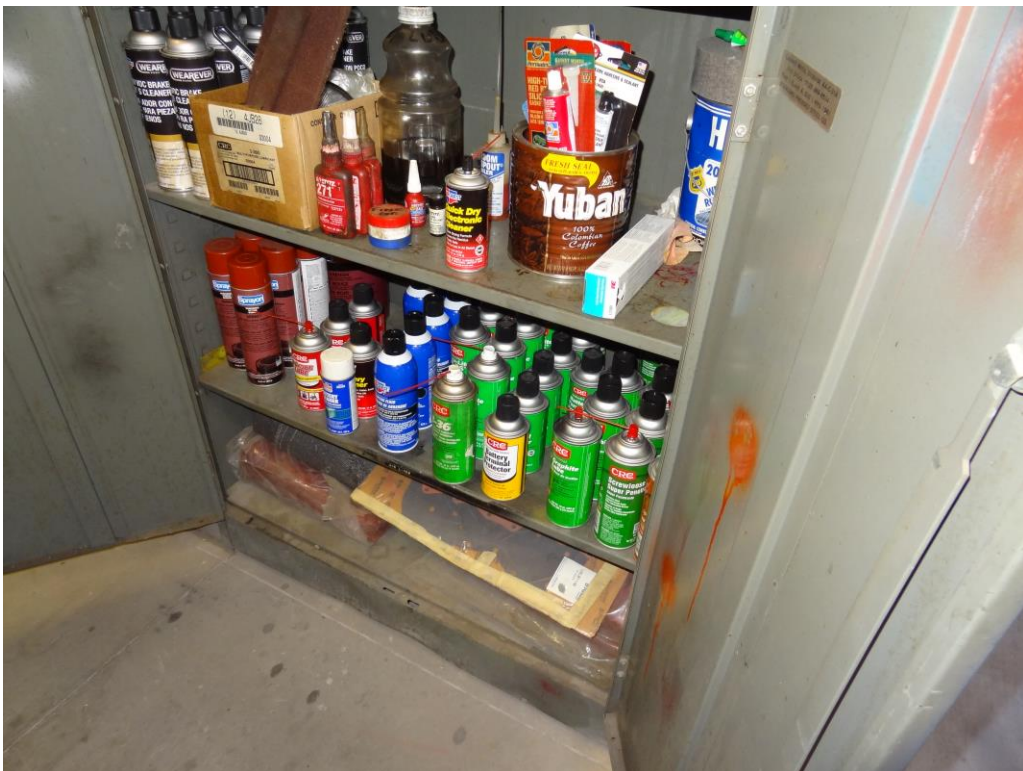
The building contains many different paints, stains, and other hazardous products located on open shelves. This does not meet OSHA standards or IFC for hazardous materials containment. This project would provide a self-closing hazardous storage container in the building and install placards on the building exterior in accordance with OSHA 1910.106 (d) and IFC Chapter 57 Section 5704.3.2.1.3.

Boulder City Museum Maintenance - Building #0841  
Description: Safety Cabinets needed.

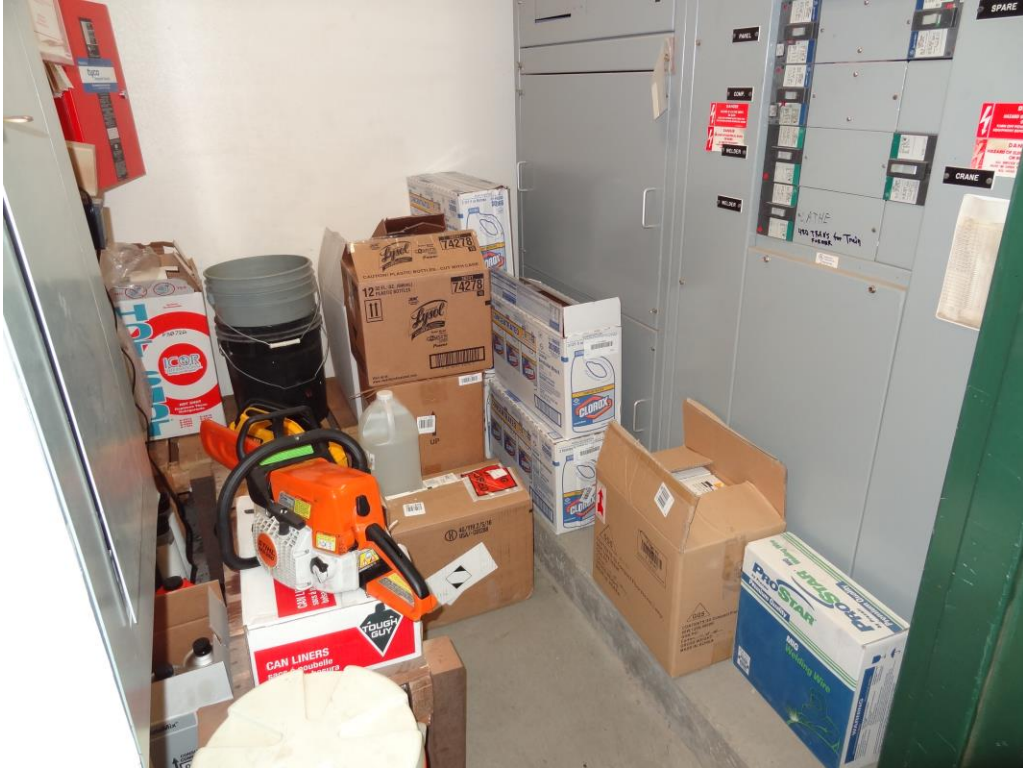
Boulder City Museum Maintenance - Building #0841  
Description: Clearance at electrical panels needed.

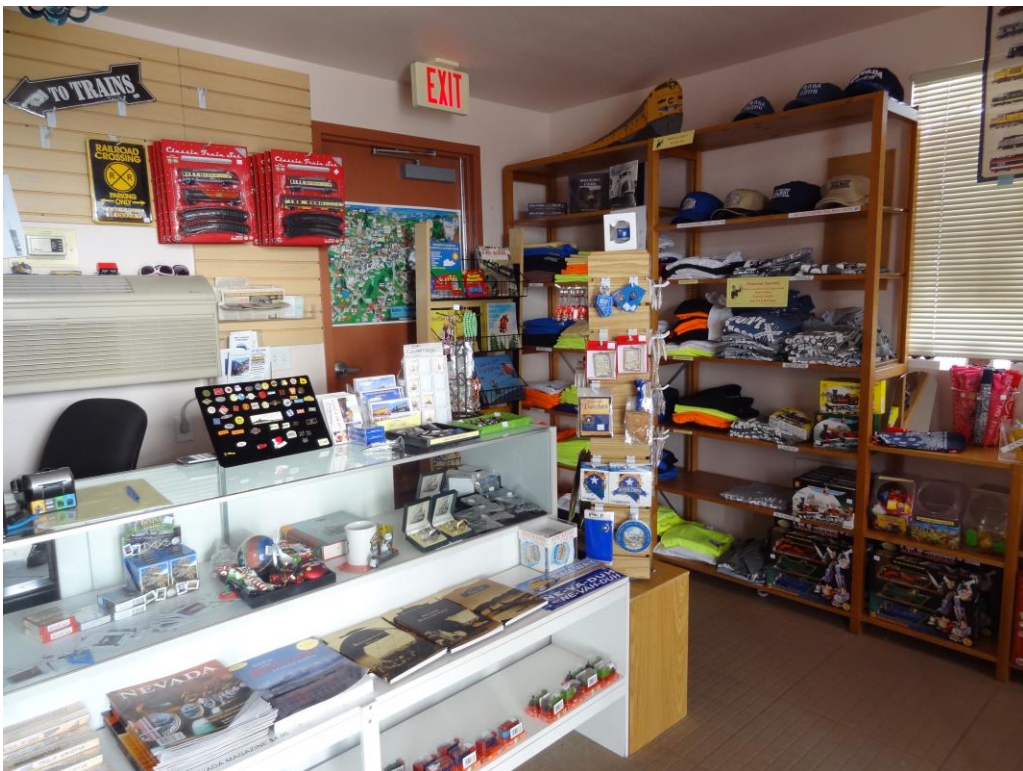
Boulder City Museum Gift Shop - Building #2202  
Description: ADA accessible counter needed.

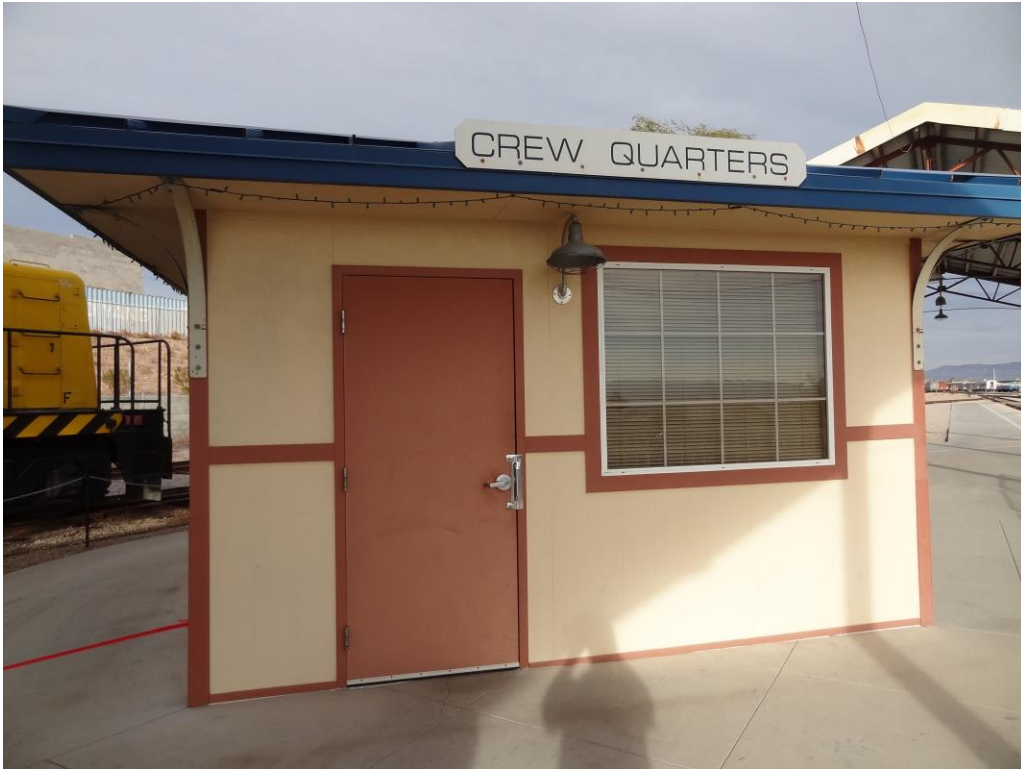
It is important to maintain the finish, weather resistance and appearance of the building. This project would provide funding to protect the exterior of the building excluding the roof. Included in the cost is sanding, priming, painting and caulking of the windows, flashing, fixtures and all other penetrations. It is recommended that the building be painted in the next 4-5 years and that this project be scheduled on a cyclical basis to maintain the integrity of the structure.

Boulder City Museum Crew Quarters - Building #2204  
Description: Exterior finishes.

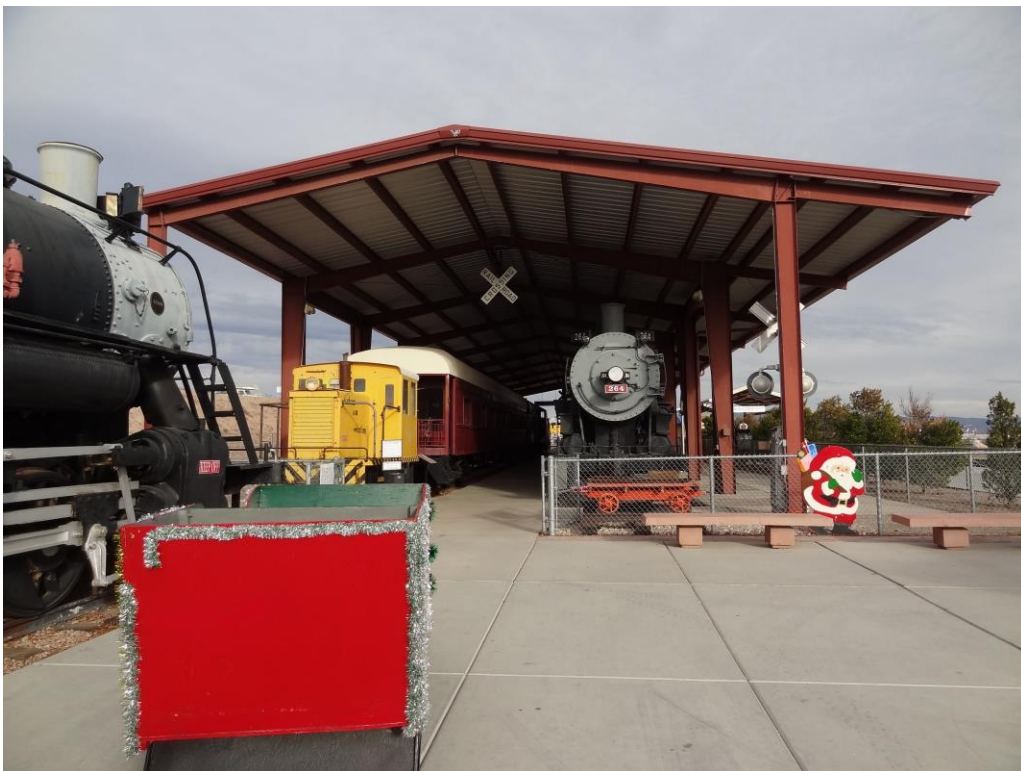
It is important to maintain the finish, weather resistance and appearance of the structure. This project would provide for painting of the structure and it is recommended that this project be scheduled on a cyclical basis to maintain the integrity of the structure.

Boulder City Museum Train Pavilion - Building #3039  
Description: Exterior finishes.
