State of Nevada
Department of Wildlife
Key Pittman Wildlife Management Area
Facility Condition Analysis

Site Number: 9954
STATE OF NEVADA PUBLIC WORKS BOARD
FACILITY CONDITION ANALYSIS

Report Printed in February 2010

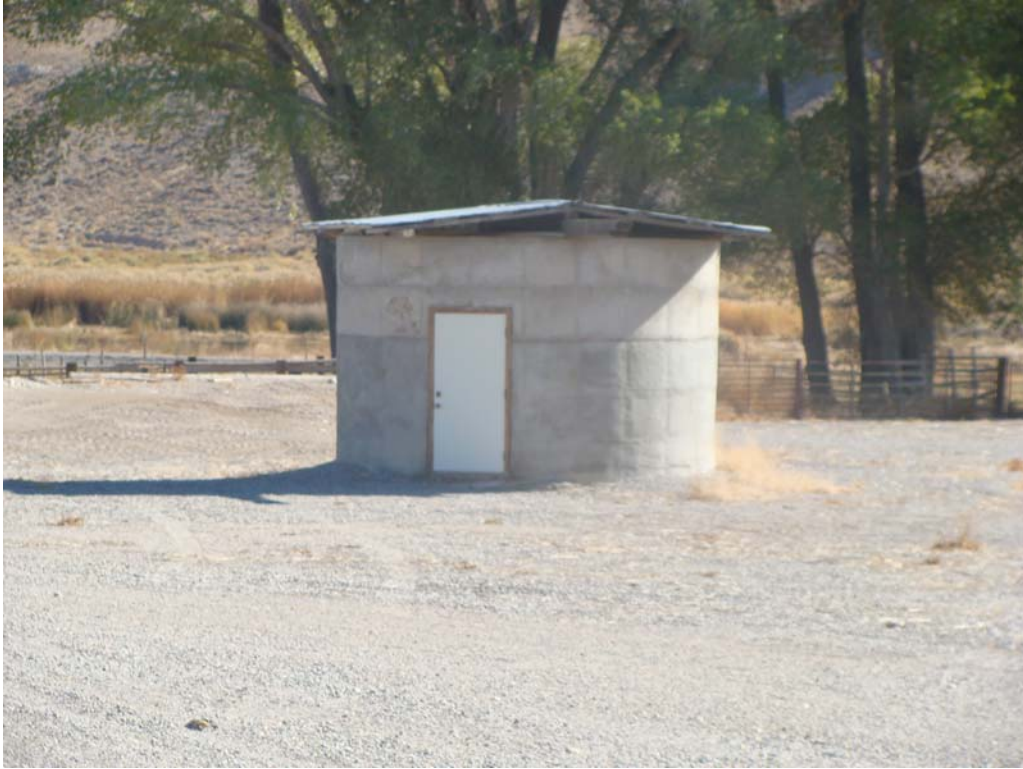
The roof framing and the corrugated metal roofing on this building were in poor condition at the time of the survey. The framing is rotted and many wood members are splitting. It is recommended that the framing and roofing be replaced in the next two to three years. This estimate includes removal and disposal of the old framing and roofing.

Granary - Building #0904
Description: Exterior of the structure.

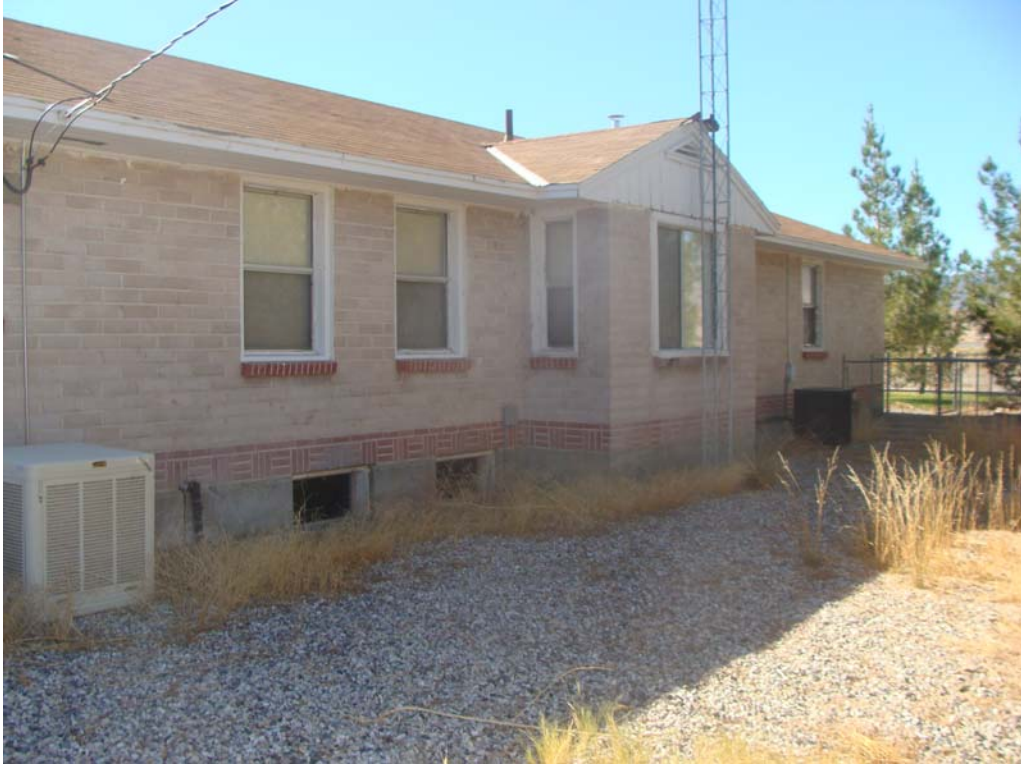
The house has considerable damage to the siding and foundation from improper drainage around the building. The grade does not slope away from the building in several areas, especially on the north side of the building. This is causing water to pool up next to the building, infiltrate the windows and damage the concrete foundation walls. This project would create positive flow away from the building by regrading and installing french drains as needed.

WMA Supervisor's Residence - Building #0903
Description: Area in need of drainage improvements.

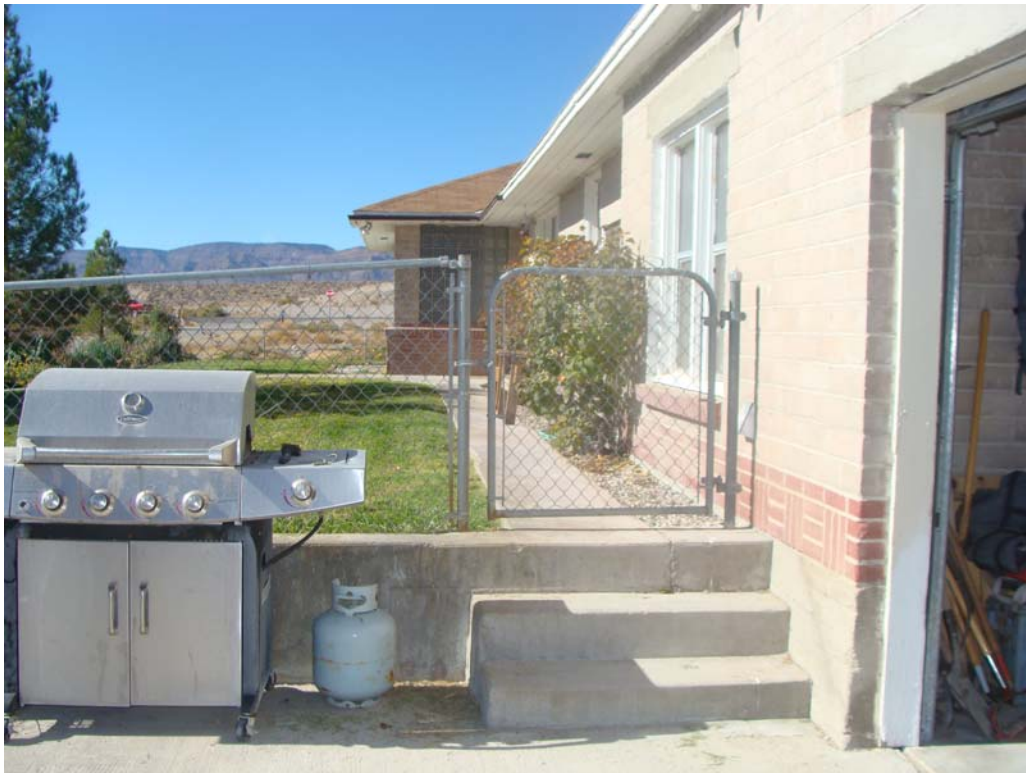
The exterior concrete stairs near the garage do not comply with 2006 IBC Chapter 10. The treads and risers are not uniform in size and the stairway is missing handrails. This project would provide for the installation of a compliant stairway including handrails. Removal and disposal of the existing stairs is included in the estimate.

WMA Supervisor's Residence - Building #0903
Description: Stairs in need of handrails.
