BUILDINGS & GROUNDS OFFICE SITE

Site Number: 9956
STATE OF NEVADA PUBLIC WORKS DIVISION
FACILITY CONDITION ANALYSIS

Report distributed in December 2021

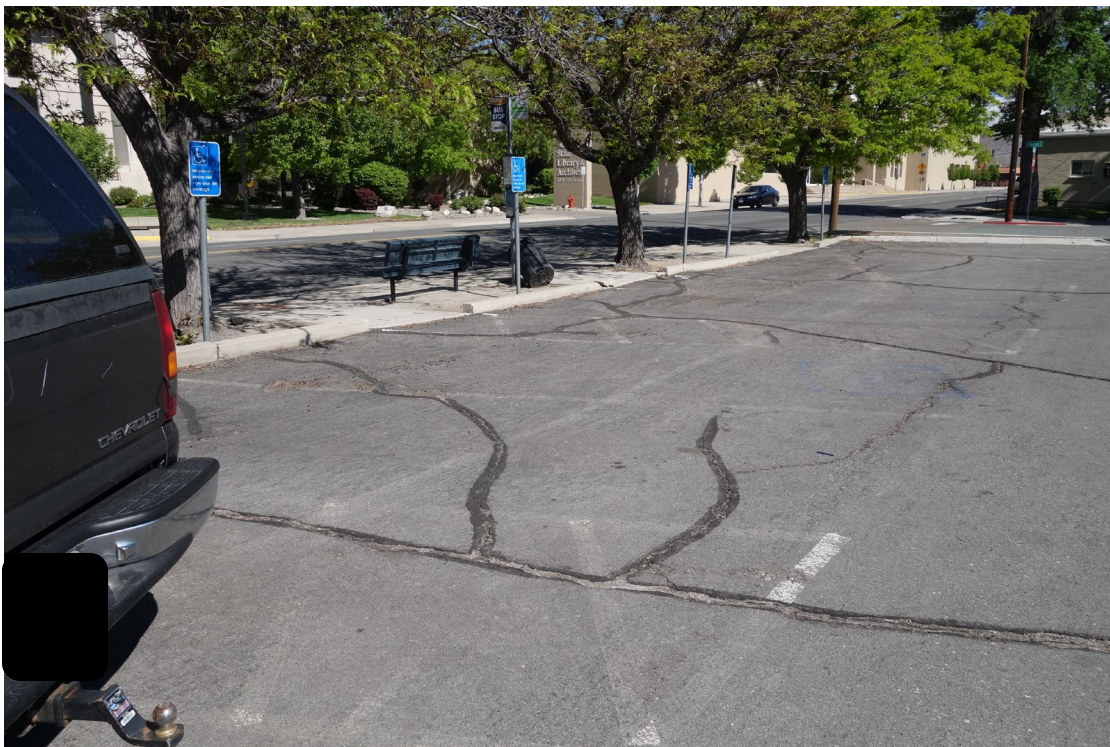
The ADA accessible parking stalls in the south parking lot do not meet slope requirements due to root damaged asphalt. This project would provide for the removal of the existing asphalt and installation of 5 new ADA compliant parking and loading zones. One shall be a van accessible space. Signage is included in this estimate. 900 square feet of paving was used to generate this estimate.

B & G Office Site - Site #9956
Description: ADA Accessible Parking Project.

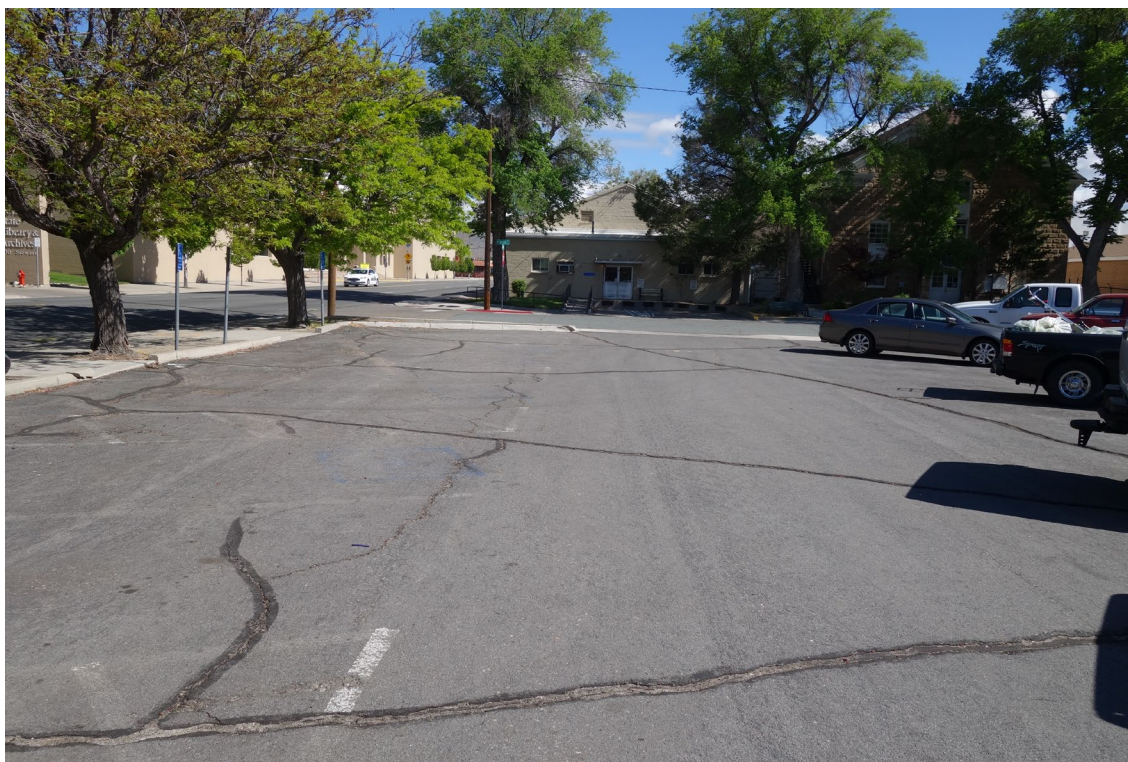
The parking lot south of the B & G buildings is in fair condition. There are numerous cracks that are in need of filling.

B & G Office Site - Site #9956
Description: South Parking Lot Crack Fill & Seal.

This project would provide for crack fill and sealing of the parking lot including striping. This project should be done concurrently with the ADA parking and sidewalk replacement projects. It is recommended that this project be done on a cyclical basis every three to five years to maintain the integrity of the pavement.

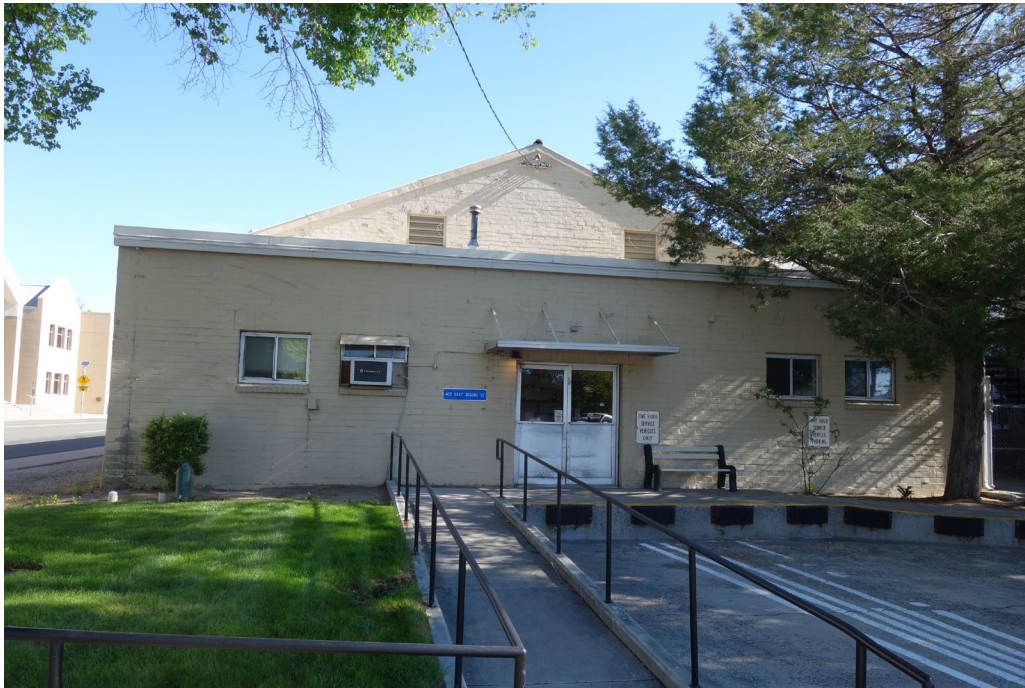
B & G Paint Shop - Building #0239
Description: ADA Ramp and Exterior of the Building.

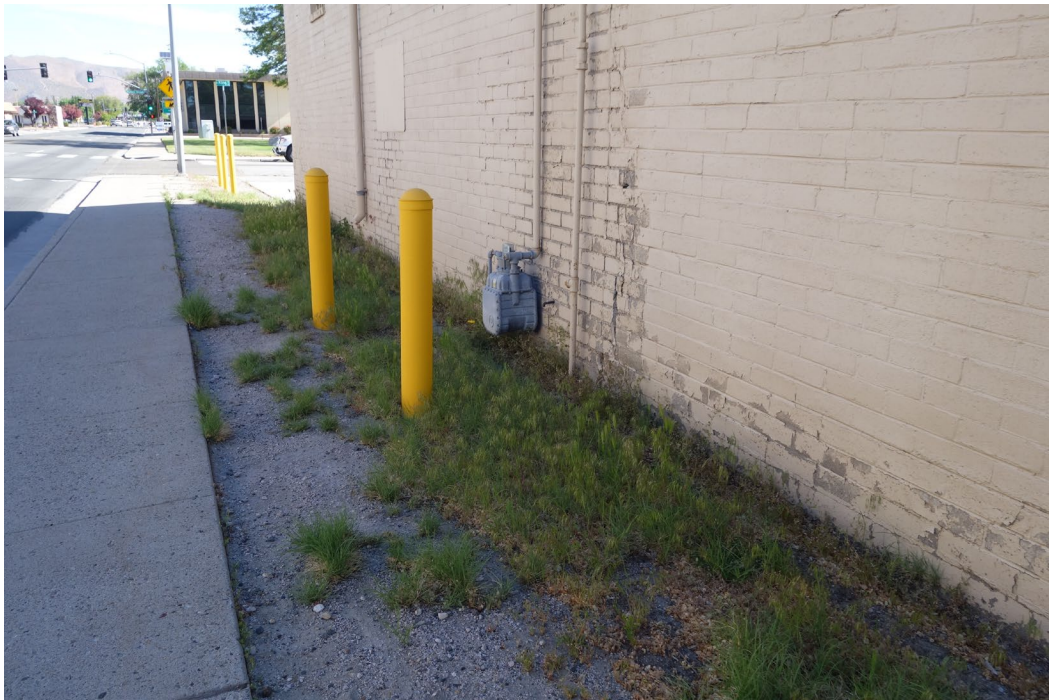
The exterior finishes are in poor condition. The paint finish has failed in multiple locations. It is important to maintain the finish, weather resistance, and appearance of the building. This project recommends work to protect the exterior building envelope, other than the roof, including painting, staining or other applied finishes, and caulking around windows, flashing, fixtures and other penetrations to maintain the building in good, weather tight condition. It is recommended that this project be implemented in the next 2 - 3 years and is recommended on a cyclical basis to maintain the integrity of the structure.

B & G Paint Shop - Building #0239
Description: Seismic Gas Valve Installation & Exterior Finishes Projects.

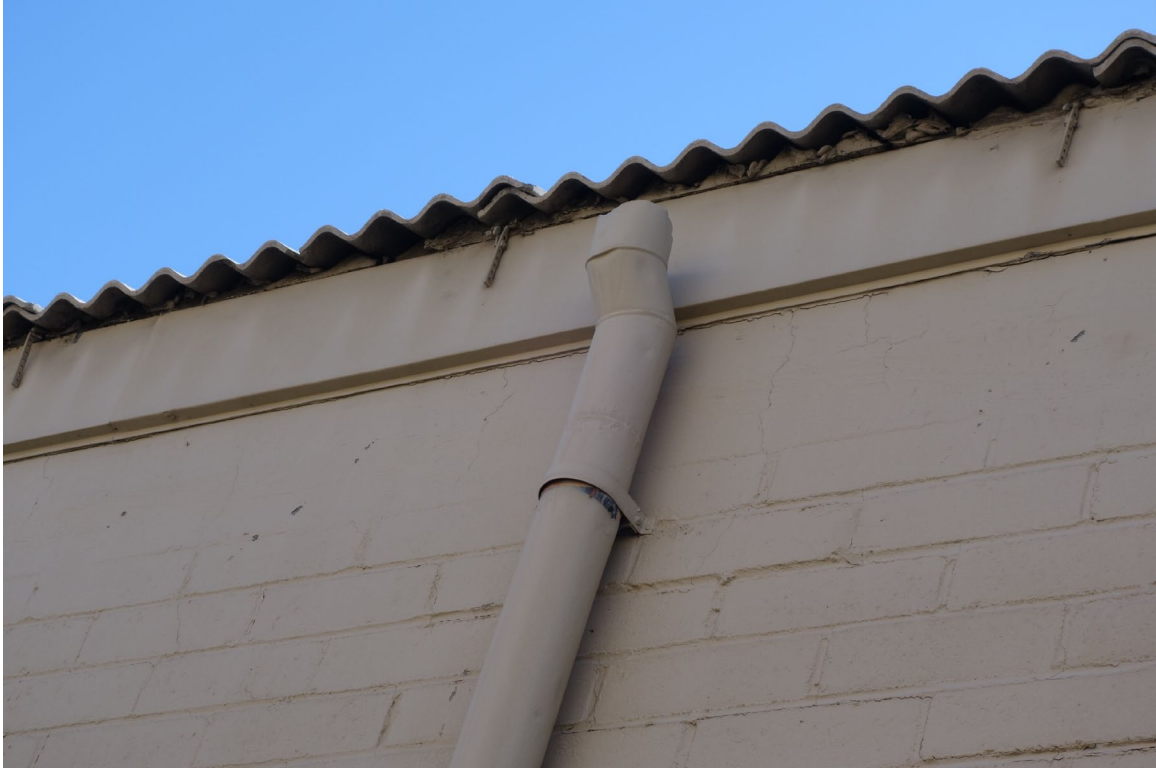
The building currently does not have rain gutters and has one abandoned downspout. This is causing rainwater to run down the building and pool next to the foundation causing damage to the foundation and stucco walls. This project would provide for the installation of rain gutters, full length downspouts to grade, and extensions away from the perimeter of the building to prevent pooling and damage to the building.

B & G Paint Shop - Building #0239
Description: Roof Replacement, Gutters and Downspouts Project.

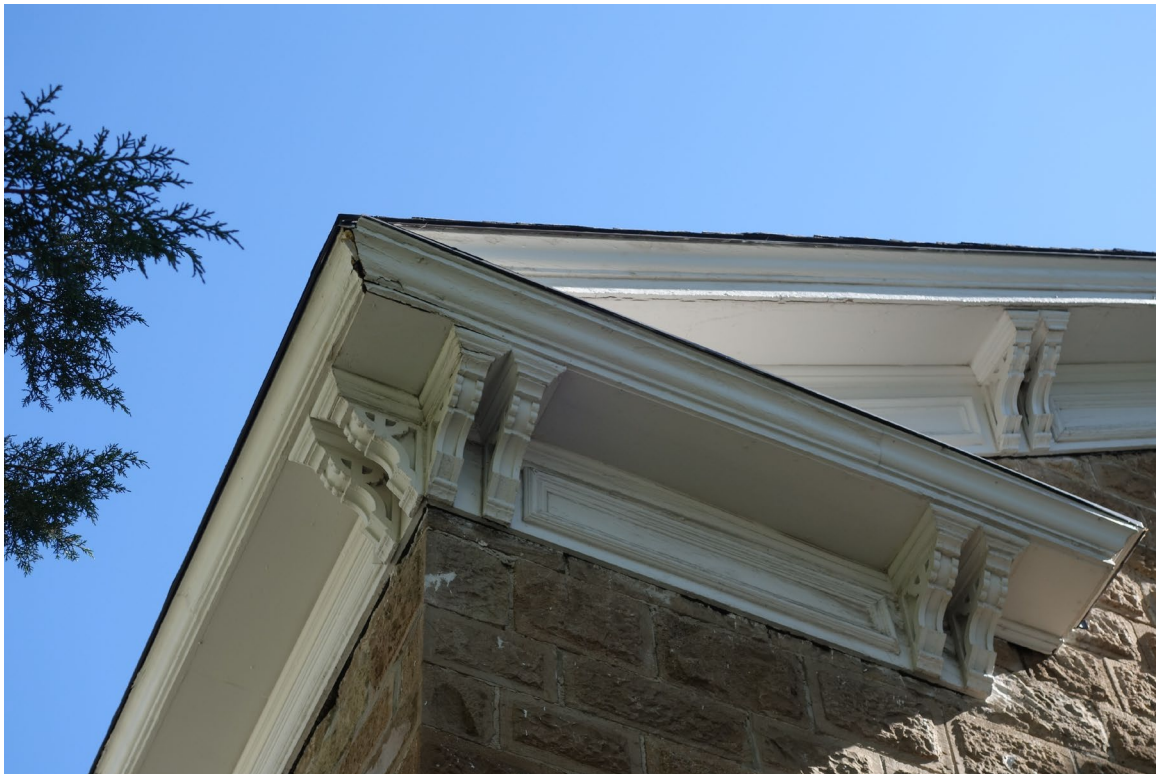
Painted wood trim and architectural details are cracking and painted surfaces are in poor condition. It is important to maintain the finish, weather resistance, and appearance of the building. This project recommends work to protect the exterior building envelope, other than the roof, including sealing the stone, painting, staining or other applied finishes, and caulking around windows, flashing, fixtures and other penetrations to maintain the building in good, weather tight condition. It is recommended that this project be implemented in the next 2 - 3 years and it is recommended that this project be scheduled on a cyclical basis to maintain the integrity of the structure.

B & G Office - Building #0391
Description: Painted Exterior Finishes.

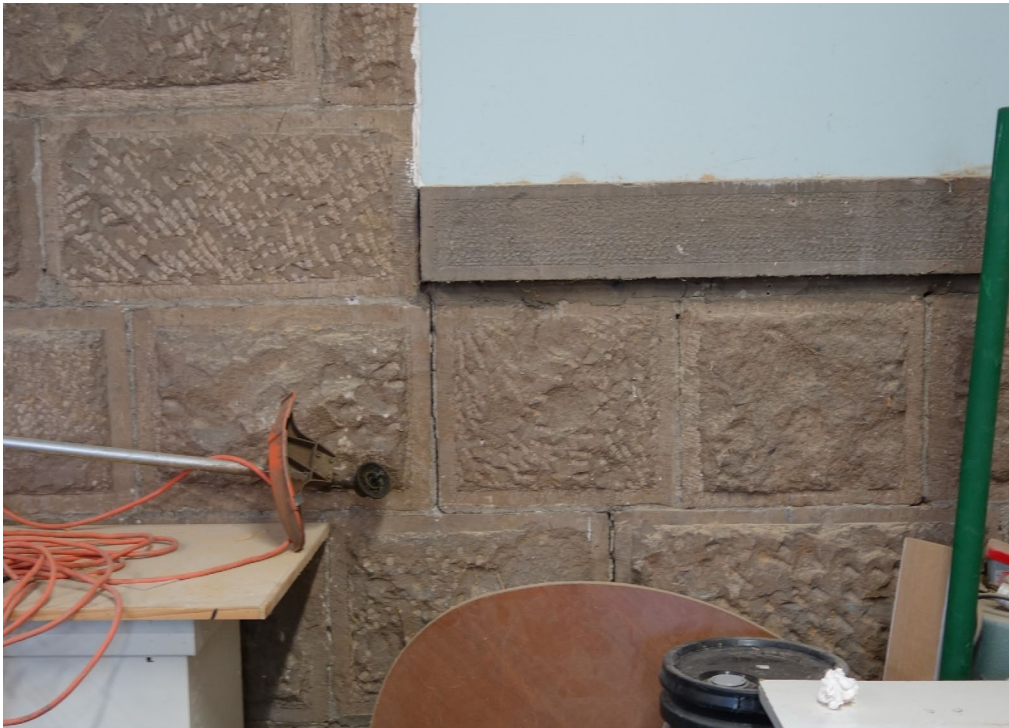
This building is an unreinforced sandstone masonry structure which requires seismic strengthening to meet current building and life safety codes. An initial study was done under CIP 07-M46 which provided detailed recommendations for a seismic retrofit. The planning and design were requested under CIP 09-P05 and the construction cost was requested for the 2011 CIP. The estimate is for the construction costs only. This project should coincide with a complete remodel of the interior of the building.

B & G Office - Building #0391
Description: Cracks in the Unreinforced Wall Structure.

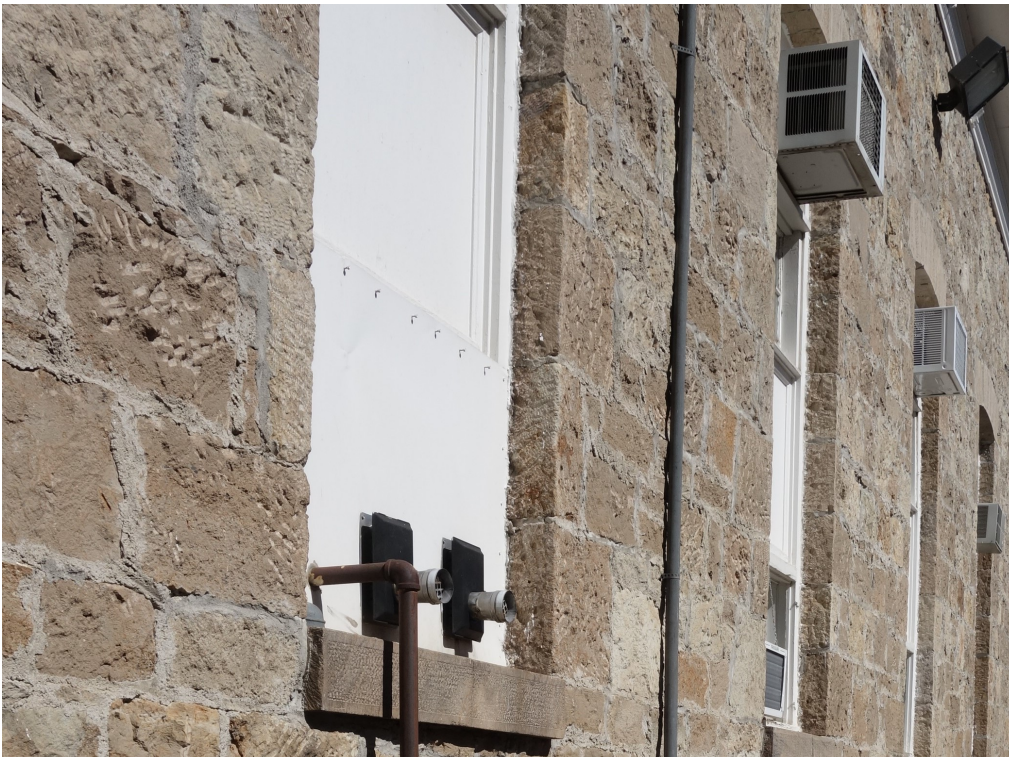
The HVAC system consists of two hot water boilers, a few isolated evaporative coolers, and window mounted air conditioning units. There is no central cooling system; although, the radiant heating from the boilers is sufficient. The boilers were replaced in 2001. This project would provide for installation of a central cooling system including duct work and grills throughout the building. This project includes removal and disposal of the existing cooling units and all required connections to utilities.

B & G Office - Building #0391
Description: Replace HVAC Equipment.

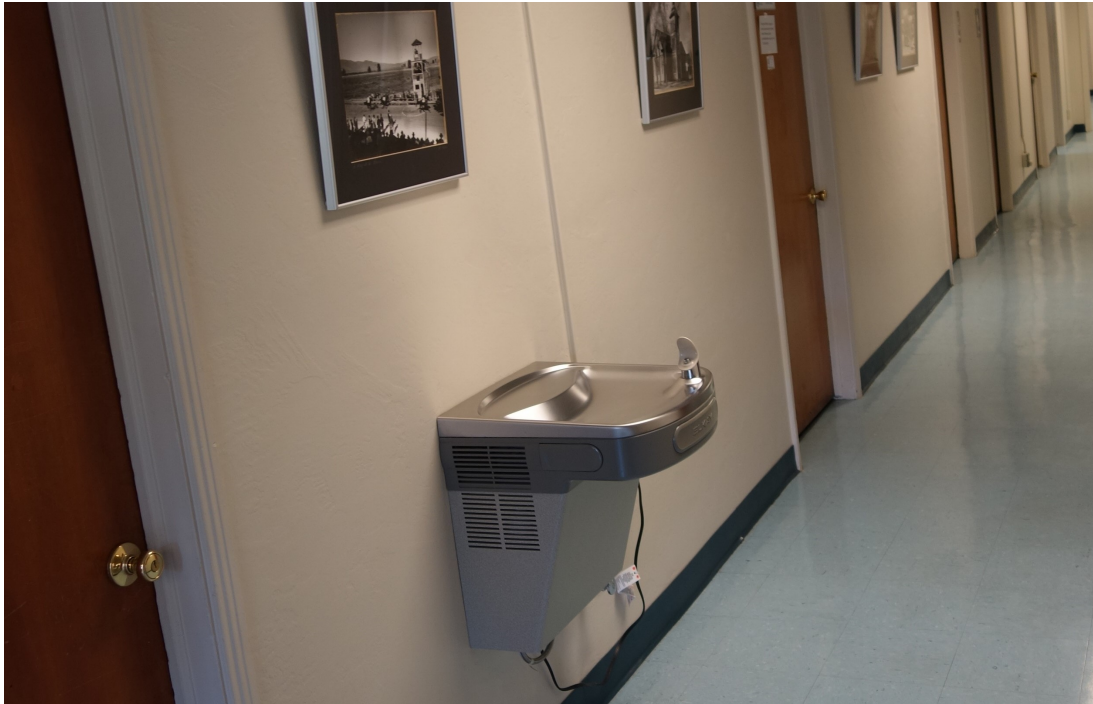
This building contains a water fountain. The 2018 IBC Section 1109.5 states where a water fountain is provided, at least half should be accessible. This project would provide funding for the purchase and replacement of a new accessible fixed high / low ADA accessible drinking fountain.

B & G Office - Building #0391
Description: ADA Accessible Water Fountain Project.

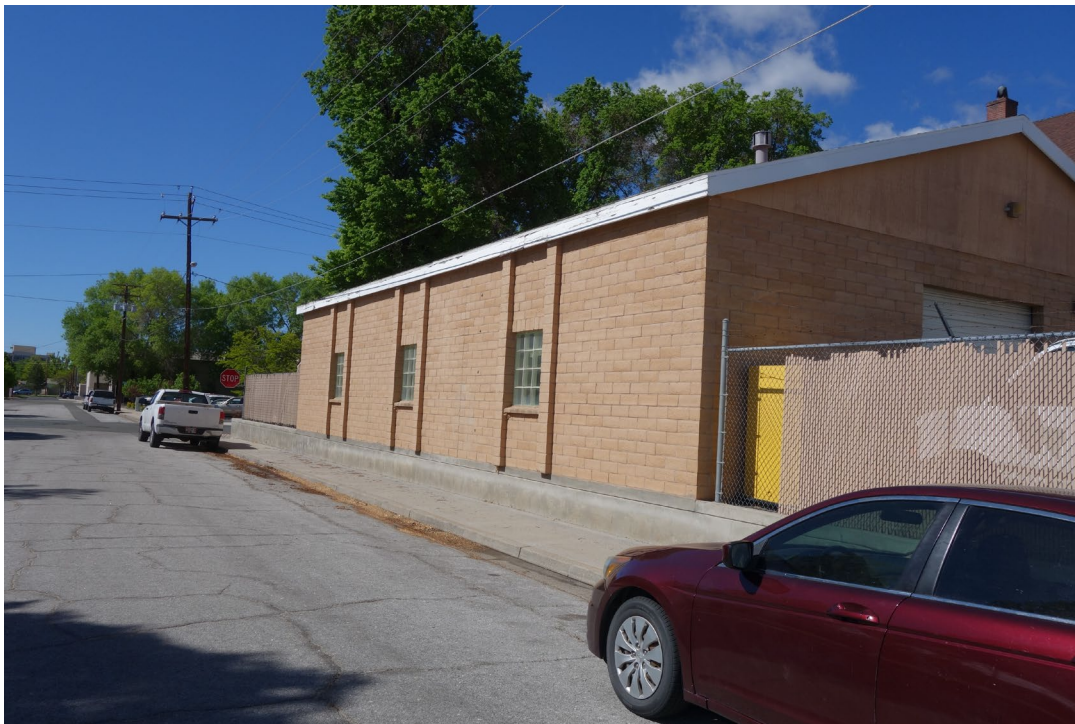
B & G Garage - Building #2312
Description: Exterior of the Building.

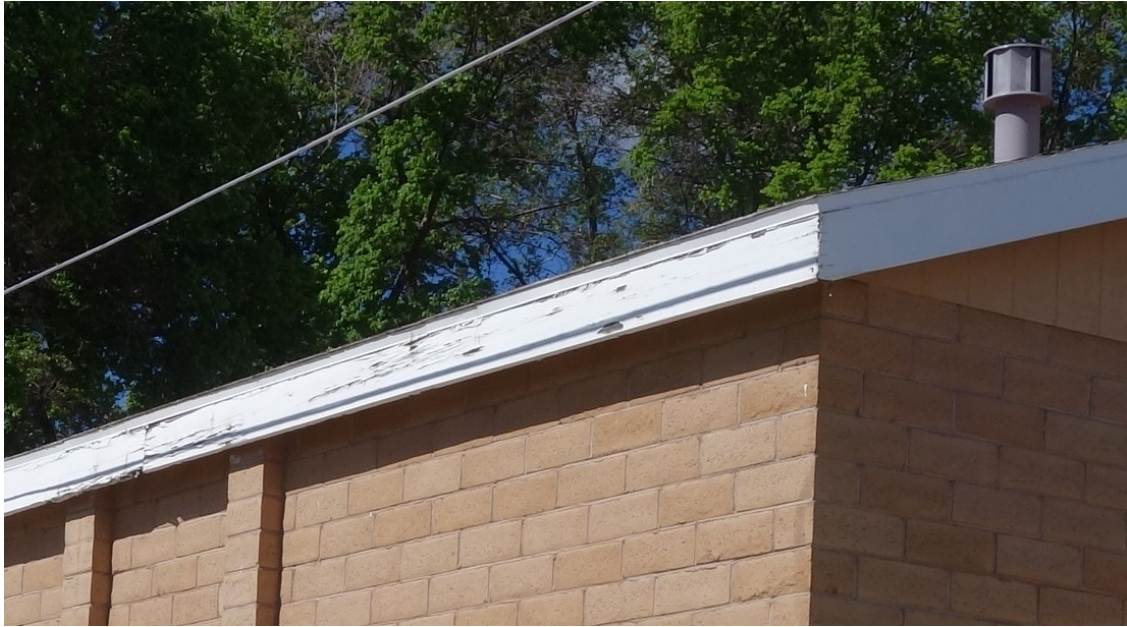
The painted wood surfaces on the exterior are in poor condition. It is important to maintain the finish, weather resistance, and appearance of the building. This project recommends work to protect the exterior building envelope, other than the roof, including painting, staining or other applied finishes, and caulking around windows, flashing, fixtures and other penetrations to maintain the building in good, weather tight condition. It is recommended that this project be implemented in the next 2 -3 years and is recommended on a cyclical basis to maintain the integrity of the structure.

B & G Garage - Building #2312
Description: Painted Exterior Finishes.

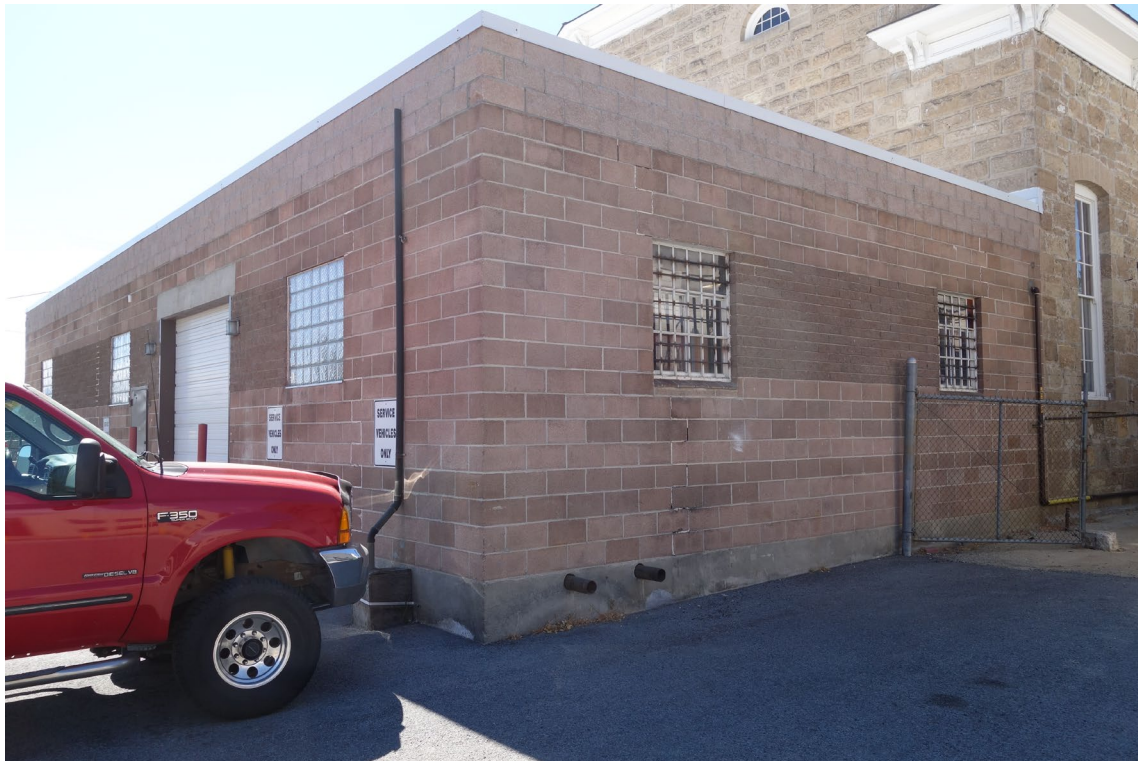
B & G Garage Addition - Building #2315
Description: Exterior of the Building.

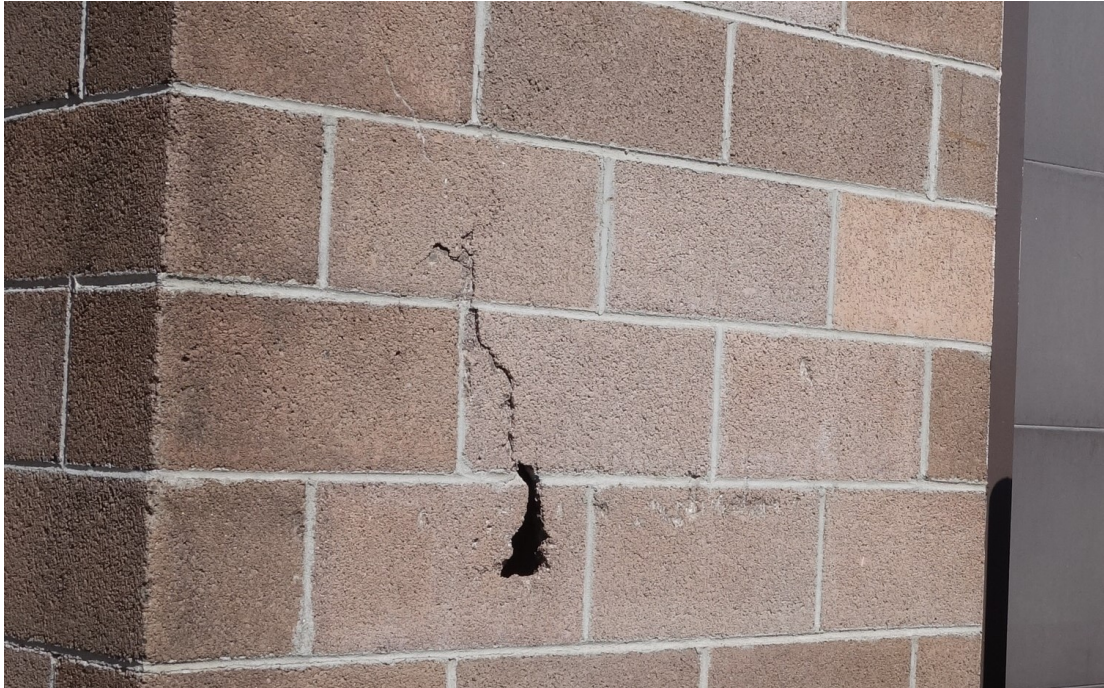
There is a hole in the CMU block wall on the exterior of the east wall. It appears that a crack is progressing vertically from this hole and could possibly be a structural concern. An analysis of this issue and subsequent repairs; if needed, is recommended. This project recommends a structural review and CMU block repair or replacement.

B & G Garage Addition - Building #2315
Description: CMU Block Repair Project.

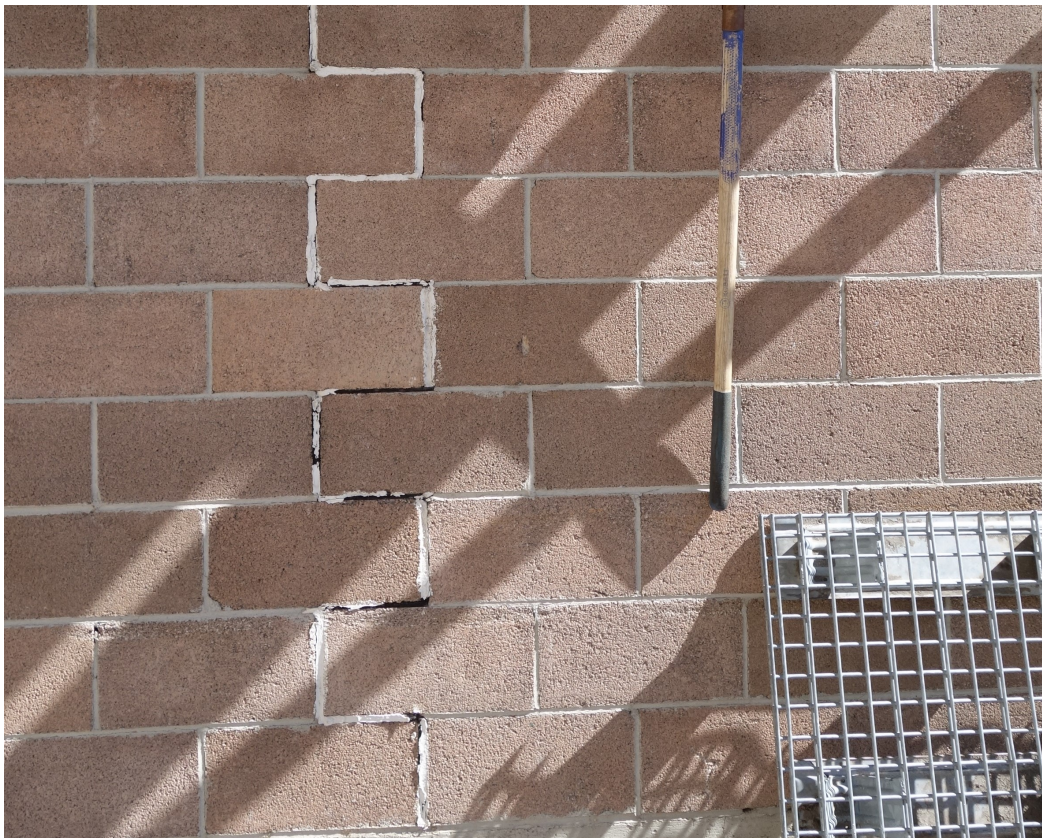
The exterior painted surfaces and caulking joints are in poor condition. It is important to maintain the finish, weather resistance, and appearance of the building. This project recommends work to protect the exterior building envelope, other than the roof, including painting, staining or other applied finishes, and caulking around windows, flashing, fixtures and other penetrations to maintain the building in good, weather tight condition. It is recommended that this project be implemented in the next 2 to 3 years and is recommended on a cyclical basis to maintain the integrity of the structure.

B & G Garage Addition - Building #2315
Description: Caulking Exterior Finishes Project.
