# DAYTON STATE PARK

**Site Number: 9961**

**STATE OF NEVADA PUBLIC WORKS DIVISION  
FACILITY CONDITION ANALYSIS**

Report distributed in January 2022

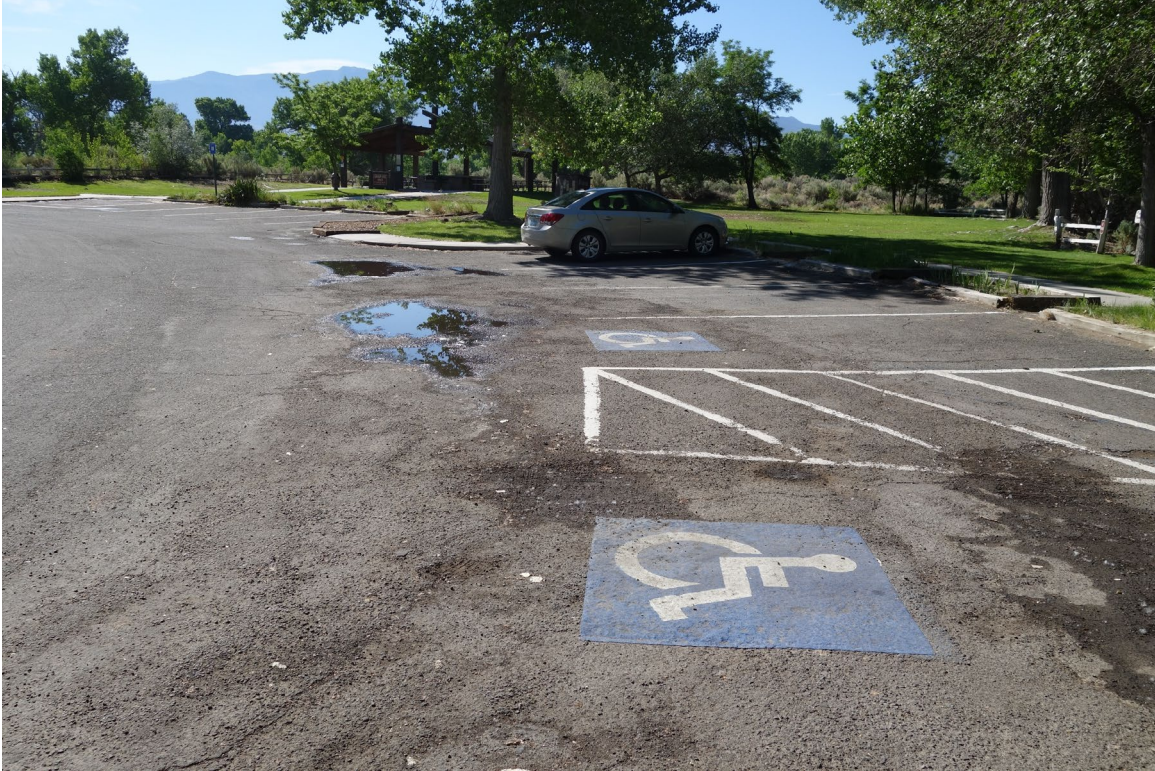
It is important to maintain the asphalt concrete paving on the site. This project would provide for patching, minor crack filling and sealing of the Comfort Station and Ramada parking area. Striping is included in this estimate. This project should be scheduled on a 5 year cyclical basis to maintain the integrity of the paving and prevent premature failure. 11,000 square feet of asphalt area was used to generate this estimate.

Dayton State Park – FCA Site #9961  
Description: Parking Area for Comfort Station and Ramada.

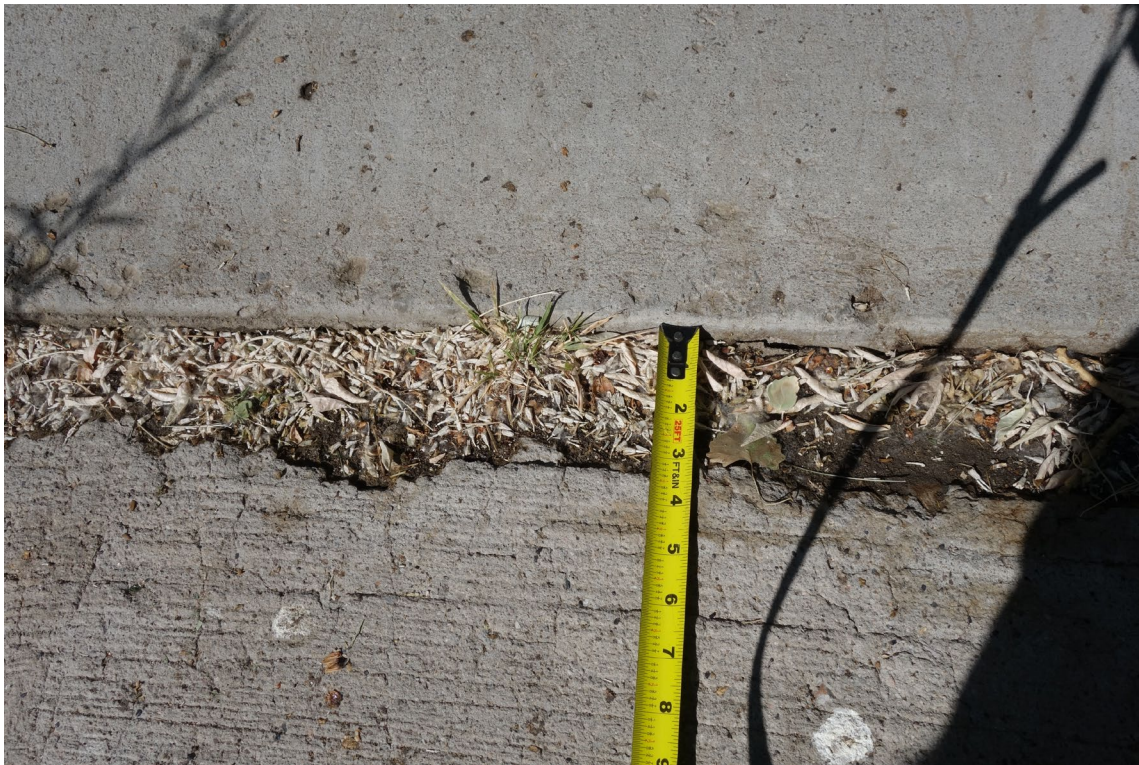
The ADA provides for accessibility to sites and services for people with physical limitations. The two ADA parking and path of travel areas for the Comfort Station and Ramada are failing and do not meet current requirements. Replacing the existing designated areas with one new compliant parking area and path of travel will meet the requirements of both locations. A concrete parking area, passenger loading area and path of travel to the sidewalk connecting both buildings are necessary to comply with ADA accessibility requirements. This project would provide for two concrete van accessible ADA parking and loading space and concrete walkway to the existing sidewalk. This will require regrading, placement of concrete, signage, striping and any other necessary upgrades. The 2018 IBC, ICC/ANSI A117.1, NRS 338.180 and the most current version of the ADA Standards for Accessible Design were used as a reference for this project. 750 square feet of concrete was used for this estimate.

Dayton State Park – FCA Site #9961  
Description: ADA Path of Travel Project.

It is recommended that this project coincide with the PATCHING, CRACK FILL & SEAL ASPHALT PAVING and ADA SIDEWALK REPLACEMENT projects.

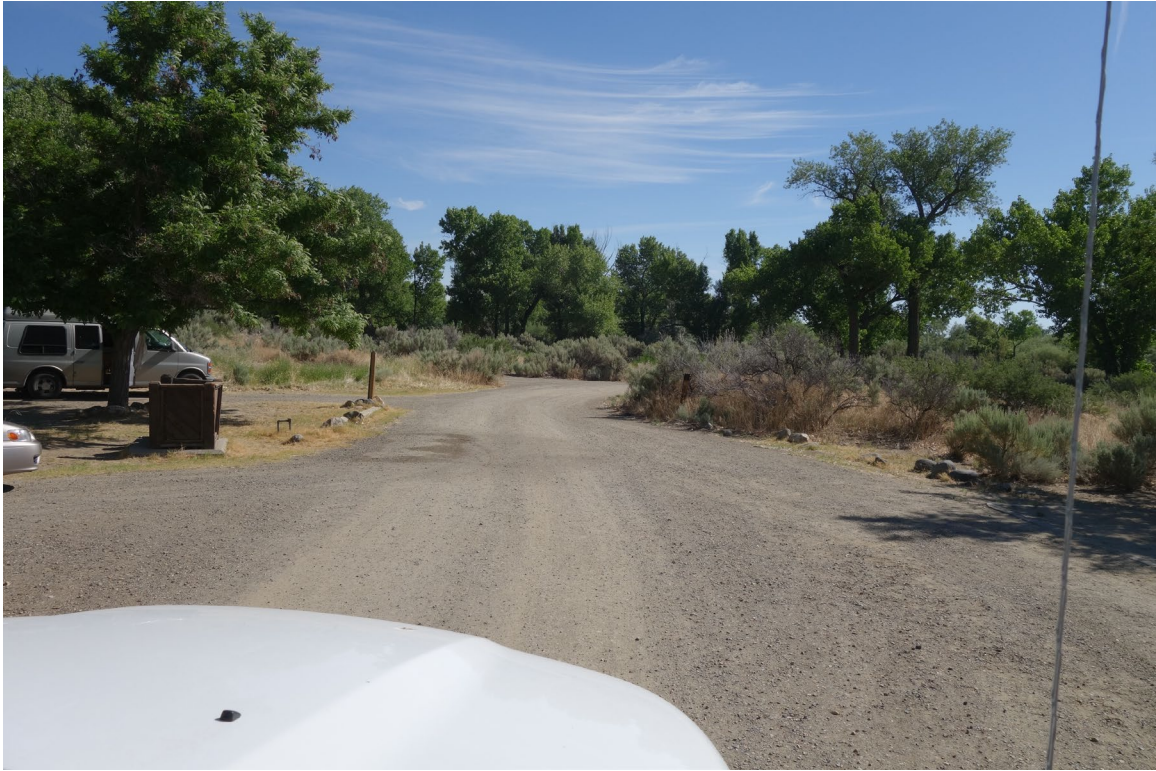
The yard around the Shop and Office, the campground loop road, and the individual campsite parking areas are not currently paved. This project would provide asphalt concrete paving for the yard, a 10' wide access road around the campground loop, and 10' wide parking spaces at each campsite. The estimate includes grading, compaction and installation of 4" thick asphalt cement.

Dayton State Park – FCA Site #9961  
Description: Asphalt Paving Installation Project.

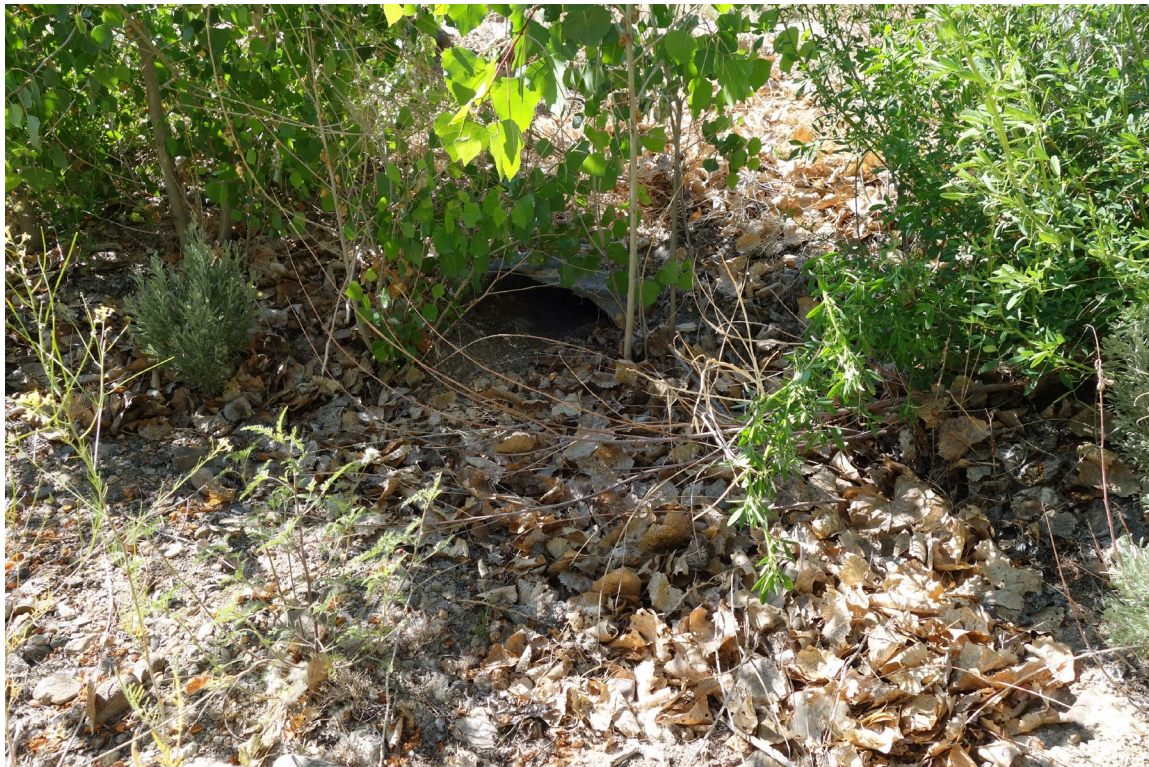
Flooding of the Carson River in the past has exposed drainage problems at the site. A culvert on the camping area loop is plugged, and brush and debris have filled the overflow canal. This project would fund the replacement of the culvert with a properly sized culvert and clean the overflow canal of debris.

Dayton State Park – FCA Site #9961  
Description: Site Drainage Upgrades Project.

This project should be done prior to the ASPHALT PAVING INSTALLATION project.
