State of Nevada
Department of Conservation and Natural Resources
Division of Forestry
Facility Condition Analysis

LAS VEGAS STATE TREE NURSERY

9600 Tule Springs Road
Las Vegas, Nevada 89131

Site Number: 9966
STATE OF NEVADA PUBLIC WORKS DIVISION
FACILITY CONDITION ANALYSIS

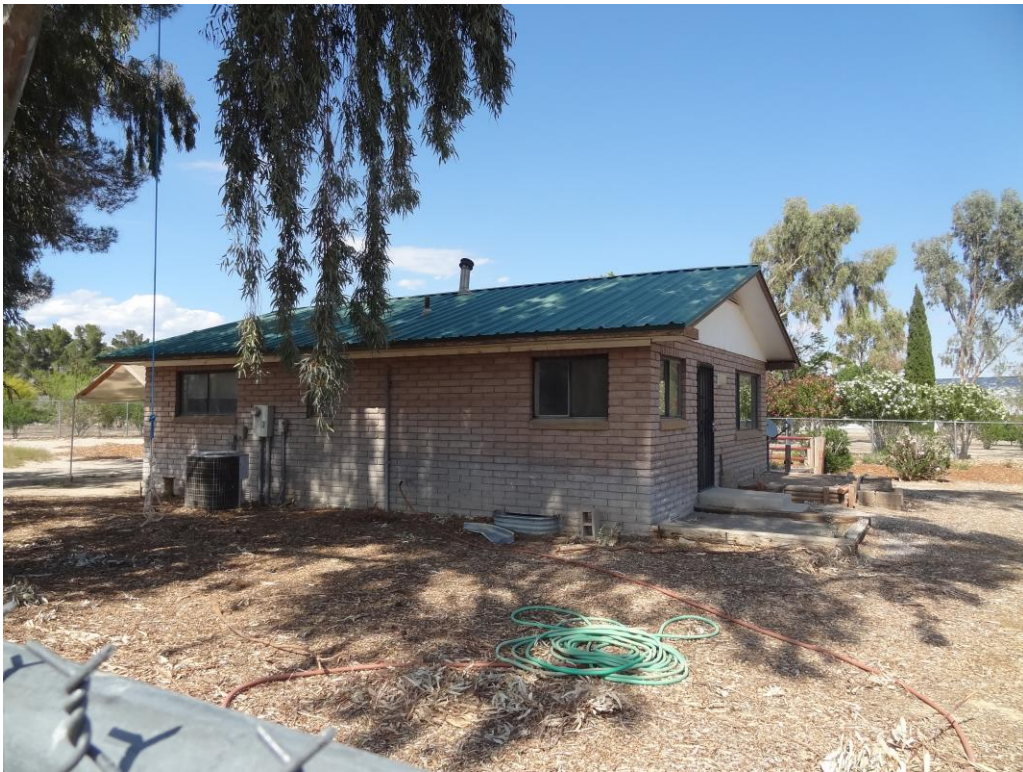
Nursery Residence - Building #3046
Description: Exterior finishes.

It is important to maintain the finish, weather resistance and appearance of the building. This project would provide funding to protect the exterior of the building. Included in the cost are cleaning and sealing the masonry, painting the wood siding and caulking of the windows, flashing, fixtures and all other penetrations. It is recommended that the building be sealed, painted and caulked in the next 2-3 years and that this project be scheduled on a cyclical basis to maintain the integrity of the structure.

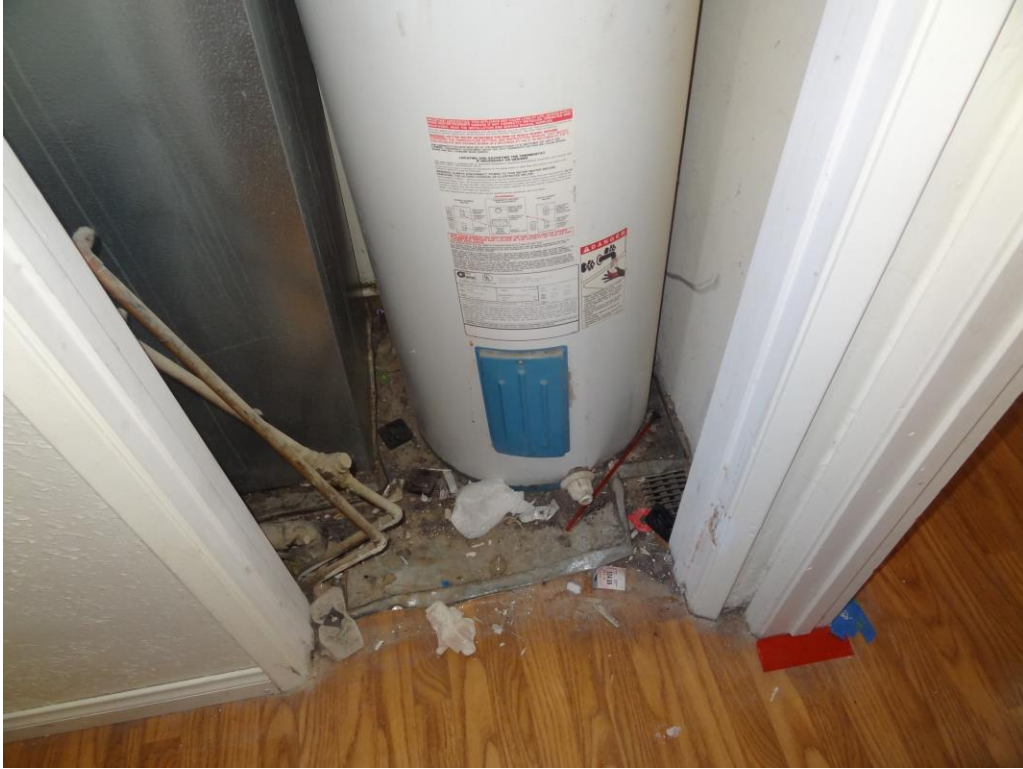
The plywood subfloor under the furnace and water heater is damaged and reaching the end of its useful life. This project would provide for a licensed contractor to evaluate the floor joists, and determine if they are structurally sound. The costs will cover repair or replacement (if necessary) and the installation of new plywood. Removal and disposal of materials has been included in the estimate.

Nursery Residence - Building #3046
Description: Damaged subfloor needs to be replaced.

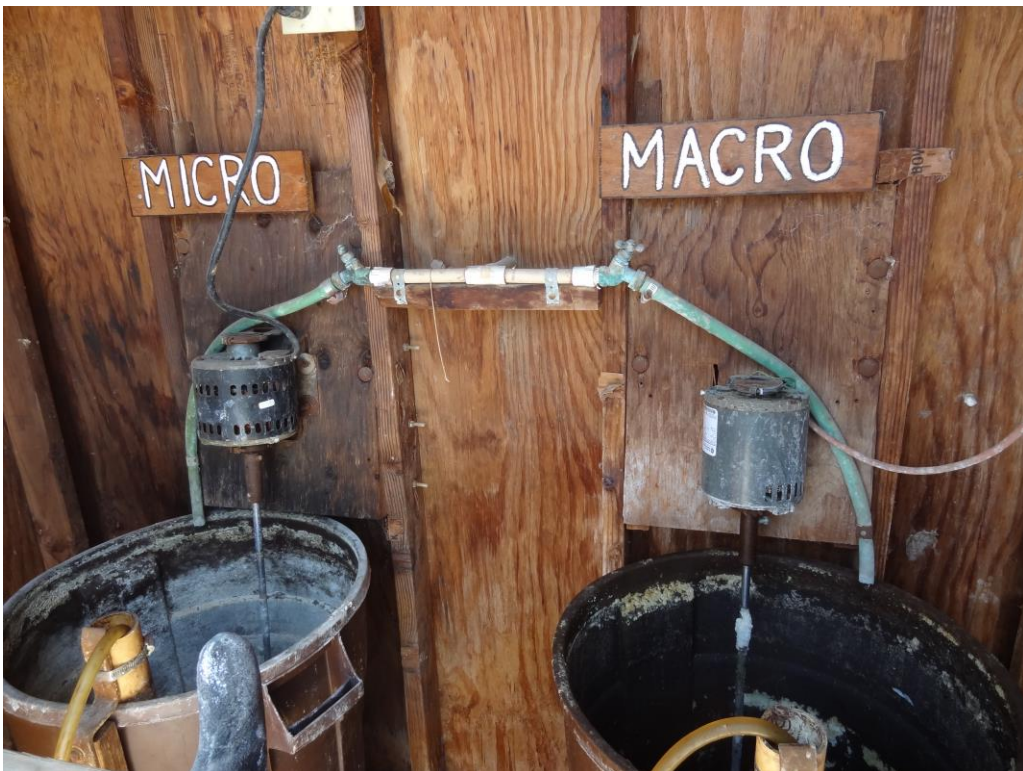
The building has fertilizer injectors on the domestic water system. The fertilizer injectors have built-up water calcium deposits, are problematic and intermittently work. This project recommends the removal and disposal of the current fertilizer injectors and the installation of new fertilizer injectors and provides for all necessary connections to the existing utilities.

Nursery Fertilization Shed - Building #3045
Description: Fertilizer injector replacement needed.

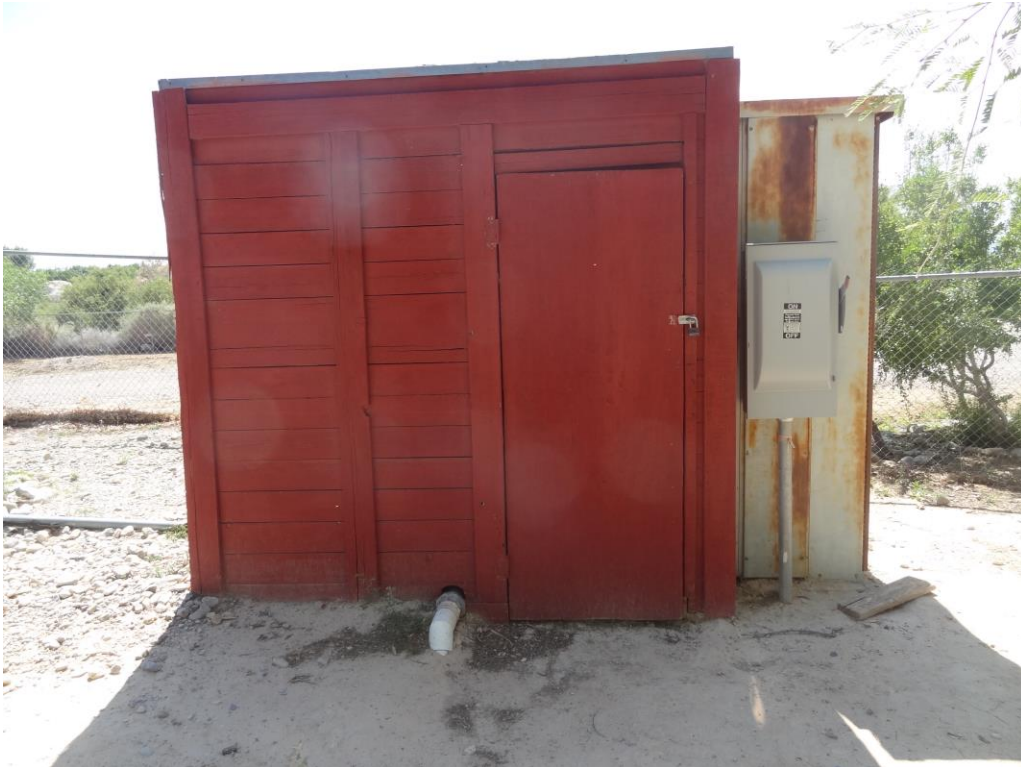
The structure is over 30 years old and houses brand new equipment including the well pump and expansion tanks. There is no solid floor and the walls and roof are damaged and severely deteriorated. There is evidence of water damage on the interior walls indicating a failed building envelope. As such, the equipment is basically exposed to the elements and will deteriorate prematurely. This project would provide for demolishing the existing structure and rebuilding a new one around the equipment. The new structure will have a poured concrete foundation, wood framing and an asphalt composition roof. Design fees are not included in this estimate.

Nursery Pump House - Building #2196
Description: Structure needs to be rebuilt.

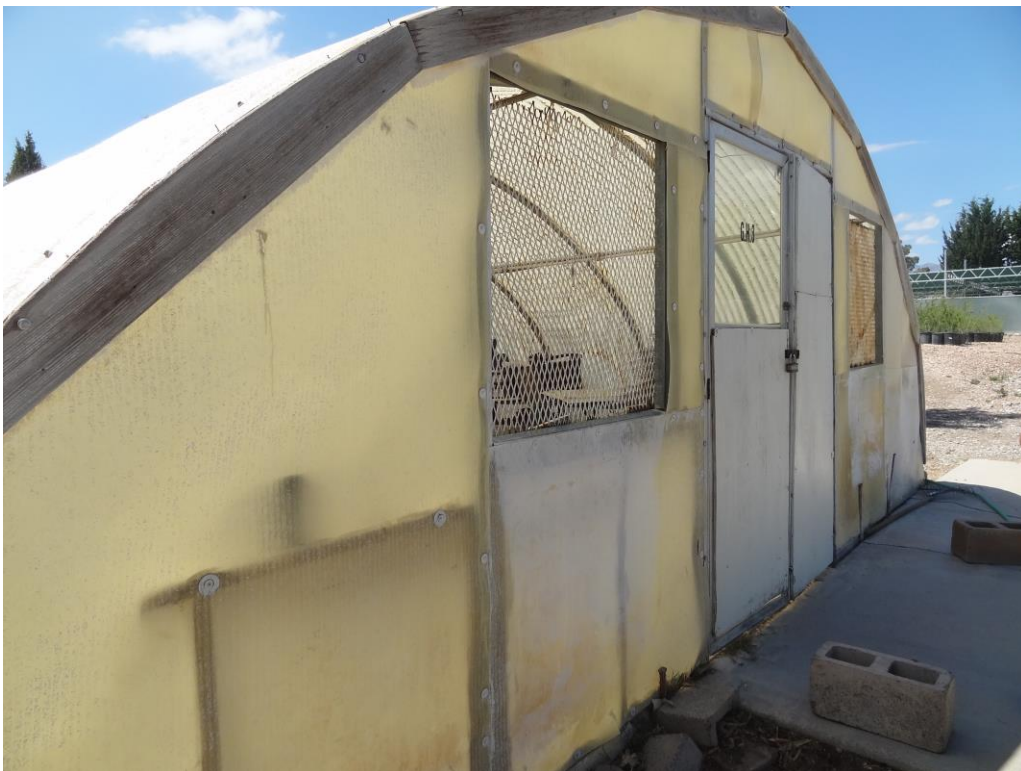
The corrugated fiberglass panels covering the building are original to the building and should be scheduled for replacement. Many of the panels are damaged from general wear and tear and have needed maintenance often. This project would provide for removal and disposal of the existing panels and replacement with polycarbonate panels. The estimate is based on 1,200 linear feet of 4'-0" wide panels at \$17 per linear foot.

Nursery Greenhouse #3 - Building #2195
Description: Exterior finishes.

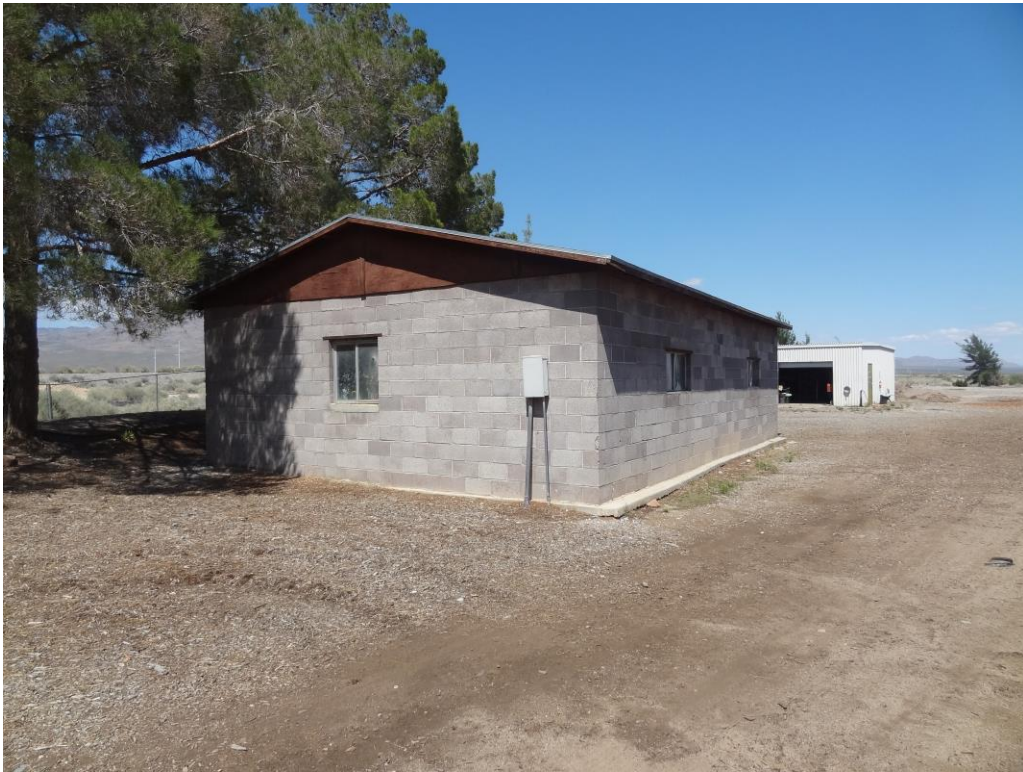
Nursery Storage #2 - Building #0638
Description: Exterior finishes.

It is important to maintain the finish, weather resistance and appearance of the building. This project would provide funding to protect the exterior of the building excluding the roof. Included in the cost are cleaning and sealing the concrete masonry units, staining the wood siding and caulking of the windows, flashing, fixtures and all other penetrations. It is recommended that the building be sealed and caulked in the next 2-3 years and that this project be scheduled on a cyclical basis to maintain the integrity of the structure.

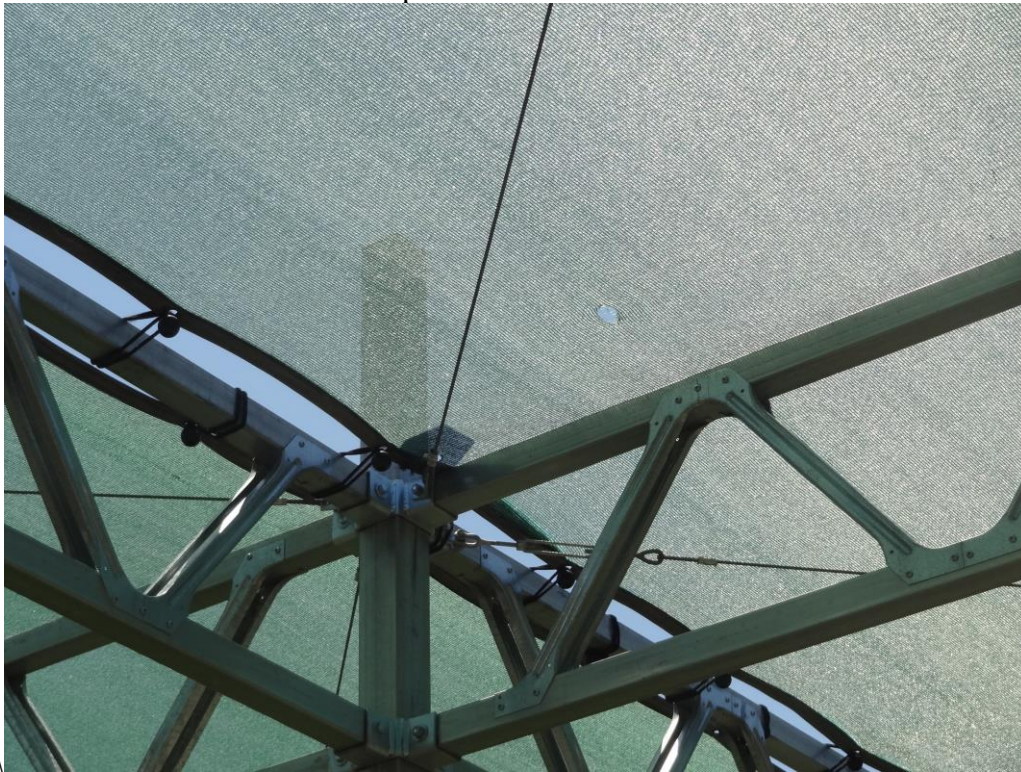
Nursery Lath House - Building #0616
Description: Roof replacement needed.

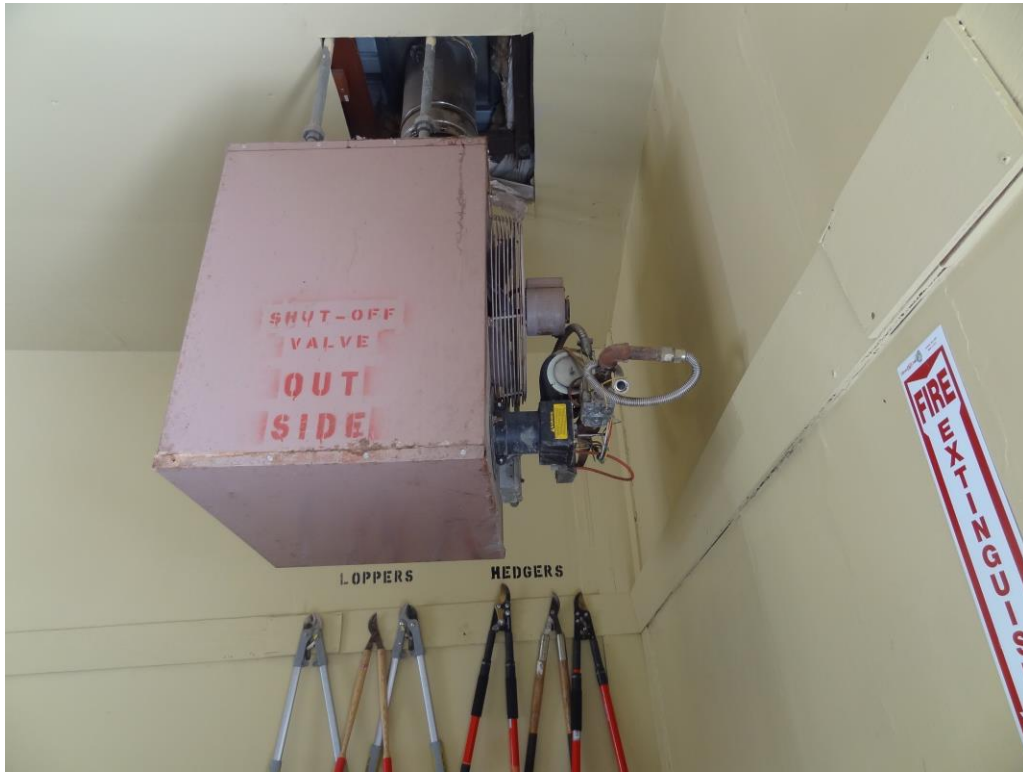
Nursery Office - Building #0283
Description: HVAC upgrade needed.

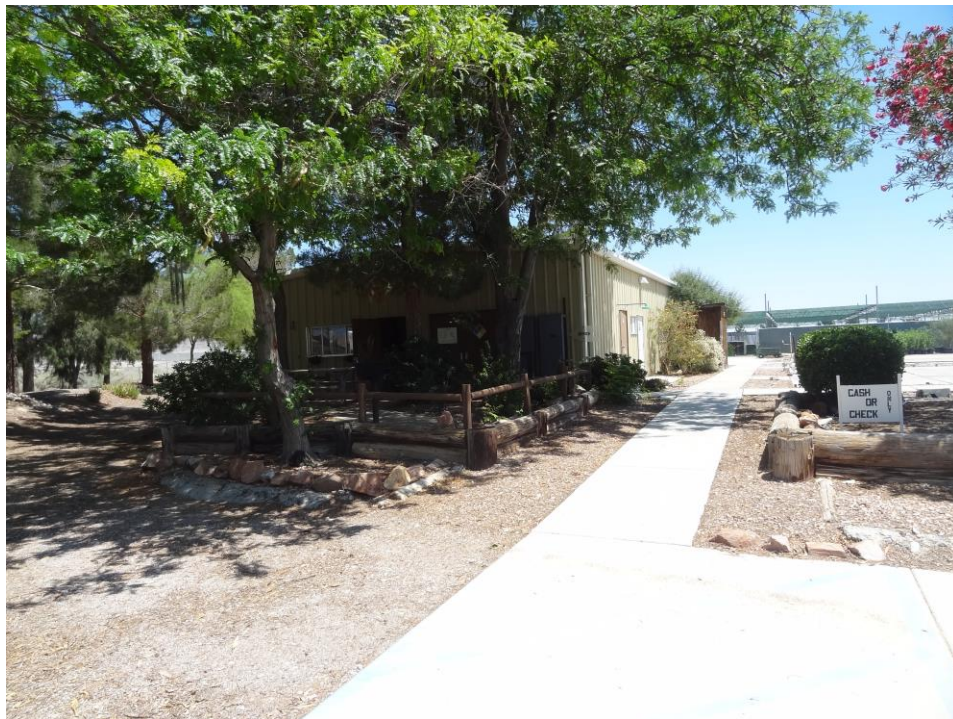
Nursery Office - Building #0283
Description: Exterior finishes.
