State of Nevada
Department of Corrections

SOUTHERN DESERT CORRECTIONAL CENTER

Site Number: 9970
STATE OF NEVADA PUBLIC WORKS DIVISION
FACILITY CONDITION ANALYSIS

Report distributed in December 2021

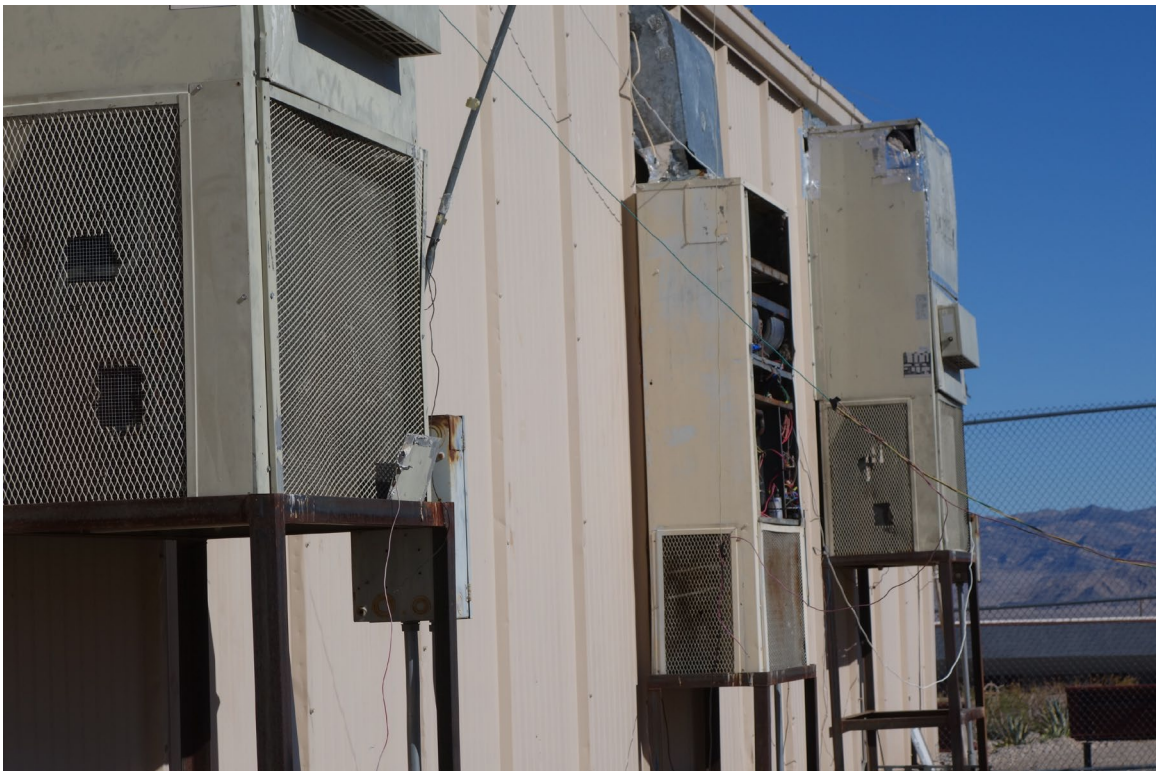
SDCC Card Sorting Building – FCA Building #3160

Description: HVAC Equipment in need of replacement.

HVAC EQUIPMENT REPLACEMENT**Project Index #: 3160HVA1****Construction Cost \$30,000**

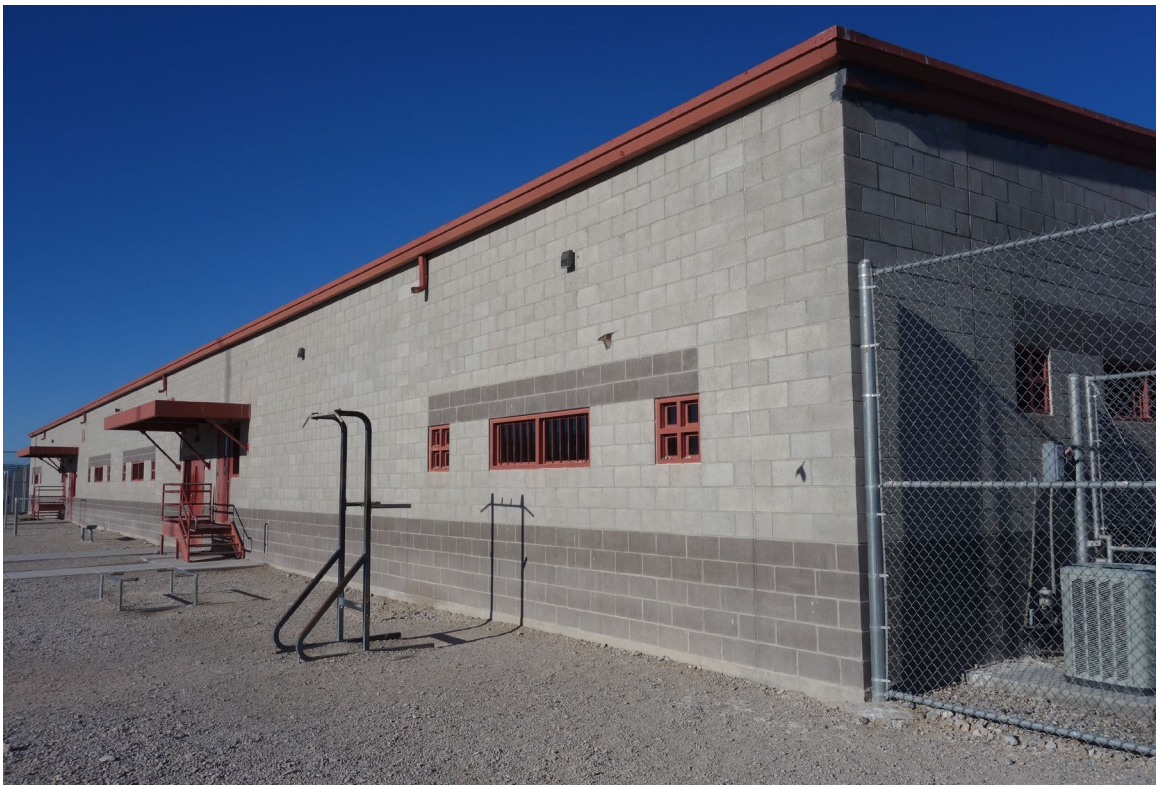
SDCC Dorm Housing Unit #12 – FCA Building #2788
Description: Exterior of the building.

Pooling water on the floor in the maintenance areas behind the restroom and shower pods indicates water leaks in the plumbing and / or the seals are broken in the shower enclosures. These leaks need to be addressed in order to prevent further damage and corrosion to the modular metal pods.

PLUMBING LEAKS**Project Index #: 2788PLM2****Construction Cost \$5,000**

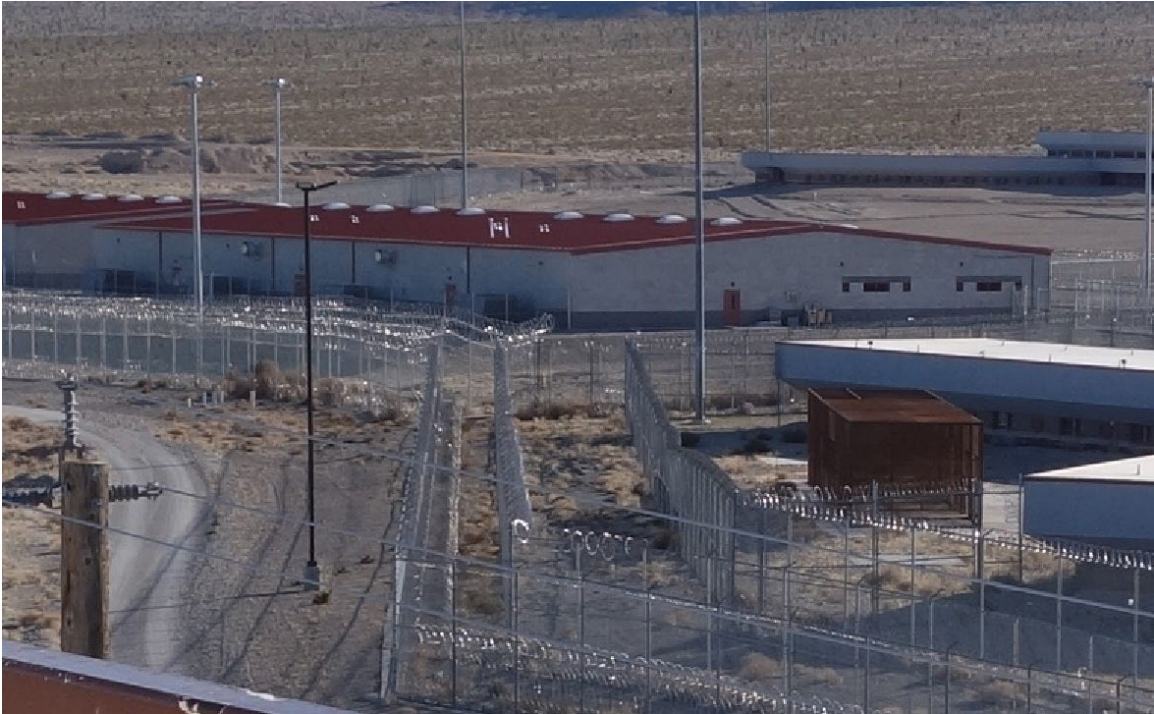
SDCC Dorm Housing Unit #11 – FCA Building #2787
Description: Exterior of the building.

Pooling water on the floor in the maintenance areas behind the restroom and shower pods indicates water leaks in the plumbing and / or the seals are broken in the shower enclosures. These leaks need to be addressed in order to prevent further damage and corrosion to the modular metal pods.

PRIORITY CLASS 1 PROJECTS**Total Construction Cost for Priority 1 Projects: \$5,000****Currently Critical****Immediate to Two Years****Project Index #: 2787PLM1****PLUMBING LEAKS****Construction Cost \$5,000**

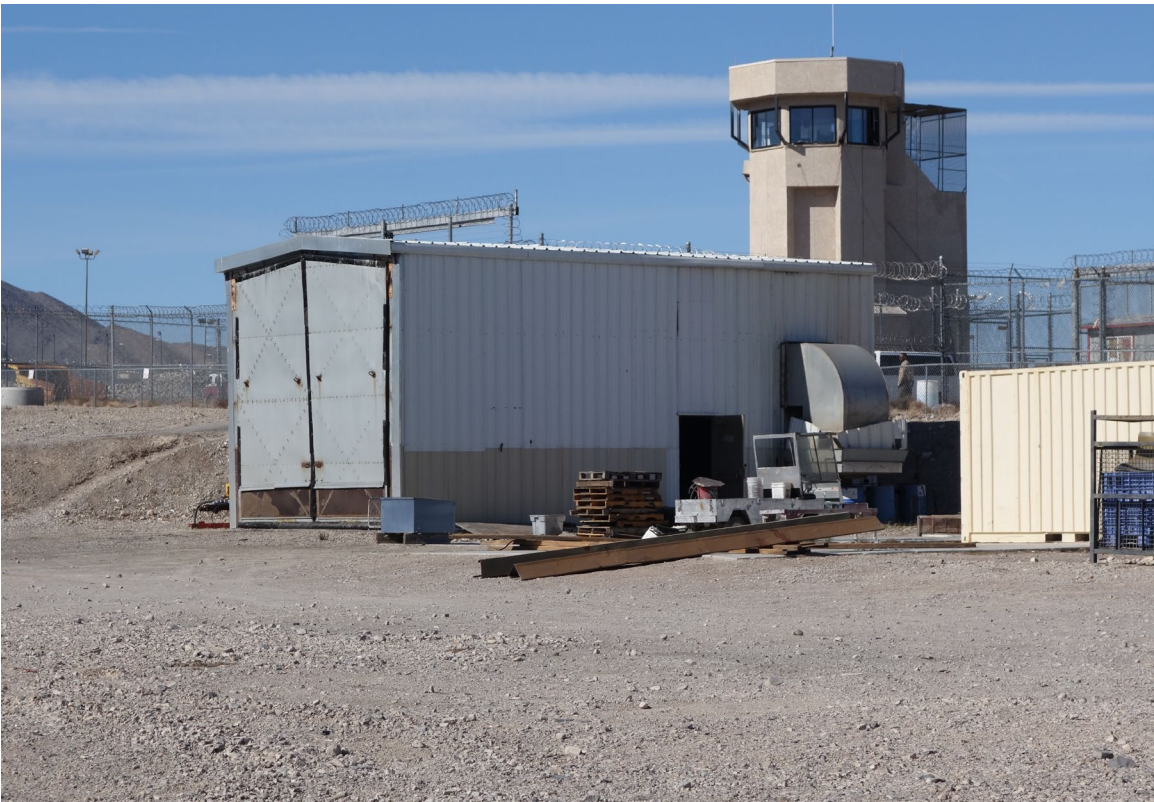
SDCC P.I. Sandblasting Shed 2 – FCA Building #2721
Description: Exterior of the building.

The building exterior is in poor condition showing multiple locations of corrosion and deterioration of the pre-finished metal panels. It is important to maintain the finish, weather resistance and appearance of the building. This project would provide funding to protect the exterior of the building excluding the roof. Included in the cost is sanding, priming and painting and caulking of the windows, flashing, fixtures and all other penetrations. It is recommended that the building be painted in the next 2 - 3 years and that this project be scheduled on a cyclical basis to maintain the integrity of the structure.
