State of Nevada
Department of Corrections
Humboldt Conservation Camp
Facility Condition Analysis

HUMBOLDT CONSERVATION CAMP

Site Number: 9972
STATE OF NEVADA PUBLIC WORKS DIVISION
FACILITY CONDITION ANALYSIS

Report Printed in January 2017

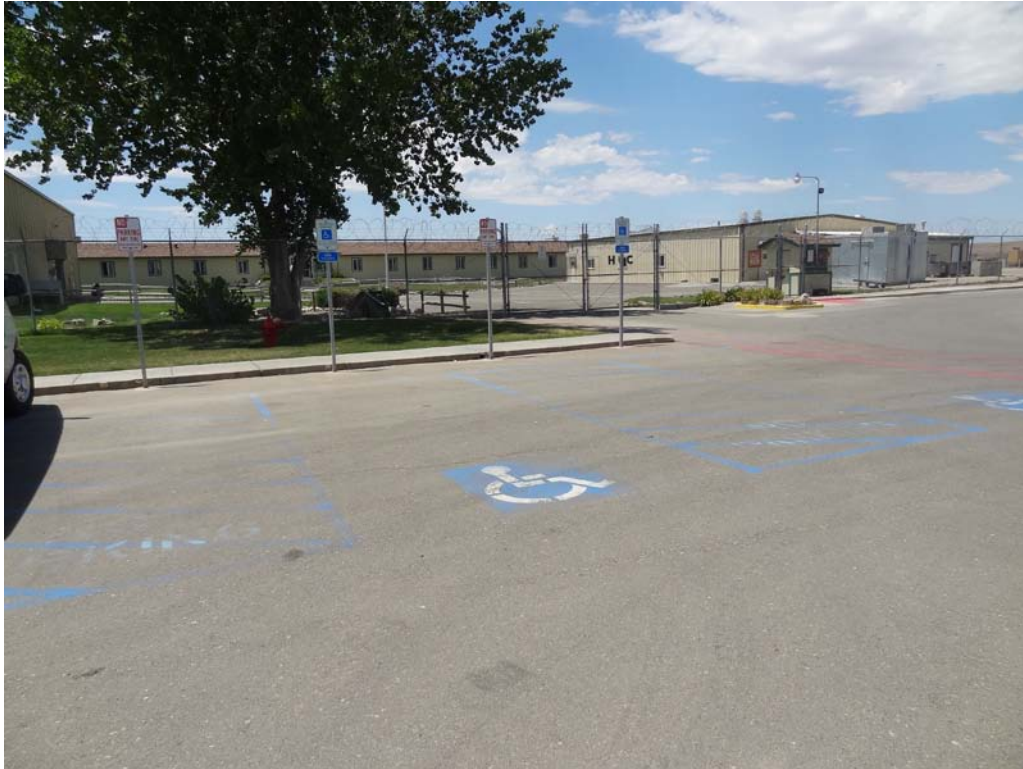
HCC - Site #9972

The Americans with Disabilities Act (ADA) provides for accessibility to sites and services for people with physical limitations. The existing ADA parking space does not meet the current requirements. This project will provide funding to bring the existing ADA parking space up to code, and will include the removal of the asphalt and replacement with P.C. concrete, updated signage, re-striping, re-grading and any other necessary upgrades. This project will also provide for the addition of a path of travel from the parking space to the gate to the visitor's entrance. The 2012 IBC, ICC/ANSI A117.1 - 2009, NRS 338.180 and the most current version of the ADA Standards For Accessible Design were used as a reference for this project.

Description: Existing ADA parking and path of travel.

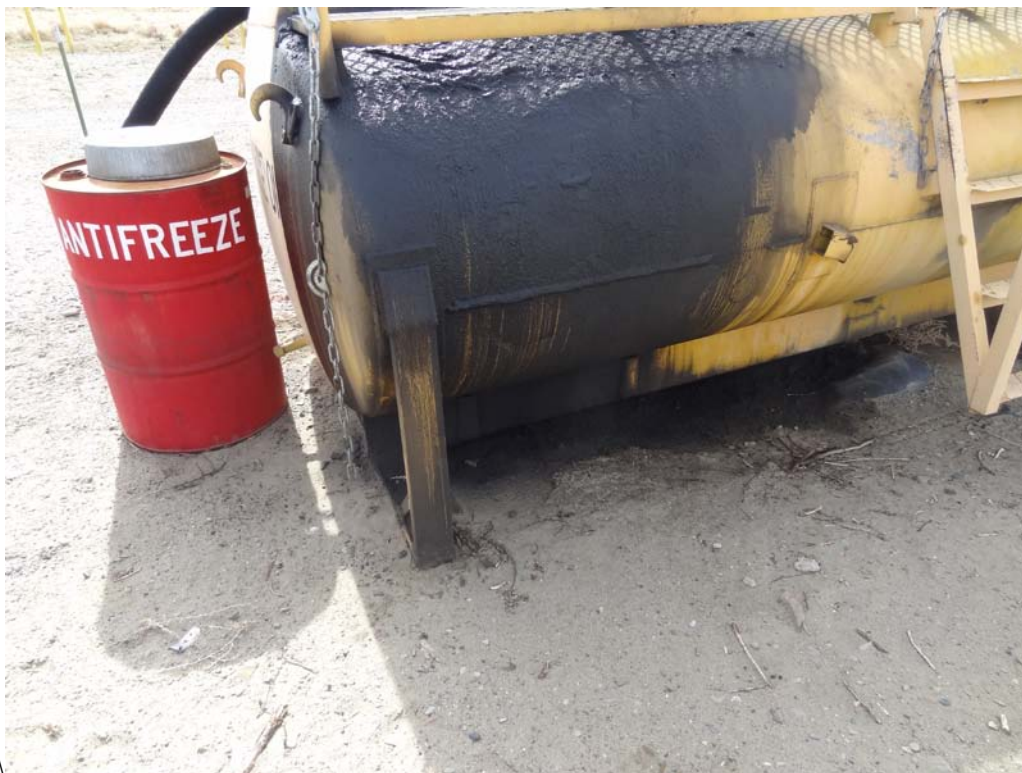
HCC - Site #9972

Description: Waste oil tank leaking onto dirt, no secondary containment.

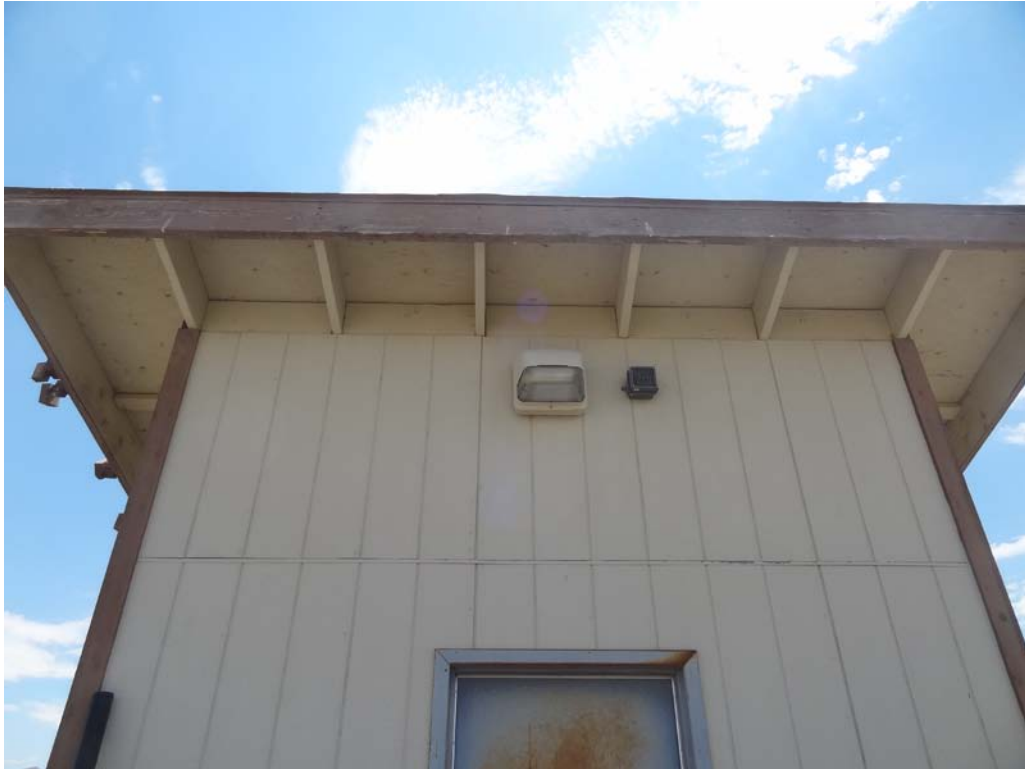
Wastewater Treatment Building - Building #3786
Description: Exterior finishes.

It is important to maintain the finish, weather resistance and appearance of the building. This project would provide funding to protect the exterior of the building excluding the roof. Included in the cost is sanding, priming, painting and caulking of the flashing, fixtures and all other penetrations. It is recommended that the building be painted in the next 2-3 years and that this project be scheduled on a cyclical basis to maintain the integrity of the structure.

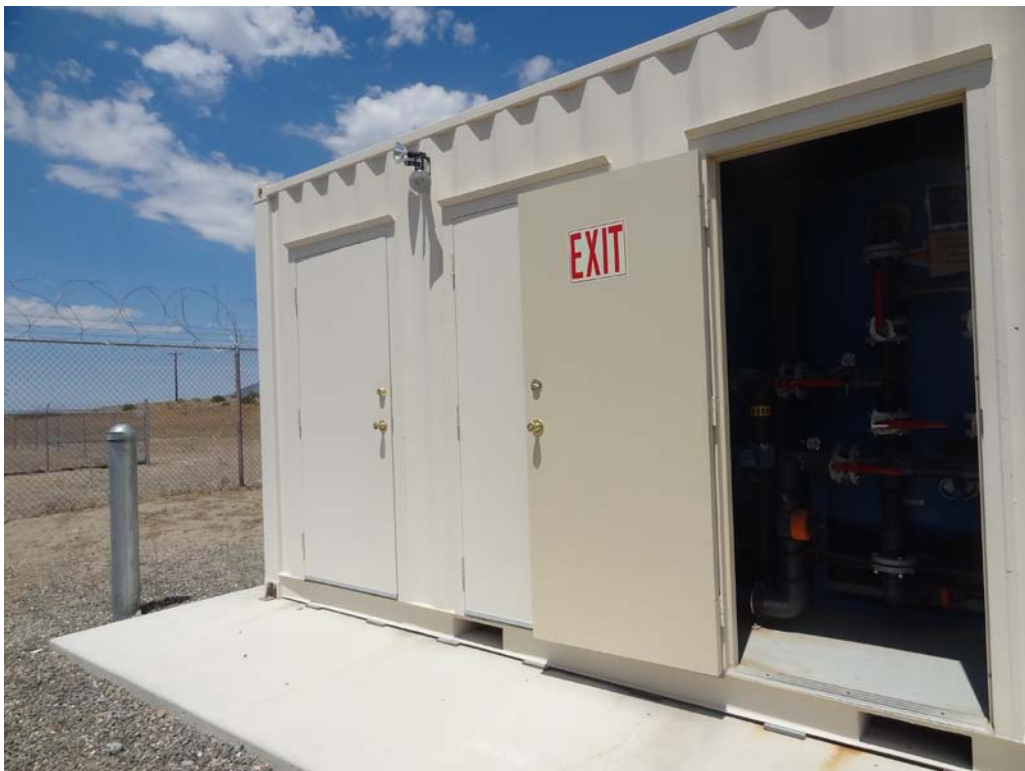
Arsenic Treatment Building - Building #3754
Description: Exterior finishes.

It is important to maintain the finish, weather resistance and appearance of the building. This project would provide funding to protect the exterior of the building excluding the roof. Included in the cost is sanding, priming and painting and caulking of the windows, flashing, fixtures and all other penetrations. It is recommended that the building be painted in the next 4-5 years and that this project is scheduled on a cyclical basis to maintain the integrity of the structure.

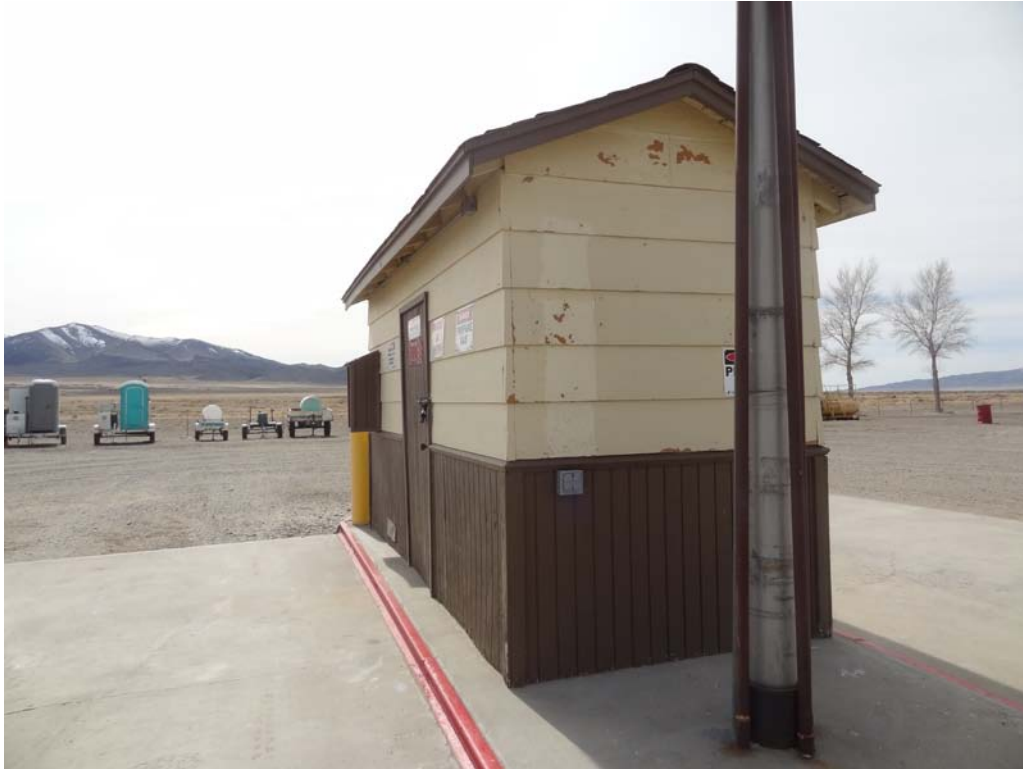
The wood siding has some areas that are damaged from exposure to the elements and should be replaced. This project would provide for the removal and replacement of damaged siding and trim including caulking and painting to match existing conditions.

Fuel Island Building - Building #2142
Description: Exterior finishes.

It is important to maintain the finish, weather resistance and appearance of the building. This project would provide funding to protect the exterior of the building excluding the roof. Included in the cost is sanding, priming and painting and caulking the flashing, fixtures and all other penetrations. It is recommended that the building be painted in the next year and that this project be scheduled on a cyclical basis to maintain the integrity of the structure.

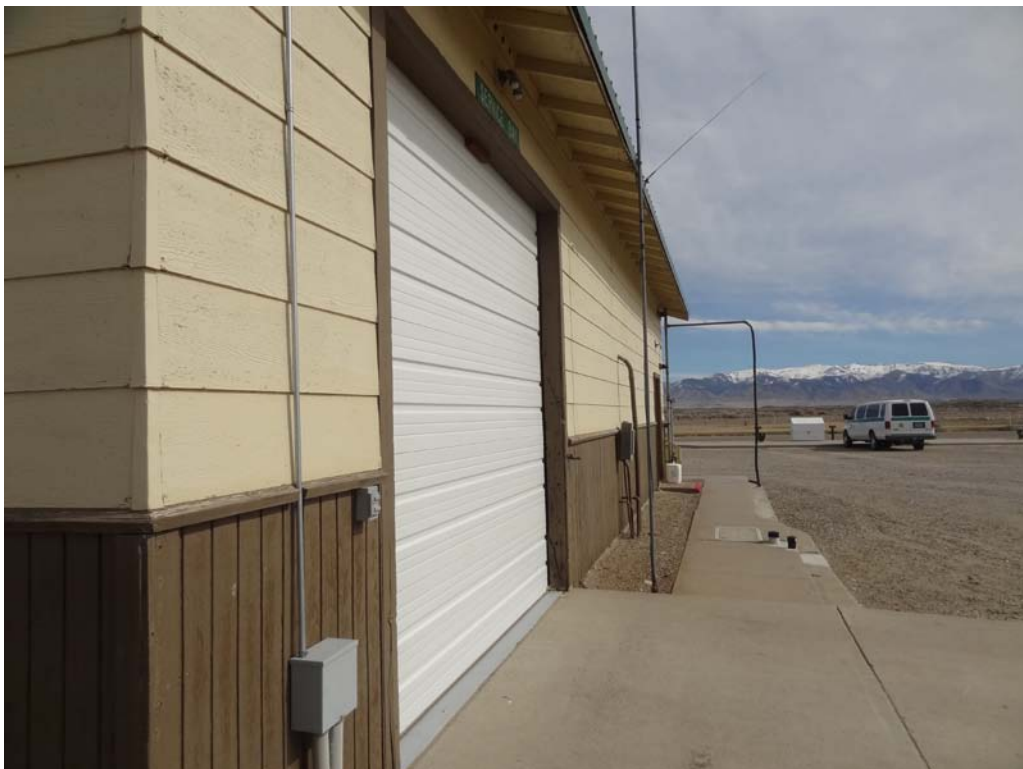
Mechanical Shop - Building #2141
Description: Exterior finishes.

It is important to maintain the finish, weather resistance and appearance of the building. This project would provide funding to protect the exterior of the building excluding the roof. Included in the cost is sanding, priming, painting and caulking of the windows, flashing, fixtures and all other penetrations. It is recommended that the building be painted in the next 2-3 years and that this project be scheduled on a cyclical basis to maintain the integrity of the structure.

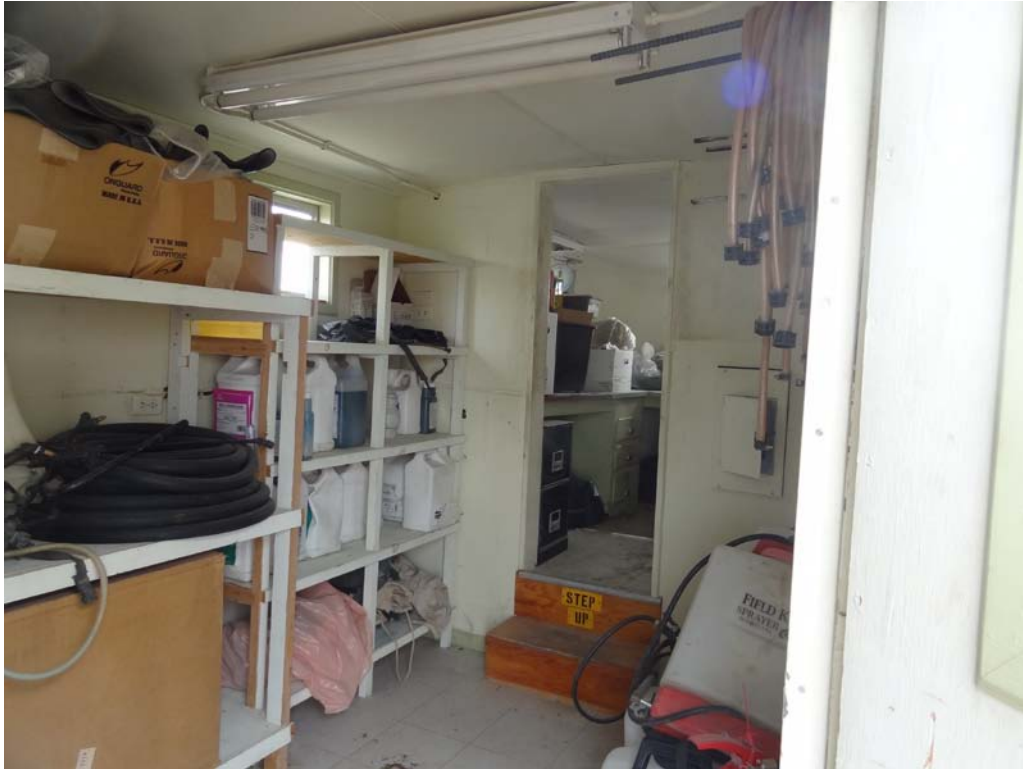
The Hazardous Material Storage Building contains hazardous materials (i.e. gasoline, herbicides and pesticides). Per International Fire Code (IFC) 2012 Hazardous Materials, and in accordance with National Fire Protection Association (NFPA); where hazardous materials are stored, dispensed or used, section 5003 states the proper use and application is to have mechanical exhaust and ventilation, and hazard identification signs shall be installed. Refer to section 5004 and 5005 for the proper use and setup. It is important to comply with all applicable codes. This project would provide for all requirements in IFC 2012, to include section 105 permits and inspections through the State Fire Marshal's Office and the State Public Works Division.

Office Trailer - Building #2140
Description: Hazardous material storage.

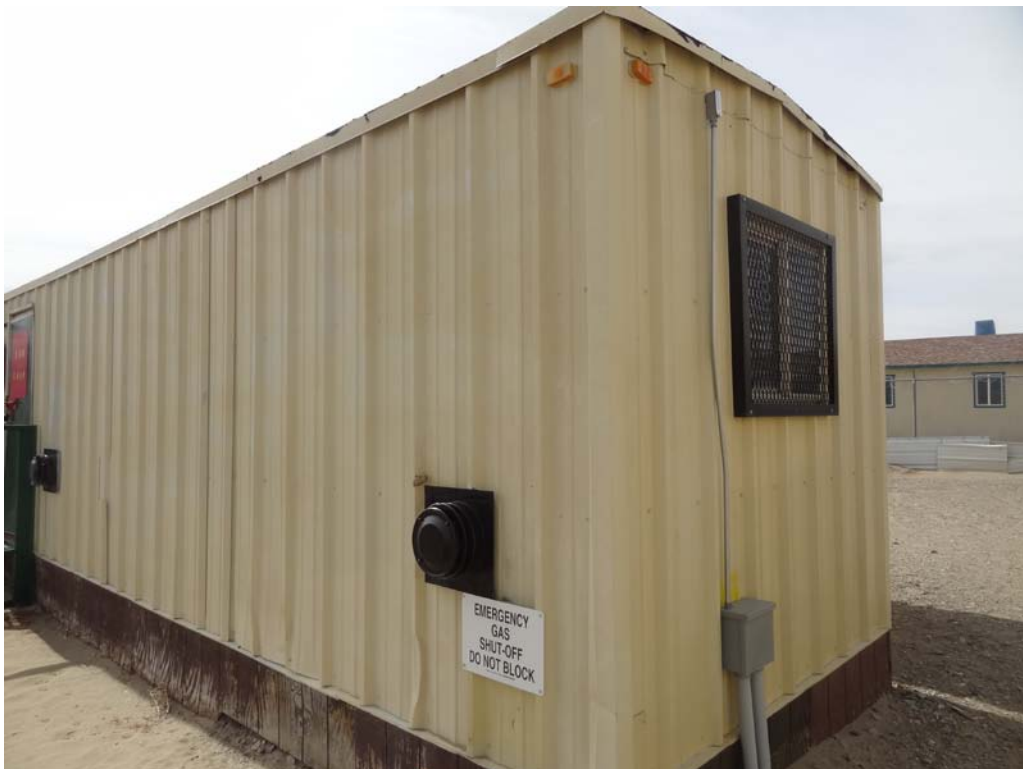
Saw Shop - Building #2138
Description: Exterior finishes including failing wood skirting.

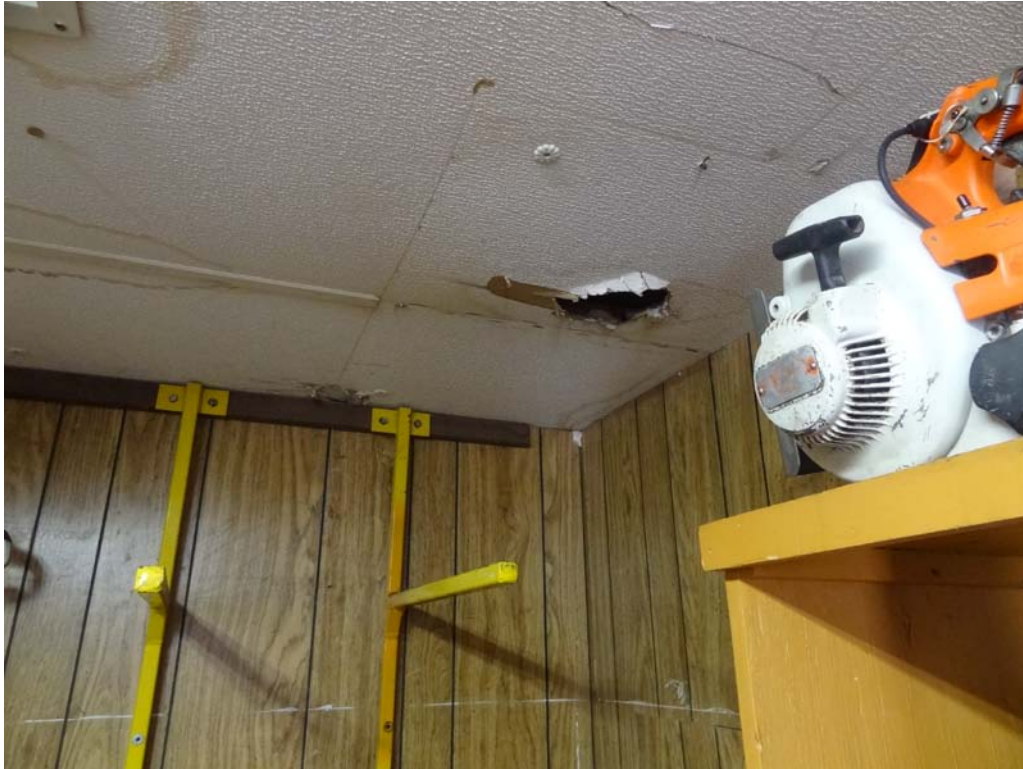
Saw Shop - Building #2138
Description: Interior finishes, water stains from leaking roof.

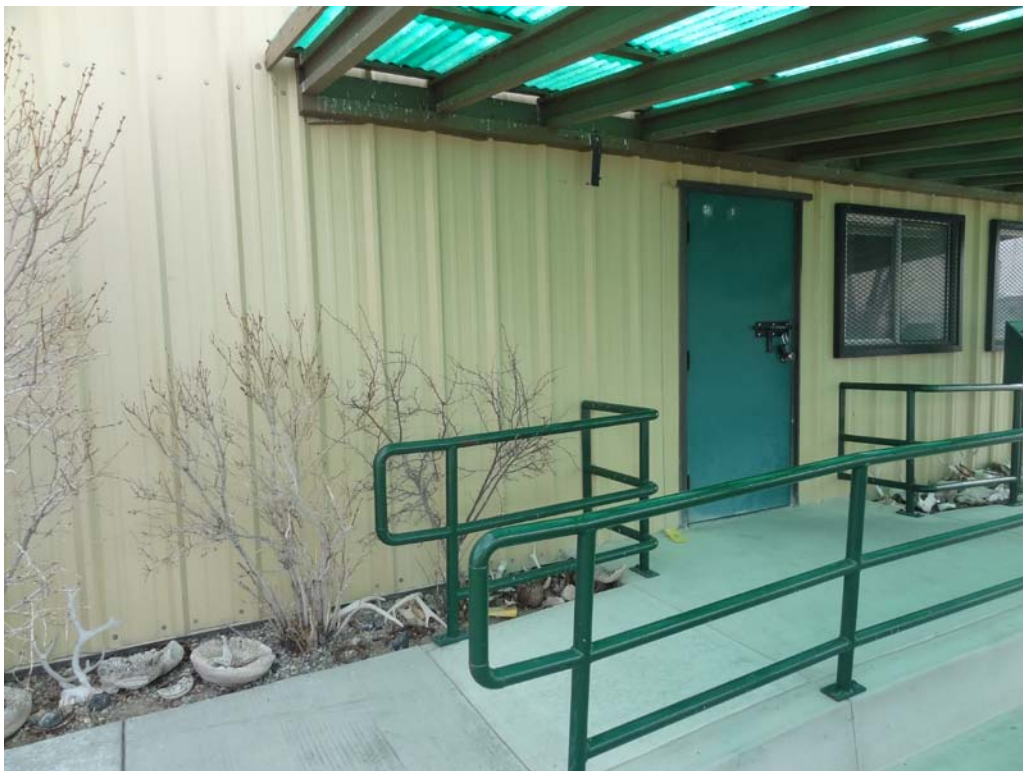
NDF Administration Office - Building #1605
Description: Exterior finishes, flush bolt on exterior of exit door.

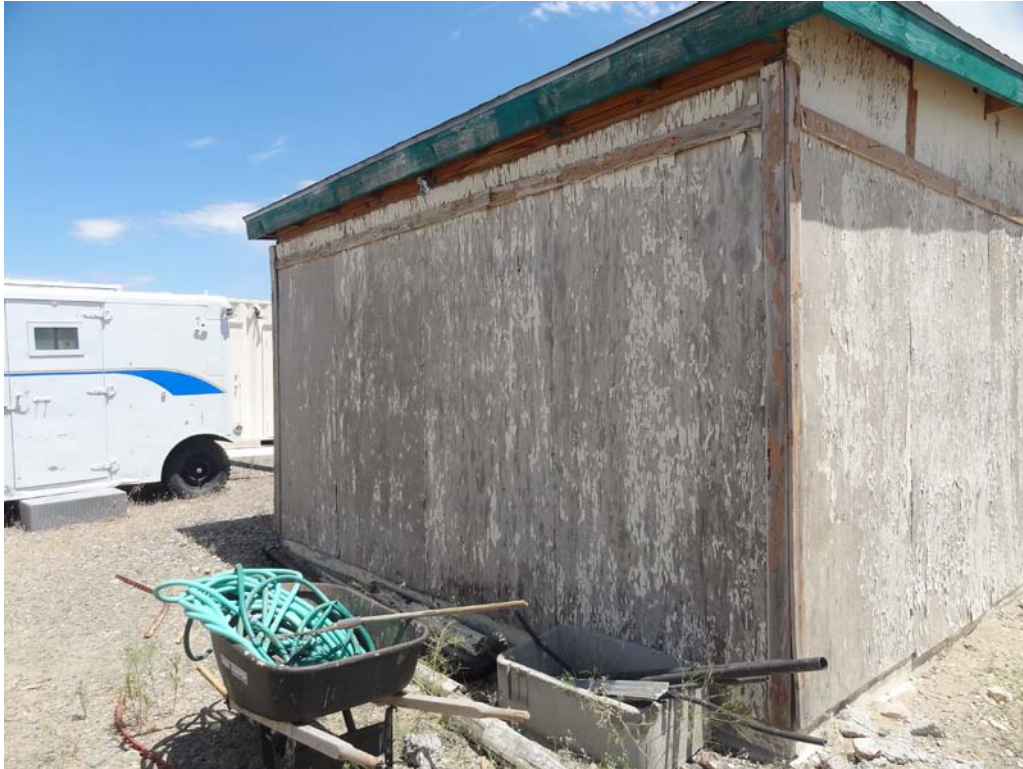
Pump House - Building #1400
Description: Exterior finishes.

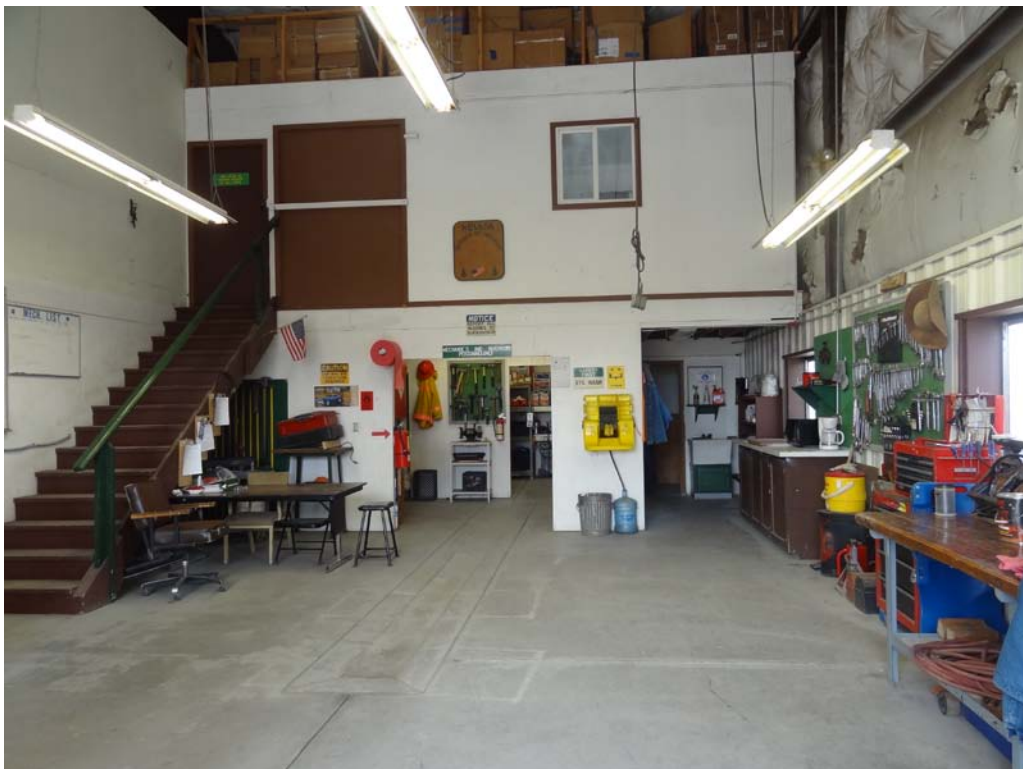
NDF Maintenance Shop - Building #1399
Description: Interior finishes.

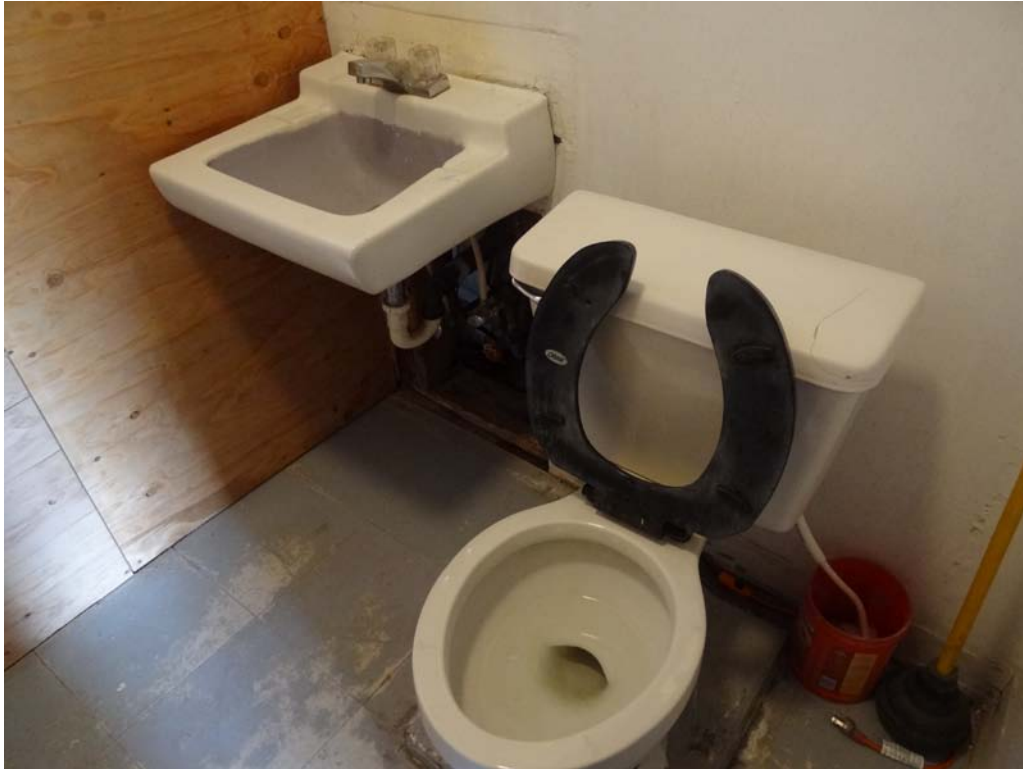
NDF Maintenance Shop - Building #1399
Description: Restroom fixtures.

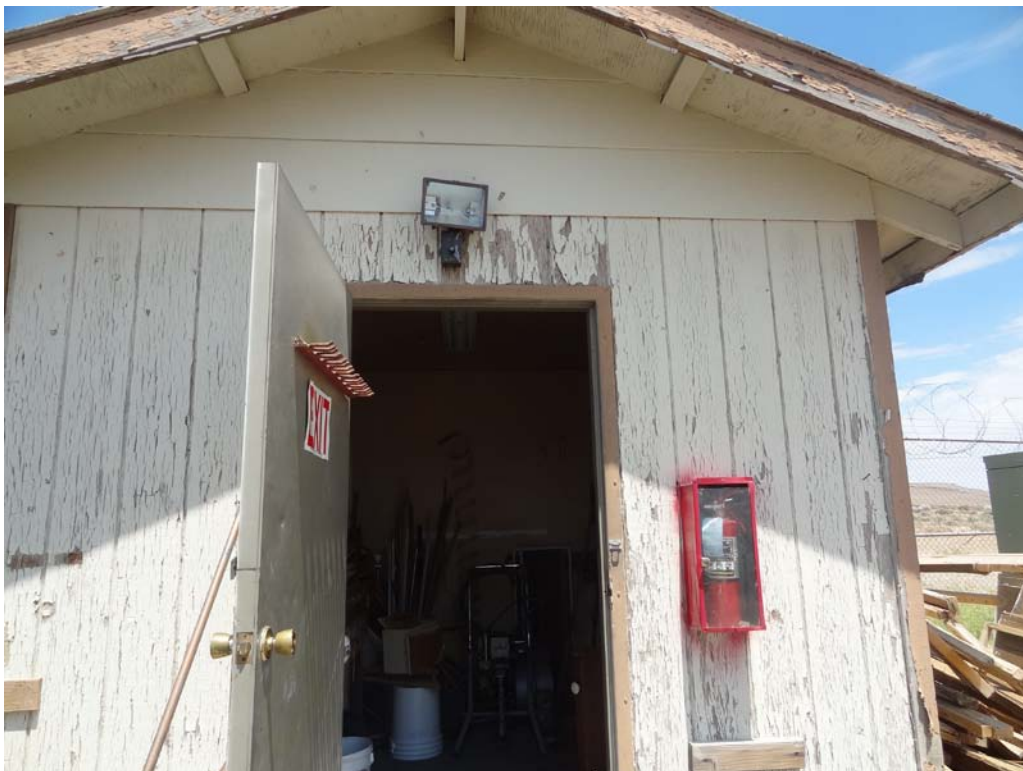
Storage Shed - Building #1398
Description: Exterior finishes.

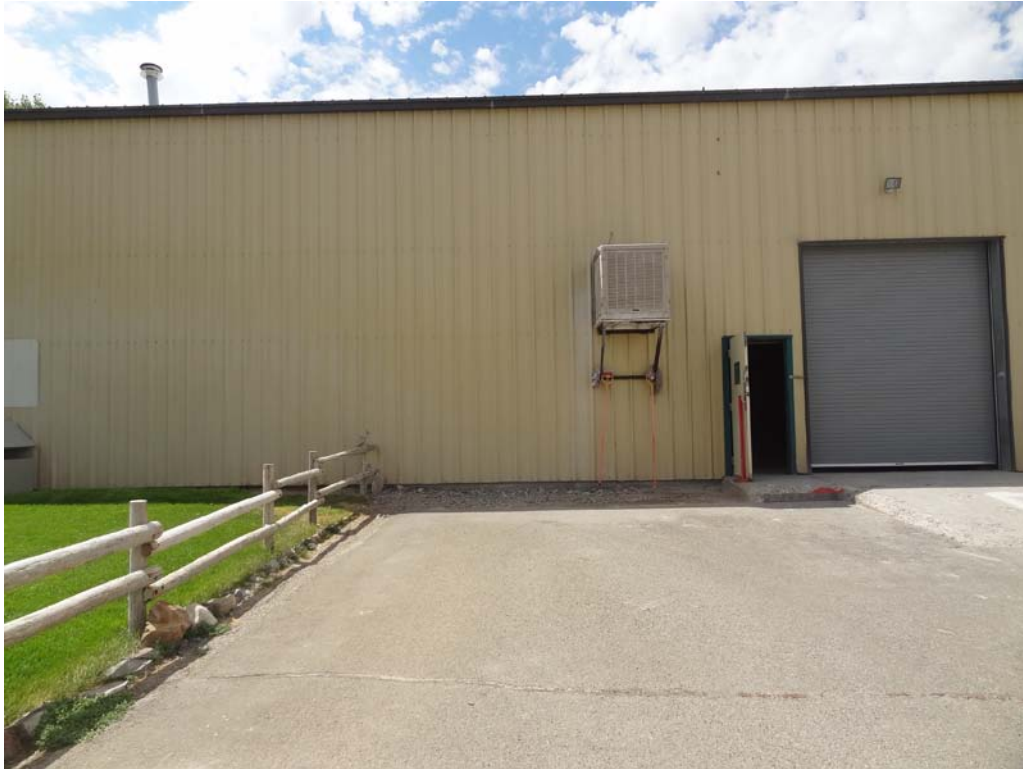
Multi-Purpose Building - Building #1397
Description: Exterior finishes.

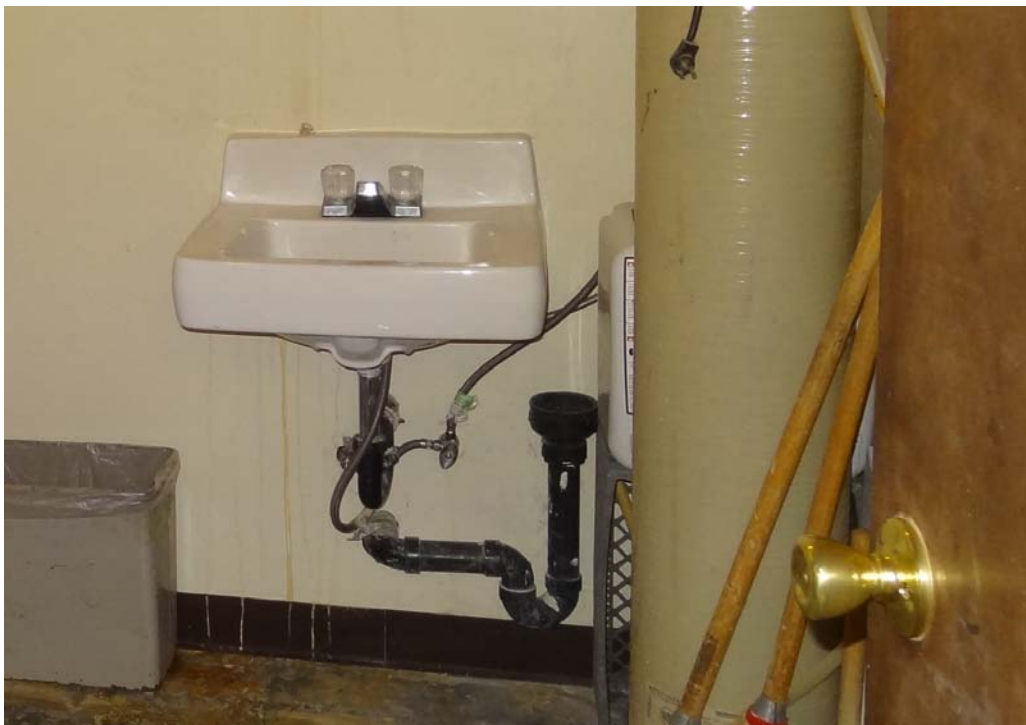
Multi-Purpose Building - Building #1397
Description: Improper plumbing connections.

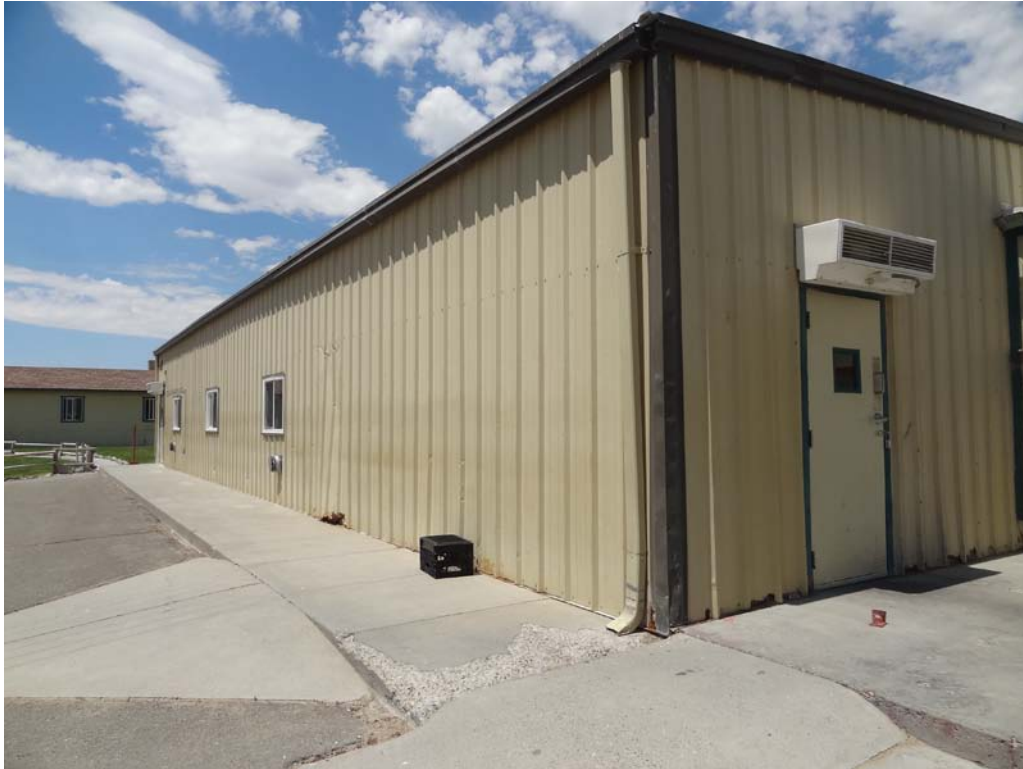
Cafeteria/ Culinary Building - Building #1395
Description: Exterior finishes.

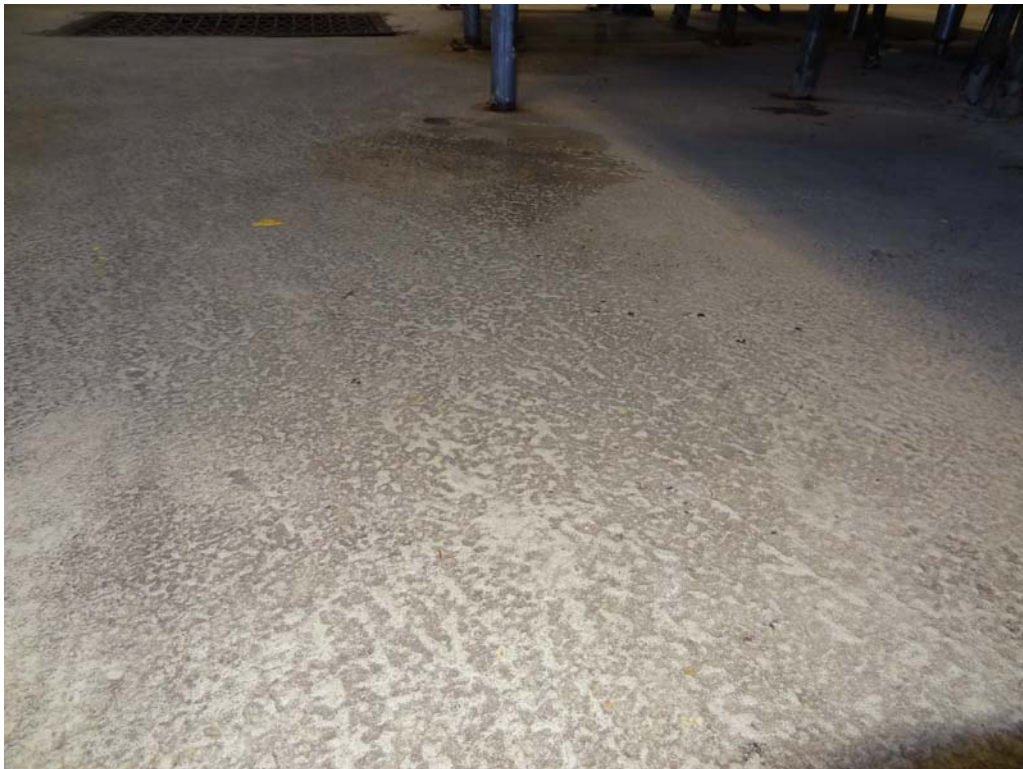
Cafeteria/ Culinary Building - Building #1395
Description: Flooring in poor condition.

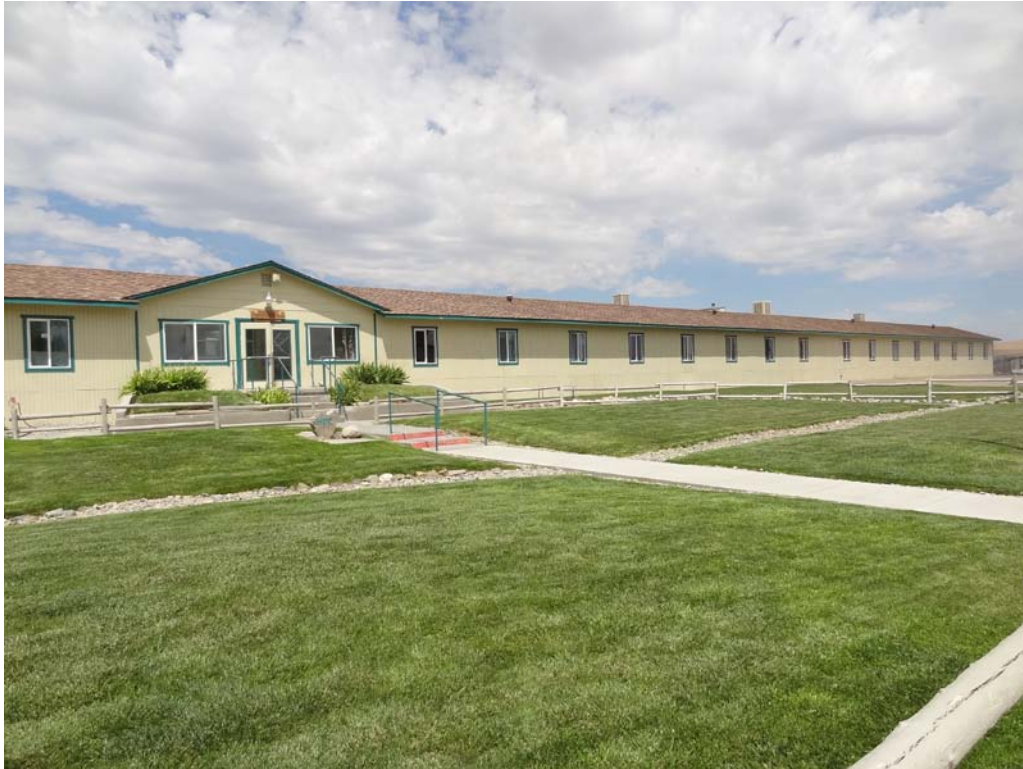
Administration/ Housing Unit - Building #1394
Description: Exterior finishes.

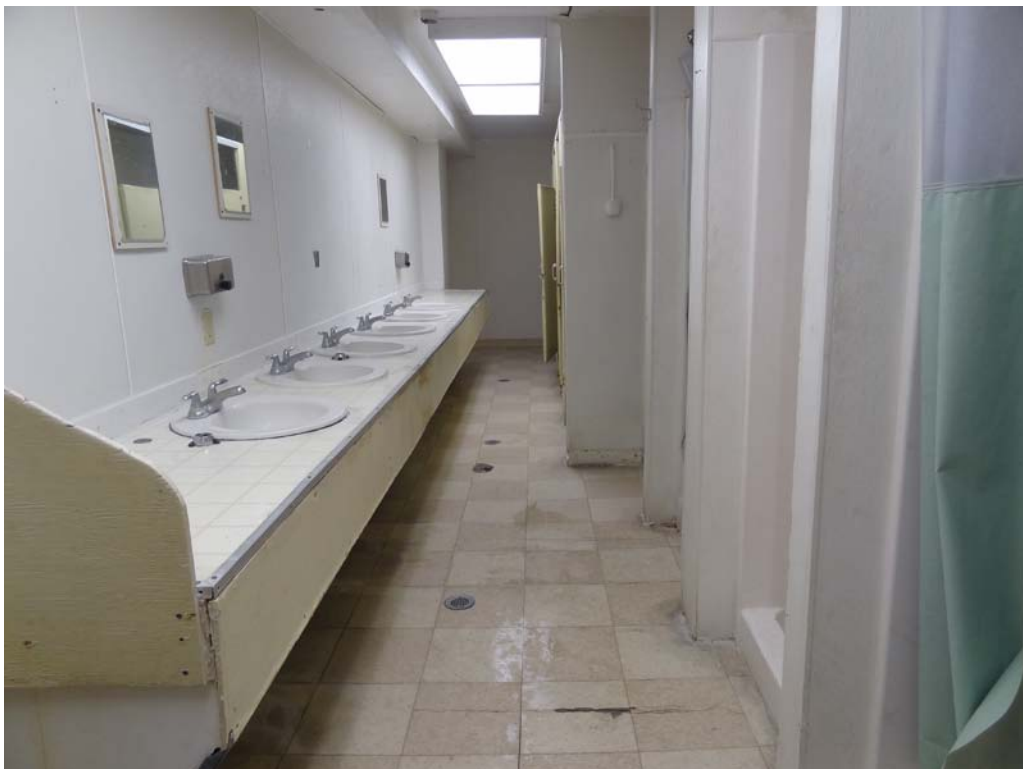
Administration/ Housing Unit - Building #1394
Description: Typical restroom.
