State of Nevada
Department of Corrections
Facility Condition Analysis

WELLS CONSERVATION CAMP

Site Number: 9974
STATE OF NEVADA PUBLIC WORKS DIVISION
FACILITY CONDITION ANALYSIS

Report distributed in April, 2018

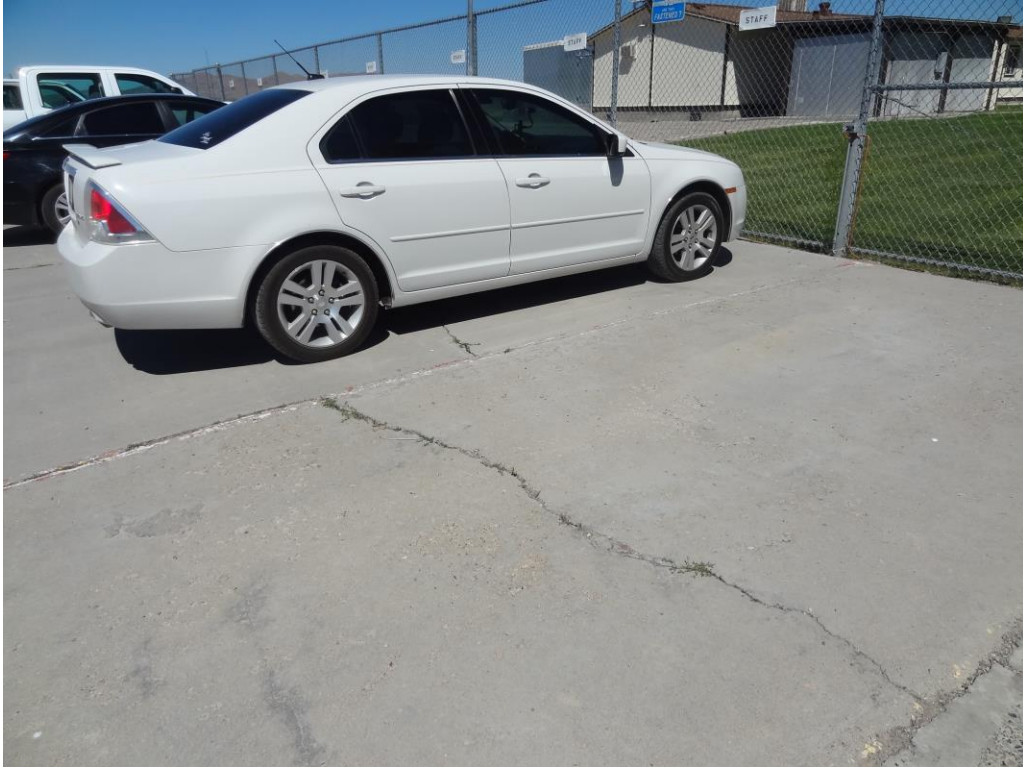
The sidewalks serving the buildings and recreation areas on this site are constructed of pieces of concrete. An ADA accessible path of travel should be provided. This project addresses the removal and the replacement of the existing concrete pieces, as needed, to provide new concrete sidewalks. 4,800 SF of 4" thick concrete was used for this estimate. NRS 338.180, IBC - 2012, ICC/ANSI A117.1 - 2009 and ADAAG - 2010 were referenced for this project. This project or a portion thereof was previously recommended in the FCA report dated 09/18/2000 and 07/22/2009. It has been amended accordingly to reflect conditions observed during the most recent survey date of 08/24/2016.

Wells Conservation Camp – Site #9974
Description: ADA accessible path of travel needed.

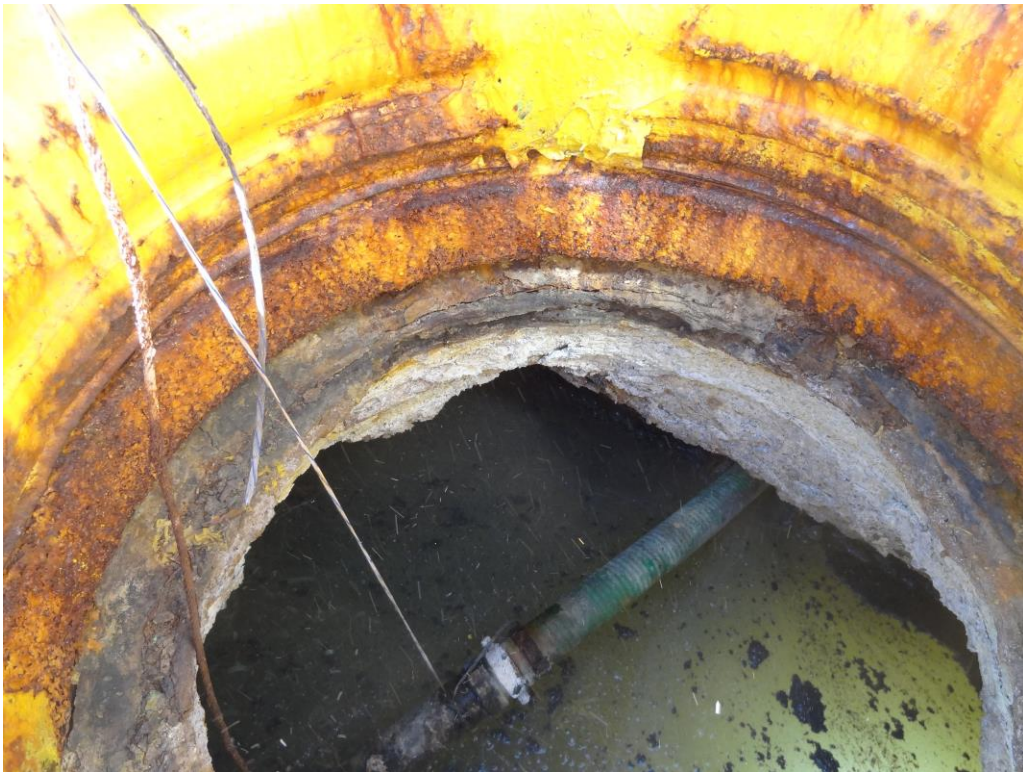
The septic system serving the site is failing. This project recommends replacing the septic tank and moving the leach field. The estimate includes abandoning and filling the old septic tank and the installation of a new tank and leach field. This estimate is for an engineered system which will conform to all required environmental rules and regulations including NDEP.

Wells Conservation Camp – Site #9974
Description: Septic system replacement needed.

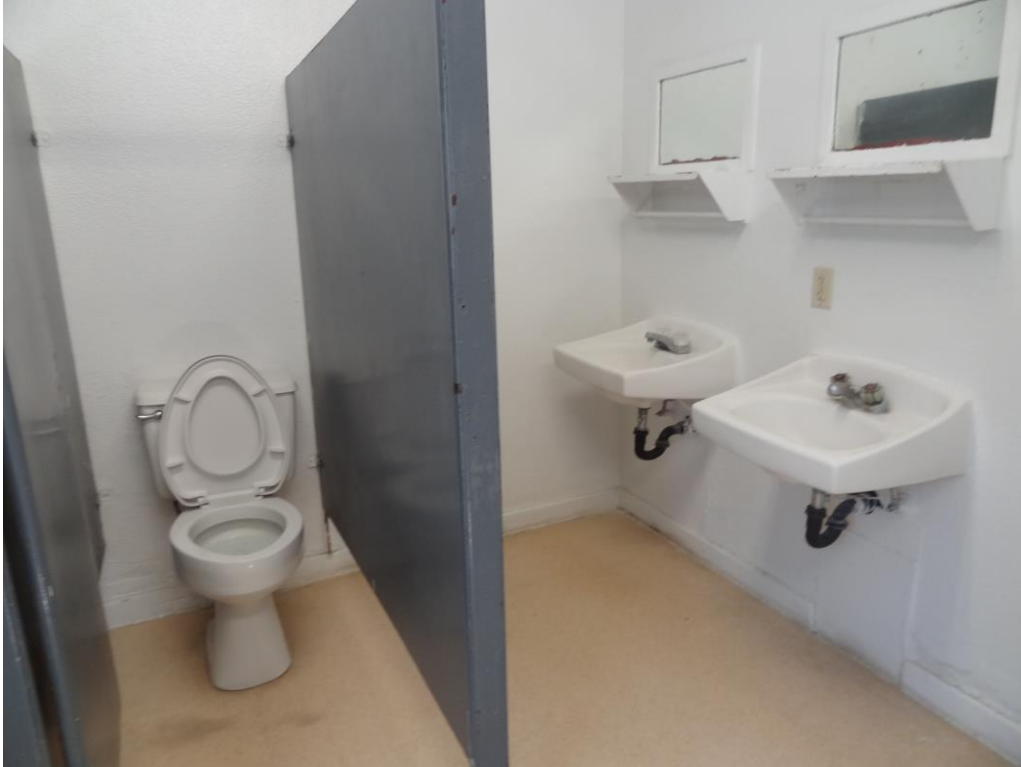
Housing/ Culinary/ Administration - Building #0708
Description: ADA restroom remodel needed.

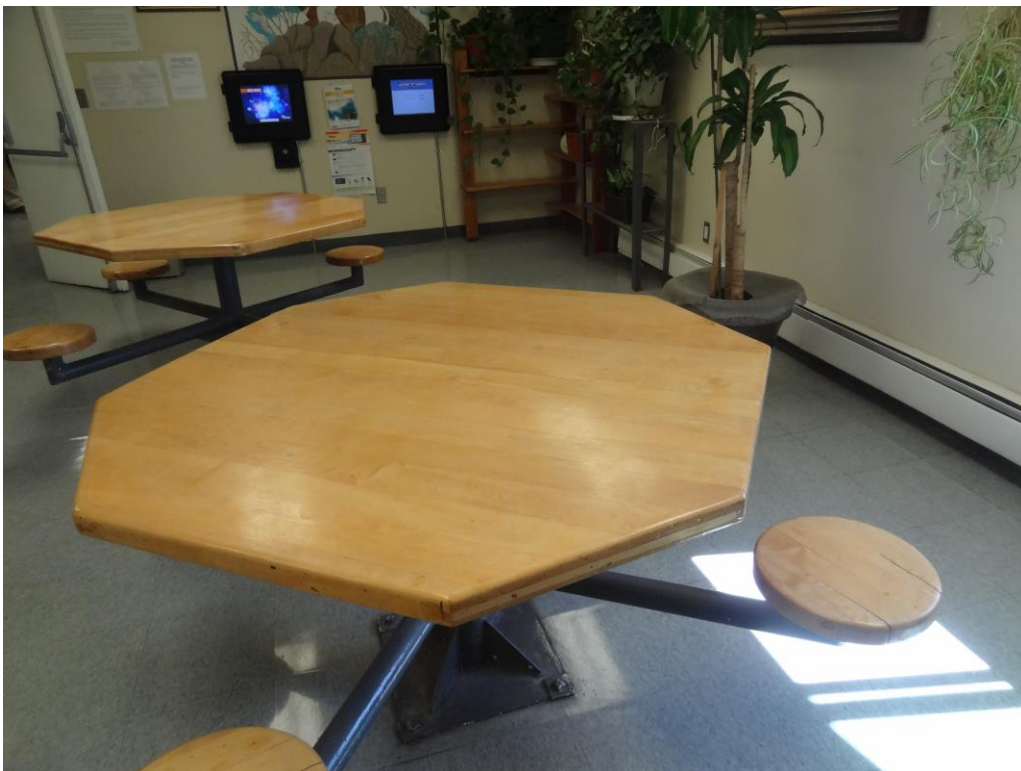
Housing/ Culinary/ Administration - Building #0708
Description: ADA table upgrade needed.

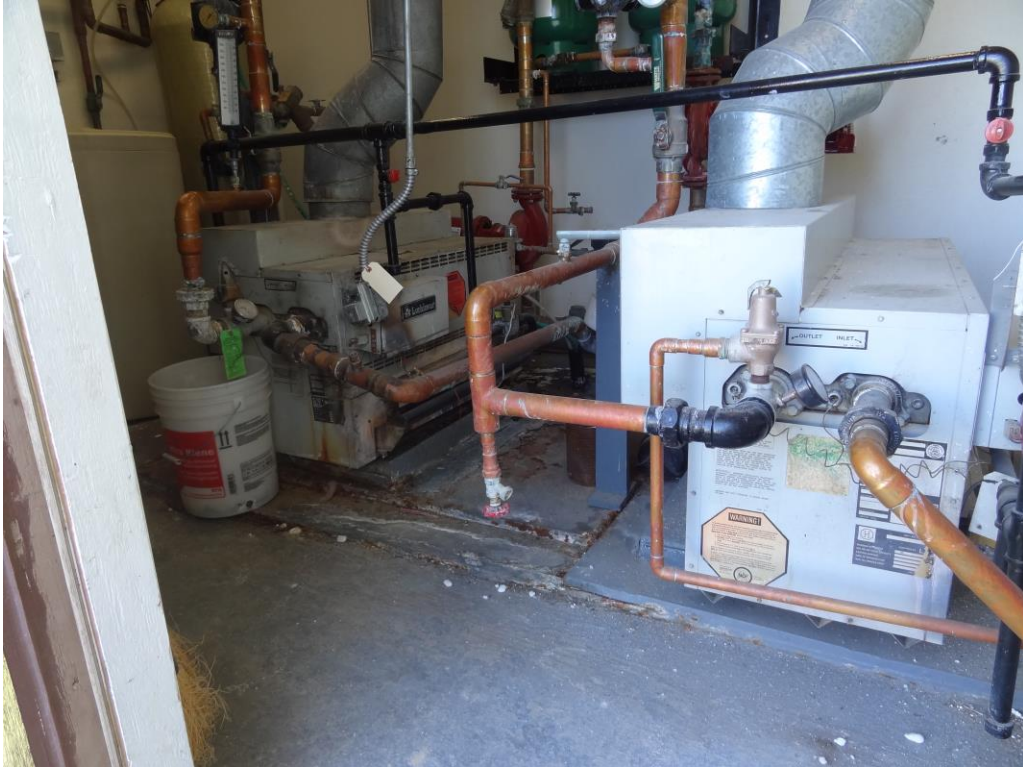
Housing/ Culinary/ Administration - Building #0708
Description: Boiler replacement needed.

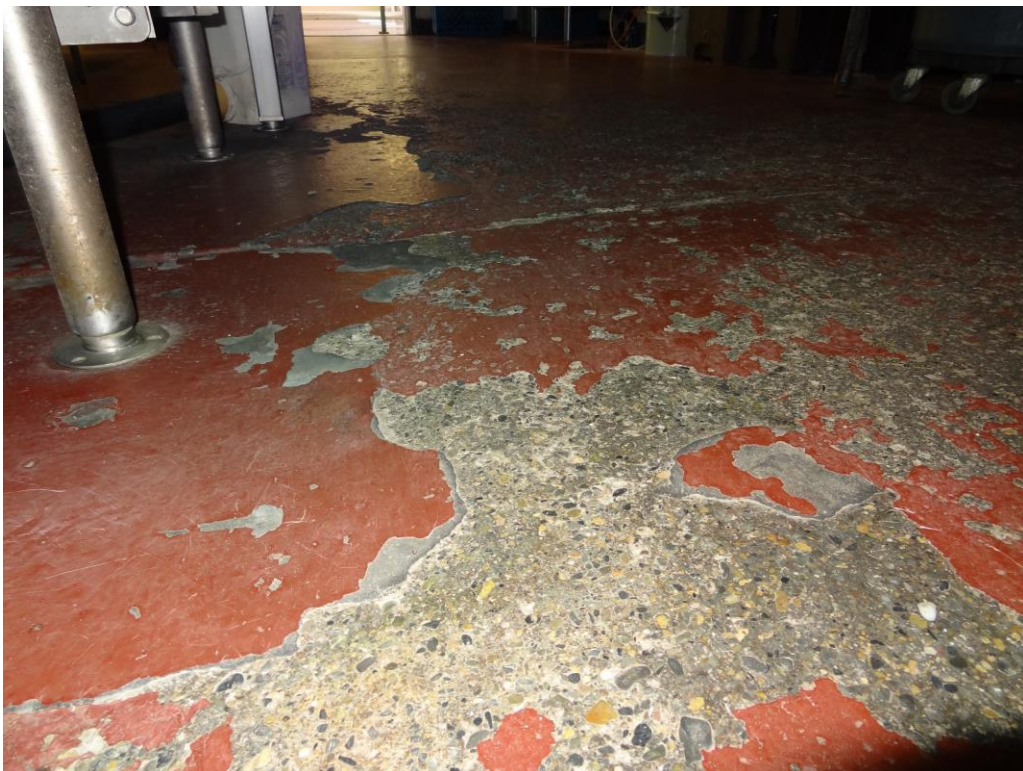
Housing/ Culinary/ Administration - Building #0708
Description: Culinary floor replacement needed.

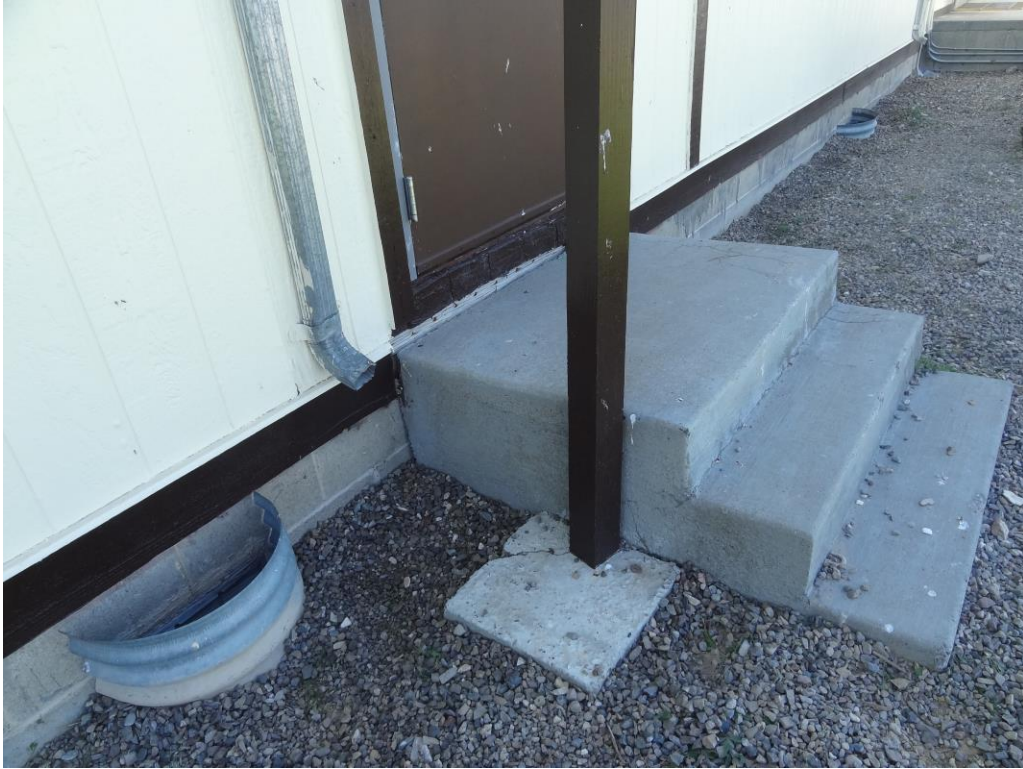
Housing/ Culinary/ Administration - Building #0708
Description: Exterior landing installation needed.

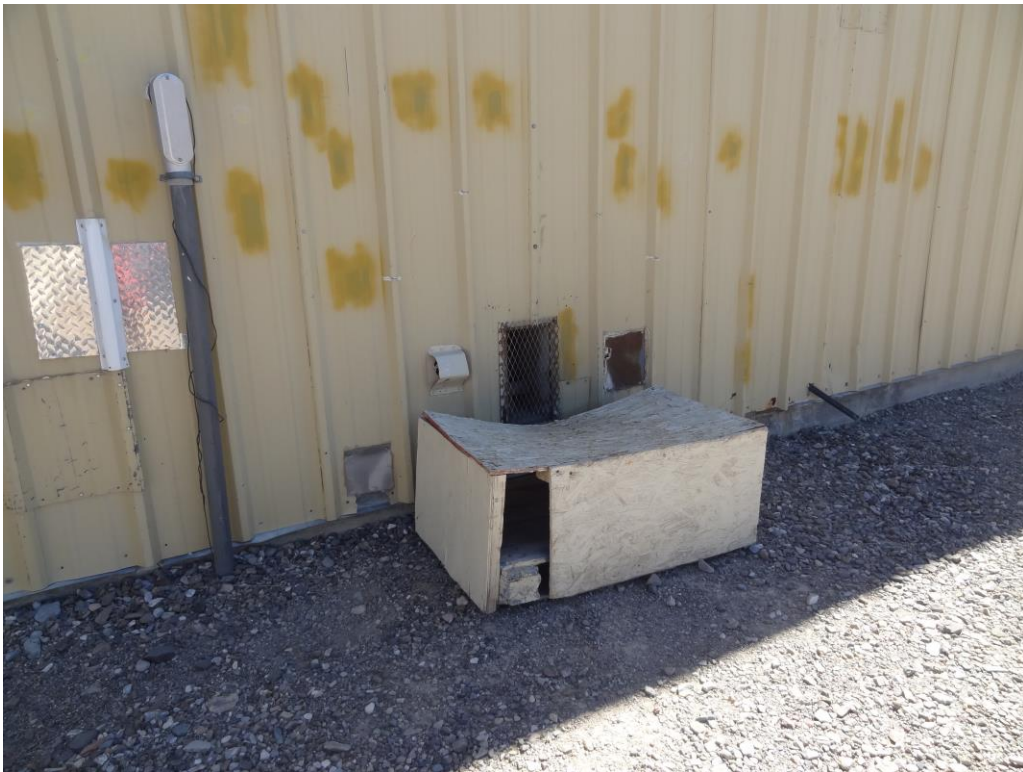
Multi-Purpose/ Gymnasium - Building #1391
Description: Exterior siding replacement needed.

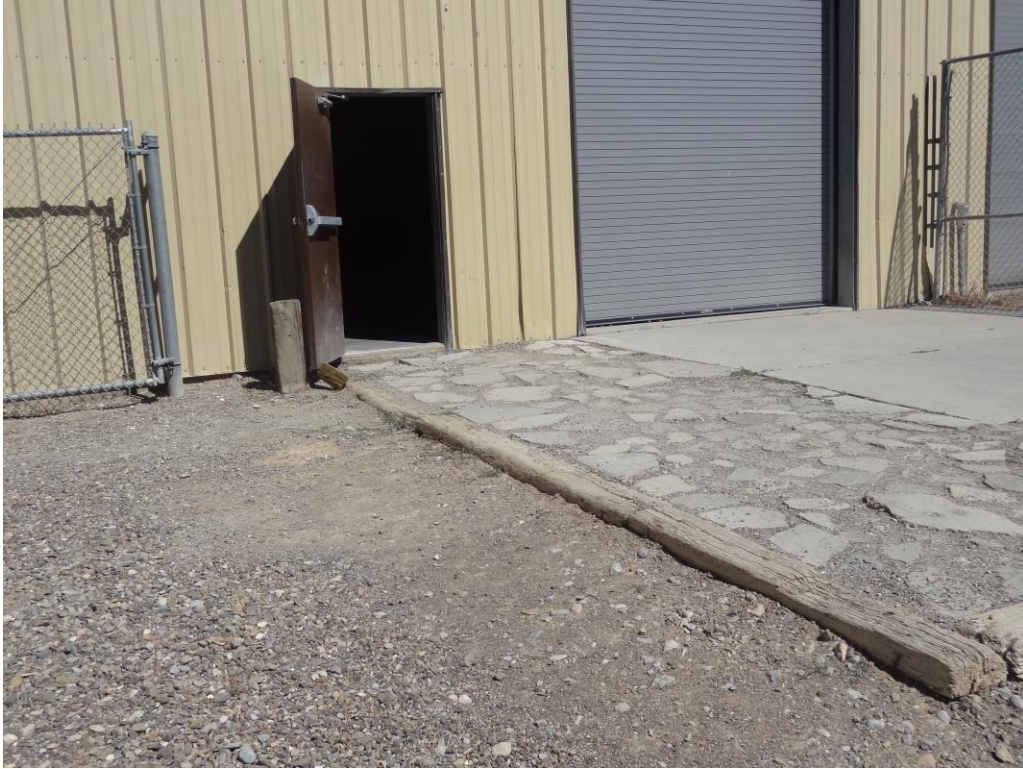
The exterior metal doors are damaged from age and general wear and tear and have reached the end of their expected life. This project would provide for the replacement of the three exterior doors with new metal doors, frames and hardware. Removal and disposal of the existing doors is included in this estimate.

Multi-Purpose/ Gymnasium - Building #1391
Description: Exterior door replacement needed.

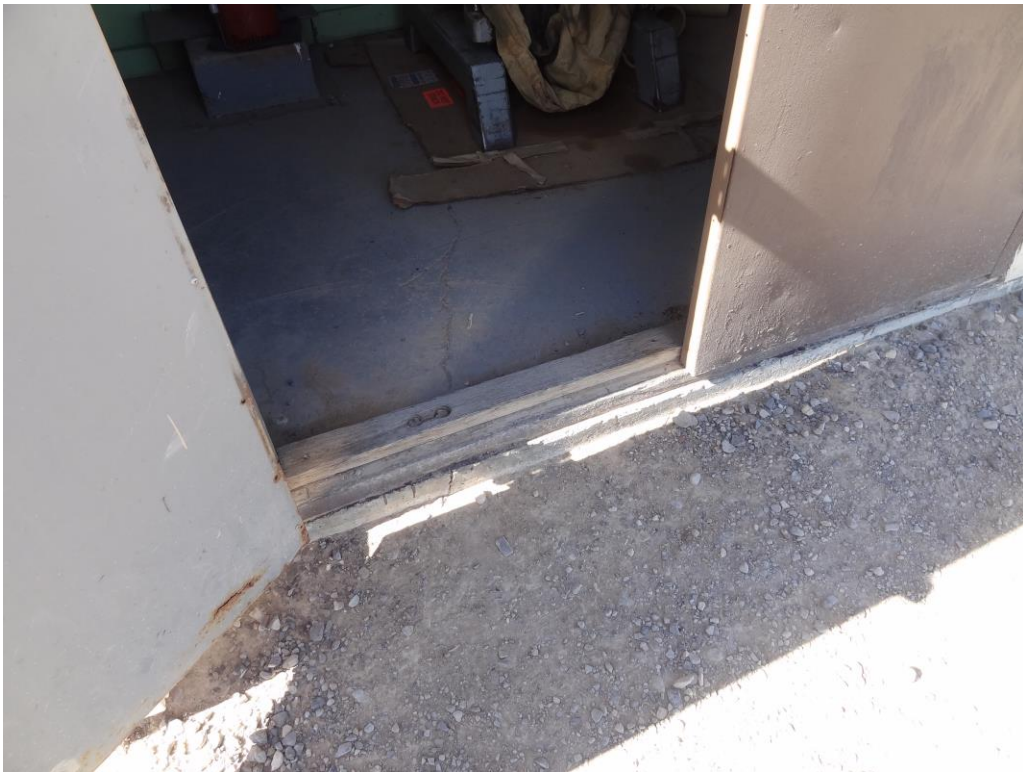
There are two out-swinging exterior doors on the building, which swing out over a step that does not have a landing. This does not comply with 2012 IBC Section 1008.1, which requires a proper landing and for the landing to not be more than 1/2" below the threshold. This project would provide for the installation of compliant landings. This project or a portion thereof was previously recommended in the FCA report dated 07/22/2009. It has been amended accordingly to reflect conditions observed during the most recent survey date of 08/24/2016.

Pump House - Building #2136
Description: Exterior landing installation needed.
