LAKES CROSSING CENTER

Site Number: 9980
STATE OF NEVADA PUBLIC WORKS DIVISION
FACILITY CONDITION ANALYSIS

Survey Date: 10/19/2017

LAKES CROSSING CENTER - BUILDING #13
BUILDING REPORT

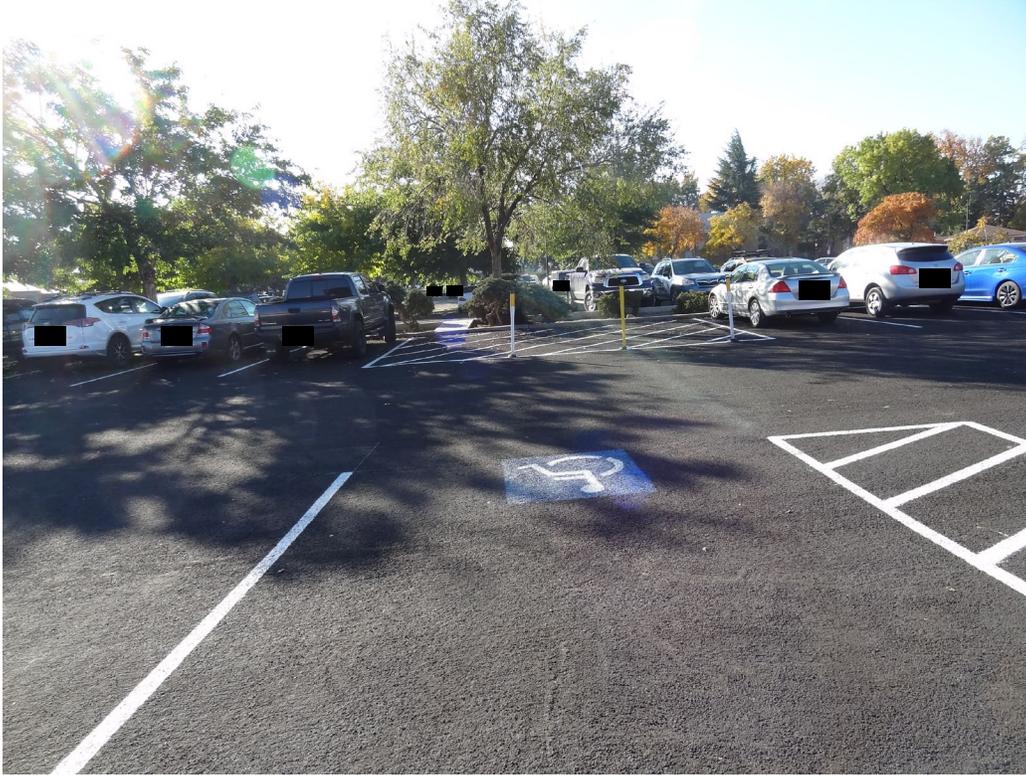
Lakes Crossing Center Site - Site #9980
Description: ADA Accessible Parking & Slurry Seal and Striping.

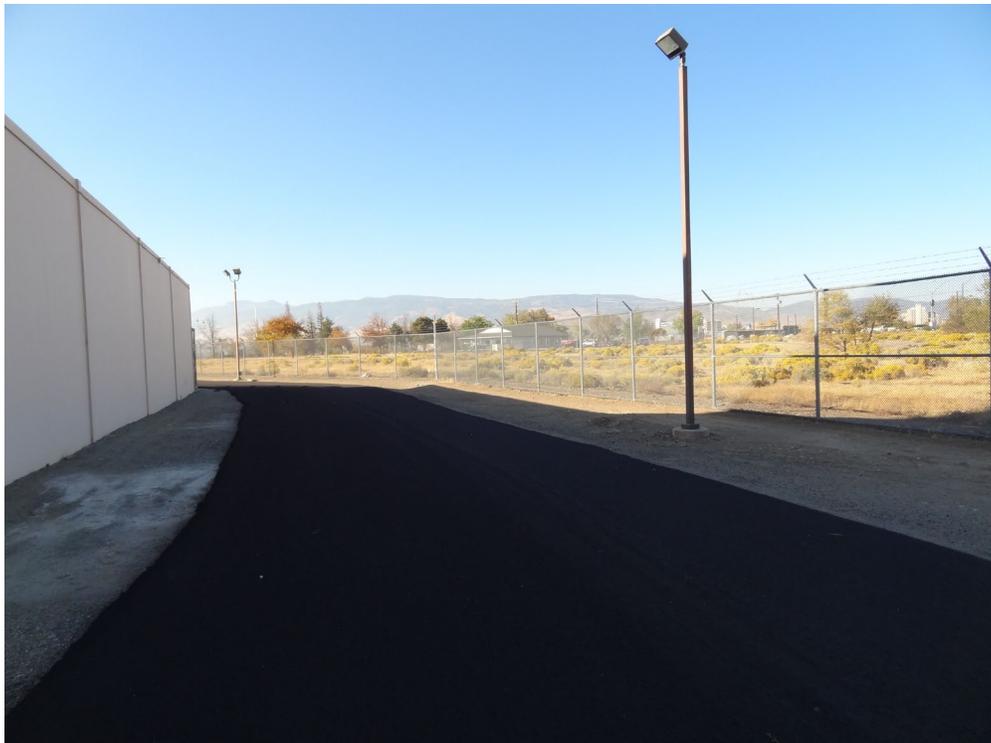
There are ten existing light poles around the site with either one or two light fixtures each. The existing lighting fixtures are the older metal halide type, and are not energy efficient. With increased traffic and development in the area, insufficient site lighting is a security and safety concern. This project would provide for the installation of 14 solar powered LED exterior light fixtures on 10 light poles with 30" diameter raised concrete bases. This installation will eliminate the need for trenching and electrical connections. Some of the existing poles may be acceptable to re-use. If so, the estimate can be reduced accordingly.

Lakes Crossing Center Site - Site #9980
Description: Exterior Site Lighting Upgrade Needed.

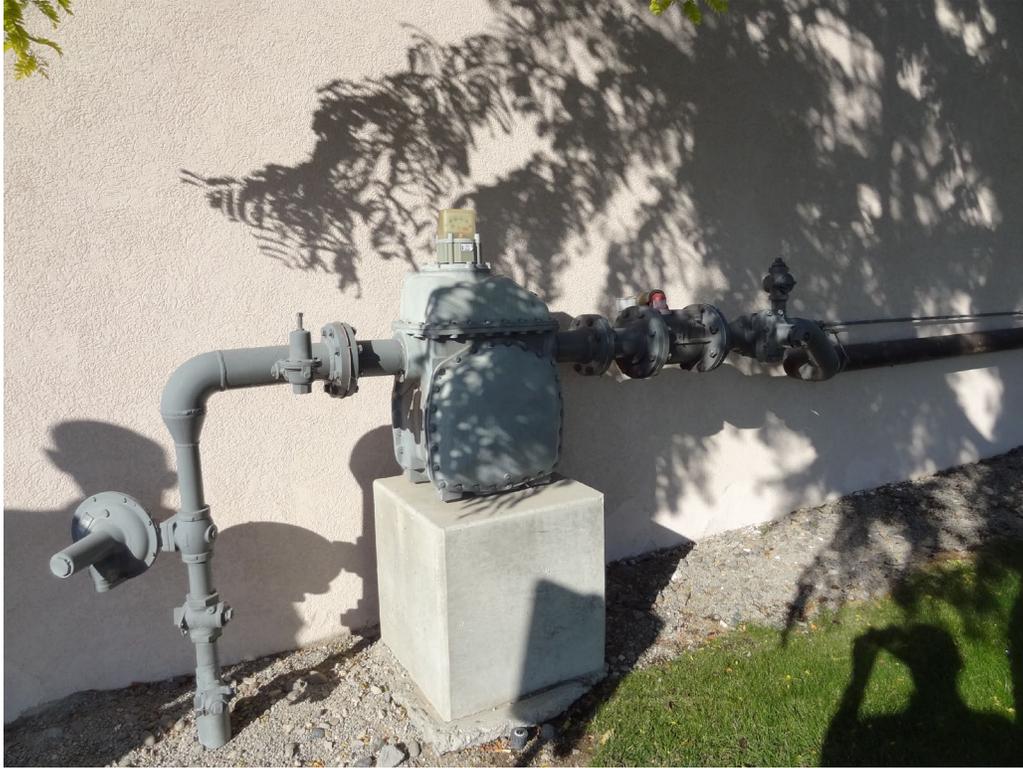
The natural gas meter is in a vulnerable position and needs protection from vehicular impact. Per International Fire Code 2018 Section 312 Vehicle Impact Protection, there needs to be steel posts installed, not less than 4 inches in diameter and filled with concrete. The spacing shall not be more than 4 feet between posts on center and located not less than 3 feet from the gas meter. This project would provide funding for 3 new bollards around the meter.

Lakes Crossing Center Site - Site #9980
Description: Bollard Protection Needed.

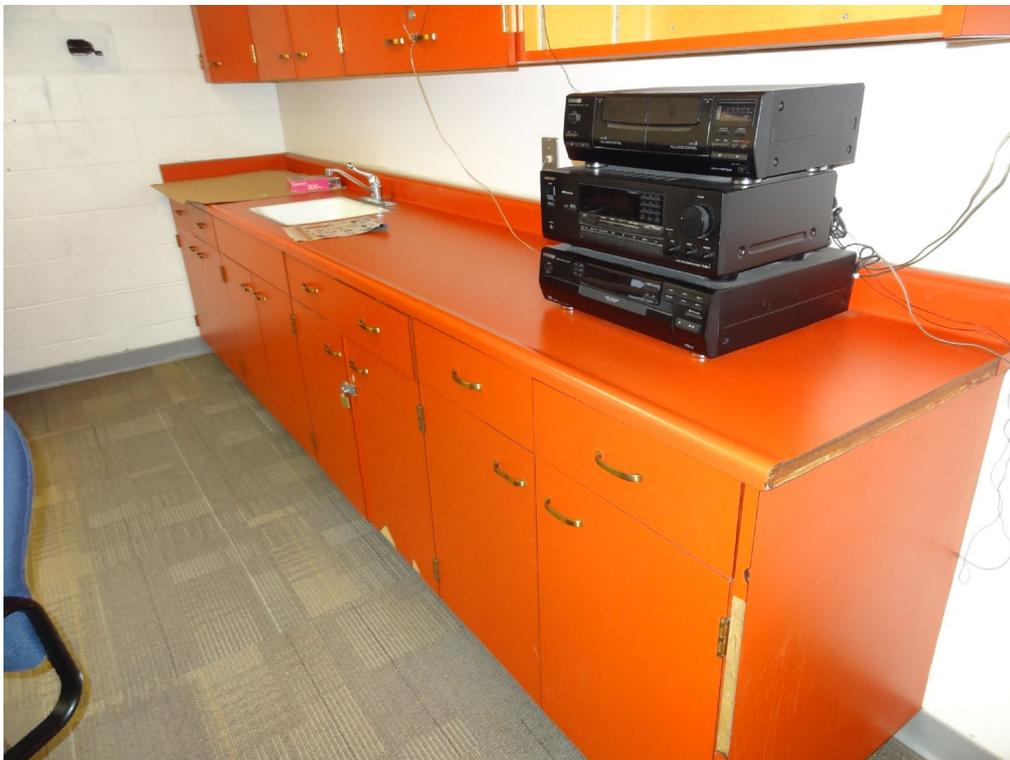
The cabinets and sinks in multiple locations are original to the building. The quality of construction and installation were inadequate for the high usage at this facility, and the cabinets and countertops are delaminating and failing. This project recommends the replacement of the existing countertops, cabinets, and associated equipment with heavy duty, quality components. The cabinets should be finished inside and outside with a melamine or similar finish which encapsulates the door, frame, and shelving. The countertops should be constructed of a highly durable product, such as stainless steel, over a moisture resistant underlayment to minimize swelling and damage from water exposure. ADA compliance according to NRS 338.180, IBC - 2018, ICC/ANSI A117.1 and the most current version of the ADA Standards for Accessible Design should be incorporated into the design such as providing an accessible sink. This estimate includes removal and disposal of the existing materials.

Lakes Crossing Center - Building #0342
Description: ADA Cabinetry & Sink Upgrade.

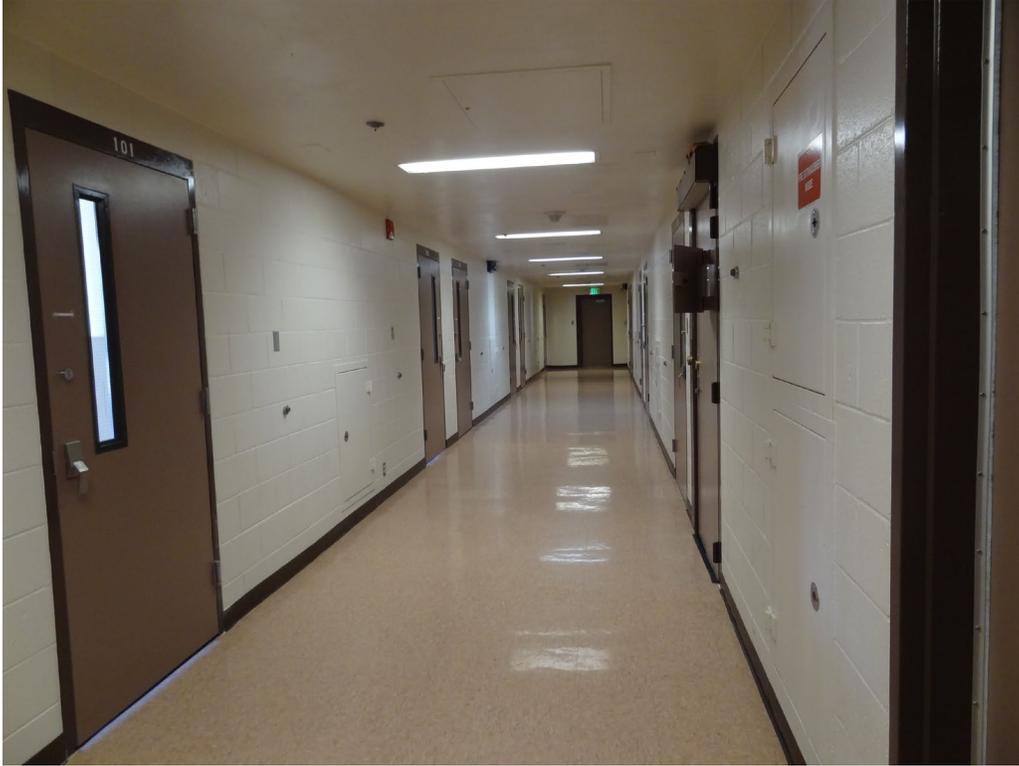
The interior doors are damaged from general abuse and age. There are 115 doors within the secured area and 20 doors outside of the secured area. Some of the doors within the secured area are fire rated doors that do not have magnetic hold opens. These fire doors are often propped open for ease of circulation which compromises the fire rating of the area. There are many doors that are loose in their frames and have worn out locking mechanisms. This project would provide for the removal of the existing doors and the purchase and installation of new doors, frames and hardware. This estimate is for 115 security grade hollow metal doors and 20 solid core wood doors. This project or a portion thereof was previously recommended in the FCA report dated 01/12/2012. It has been amended accordingly to reflect conditions observed during the most recent survey date of 10/19/2017.

Lakes Crossing Center - Building #0342
Description: Interior Door Replacement Needed.

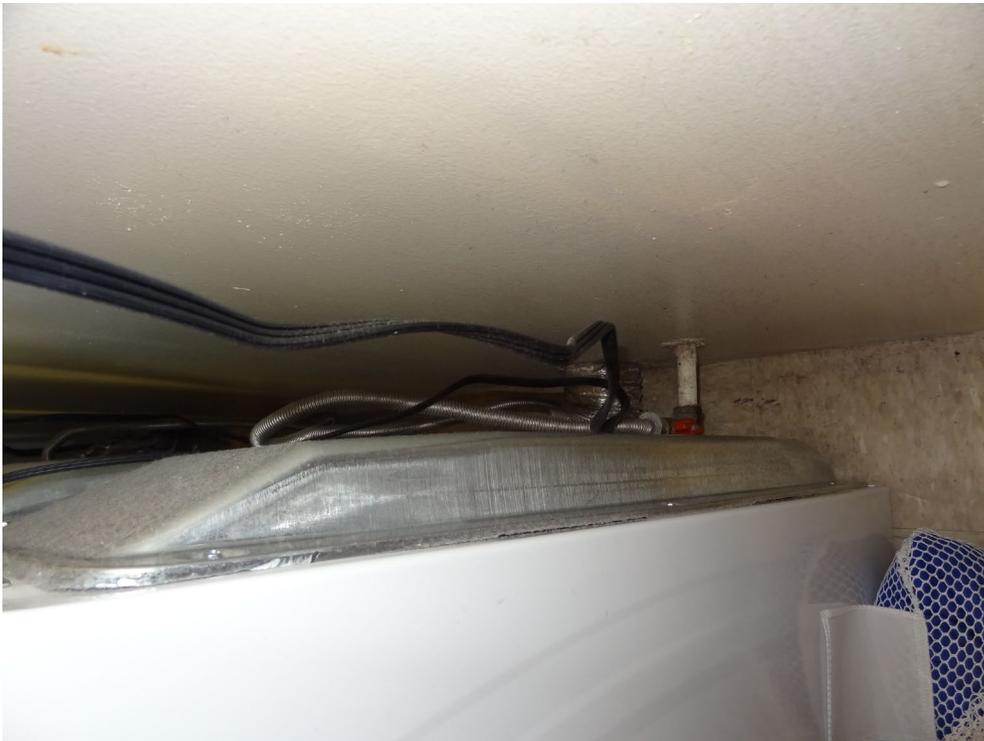
The existing natural gas fired clothes dryers have been identified as a risk due to the gas being a source to start a fire. This project recommends replacing the 3 gas dryers with 3 commercial electric dryers. Removal and disposal of the existing dryers is included in this project.

Lakes Crossing Center - Building #0342
Description: Laundry Dryer Replacement – Gas is Source to Start Fires.

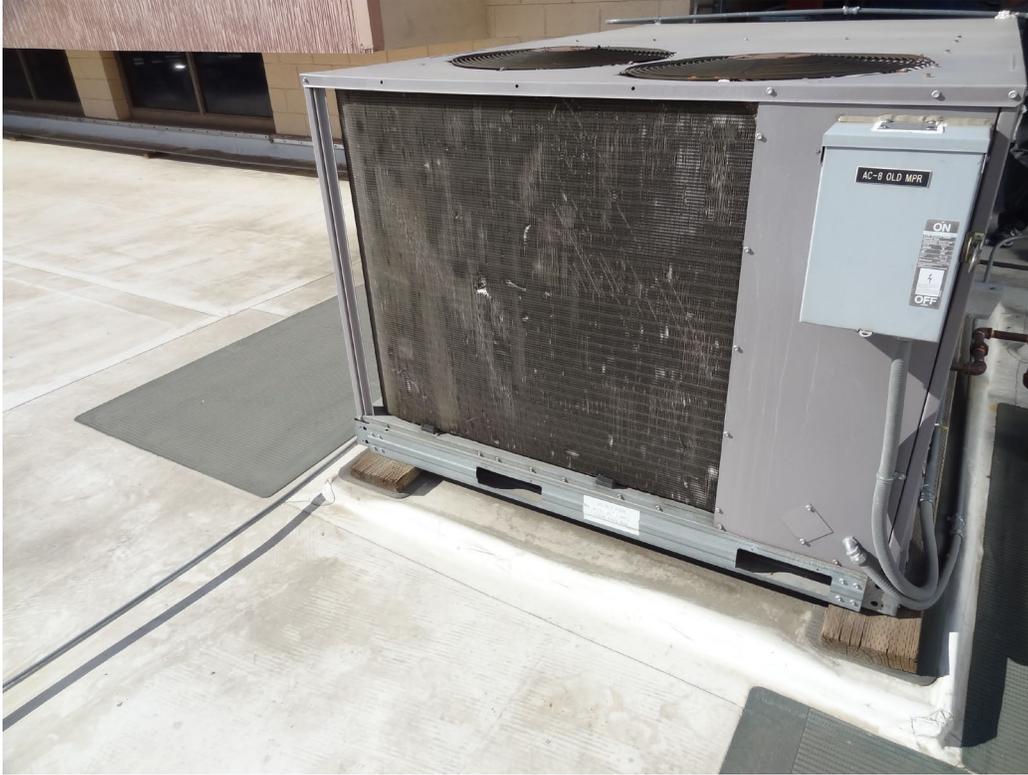
The central HVAC system consists of two hot water boilers (replaced in 2014), three rooftop air handling units (AHU 1 & 3 replaced in 2012), multiple rooftop packaged units and other related equipment throughout the building. Except as noted above at the time of the survey, the equipment was installed in the late 1990's, is not energy efficient and should be scheduled for replacement. The R-22 refrigerant in the older rooftop units is no longer EPA compliant and its production is mandated to be phased out completely by January 1, 2020. This project would provide for installation of new packaged rooftop units, associated equipment and cleaning of the existing duct work and grilles. This project includes removal and disposal of the existing HVAC units and all required connections to utilities.

Lakes Crossing Center - Building #0342
Description: Rooftop Unit Replacement Needed.

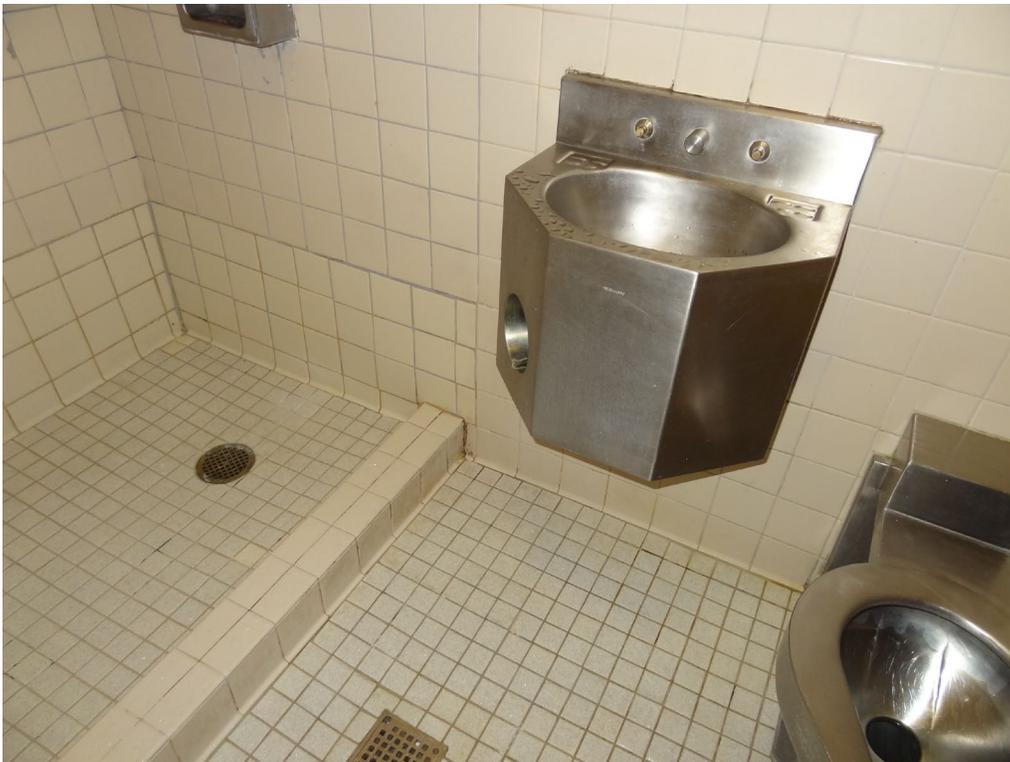
There are 16 shower stalls in the building that are showing signs of failure and should be scheduled for replacement. This project would provide for 16 stainless steel shower cabinets to be installed to provide shower facilities for the housing units. Removal and disposal of the existing materials is included in the estimate.

Lakes Crossing Center - Building #0342
Description: Shower Upgrades Needed.

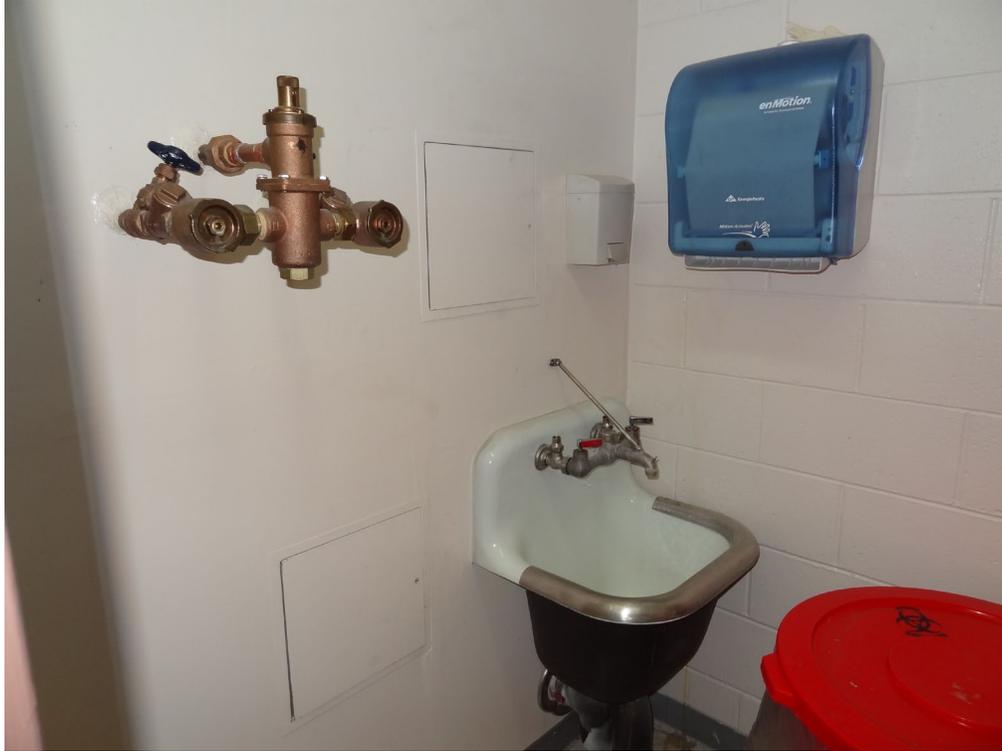
The mop sinks in the Janitors Closets are mounted adjacent to gypsum board and are showing signs of water damage. This project would provide fiberglass reinforced plastic (FRP) to be installed on the walls adjacent to the mop sink. The FRP shall extend two feet beyond the edge of the sink and a minimum of 54" above the floor finish.

Lakes Crossing Center - Building #0342
Description: Janitor's Closet Repairs – FRP Sink Splash Protection Needed.
