State of Nevada
Department of Health & Human Services
Division of Mental Health & Developmental Services
Lakes Crossing Center
Facility Condition Analysis

500 Galletti Way
Sparks, Nevada 89431

Site Number: 9980
STATE OF NEVADA PUBLIC WORKS DIVISION
FACILITY CONDITION ANALYSIS

Report Printed in April 2012

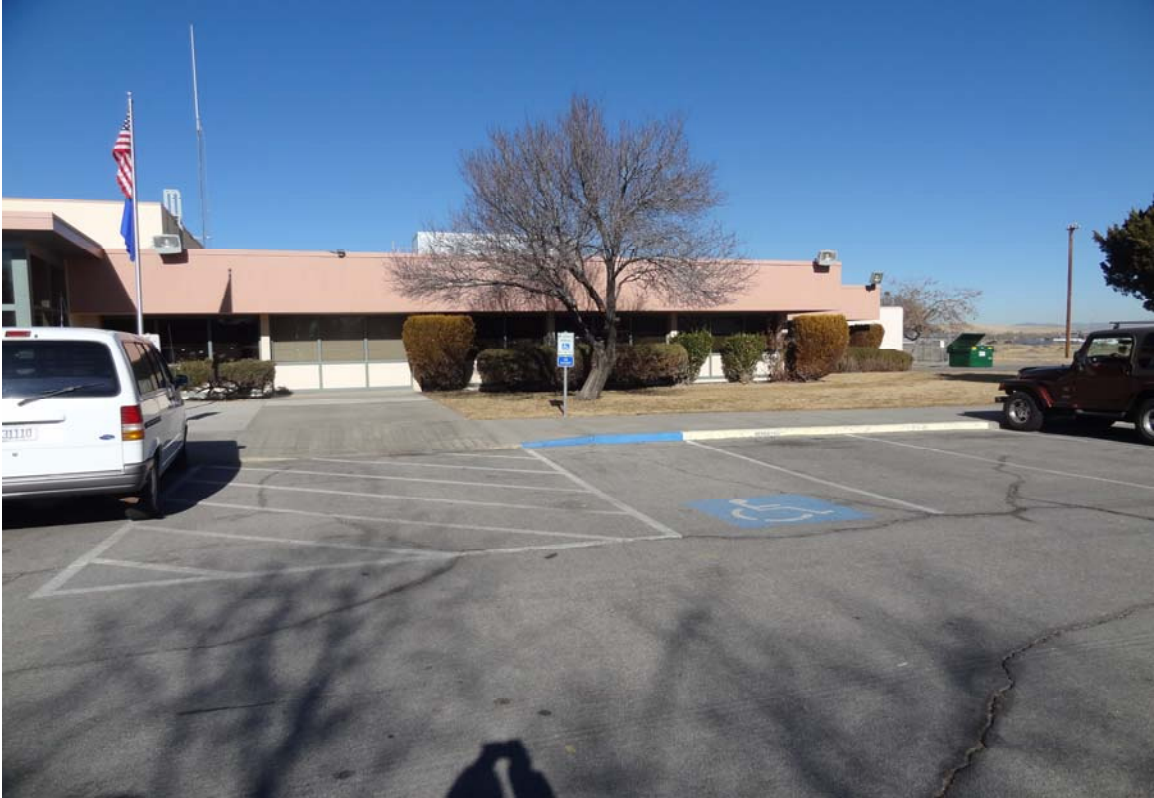
Lakes Crossing Center Site - Site #9980
Description: ADA accessible parking.

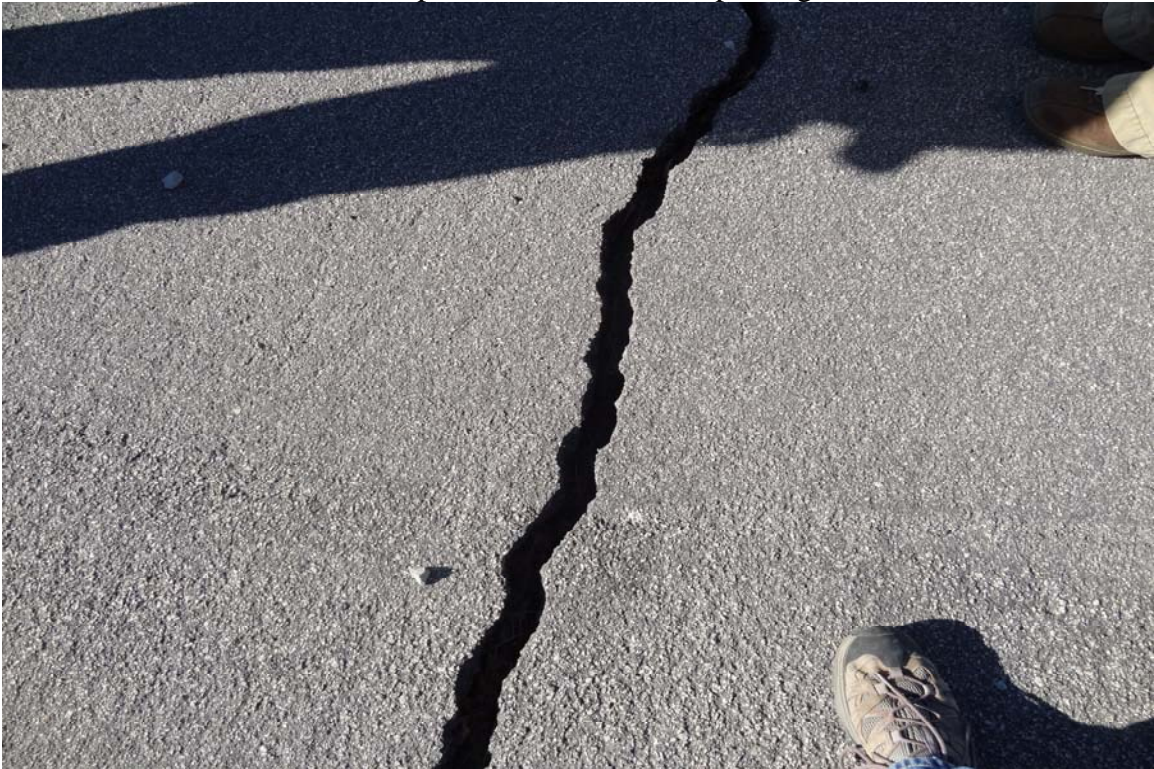
Lakes Crossing Center Site - Site #9980
Description: Access road pavement in need of crack filling.

It is important to maintain the asphalt concrete paving on the site. This project would provide for minor crack filling and slurry sealing of the paving site wide including access roads, parking areas and the perimeter road and some regrading on the north west portion of the parking lot. This area does not drain well and causes water to pool up in the parking area. Striping is included in this estimate. This project should be scheduled on a 5 year cyclical basis to maintain the integrity of the paving and prevent premature failure. 45,000 square feet of asphalt area was used to generate this estimate.

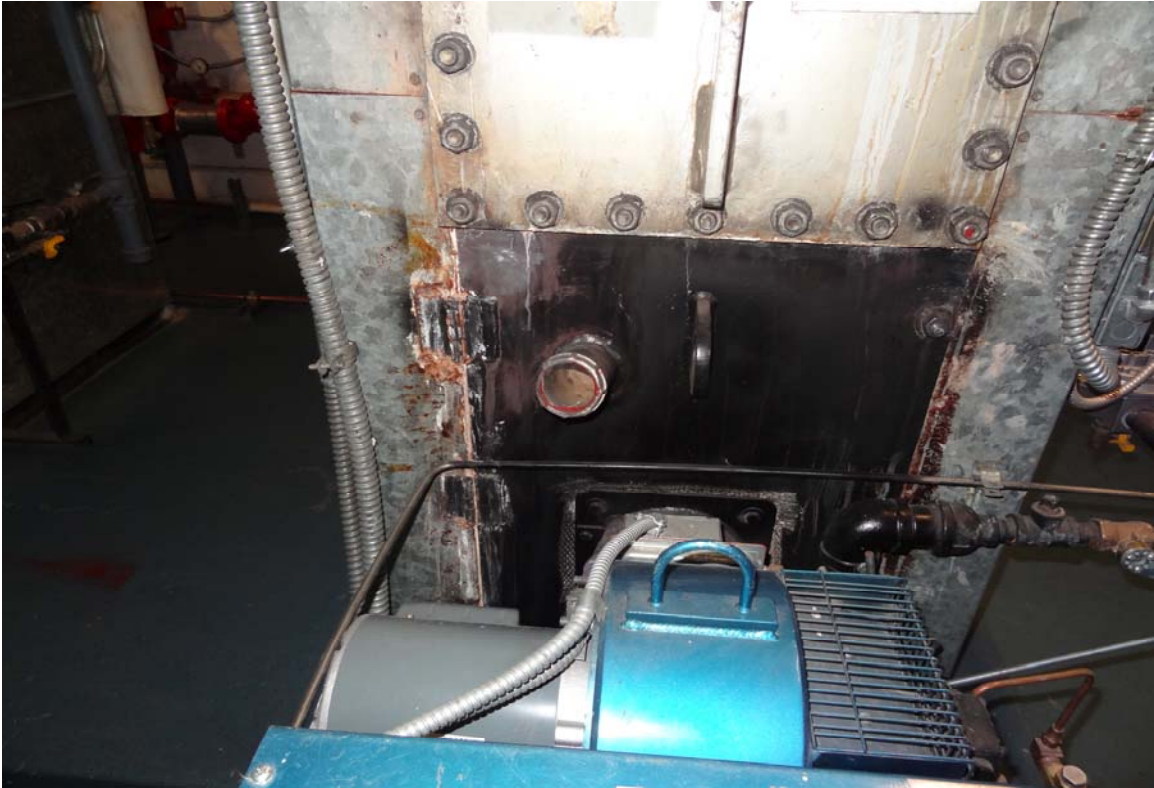
The central HVAC system consists of two hot water boilers, two rooftop outside air HVAC units, several rooftop packaged units and other related equipment throughout the building. This equipment was installed in the late 1990's, are not energy efficient and should be scheduled for replacement. The boilers are of poor quality and require constant maintenance including replacement of major components. This project would provide for installation of new boilers, rooftop units, associated equipment and cleaning of the existing duct work and grilles. This project includes removal and disposal of the existing HVAC units and all required connections to utilities.

Lakes Crossing Center - Building #0342
Description: Boiler in need of replacement.

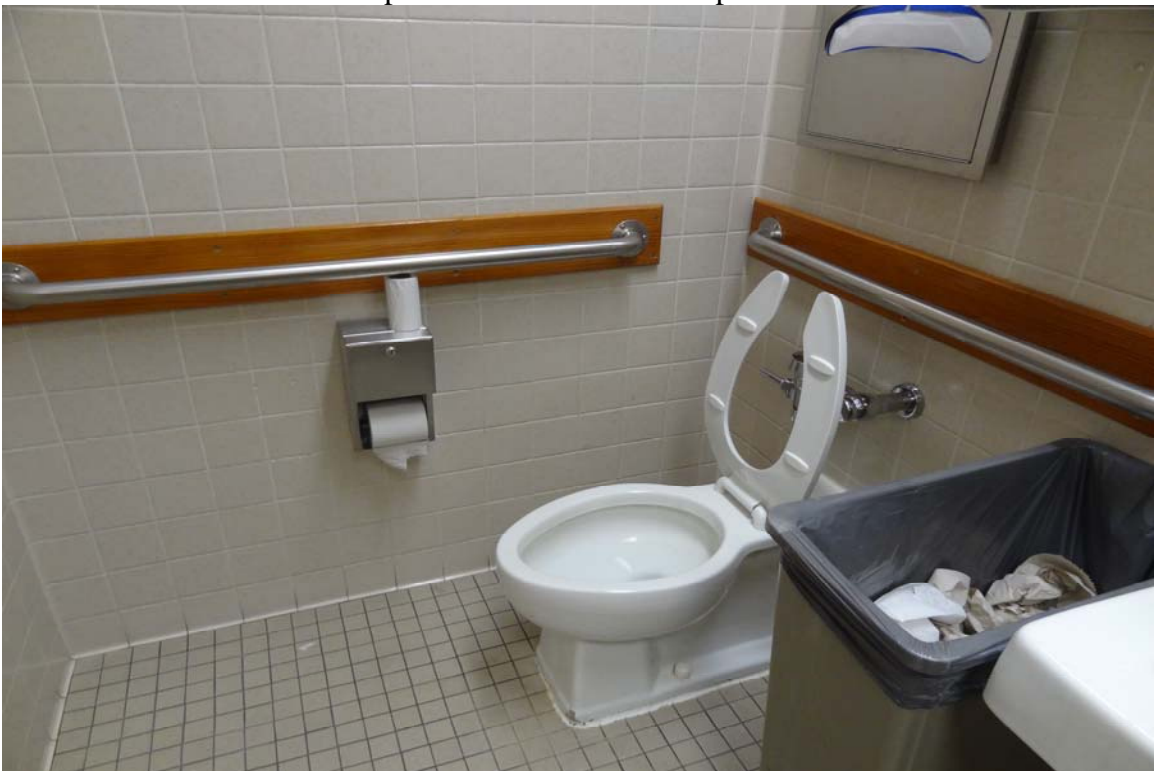
The Men's and Women's designated ADA restrooms for the staff offices do not meet the Americans with Disabilities Act (ADA) requirements. A complete retrofit is necessary. This project would provide funding for construction of Men's and Women's accessible restrooms. These items may include a new sink, toilet, hardware, mirrors, fixtures, flooring and paint. NRS 338.180, IBC - 2006, ICC/ANSI A117.1 - 2003 and the most current version of the Americans with Disabilities Act Accessibility Guidelines (ADAAG) were used as a reference for this project.

Lakes Crossing Center - Building #0342
Description: Non-ADA compliant staff Men's restroom.

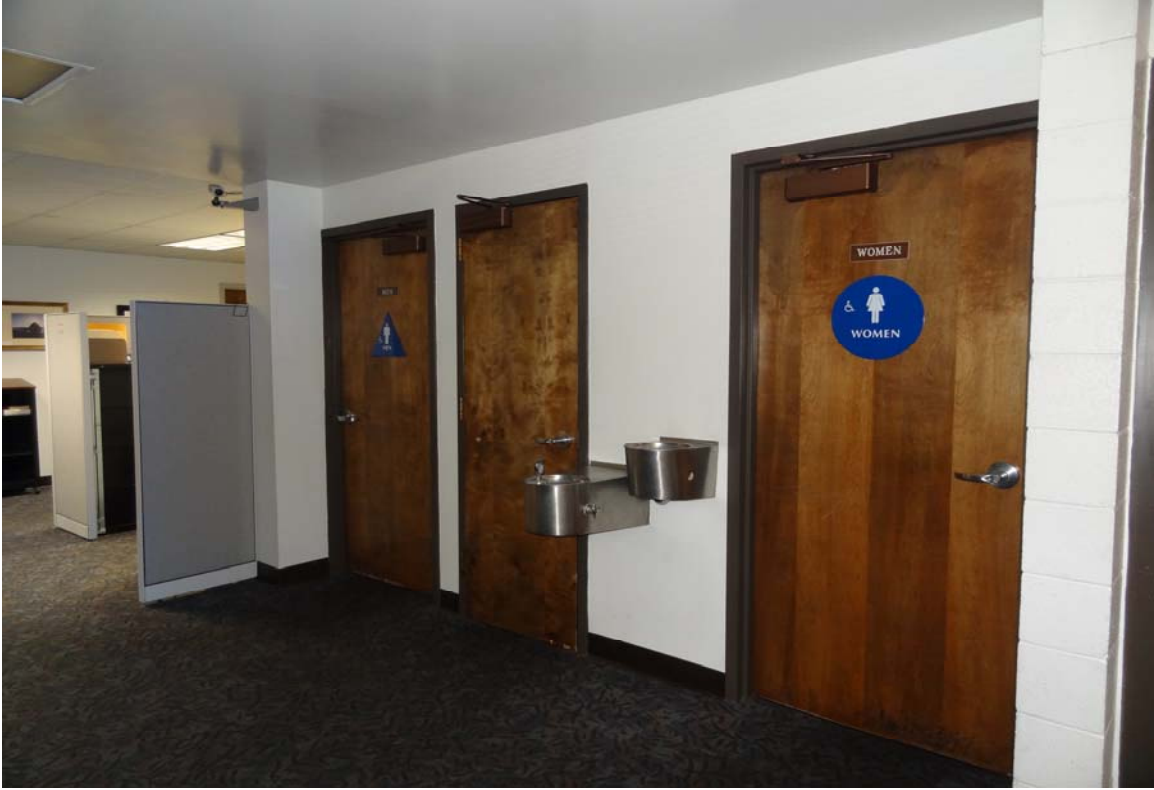
Lakes Crossing Center - Building #0342
Description: Non-ADA compliant staff restroom entrances.

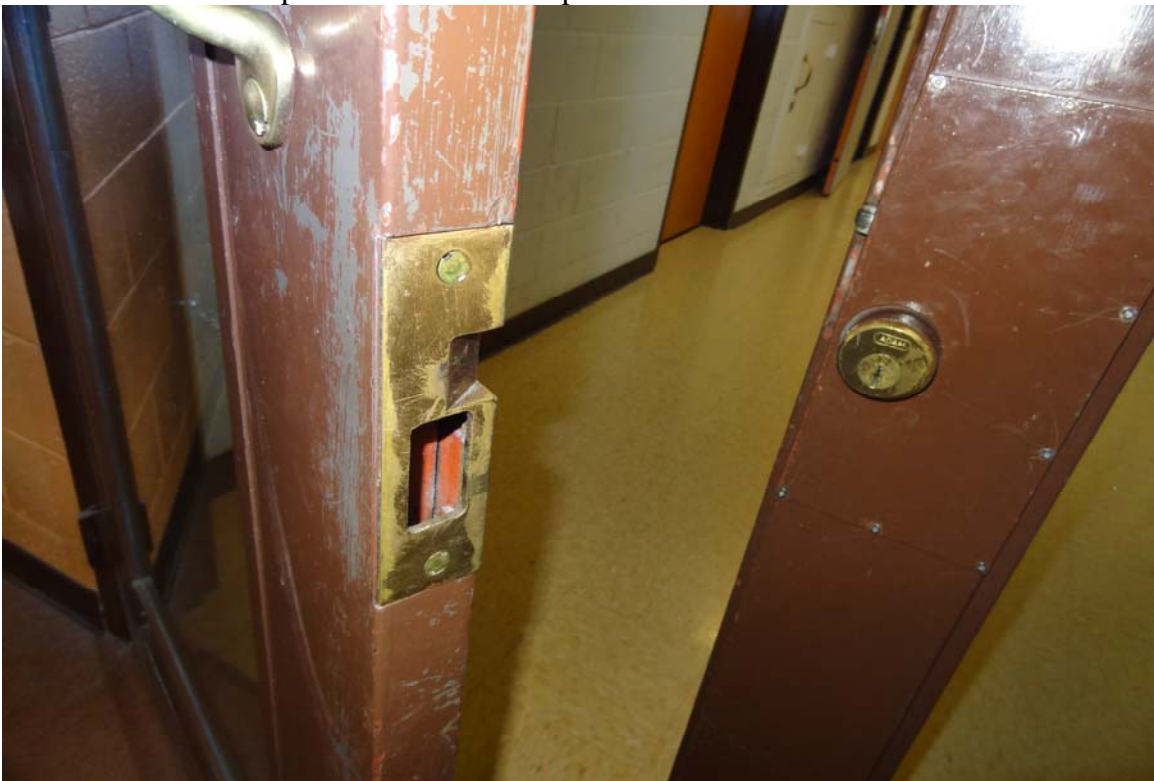
The interior doors are damaged from general abuse and age. There are 115 doors within the secured area and 20 doors outside of the secured area. Some of the doors within the secured area are fire rated doors that do not have magnetic hold opens. These fire doors are often propped open for ease of circulation which compromises the fire rating of the area. There are many doors that are loose in their frames and have worn out locking mechanisms. This project would provide for the removal of the existing doors and the purchase and installation of new doors, frames and hardware. This estimate is for 115 security grade hollow metal doors and 20 solid core wood doors.

Lakes Crossing Center - Building #0342
Description: Damaged door / hardware.

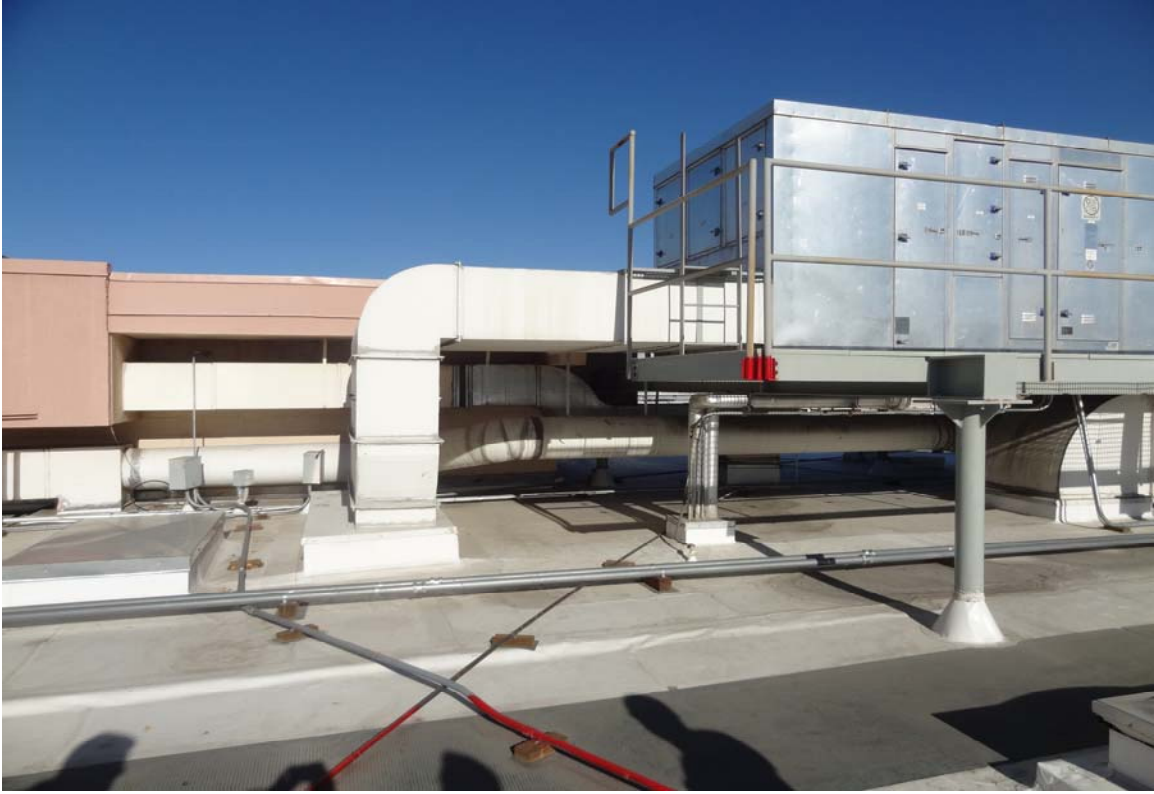
Lakes Crossing Center - Building #0342
Description: View of the roof mounted HVAC unit.

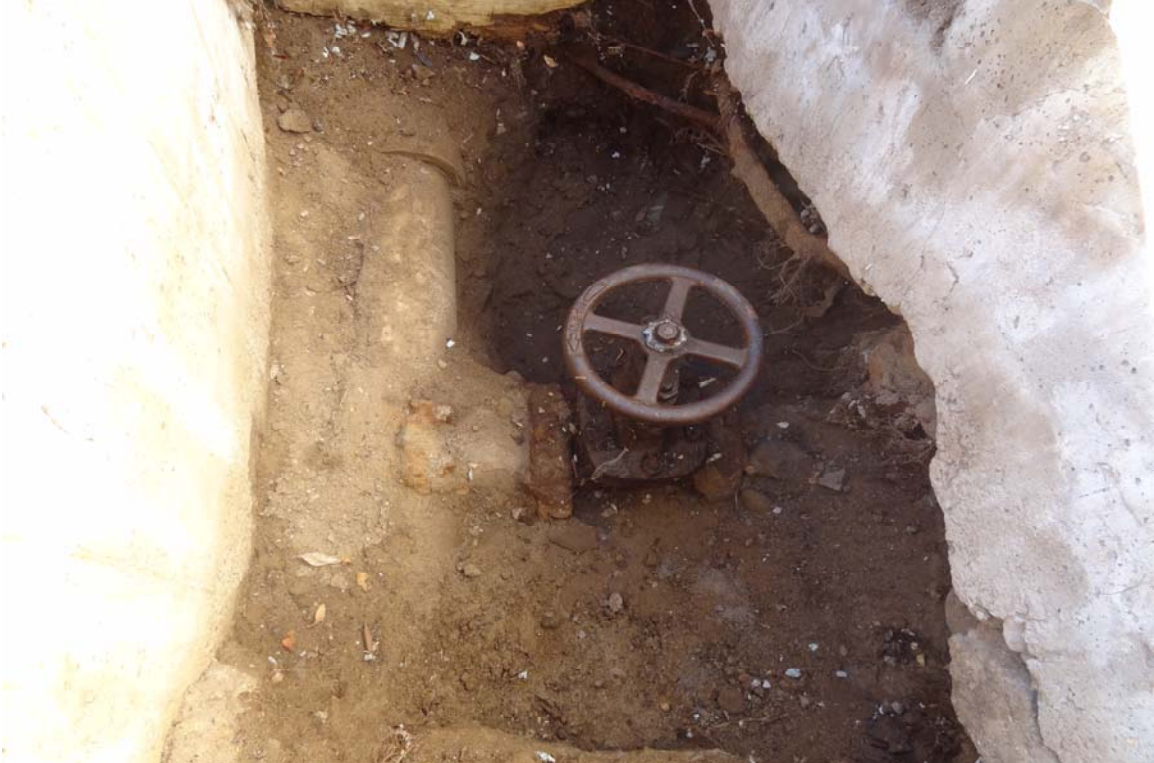
The 6" main water line coming into the site is equipped with a gate valve to control the irrigation system. It has reached the end of its expected life, leaks and should be replaced in the next one to two years. A contributing factor to the deterioration of the valve is that the vault that contains the valve does not have solid sides and allows dirt to build up and bury the valve. This project would provide for replacing the valve and installing a new vault around the valve with a solid cover and solid walls.

Lakes Crossing Center - Building #0342
Description: View of leaking irrigation gate valve.
