SOUTHERN NEVADA ADULT MENTAL HEALTH SERVICES

6161 West Charleston Blvd.
Las Vegas, Nevada 89146

Site Number: 9992
STATE OF NEVADA PUBLIC WORKS DIVISION
FACILITY CONDITION ANALYSIS

Report distributed in August 2022

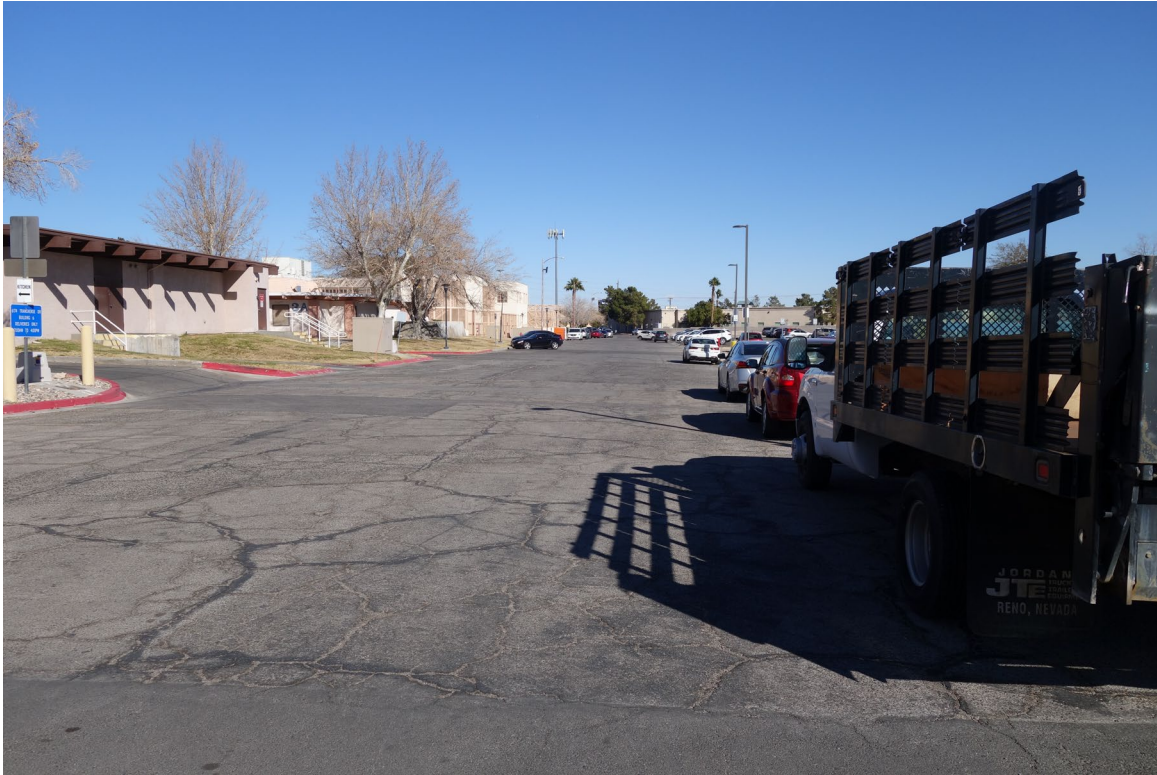
This road is in a state of failure, and replacement is needed. The staff from the Stein Hospital are utilizing the on street parking which is in disrepair and does not have ADA required parking or access to the building. This project would pulverize and repave a portion of Transverse Drive at the Southern Nevada Mental Health Services campus. This rehabilitation effort will include the construction of sidewalks with required accessibility components. This project will also make repairs to the existing street lighting.

Southern Nevada Adult Mental Health Services Site – FCA Site #9992
Description: Transverse Drive Rehabilitation Needed.

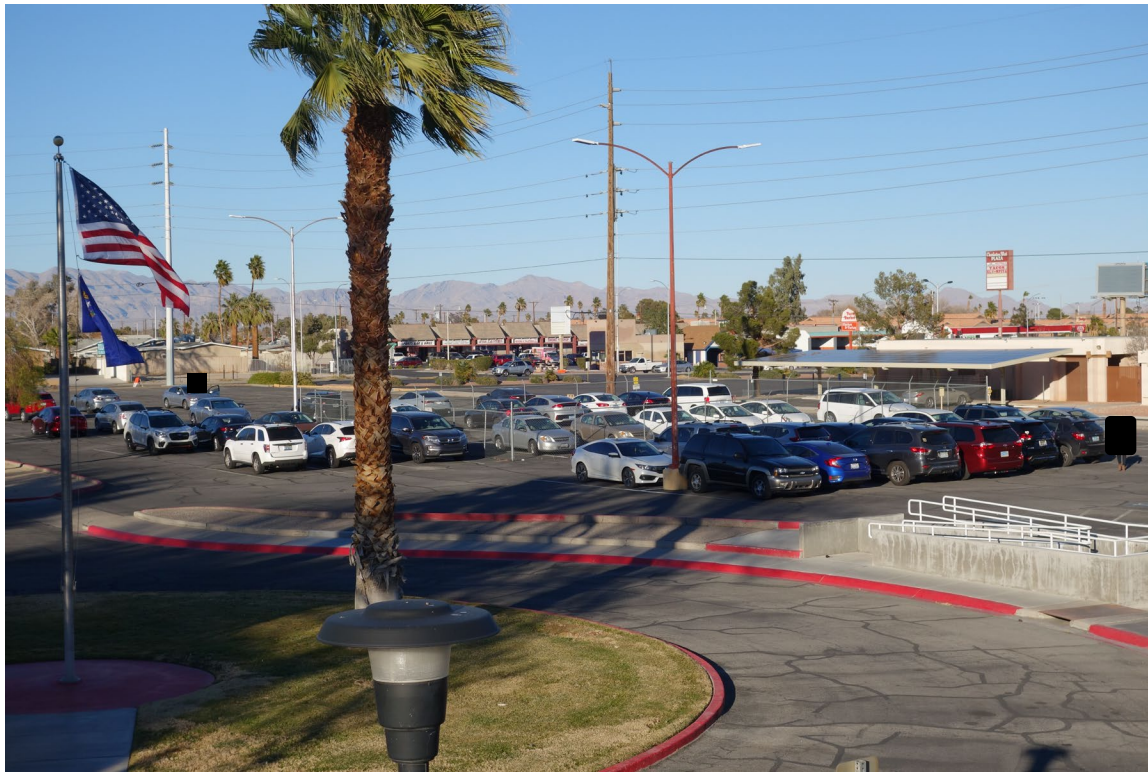
Southern Nevada Adult Mental Health Services Site – FCA Site #9992
Description: Crack Fill & Seal Asphalt Paving.

It is important to maintain the asphalt concrete paving on the site. This project would provide for minor crack filling and sealing of the parking lot and access roads on the site. Striping is included in this estimate. This project should be scheduled on a 5 year cyclical basis to maintain the integrity of the paving and prevent premature failure. 70,000 square feet of asphalt area was used to generate this estimate.

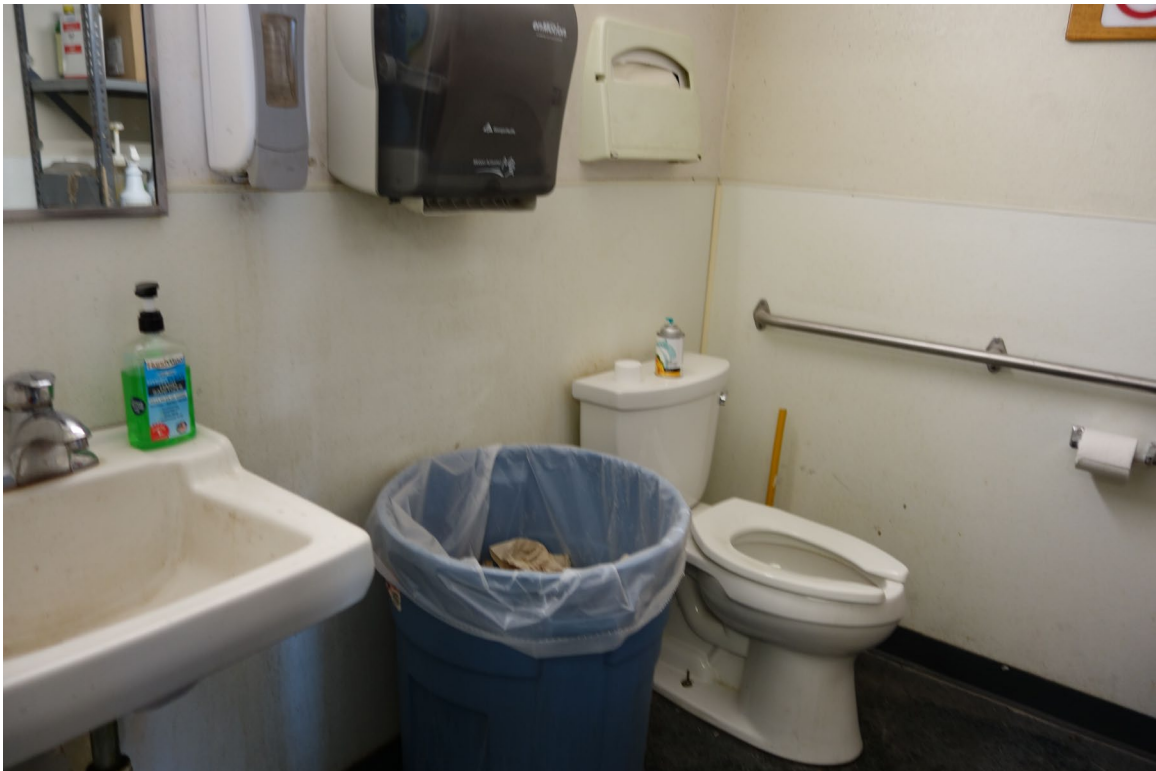
#6 Storage / Shop – FCA Building #1954
Description: ADA Restroom Upgrade Needed.

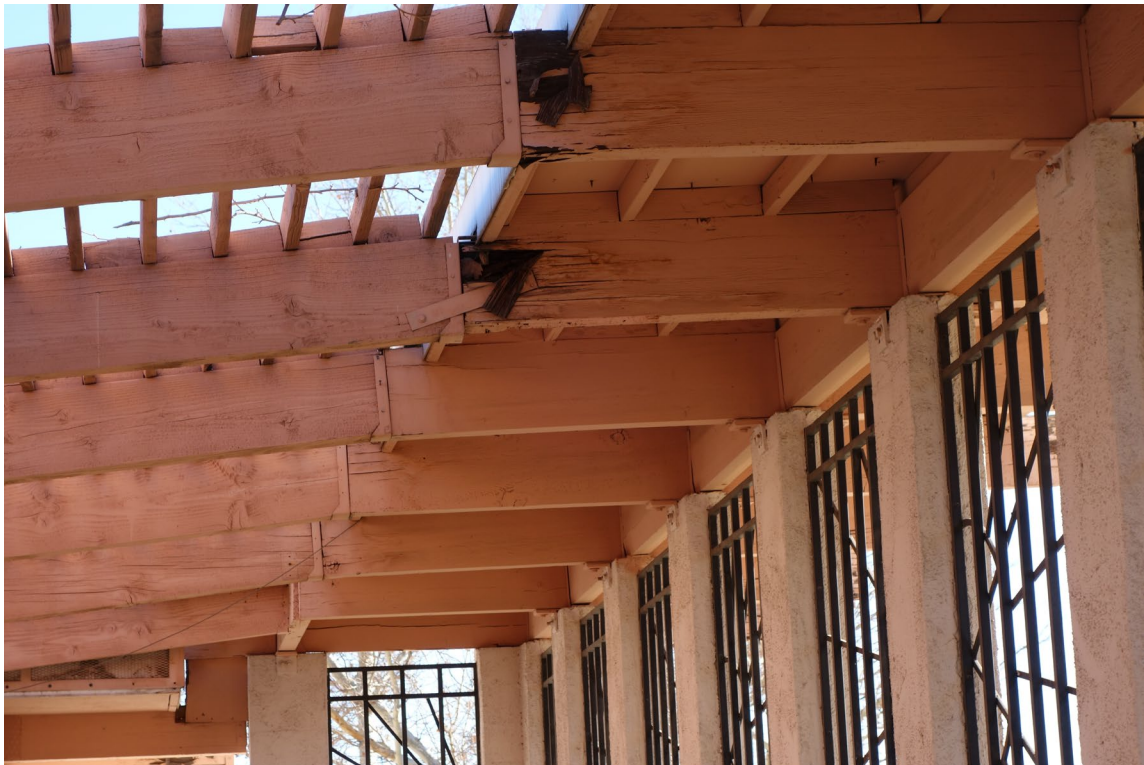
This facility has a shade canopy along the west side of the building's exterior. The structure is a mix of wood cantilever beams, wood and CMU support columns in varying stages of weathered decay. The structure appears to be a retrofit after the original construction and no documentation could be located. The deteriorating condition raises concern for the structural integrity of the canopy. This project recommends a structural analysis to determine the integrity of the structure. Structural rehabilitation or demolition are not included in this estimate.

#3A Crisis Observation Unit – FCA Building #1951
Description: Structural Assessment of Shade Canopy Needed.

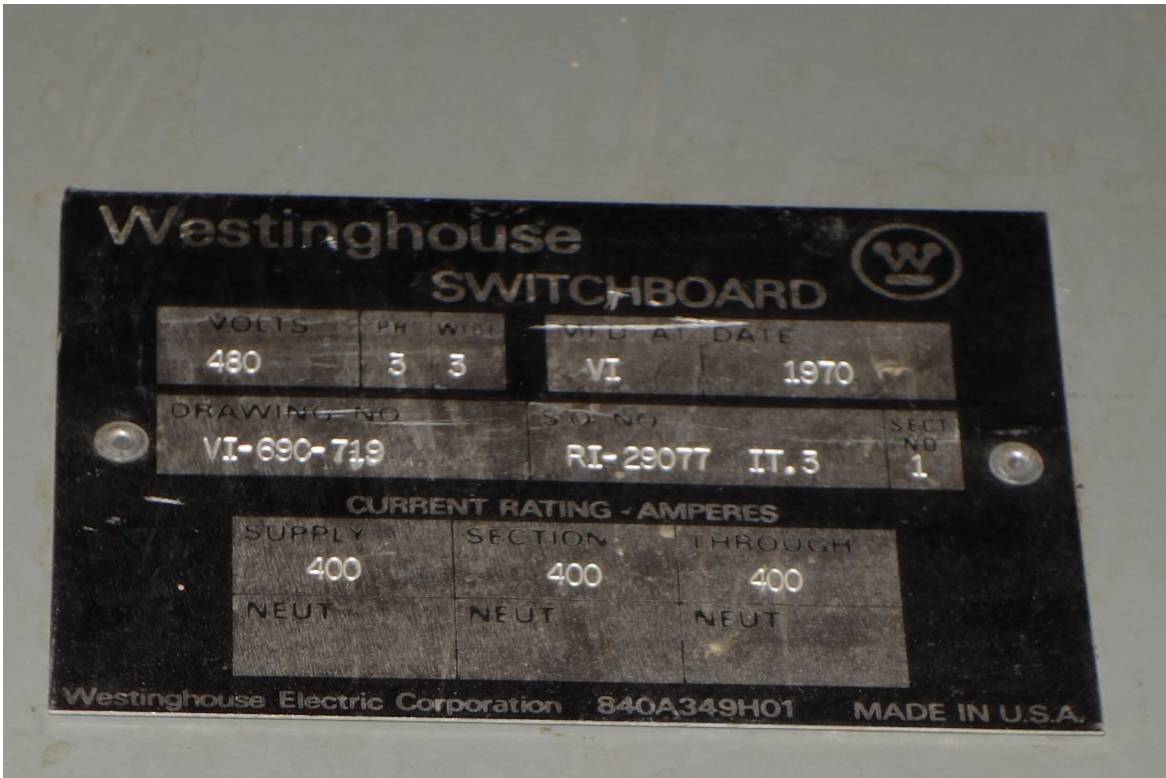
This building is over 50 years old and the electrical system has reached the end of its useful life. Additionally, it was constructed before the requirements for NEC 70e electrical Arc Flash Assessments. As a consequence, the original subpanels, distribution boards and breakers are not labeled with available fault current (AIC Rating). In order to comply with the NEC 70e requirements, it is recommended that the original electrical equipment be replaced with new to facilitate the required Breaker Coordination and Arc Flash studies. Removal and disposal of the existing equipment is included in this project.

#3A Crisis Observation Unit – FCA Building #1951
Description: Electrical Upgrade Needed.

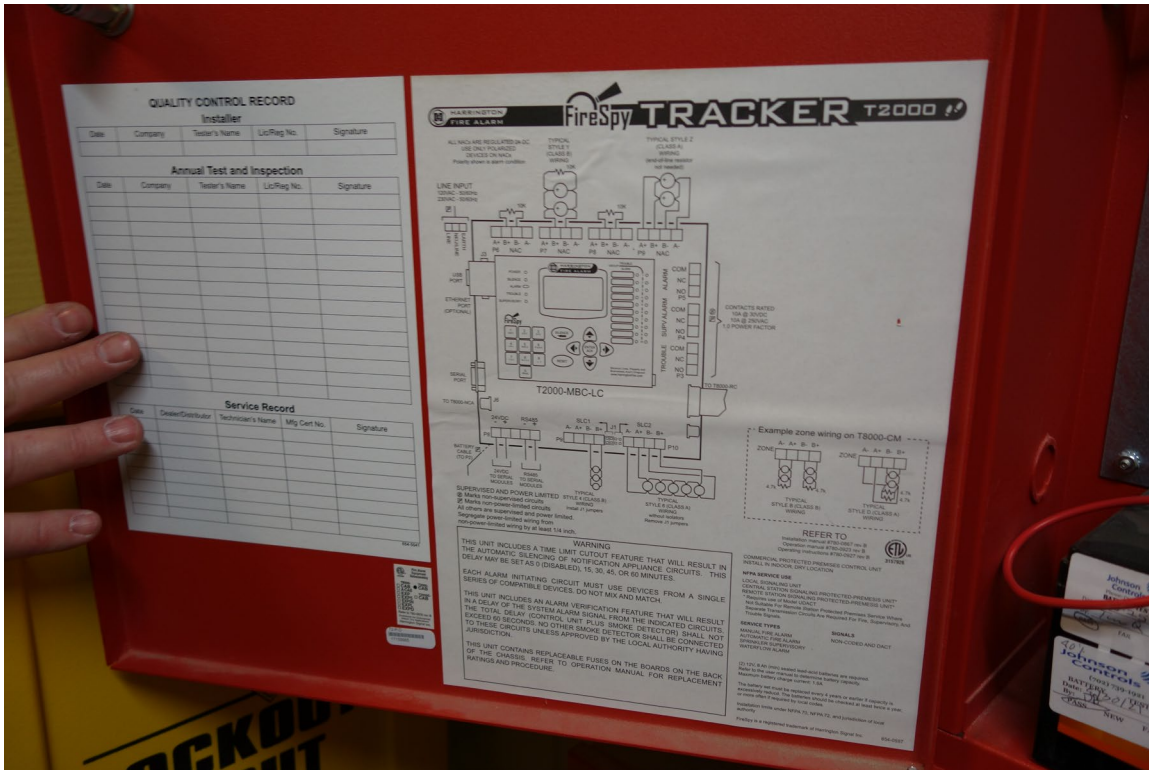
#1 Administration / Outpatient Services – FCA Building #1949
Description: Fire Alarm Obsolete Replacement Needed.

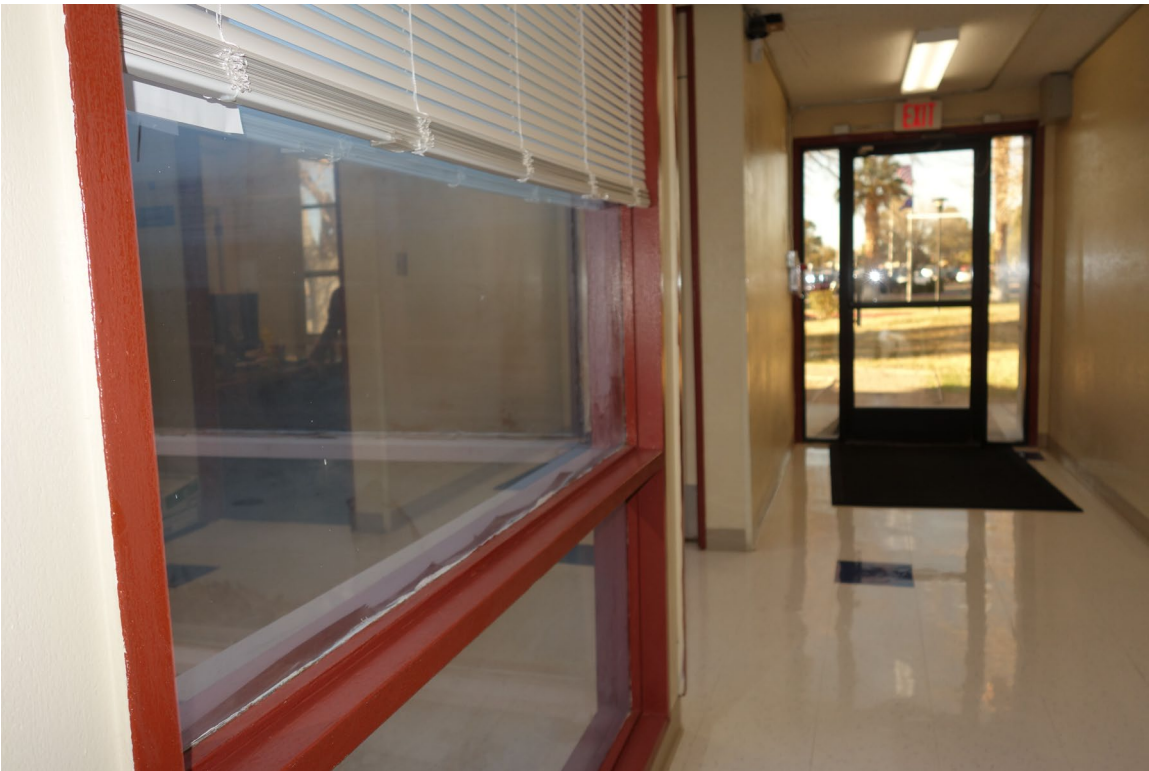
#1 Administration / Outpatient Services – FCA Building #1949
Description: Single Pane Windows Replacement Needed.

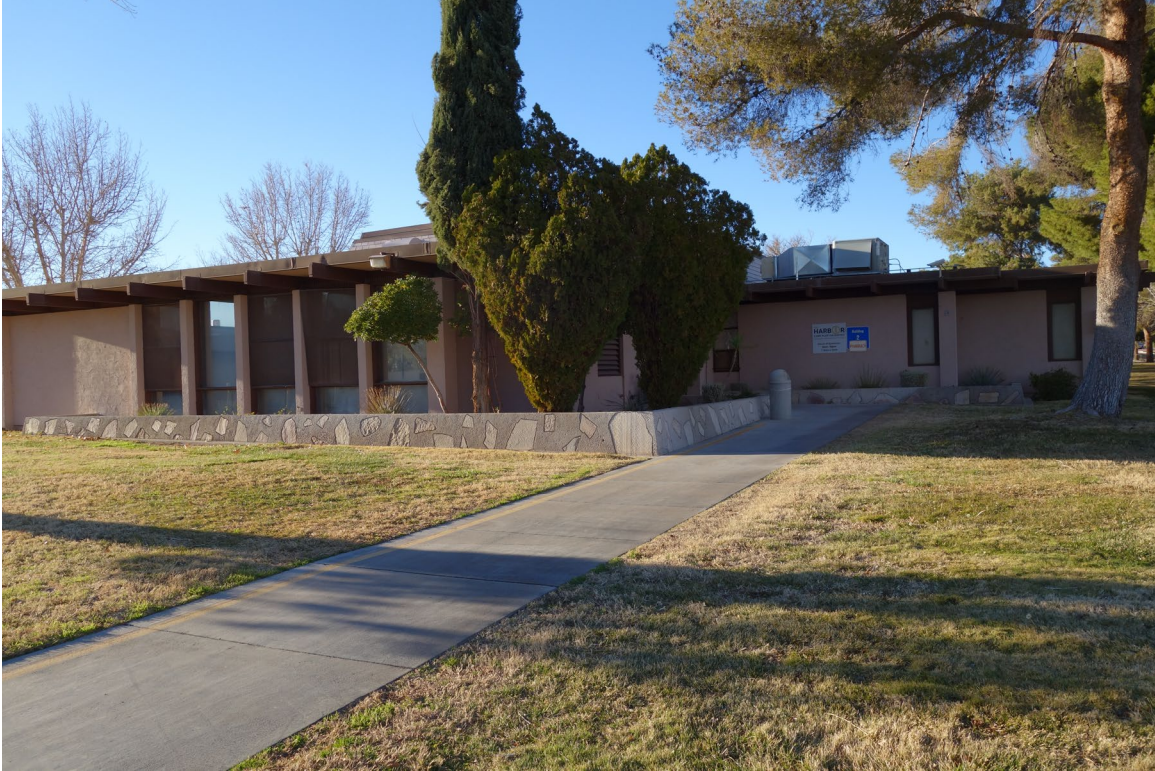
#2 Pharmacy / Laboratory Building – FCA Building #0243
Description: Window Replacement Needed.

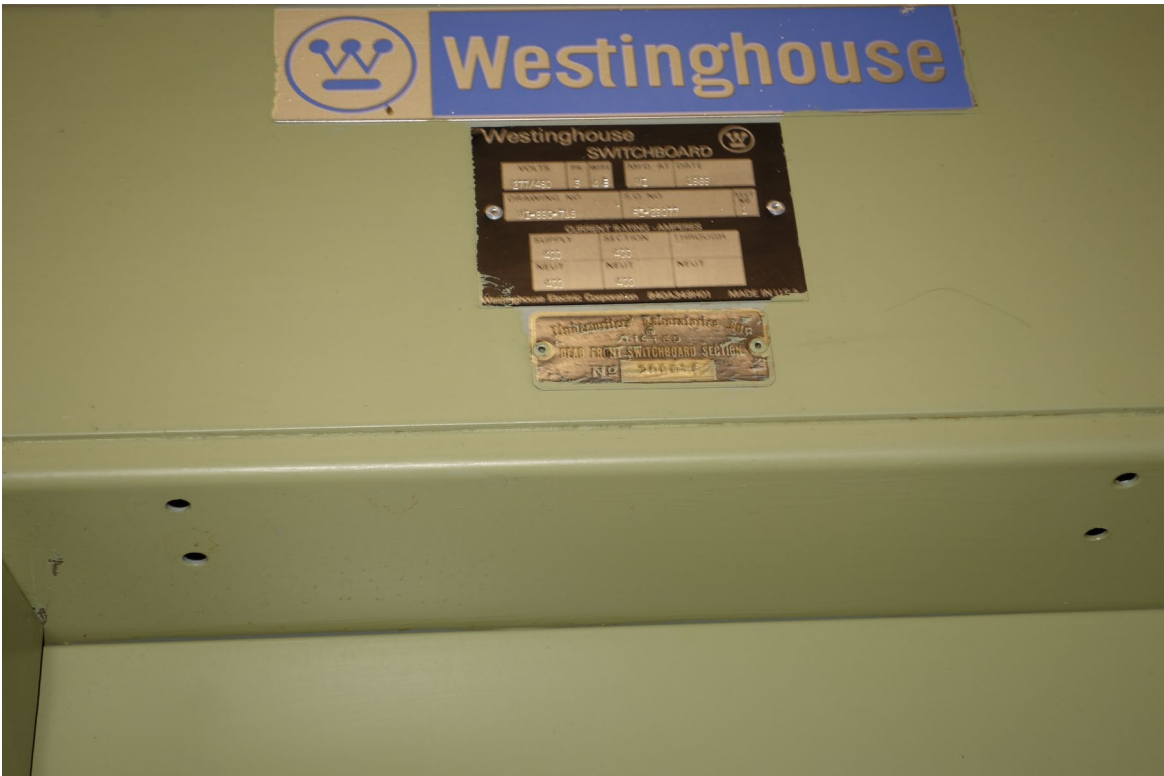
#2 Pharmacy / Laboratory Building – FCA Building #0243
Description: Electrical Upgrade Needed.
