1 EXISTING DAM PLAN
SCALE: 1"=40'

POTENTIAL DEFICIENCY MATRIX

S1.0
DATE: NOV. 13, 2018
DRAWN BY: S.R.M.
DESIGNED BY: T.R.T.
CHECKED BY: -
JOB NO.: 9624.000
SHEET: 1 OF 3

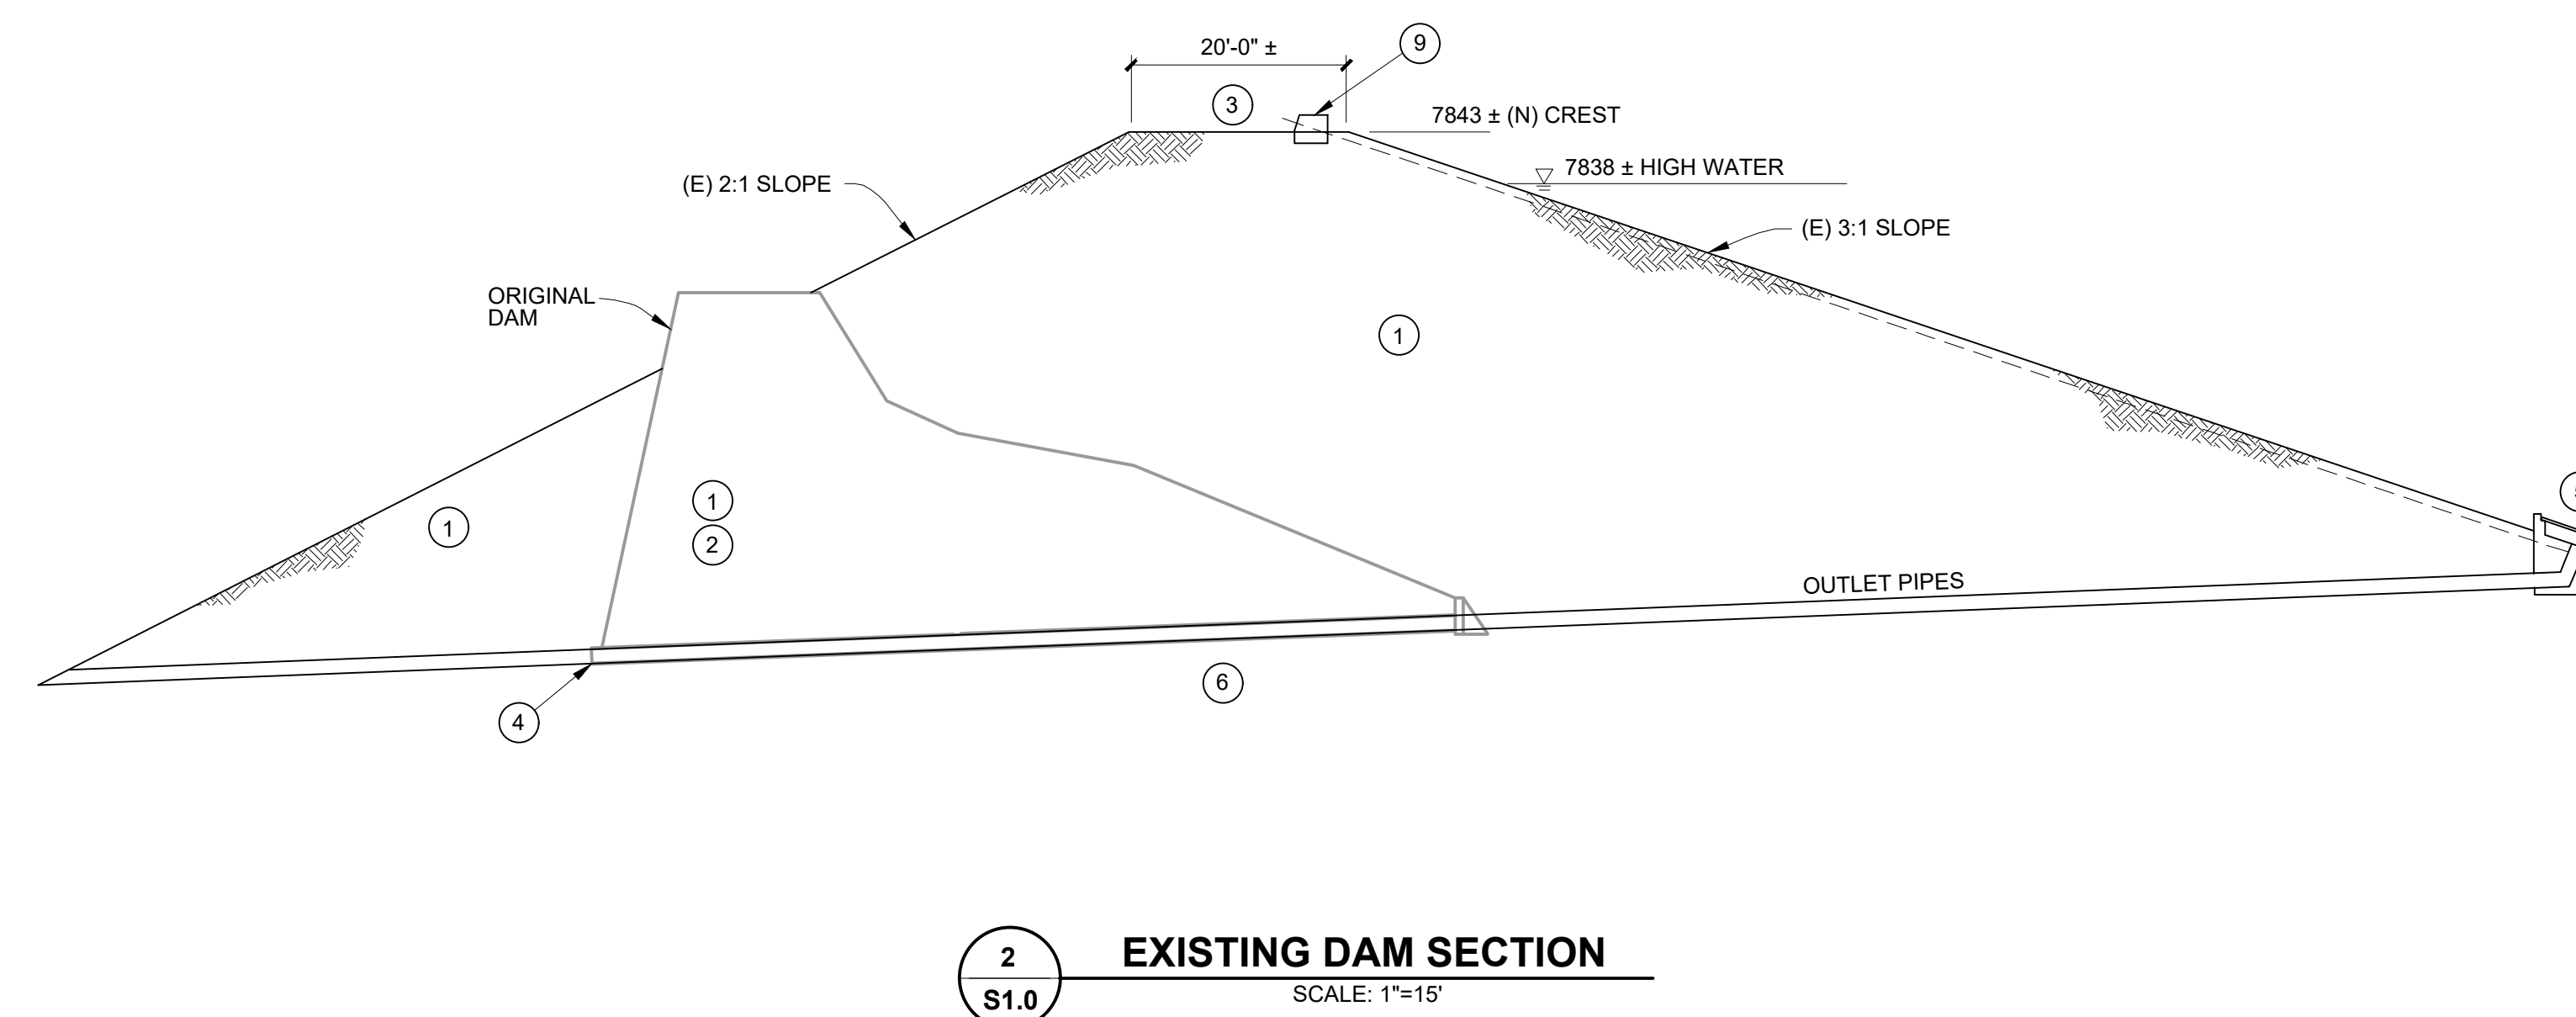
2 EXISTING DAM SECTION
SCALE: 1"=15'

MARK	DEFICIENCY	PREFERRED UPGRADE
1	EMBANKMENT UNSTABLE DURING A SEISMIC EVENT	INSTALL (N) 3:1 SLOPE AND STABILITY BERM - SEE 3/S1.0 & NOTE 1
2	INADEQUATE COMPACTION LEADING TO SETTLEMENT DURING A SEISMIC EVENT	DENSIFY ORIGINAL DAM EMBANKMENT - SEE 3/S1.0
3	OVERTOPPING OF CREST DURING A SEISMIC EVENT	INCREASE CREST HEIGHT - SEE 3/S1.0
4	LEAKAGE AND CORROSION IN OUTLET PIPES	REPLACE OUTLET PIPES - SEE 3/S1.0
5	DETERIORATED OUTLET STRUCTURE	REPLACE - SEE 3/S1.0
6	POTENTIAL LIQUIFACTION DURING A SEISMIC EVENT	COMPACTION GROUT
7	UNSTABLE SLOPE ABOVE SPILLWAY	SEE 2/S2.0
8	DETERIORATION IN SPILLWAY WALLS; SPILLWAY FILLS w/ SNOW	SEE 2/S2.0
9	INADEQUATE MANUAL CONTROLS	REPLACE
