State of Nevada
Department of Corrections
Southern Desert Correctional Center
Facility Condition Analysis

SDCC HOUSING UNIT #8

STATE OF NEVADA PUBLIC WORKS DIVISION
FACILITY CONDITION ANALYSIS

Report Printed in December 2016

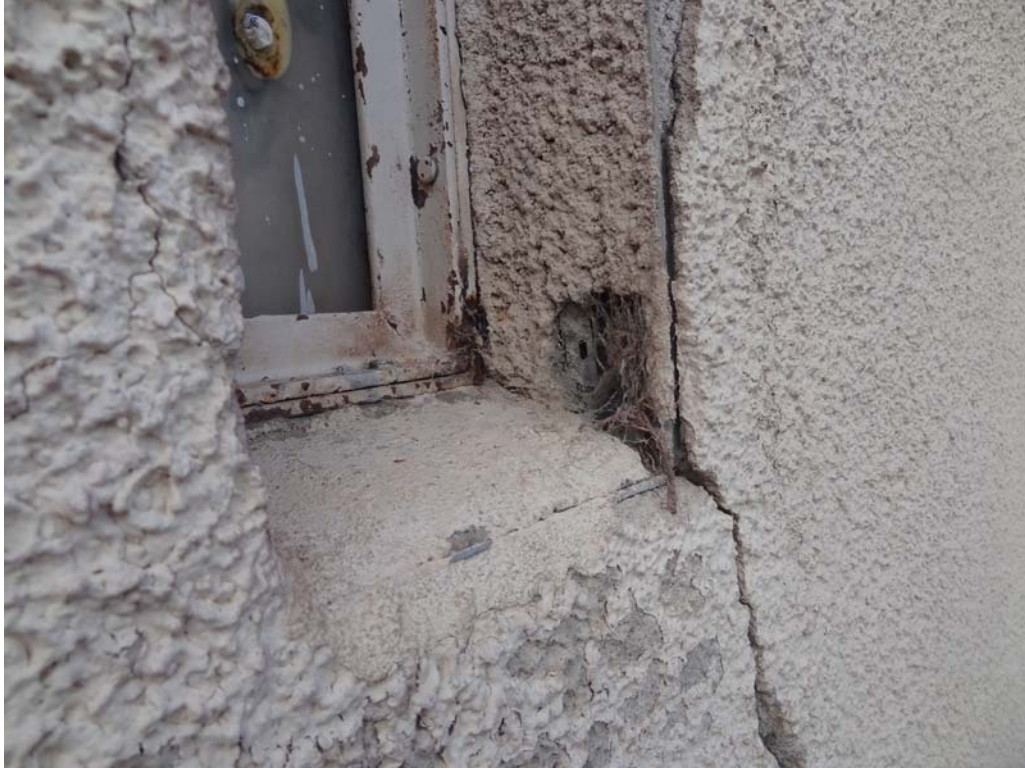
It is important to maintain the finish, weather resistance, and appearance of the building. This project would provide funding to protect the exterior of the building excluding the roof. Included in the cost is repairing damaged areas of stucco, power washing, priming and painting and caulking of the windows, flashing, fixtures and all other penetrations. It is recommended that the building be repaired and painted in the next year and that this project be scheduled on a cyclical basis to maintain the integrity of the structure.

Housing Unit #8 – FCA Building #1481
Description: Damage to exterior finishes.

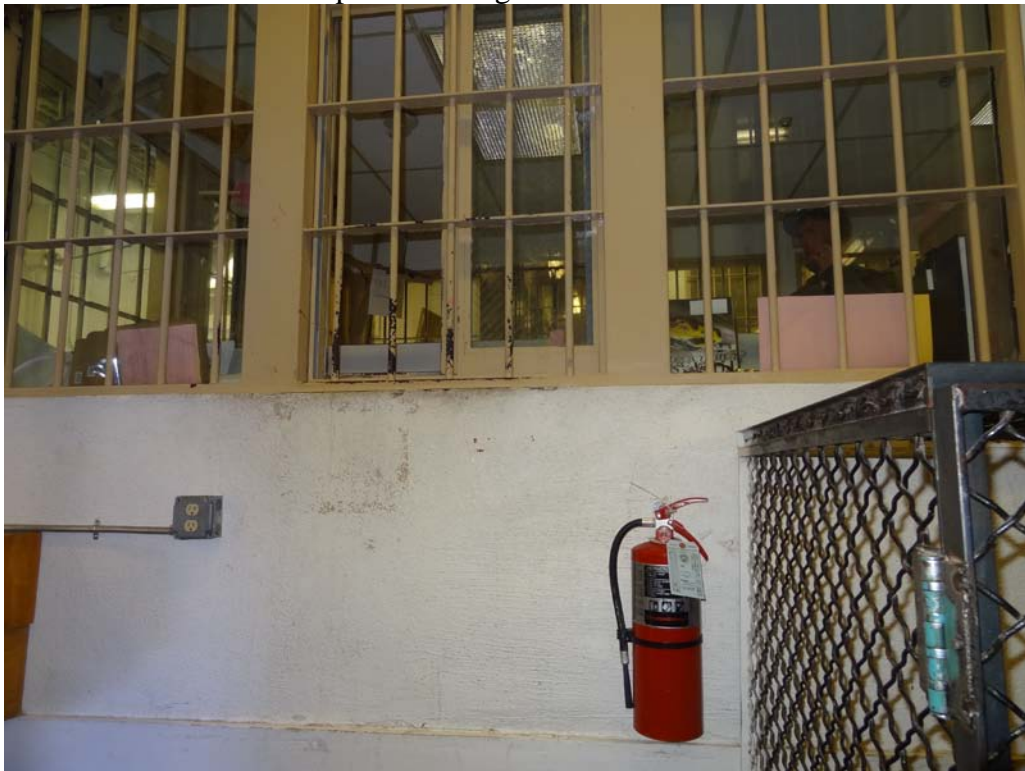
It is recommended that the interior walls and ceilings be painted at least once in the next year and that this project be scheduled on a cyclical basis to maintain the integrity of the structure. Prior to painting, all surfaces should be repaired and prepped. An epoxy-based paint should be utilized in wet areas for durability. This project or a portion thereof was previously recommended in the FCA report dated 12/01/2001, 04/03/2007 and 4/30/2013. It has been amended accordingly to reflect conditions observed during the most recent survey date of 12/13/2016.

Housing Unit #8 – FCA Building #1481
Description: Damage to interior finishes.

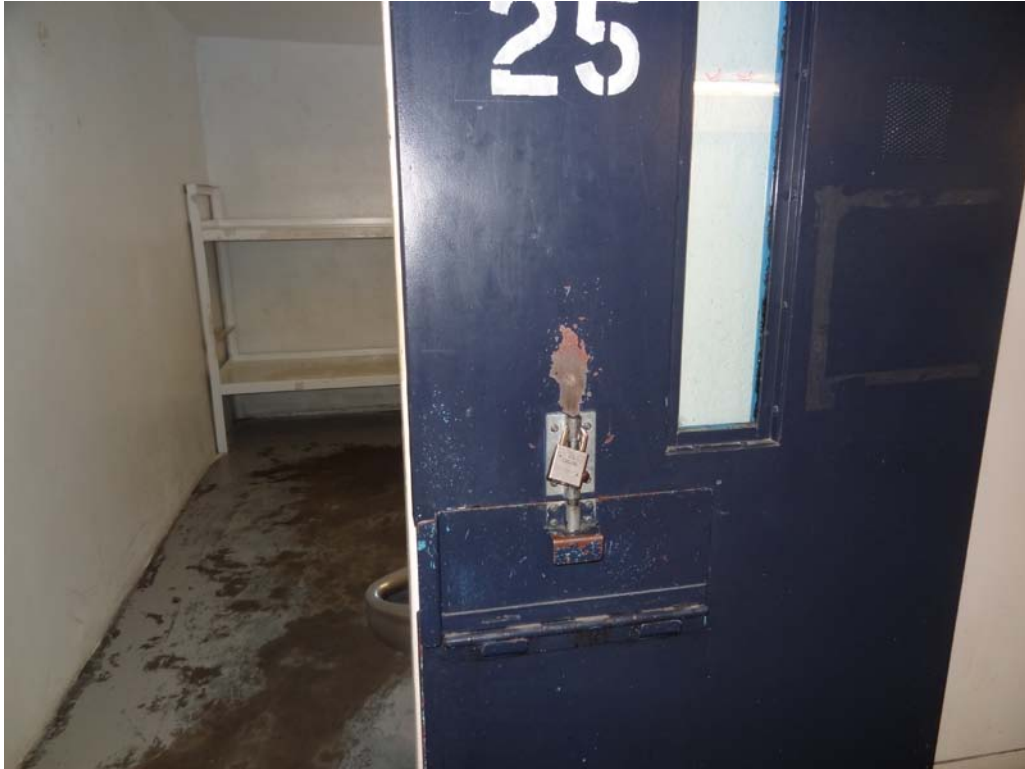
Housing Unit 8 was constructed in 1988. The cell doors, locks and controls are original to the building and have been problematic due to inmate abuse and age. This project would provide for installing new cell doors, locks and controls. A total of 200 doors were used for this estimate. Removal and disposal of the existing equipment is included in this estimate.

Housing Unit #8 – FCA Building #1481
Description: 30 year old cell door.

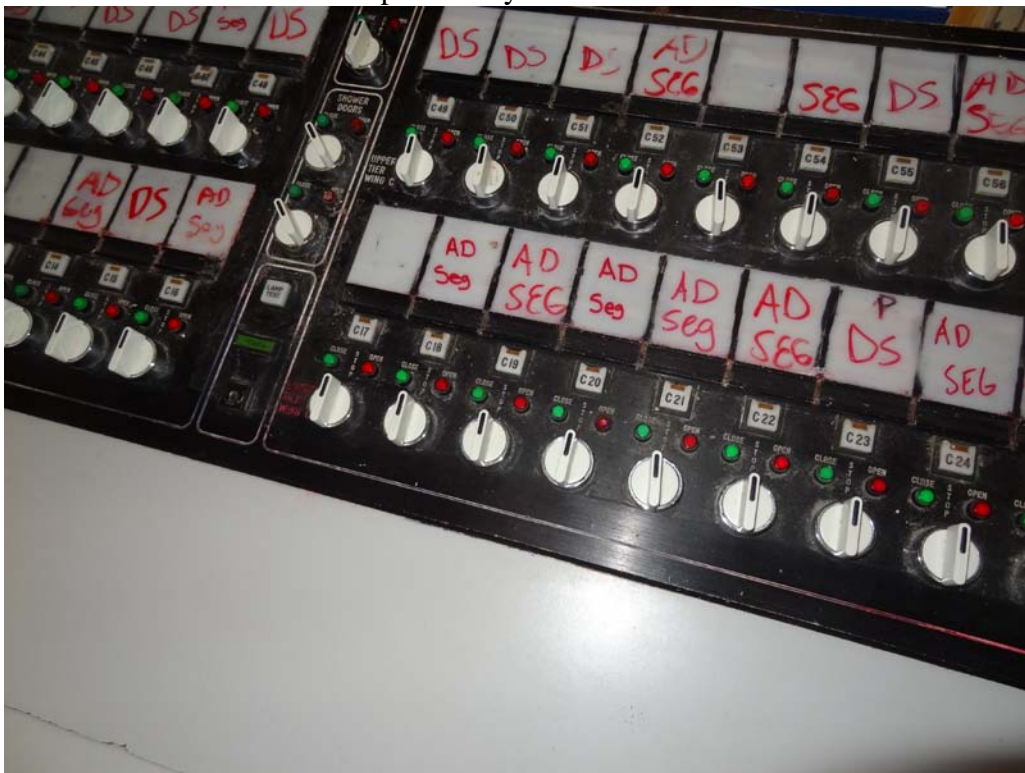
Housing Unit #8 – FCA Building #1481
Description: 30 year old cell door control panel.

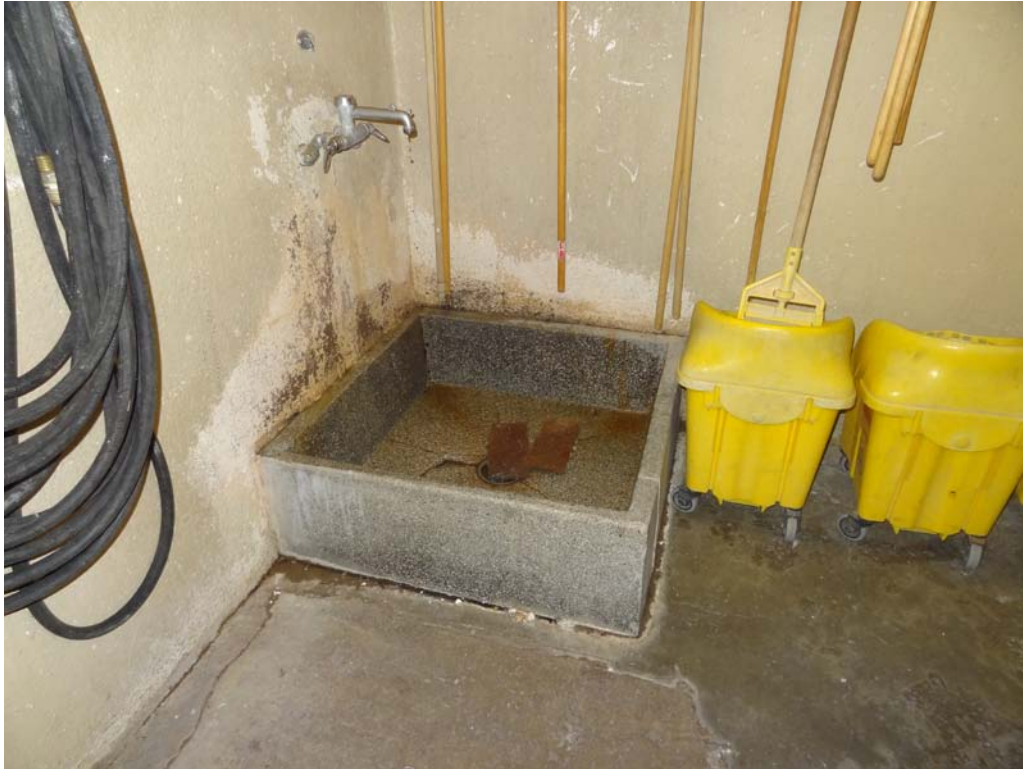
The mop sink in the Janitors Closet has several cracks in the concrete and is leaking. This could lead to mold growth if not addressed. This project would provide for a new fiberglass mop sink and fiberglass reinforced panels (FRP) to be installed on the walls adjacent to the mop sink. The FRP shall extend two feet beyond the edge of the sink and a minimum of 54" above the floor finish.

Housing Unit #8 – FCA Building #1481
Description: Cracked mop sink and damaged interior finishes.

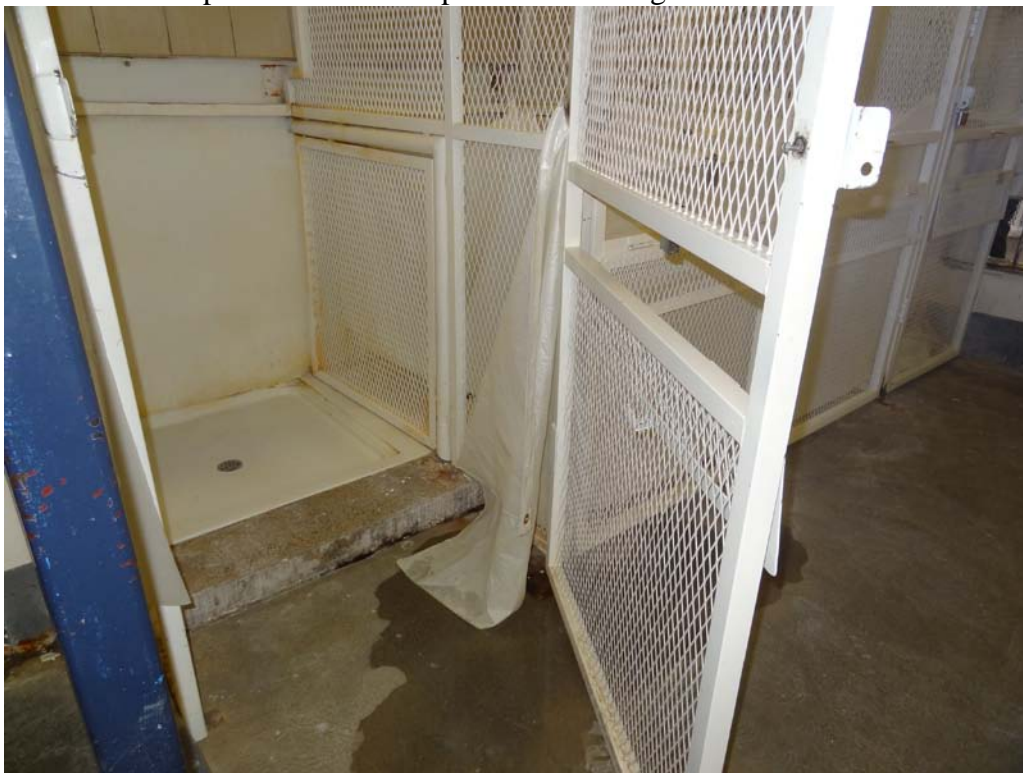
There are seventeen showers in the building that are showing signs of failure. The walls and fixtures should be scheduled for repairs. The walls are constructed of gypsum board covered by fiberglass reinforced panels (FRP). The gypsum board is failing in the wet environment and should be replaced with a cementitious backerboard. This project would provide for removing the gypsum board and replacing it with a more appropriate wall board, such as Hardiboard, covered with new FRP and new fixtures. Removal and disposal of the existing materials is included in the estimate.

Housing Unit #8 – FCA Building #1481
Description: Typical shower enclosure.

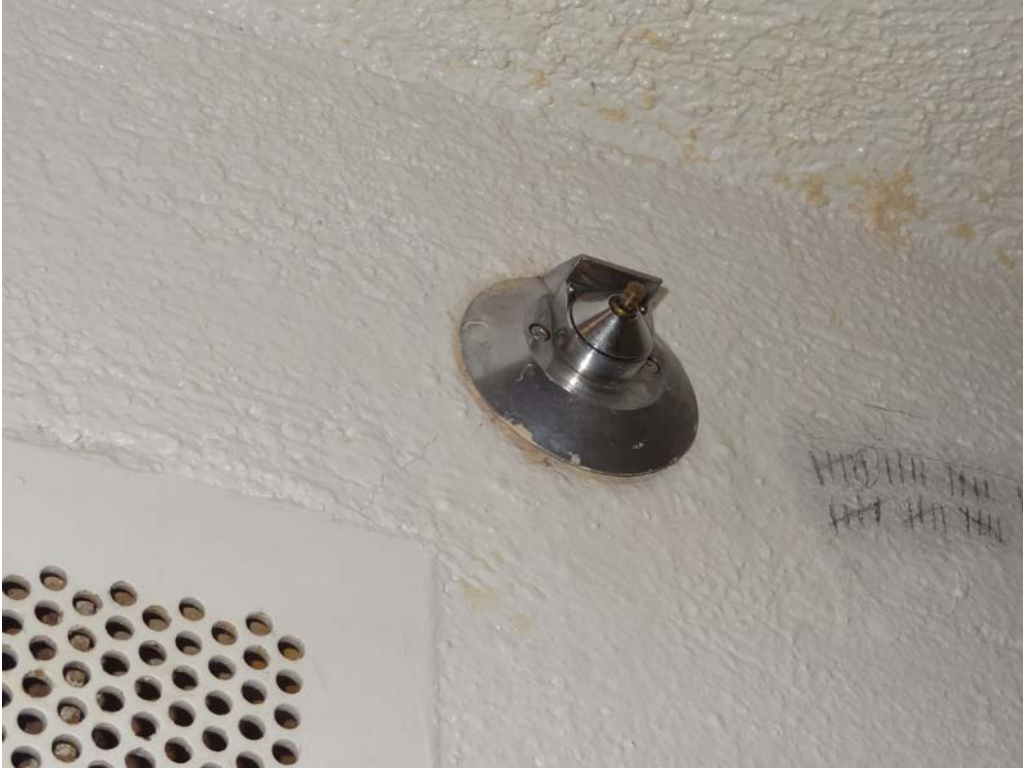
The existing fire suppression sprinkler heads are an older style and are susceptible to damage and misuse by the inmates. Inmates have tied strings to them and have broken them in the past. This project recommends that all of the fire sprinkler heads in all cells be removed and replaced with tamper-resistant sprinkler heads.

Housing Unit #8 – FCA Building #1481
Description: Typical sprinkler head in cell.

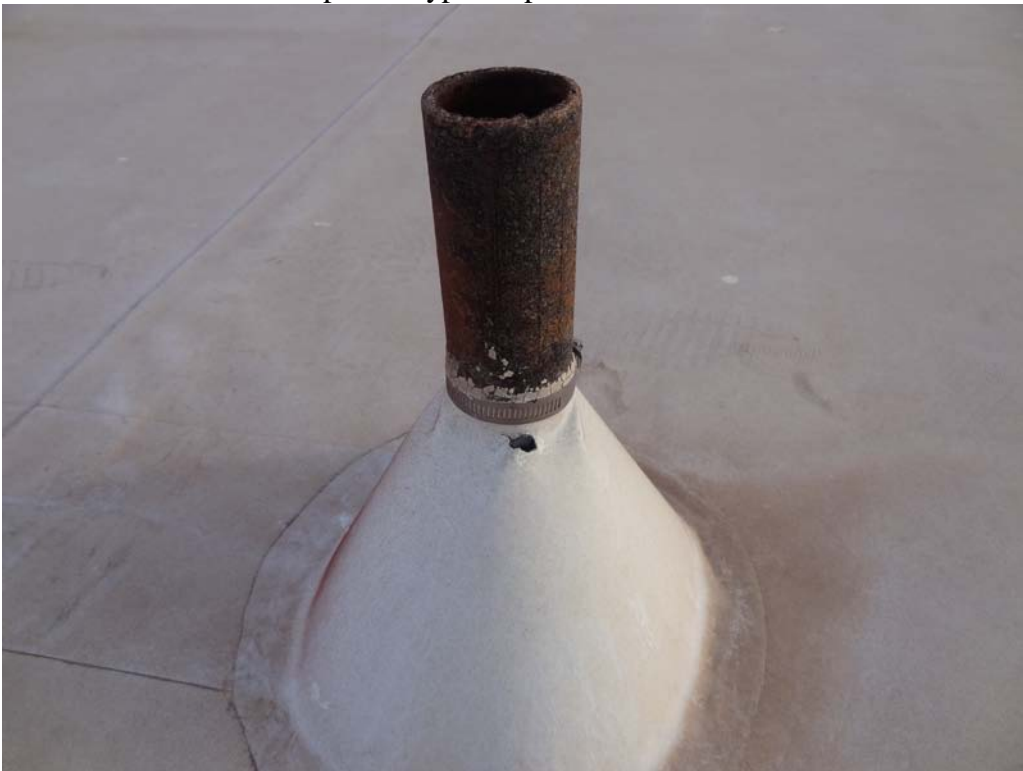
The curb and ductwork flashings and sealants around the roof penetrations and in the rain gutters are due for repair. The sealants are dried out and cracking and the flashings are coming loose. Birds on the roof are pecking at the sealants, causing them to prematurely breakdown and to leak. This project would provide funds for repairing the roof. The estimate includes repairing the curb and ductwork flashings, removing the existing sealants and applying new sealants.

Housing Unit #8 – FCA Building #1481
Description: Typical roof penetration with deteriorated sealants and punctures in the membrane.

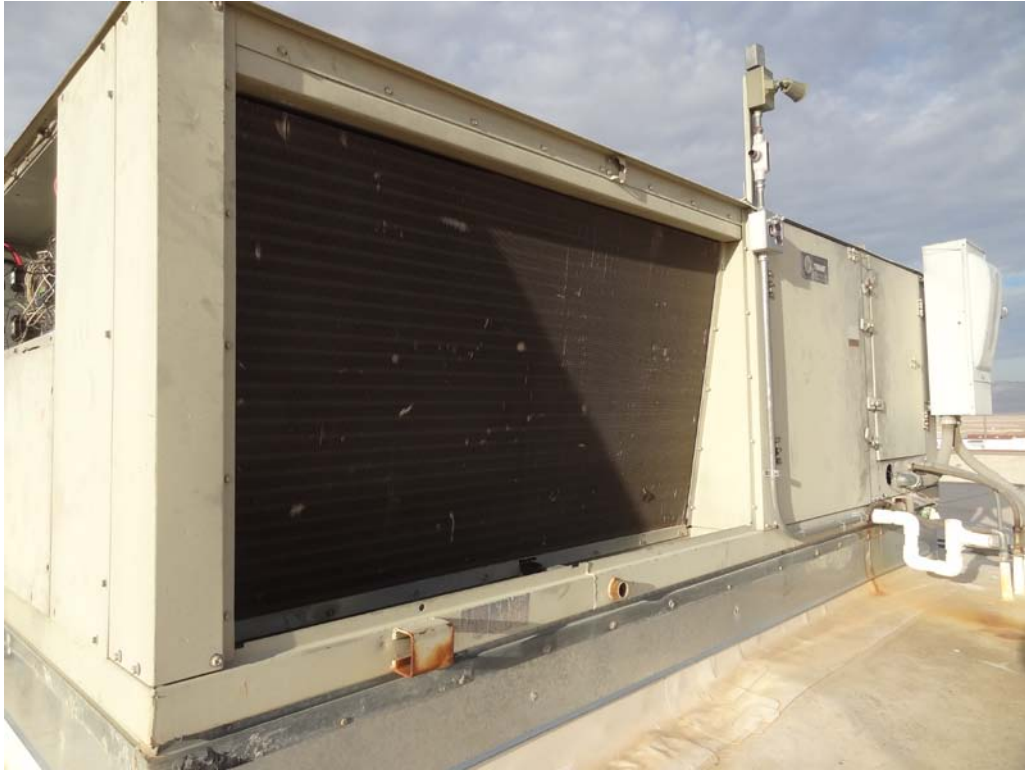
There are 4 rooftop packaged HVAC units that are original to the building and are not energy efficient. The packaged HVAC units have been cannibalized, the heat pump systems have been removed, the air conditioning has been converted to R-22 and the heating has been converted to electric heat strip. The packaged HVAC units have reached the end of their expected and useful life. This project would provide for the installation of three new 20 ton and one new 4 ton packaged HVAC units. Also included in this estimate is new curb adapters, roofing modifications, 100 feet of new condensate line, crane and rigging removal and installation and all required connections to utilities. Additional features to include direct drive, economizer and Direct Digital Controls (DDC).

Housing Unit #8 – FCA Building #1481
Description: 30 year old HVAC equipment.

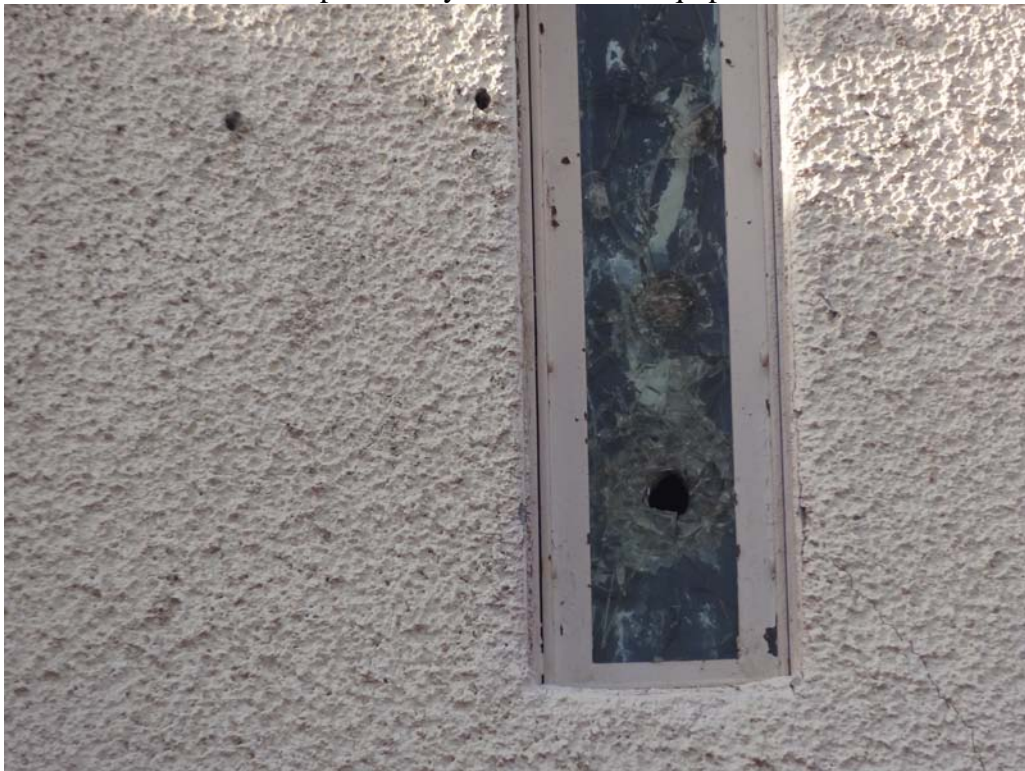
The existing windows in this building are of single pane wire mesh construction. Some are broken and all are not energy efficient. This project would provide for the removal and replacement of the windows with new dual pane security rated windows.

Housing Unit #8 – FCA Building #1481
Description: Typical cell window.

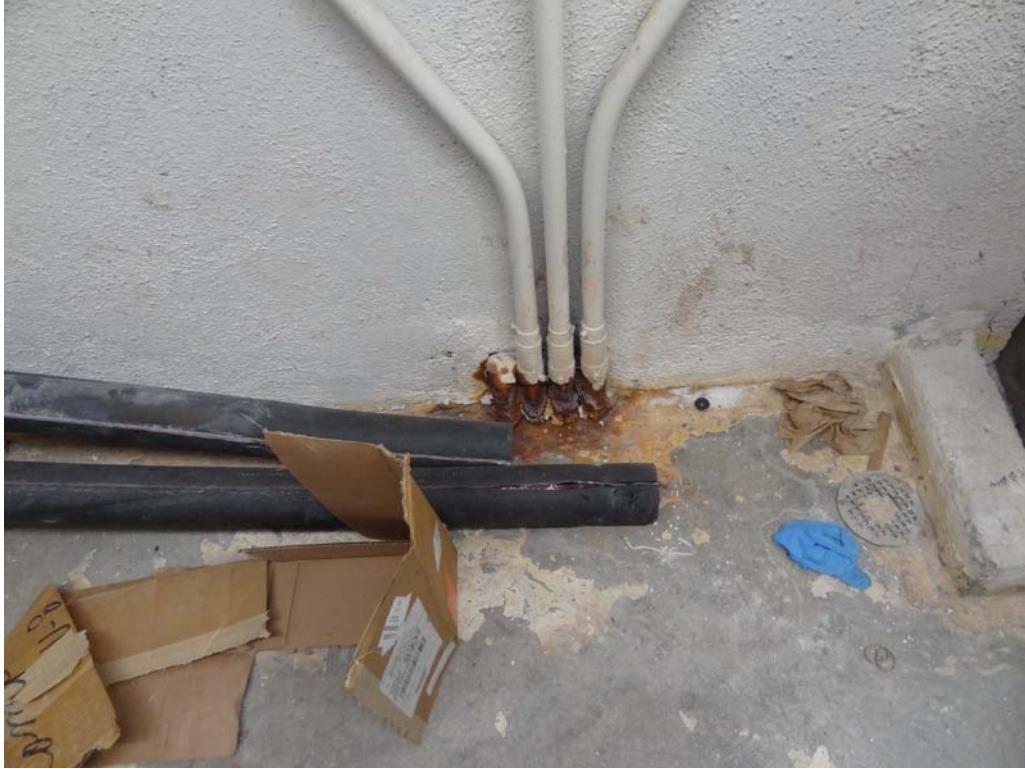
This building was constructed before the high demand for electrical services were needed for security systems, computers and other electrical devices. As time has progressed, the building's electrical demand and system has changed. The electrical panels and receptacles are at their limit. There are also problems with rusting conduits particularly underground conduits. As failures have happened, new conduits have been installed on the interior walls and some are not properly connected. It is recommended the entire system be upgraded to meet the evolving needs of the building and provide safe electrical distribution.

Housing Unit #8 – FCA Building #1481
Description: Rusted electrical conduit in Mechanical Room.

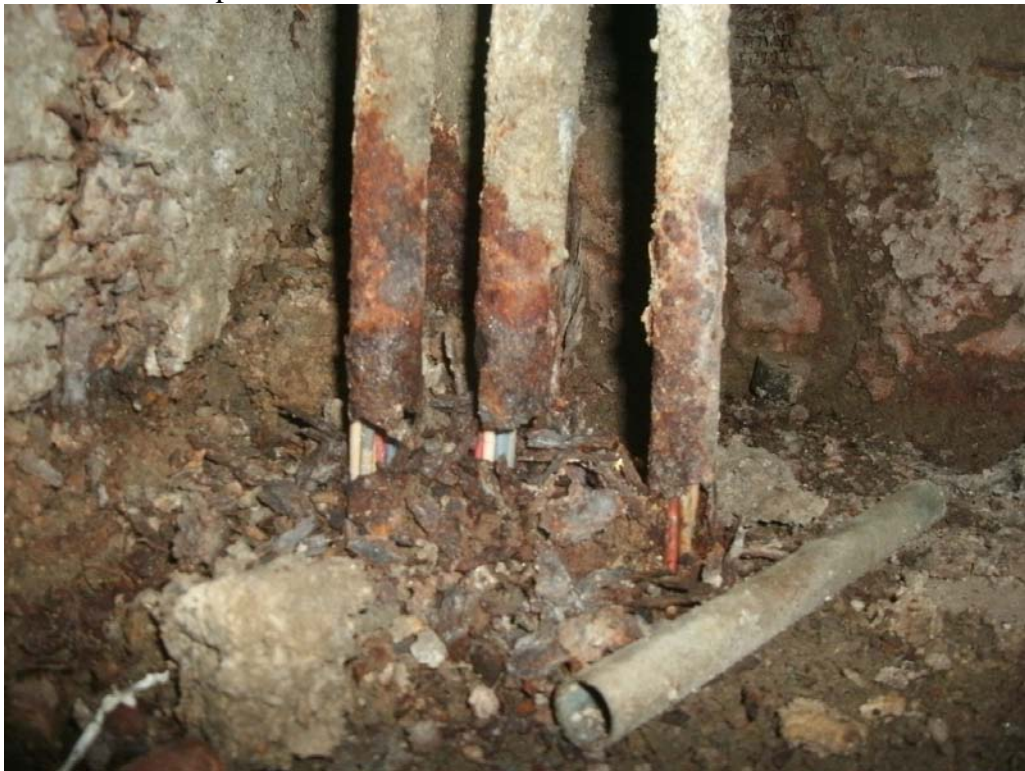
Housing Unit #8 – FCA Building #1481
Description: Rusted electrical conduit in utility chase.

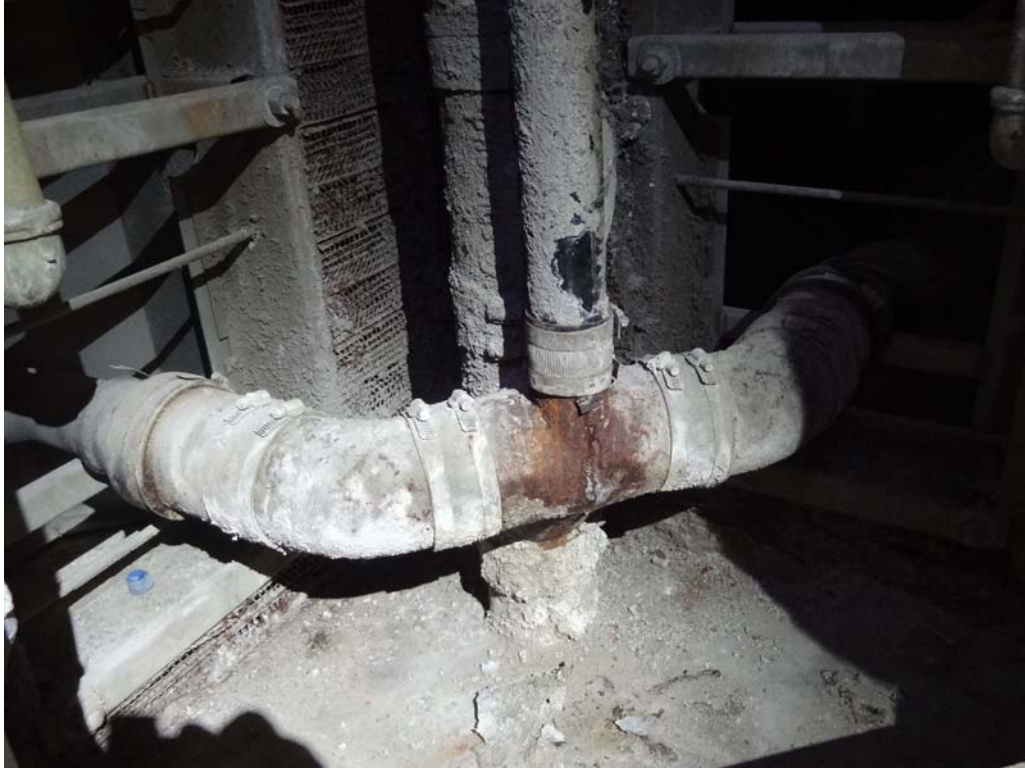
The plumbing and waste system is older and in poor condition. Most of the system appears to be original to the building and should be scheduled for replacement. The sewer lines are rusted and failing especially underground. This project recommends replacing all of the water and sewer lines in the building. This estimate includes removal and disposal of the existing system as required.

Housing Unit #8 – FCA Building #1481
Description: Typical plumbing chase between cells.

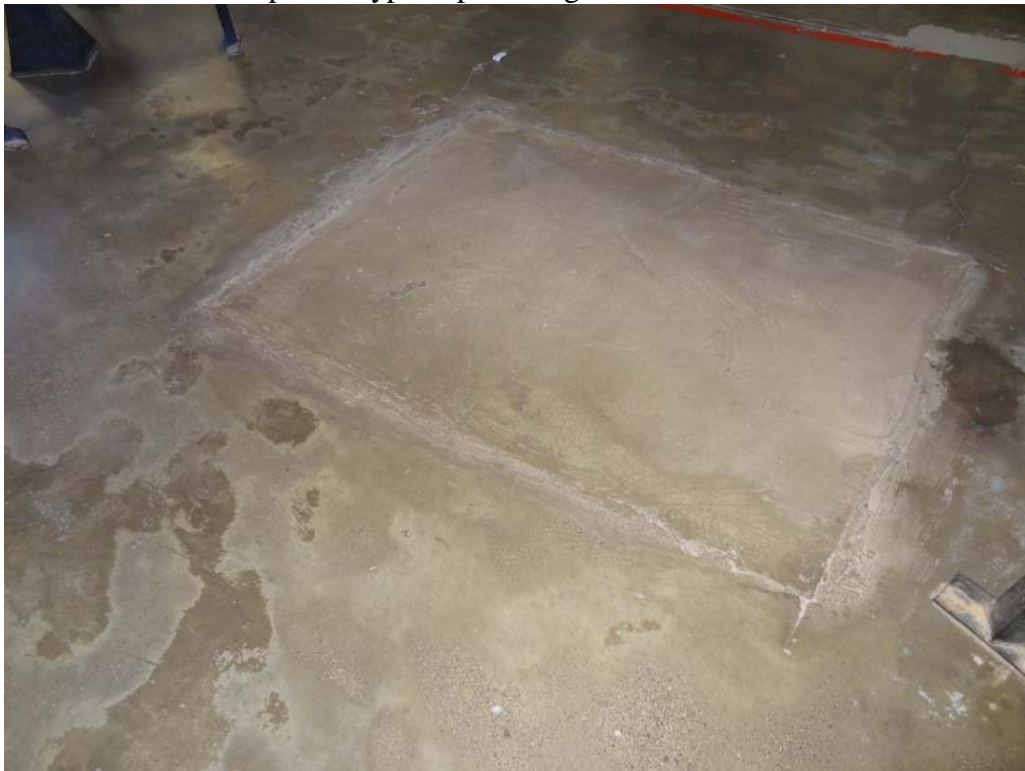
Housing Unit #8 – FCA Building #1481
Description: One of several areas of concrete removal and replacement to access clogged sewer piping.

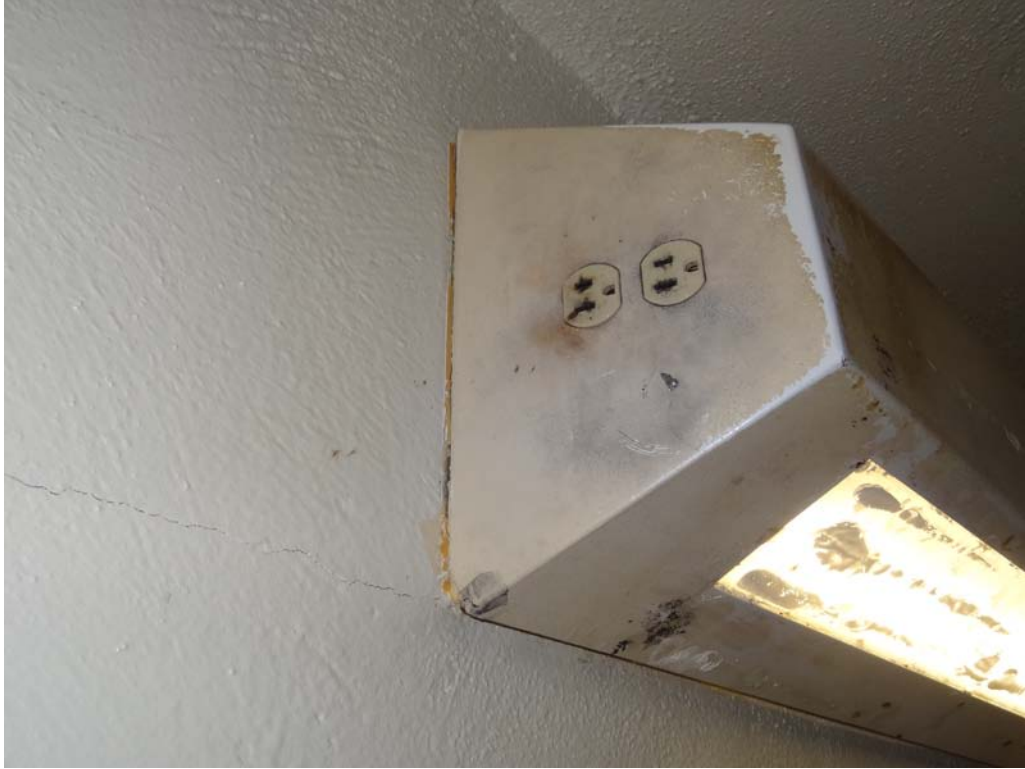
The existing lighting fixtures are the older fluorescent type, and are not energy efficient. This project will upgrade fixtures to higher efficiency units with a longer life cycle. 5,000K LED lamps, without the ballasts, are suggested and new tombstones (if needed). Occupancy sensors will be installed in low occupancy areas for additional savings. Any electrical wiring upgrades are not included in this estimate.

Housing Unit #8 – FCA Building #1481
Description: Typical lighting and electrical in cells.

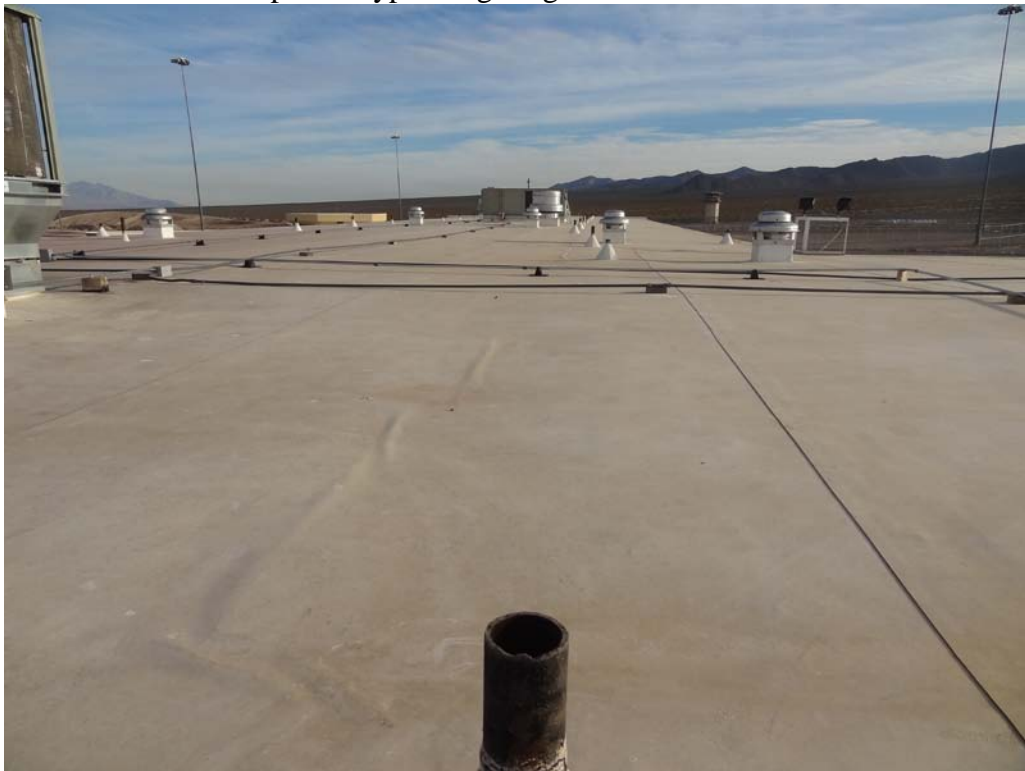
The roof on this building was in fair condition at the time of the survey. The statewide roofing program has set the useful life of an average roof at 20 years. The roof warranty expires on 05/20/2017. The temperature fluctuations throughout the year, consistent wind which blows sand and dirt onto the roof membrane, and constant exposure to the sun are contributing factors to wear and deterioration. The current roofing system was installed in 05/20/2002. It is recommended that this building be re-roofed in the next 4-5 years.

Housing Unit #8 – FCA Building #1481
Description: 14 year old single-ply roof membrane.
