# NAVY OPERATIONAL SUPPORT CENTER SITE

4601 Cocoa Ave.  
Stead, Nevada 89506

**Site Number: 9773**  
**STATE OF NEVADA PUBLIC WORKS DIVISION**  
**FACILITY CONDITION ANALYSIS**

Report distributed in May 2021

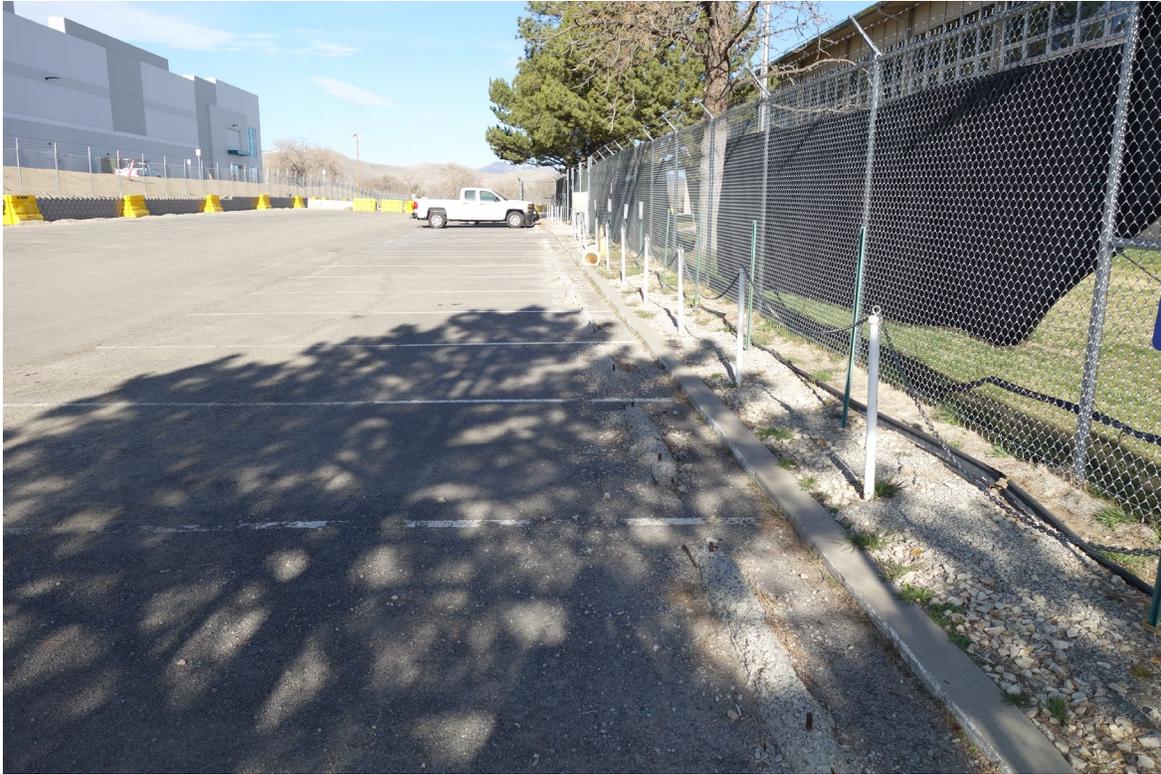
It is important to maintain the asphalt concrete paving on the site. This project would provide for minor replacement of deteriorated paving, minor crack filling, replacement of car curb bumpers, and slurry sealing of the paving site wide. Striping is included in this estimate. This project should be scheduled on a 5 year cyclical basis to maintain the integrity of the paving and prevent premature failure. 20,000 square feet of asphalt area was used to generate this estimate.

Navy Operational Support Center Site – FCA Site #9773  
Description: View of South (Visitor) Parking Lot.

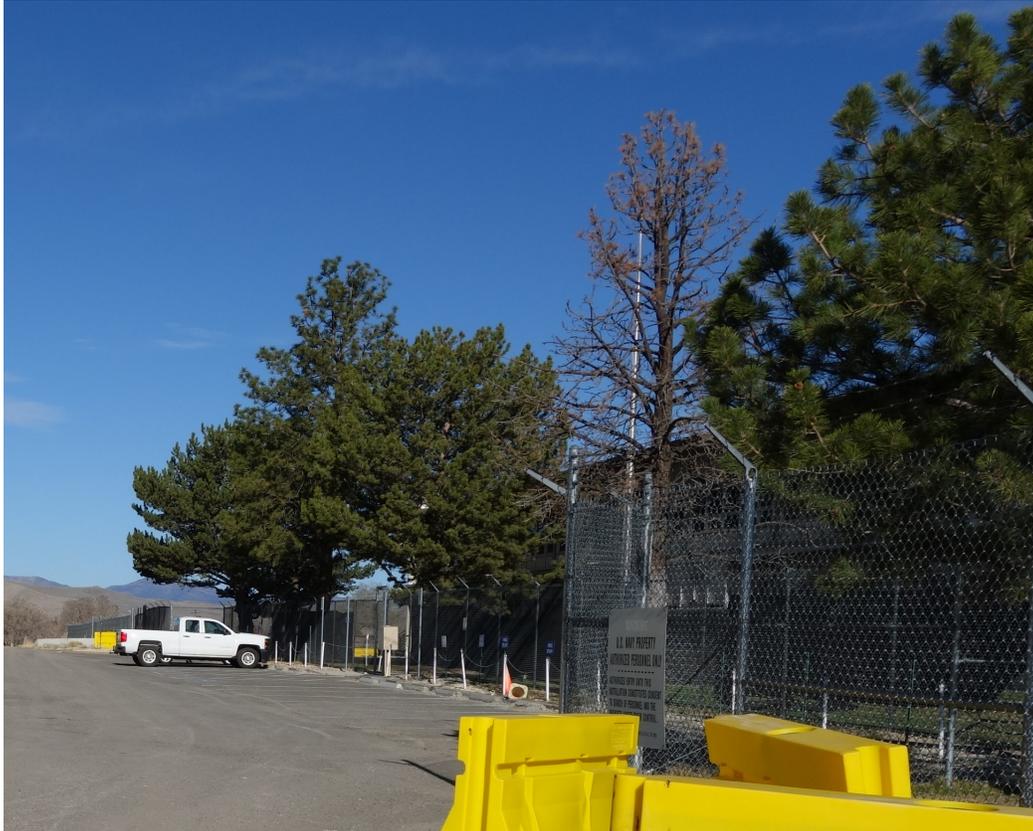
There are two dead trees on the site that are in need of removal. One tree is located near the main building endangering the building and any personnel if it falls. This project would provide for the removal of both trees and the restoration of the landscaping to match the surroundings.

Navy Operational Support Center Site – FCA Site #9773  
Description: Tree Removal Needed at Main (Visitor) Entrance.

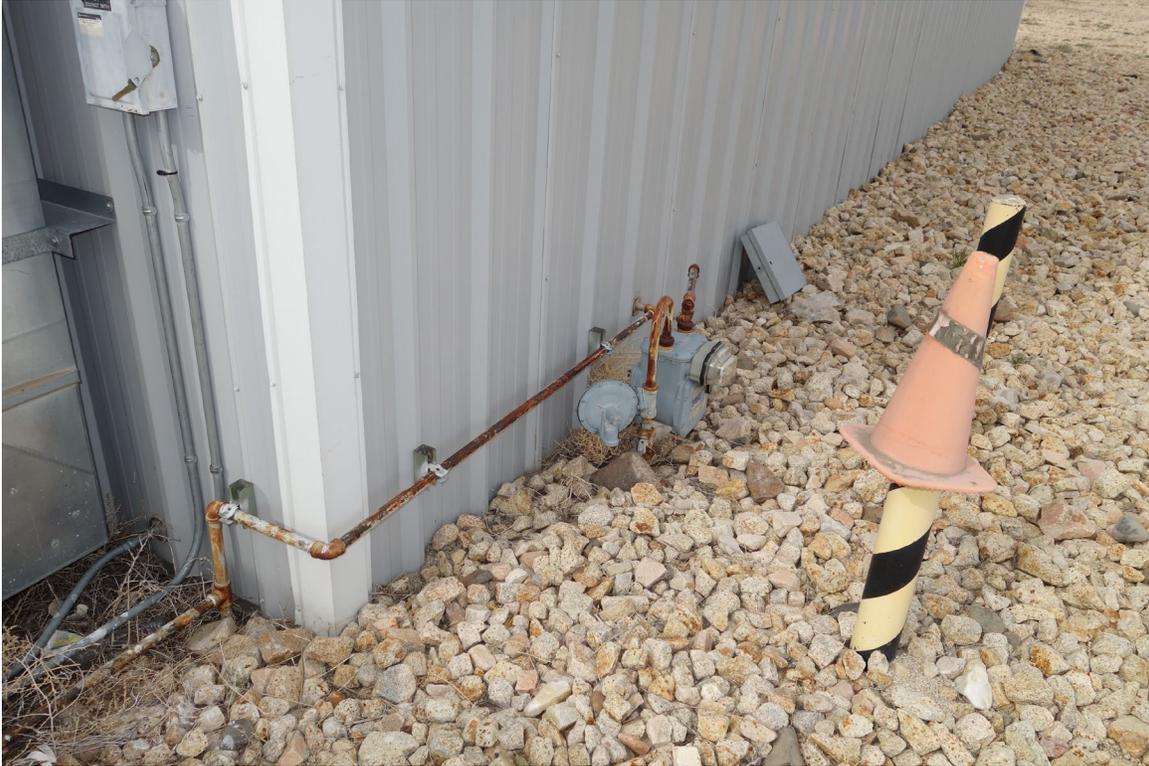
This project would provide for the installation of a seismic gas shut-off valve on the main gas service piping prior to entering the building. Alternately, for propane services, consider installation at the tank if the tank feeds multiple buildings. This estimate is based on the manufacturer Pacific Seismic Products or approved equal, equipped with the optional Model MS remote monitoring switch (to be interfaced with the direct digital control system and/or with an audible alarm). The gas piping immediately adjacent to the seismic gas valve shall be secured to the building utilizing unistrut channel bracing.

Boat House – FCA Building #4174  
Description: Seismic Gas Shut-Off Installation.

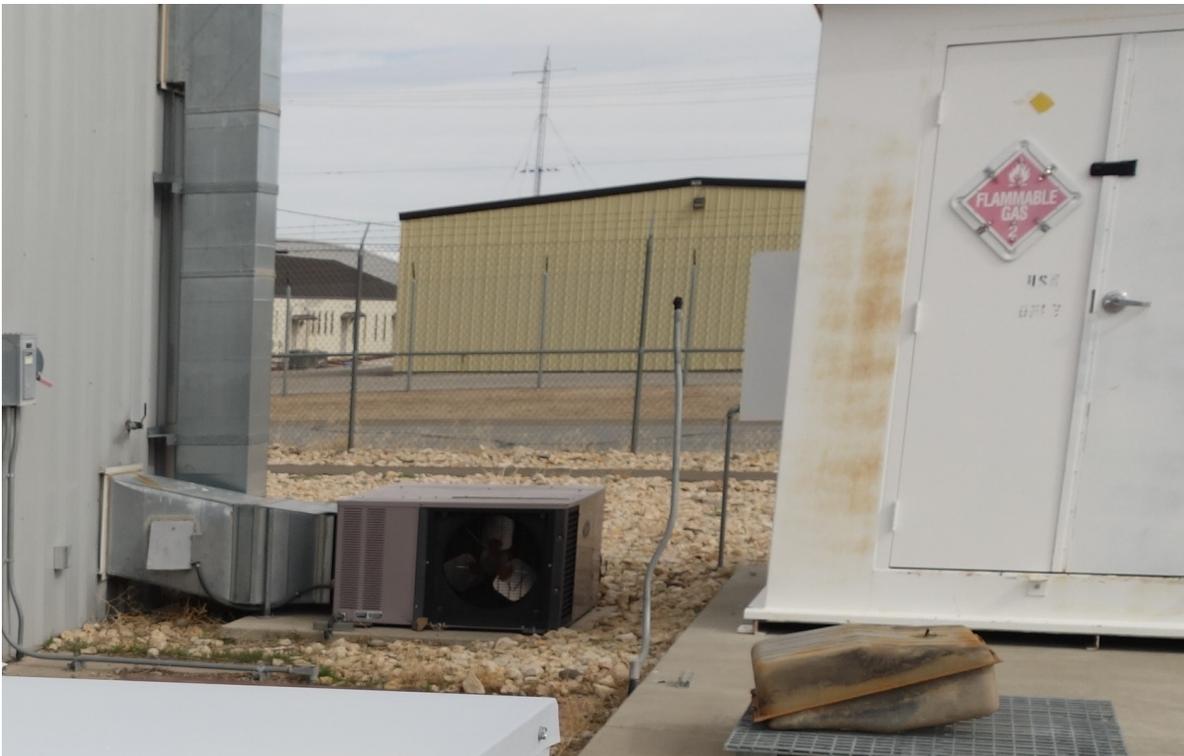
The HVAC system is original to the building and should be scheduled for replacement. It is not energy efficient and has reached the end of its expected and useful life. The R-22 refrigerant in the cooling system is no longer EPA compliant and its production is mandated to be phased out completely by January 1, 2020. This project would provide for installation of a new HVAC system and cleaning of the existing duct work and grilles. This project includes removal and disposal of the existing HVAC system and all required connections to utilities.

Boat House – FCA Building #4174  
Description: HVAC Equipment Replacement.

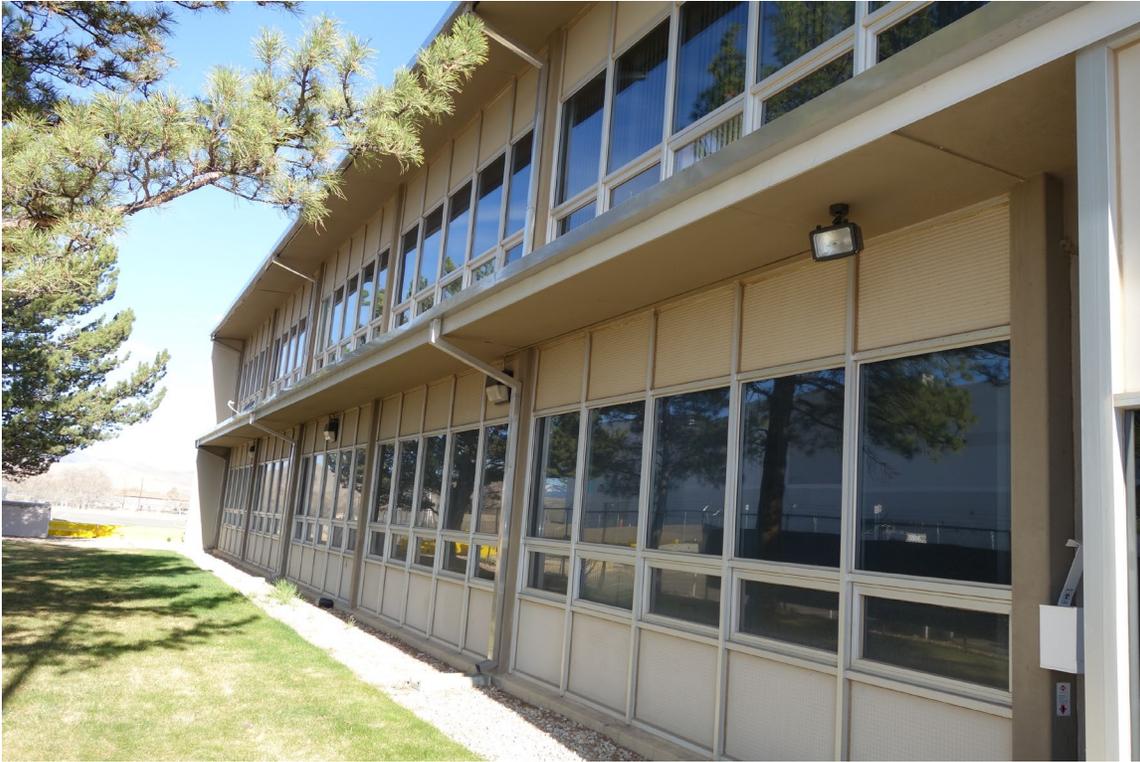
A visual survey of the building exterior's glazed curtain walls show the majority are original to the building and are non-thermally broken. The age of the system creates significant paths for infiltration, leaks, and energy loss. A portion of the system on the northwest side has been replaced and is in good condition. This project recommends the removal and replacement of the original curtain wall system with a new wall system with much higher thermal insulation. Demolition and disposal of the existing curtain wall is included in this estimate. 3,800 square feet of wall area was used for this estimate.

Navy Operational Support Center – FCA Building #4173  
Description: View of Glazed Curtain Wall on South Side of Building.

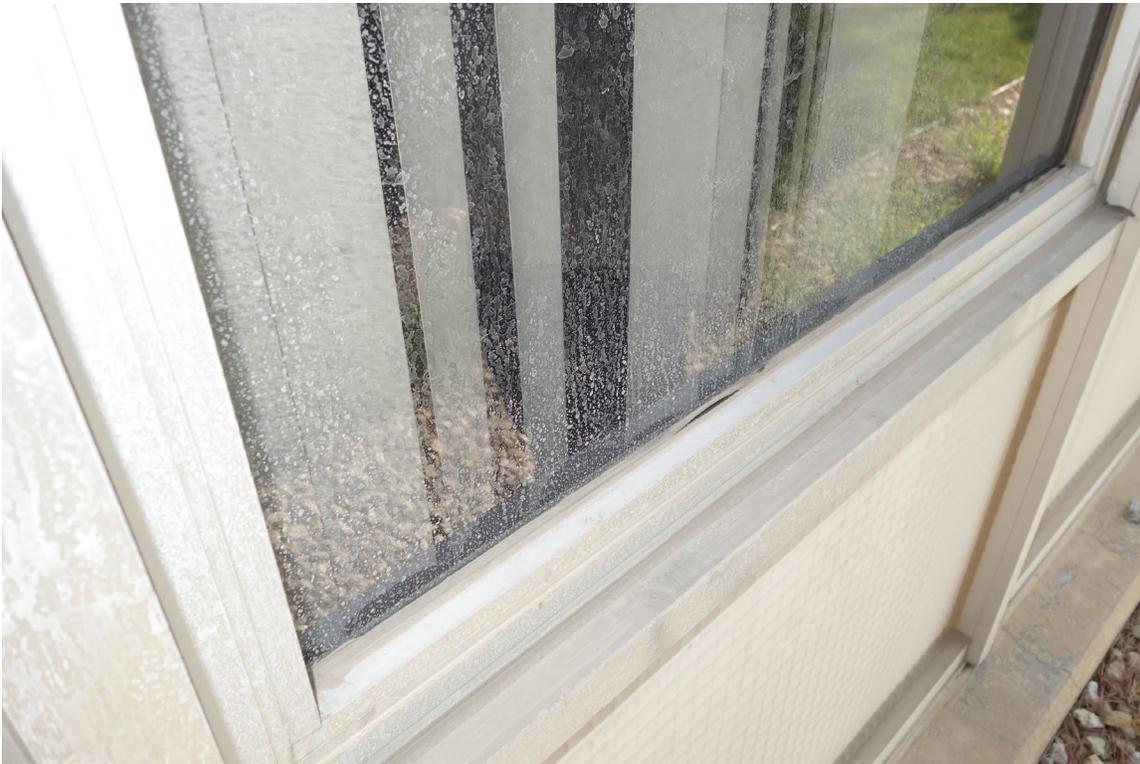
Navy Operational Support Center – FCA Building #4173  
Description: View of Curtain Wall Failed Window Seals.

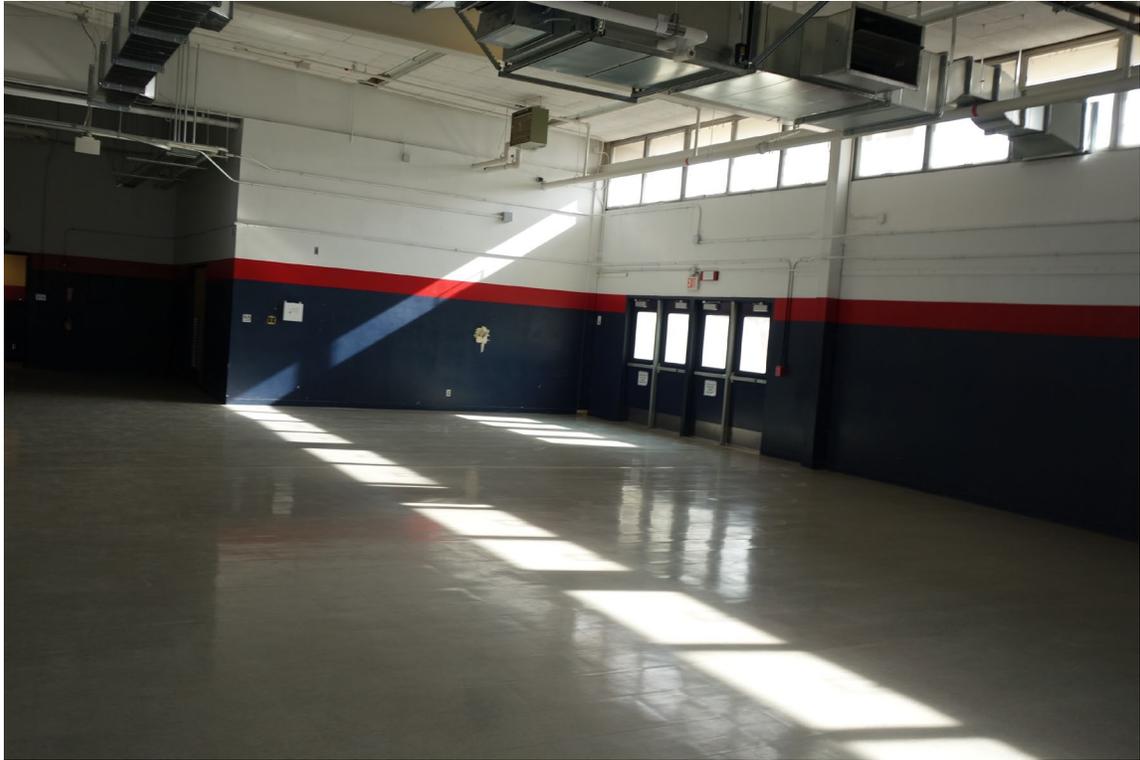
The interior finishes are in fair condition. It is recommended to paint the interior walls and ceilings at least once in the next 4 - 5 years and that this project be scheduled on a cyclical basis to maintain the integrity of the structure. Prior to painting, all surfaces should be repaired and prepped. An epoxy-based paint should be utilized in wet areas for durability.

Navy Operational Support Center – FCA Building #4173  
Description: View of Interior Finishes of the Drill Hall.

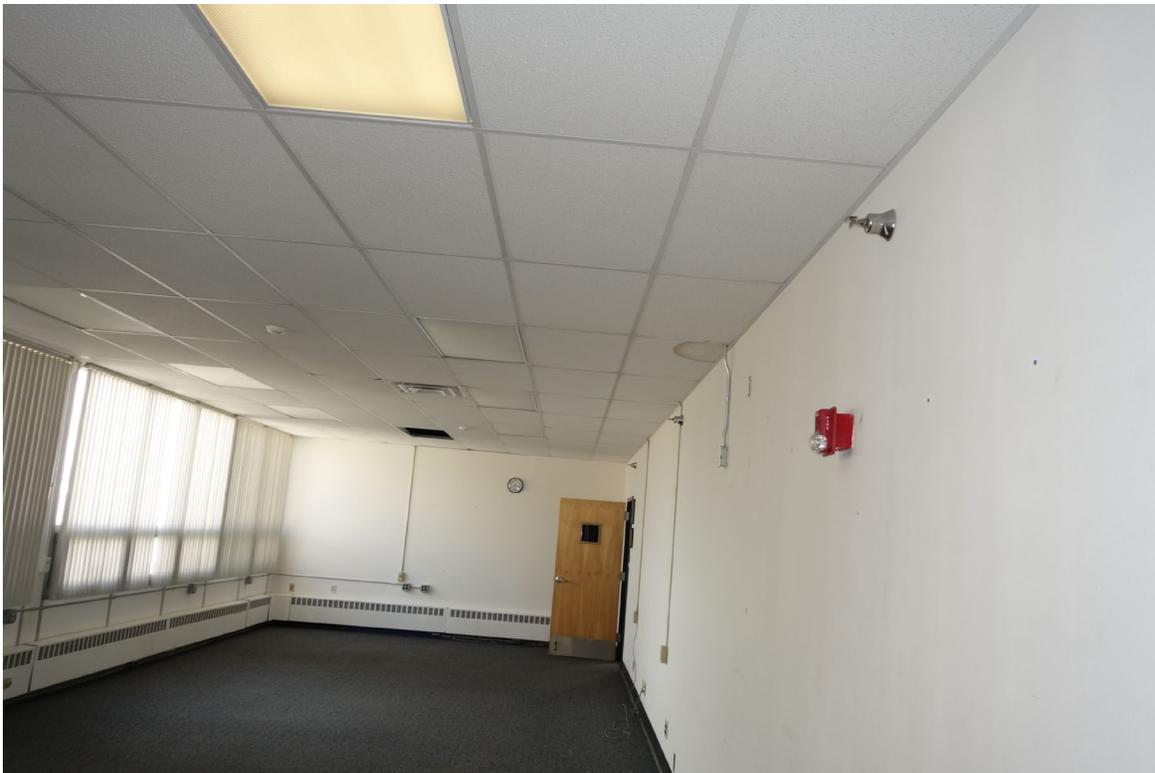
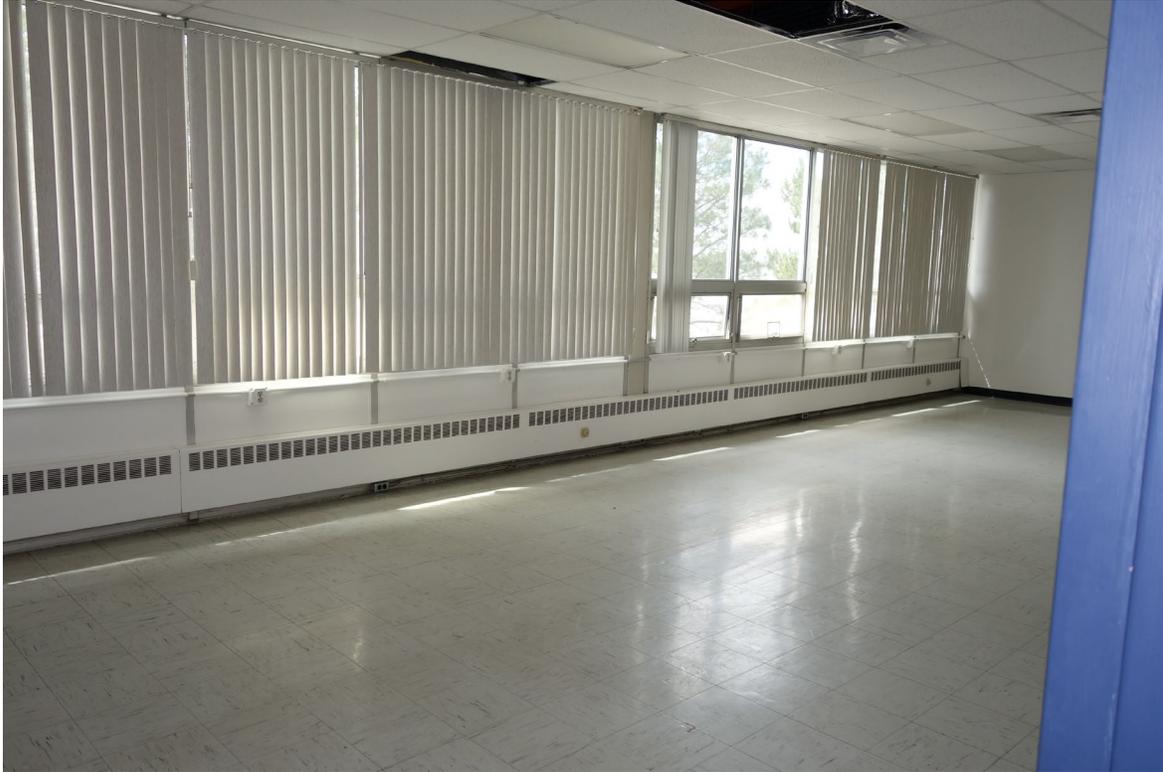
A visual survey of the HVAC system indicates that it is not adequate to meet the needs of the future occupants. The hydronic baseboard system was removed in some locations (northwest 2 story section) without a visible means to heat this space. The balance of the baseboards are currently disabled due to the boiler being inoperable (boiler replacement under a separate project). The Direct Expansion (DX) cooled Air Handling Unit (AHU) in Room 205 appears disabled due to missing condensing unit and ductwork. In addition a 50 ton cooling only packaged unit contains R-22 refrigerant which is no longer EPA compliant and its production ceased January 1, 2020. The balance of the building is conditioned by hydronic unit heaters and 4 air cooled heat pumps ranging from 2 - 8 nominal tons. There is no Building Automation System (BAS). The project recommends a complete retrofit of the building's HVAC system that is energy efficient, will increase comfort, and meets the needs of the future occupants.

Navy Operational Support Center – FCA Building #4173  
Description: View of Interior Office Space and Baseboard Heating System.

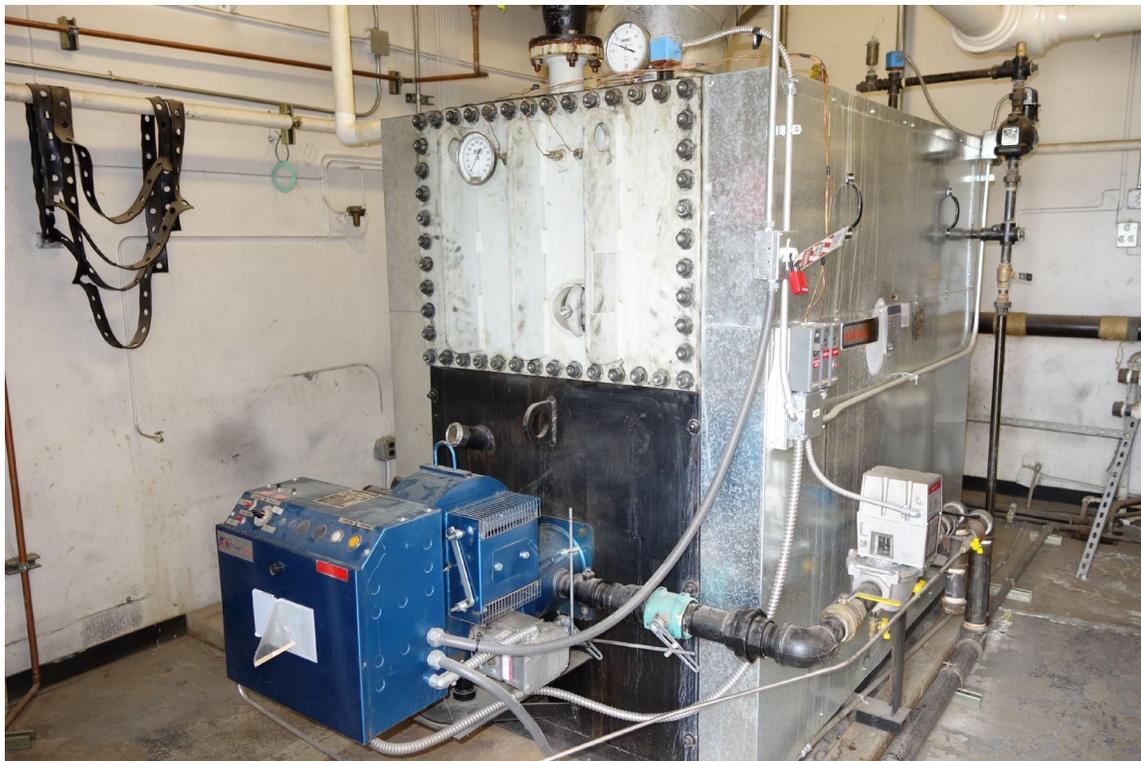
The single boiler appears to be original to the building, is currently inoperable, and has reached the end of its useful life. In addition, the boiler manufacturer, Ajax Boiler Inc., is no longer in business. This project will replace the existing gas-fired boiler with redundant boilers. The scope of work also includes replacing the existing heating water pumps, accessories, boiler room piping, and associated controls. Removal and disposal are included in this estimate.

Navy Operational Support Center – FCA Building #4173  
Description: Recommended Boiler (Inoperable) Replacement.

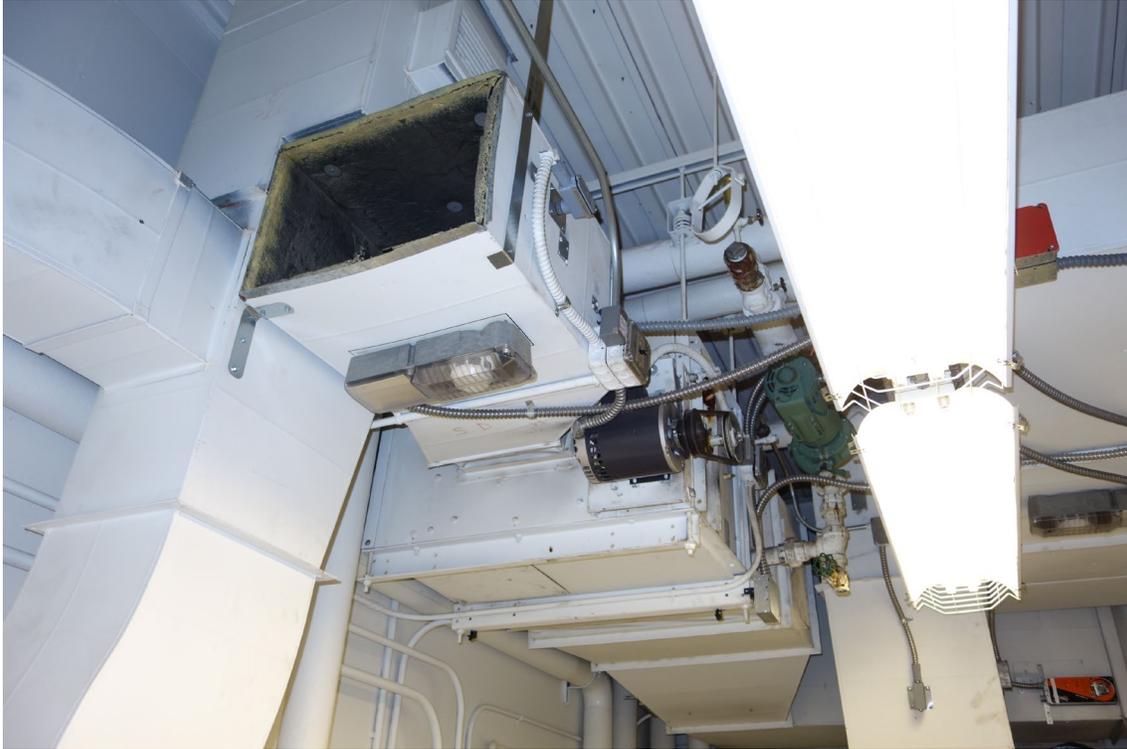
Navy Operational Support Center – FCA Building #4173  
Description: Recommended HVAC Retrofit.

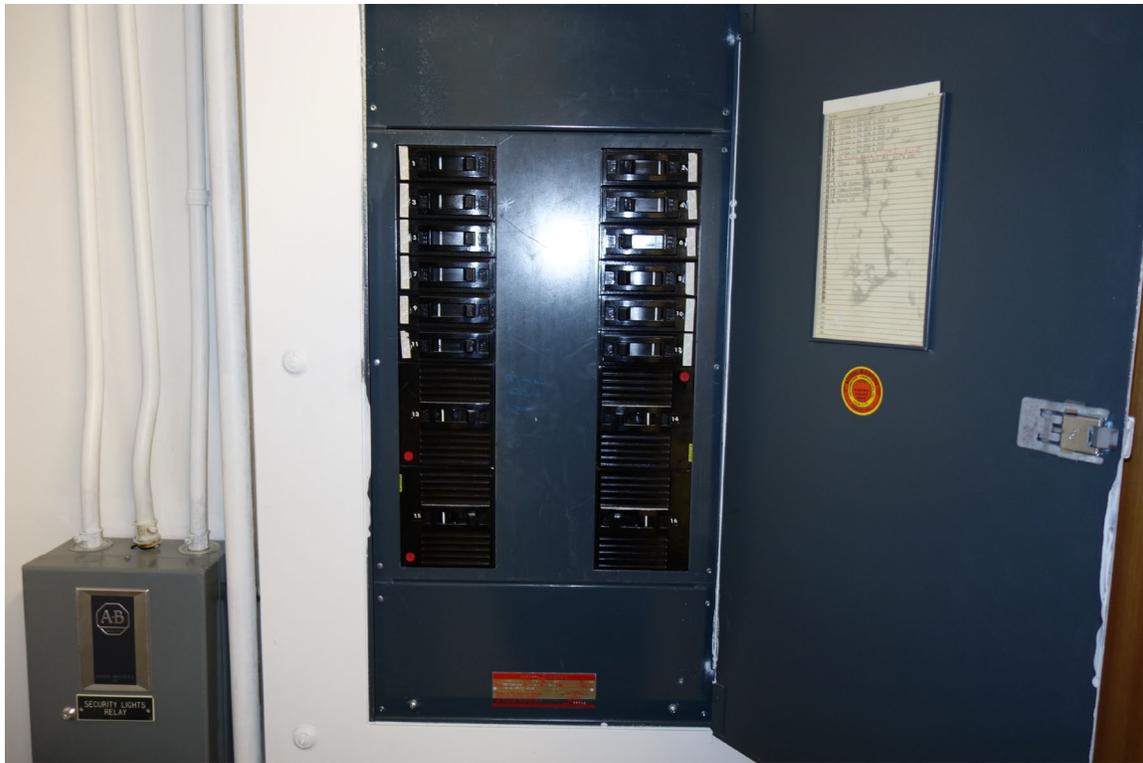
This building was constructed before the requirements for NEC 70e electrical Arc Flash Assessments. As a consequence, the original subpanels, distribution boards and breakers are not labeled with Ampere Interrupting Current (AIC Rating). In order to comply with the NEC 70e requirements, it is recommended that the original electrical equipment be replaced with new equipment to facilitate the required Breaker Coordination and Arc Flash studies. Removal and disposal of the existing equipment is included in this project.

Navy Operational Support Center – FCA Building #4173  
Description: Recommended Electrical Upgrade.
