WALKER RIVER SRA FLYING M SITE

70 Pine Grove Road
Yerington, NV 89447

Site Number: 9873
STATE OF NEVADA PUBLIC WORKS DIVISION
FACILITY CONDITION ANALYSIS

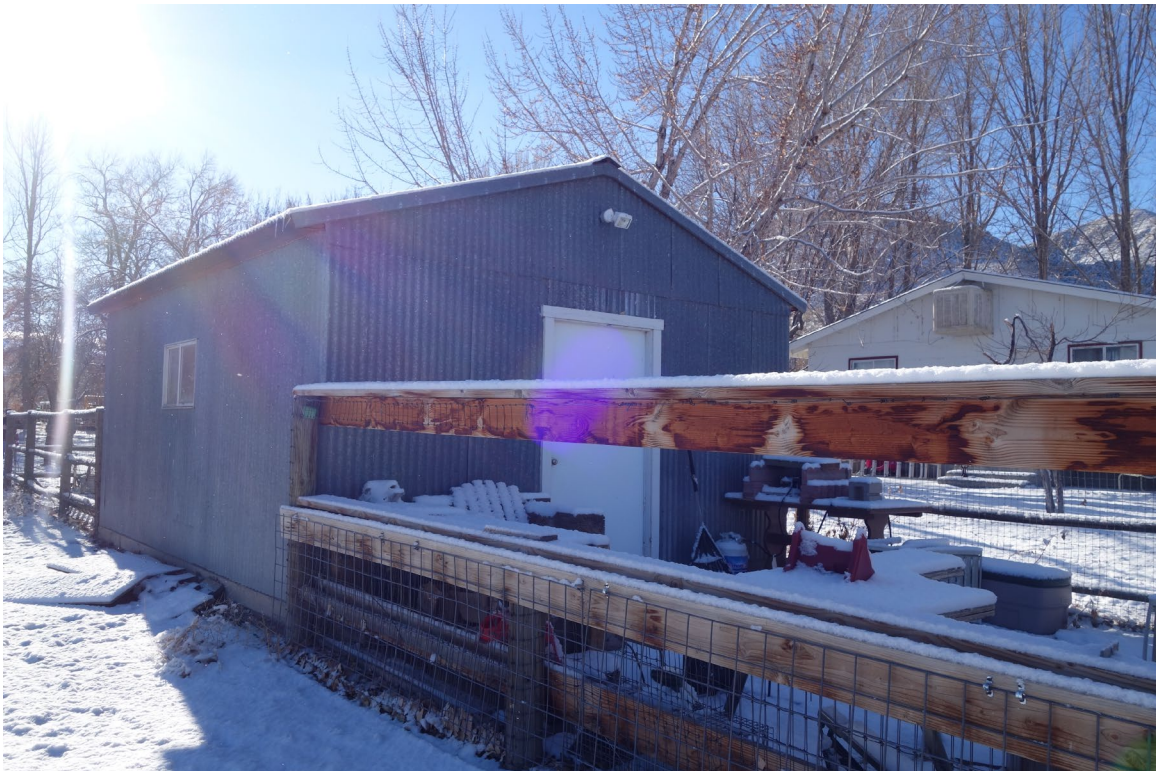
Morgan Main House Shed - FCA Building #4139
Description: Exterior of the Building.

It is important to maintain the finish, weather resistance and appearance of the building. This project would provide funding to protect the exterior of the building excluding the roof. Included in the cost is the caulking and sealing of the windows, flashing, fixtures and all other penetrations. It is recommended that the building be caulked and sealed in the next 7 - 9 years and that this project be scheduled on a cyclical basis to maintain the integrity of the structure.

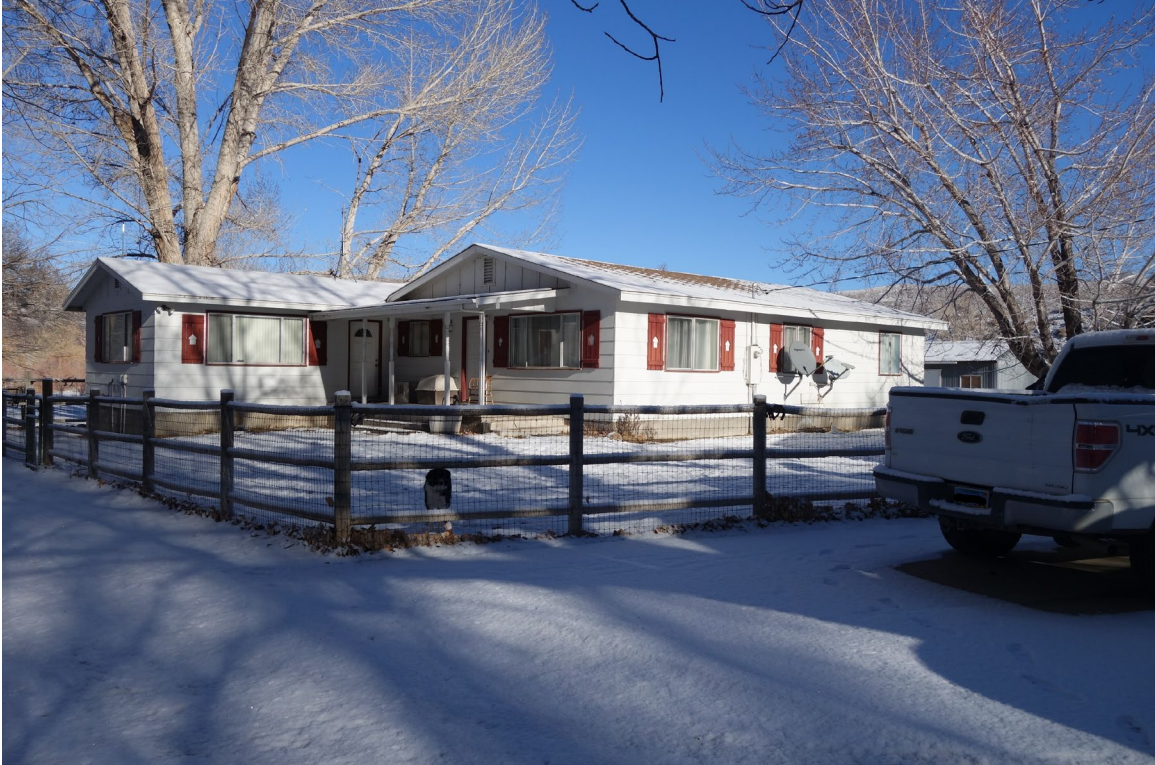
Morgan Main House - FCA Building #4138
Description: Exterior of the Building.

The exterior finishes were in good condition. It is important to maintain the finish, weather resistance and appearance of the building. This project would provide funding to protect the exterior of the building excluding the roof. Included in the cost is sanding, priming and painting and caulking of the windows, flashing, fixtures and all other penetrations. It is recommended that the building be painted in the next 7 - 9 years and that this project be scheduled on a cyclical basis to maintain the integrity of the structure.

The existing roof was installed in 1990 and has no reported leaks. The asphalt composition shingle roof on this building was in fair condition at the time of the survey. It is recommended that this building be re-roofed in the next 6 - 8 years with a new 50 year asphalt composition roofing shingle and new underlayment. This estimate includes replacement of existing gutters, removal and disposal of the old roofing system.

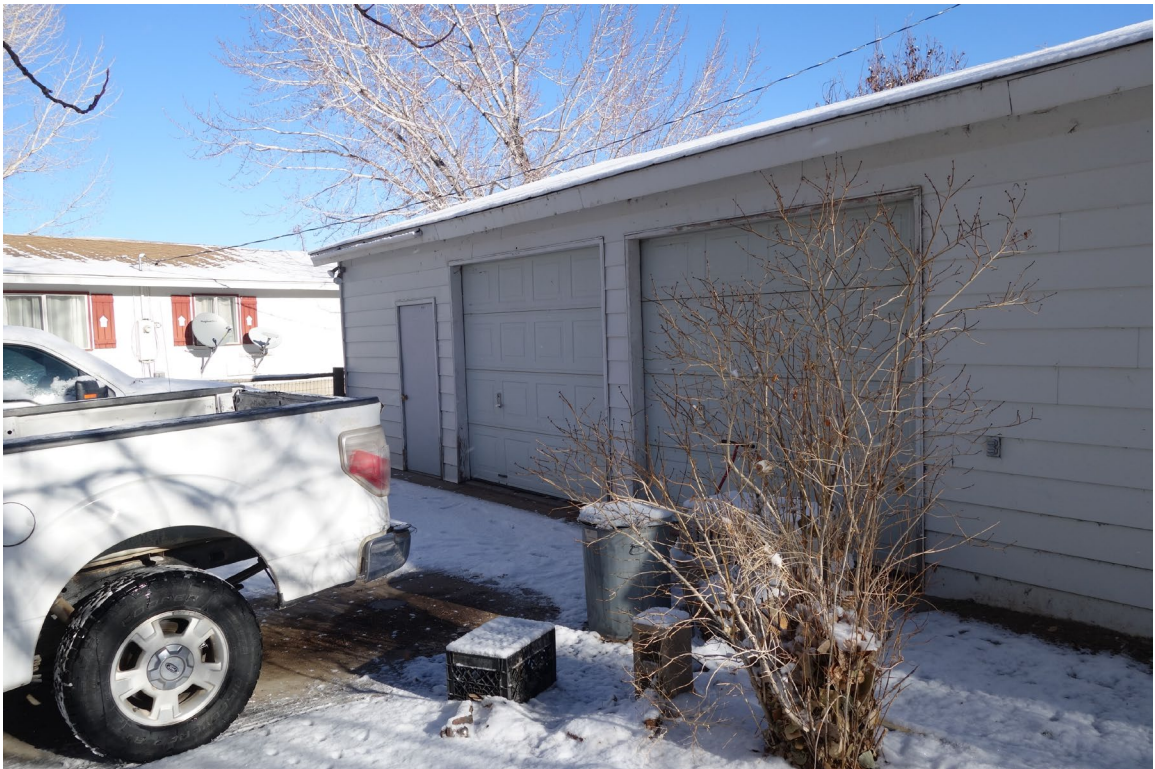
Morgan Garage - FCA Building #4137
Description: Exterior of the Building.

The exterior finishes were in fair condition except the trim around entry points which need re-finishing. It is important to maintain the finish, weather resistance and appearance of the building. This project would provide funding to protect the exterior of the building excluding the roof. Included in the cost is sanding, priming and painting and caulking of the windows, flashing, fixtures and all other penetrations. It is recommended that the building be painted in the next 4 - 5 years and that this project be scheduled on a cyclical basis to maintain the integrity of the structure.

The existing roof was installed in 1990 and has no reported leaks. The asphalt composition shingle roof on this building was in fair condition at the time of the survey. It is recommended that this building be re-roofed in the next 6 - 8 years with a new 50 year asphalt composition roofing shingle and new underlayment. This estimate includes replacement of existing gutters, removal and disposal of the old roofing system.

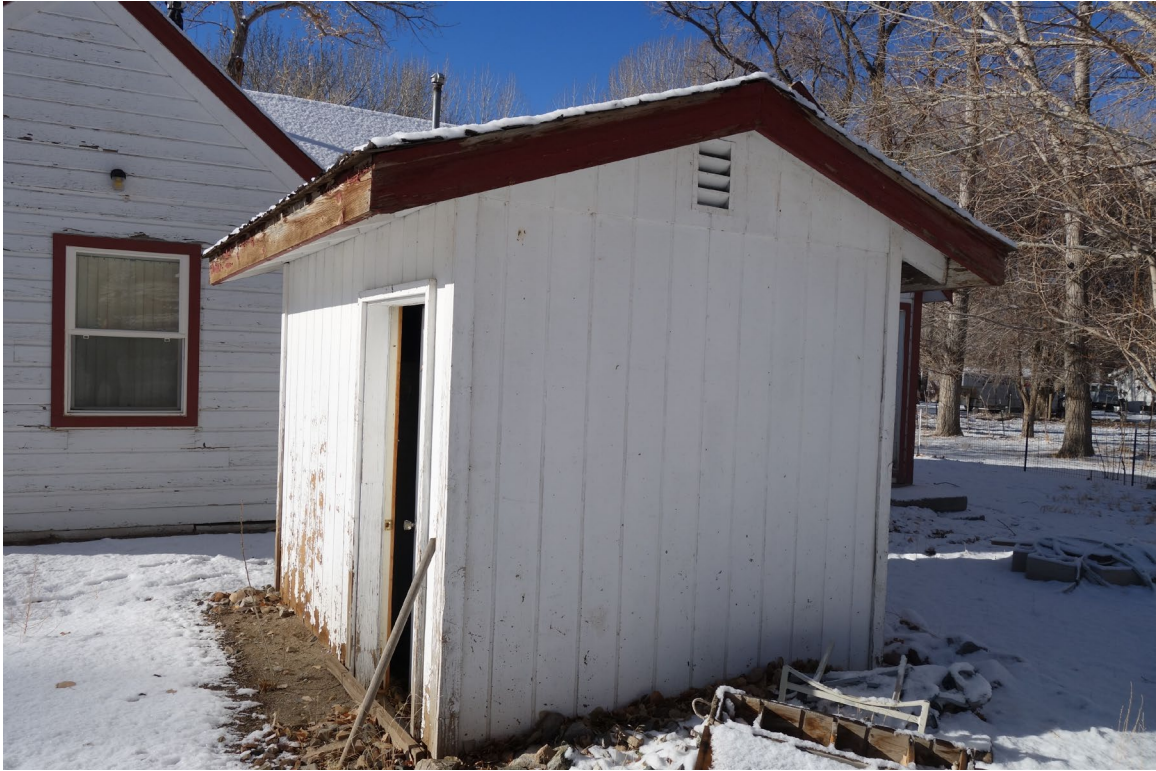
Old Morgan Pumphouse - FCA Building #4136
Description: Exterior of the Building.

The building has grade soils in direct contact with the exterior wood siding. Code (IBC 2018 Section 2304.12) requires a minimum of 6" clearance between wood siding and earth to prevent decay and termite infestations. This project provides for the removal of excess soils, regrading to ensure the proper slope away from the building.

The exterior finishes were in poor condition. It is important to maintain the finish, weather resistance and appearance of the building. This project would provide funding to protect the exterior of the building excluding the roof. Included in the cost is sanding, priming and painting and caulking of the windows, flashing, fixtures and all other penetrations. It is recommended that the building be painted in the next 2 - 3 years and that this project be scheduled on a cyclical basis to maintain the integrity of the structure.

The existing roof was installed in 1990 and has no reported leaks. The asphalt composition shingle roof on this building was in fair condition at the time of the survey. It is recommended that this building be re-roofed in the next 6 - 8 years with a new 50 year asphalt composition roofing shingle and new underlayment. This estimate includes replacement of existing gutters, removal and disposal of the old roofing system.

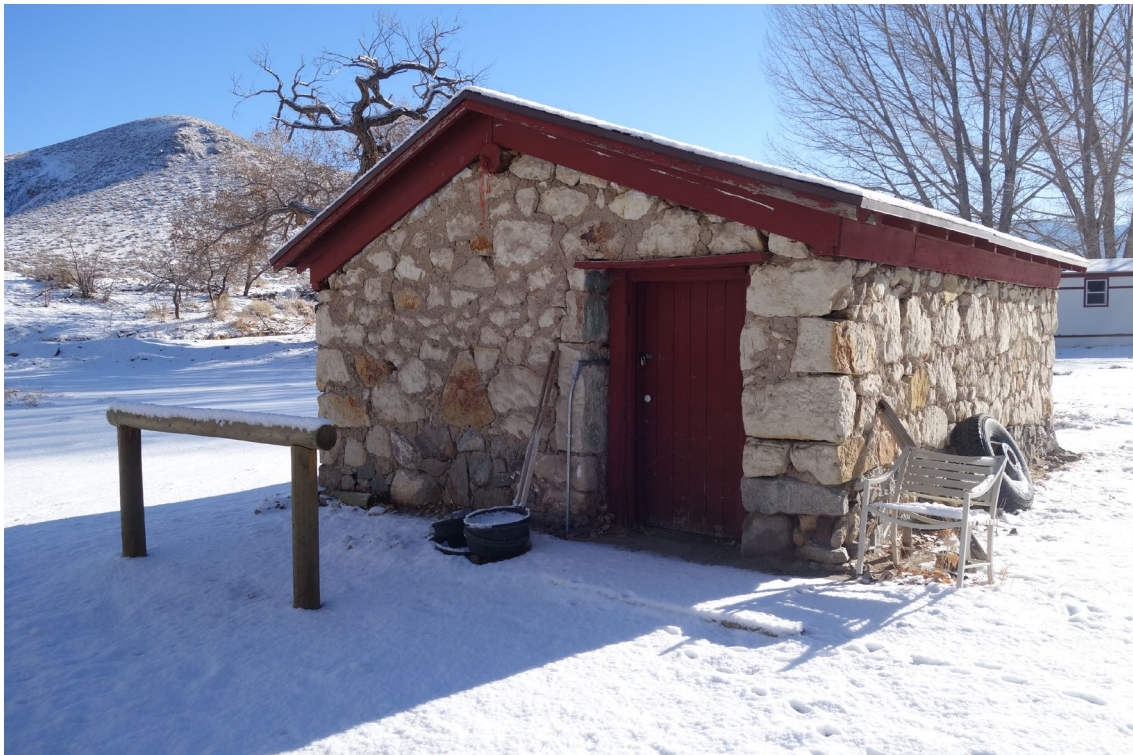
Morgan Saddle Shed - FCA Building #4135
Description: Exterior of the Building.

The Morgan Saddle Shed is an unreinforced masonry building with a wood framed roof and asphalt shingles. A visual inspection shows multiple cracks in the mortar joints that may affect the structural integrity of the building. The building is located south of the Old Morgan Residence.

The structure is made of unreinforced stone masonry. It is likely over 100 years old and there are areas where the mortar is failing, missing and not sealed properly. This project would provide for the cleaning, repair and re-pointing of the stone work and maintaining the structure. This project should be coordinated with the Nevada State Historical Preservation Office for possible restrictions or requirements which are not included in this estimate. It is recommended that the work be done in the next 2 - 3 years and that this project be scheduled on a cyclical basis to maintain the integrity of the structure.

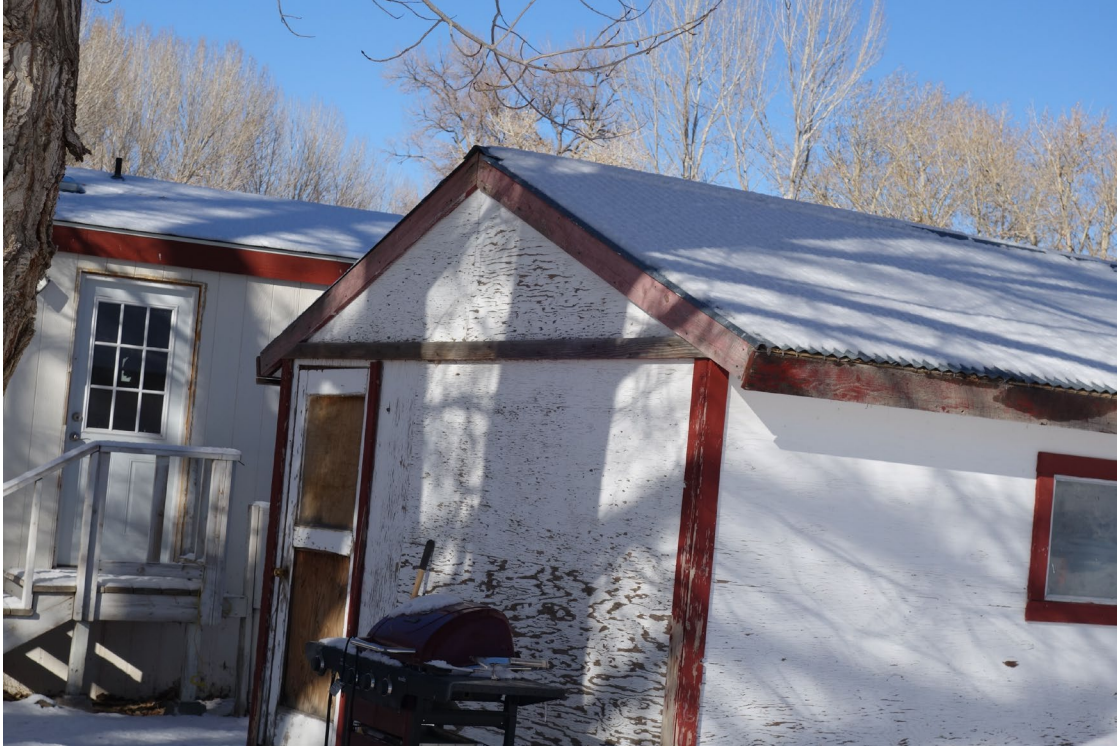
Morgan Singlewide Shed - FCA Building #4134
Description: Exterior of the Building.

The building has grade soils in direct contact with the exterior wood siding. Code (IBC 2018 Section 2304.12) requires a minimum of 6" clearance between wood siding and earth to prevent decay and termite infestations. This project provides for the removal of excess soils, regrading to ensure the proper slope away from the building.

The exterior finishes were in poor condition. It is important to maintain the finish, weather resistance and appearance of the building. This project would provide funding to protect the exterior of the building excluding the roof. Included in the cost is sanding, priming and painting and caulking of the windows, flashing, fixtures and all other penetrations. It is recommended that the building be painted in the next 2 - 3 years and that this project be scheduled on a cyclical basis to maintain the integrity of the structure.

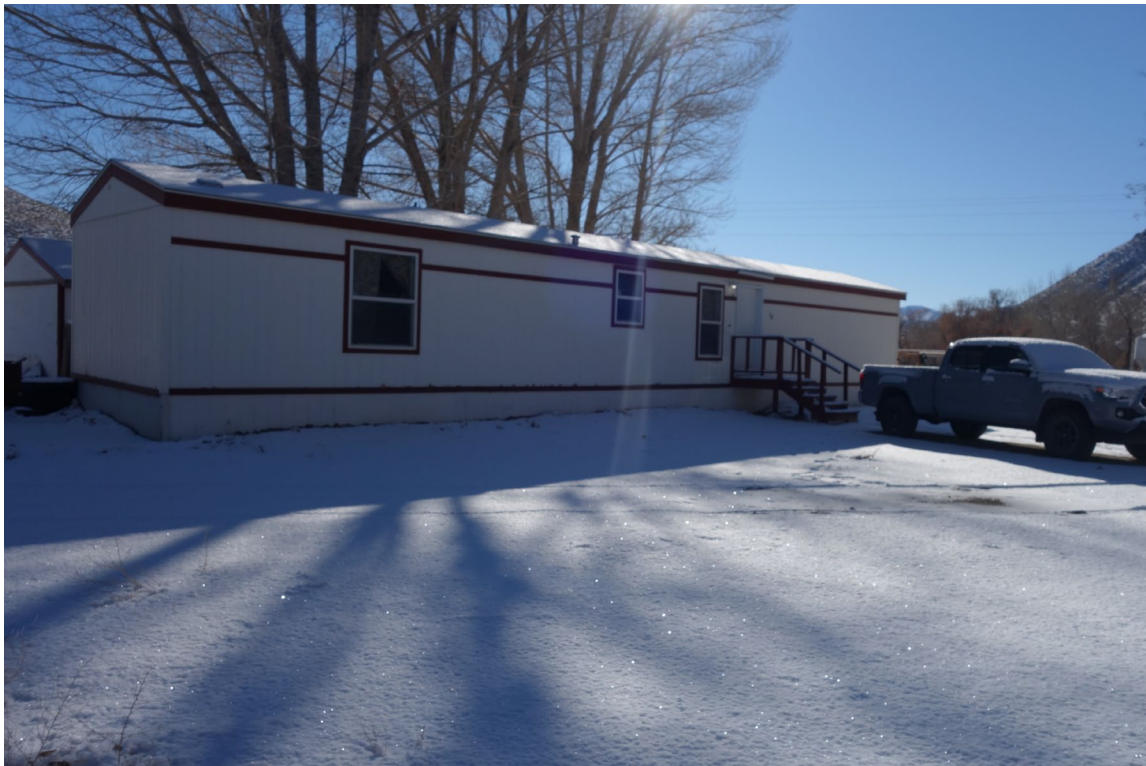
Morgan Singlewide Residence - FCA Building #4133
Description: Exterior of the Building.

The building has grade soils in direct contact with the exterior wood skirting. Code (IBC 2018 Section 2304.12) requires a minimum of 6" clearance between wood siding and earth to prevent decay and termite infestations. This project provides for the removal of excess soils, regrading to ensure the proper slope away from the building.

The exterior finishes were in fair condition. It is important to maintain the finish, weather resistance and appearance of the building. This project would provide funding to protect the exterior of the building excluding the roof. Included in the cost is sanding, priming and painting and caulking of the windows, flashing, fixtures and all other penetrations. It is recommended that the building be painted in the next 4 - 6 years and that this project be scheduled on a cyclical basis to maintain the integrity of the structure.

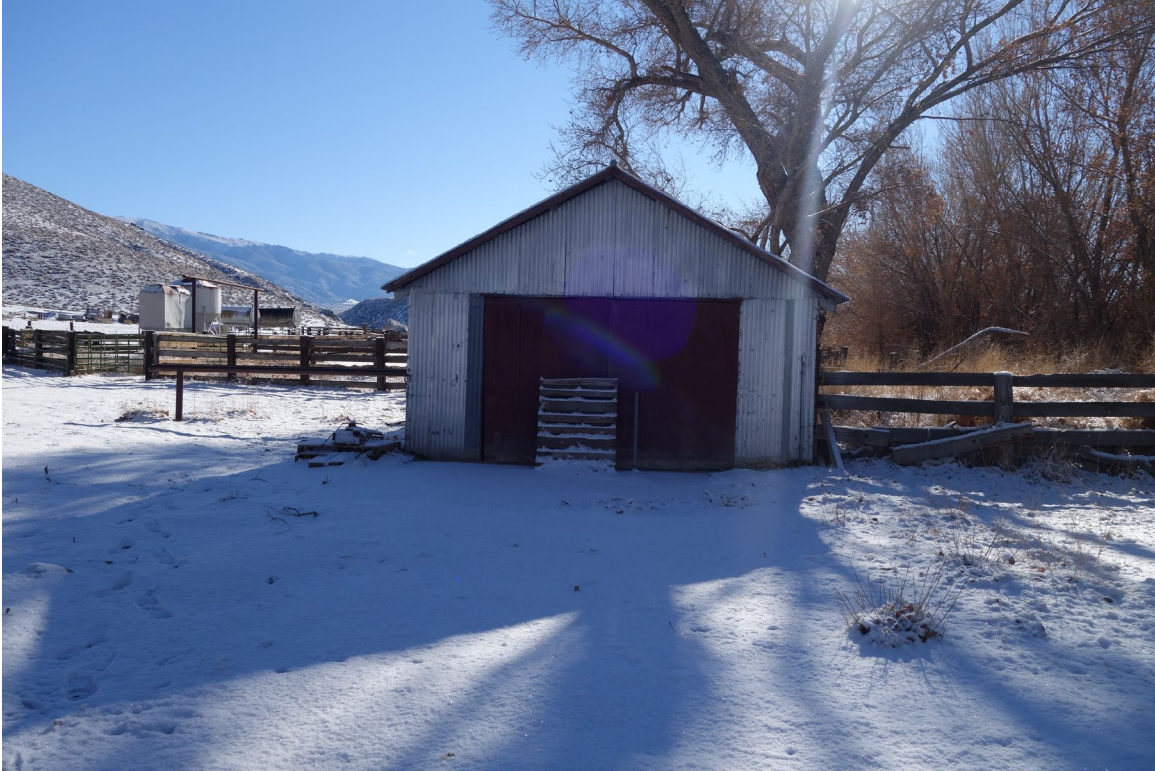
Morgan Barn / Shed - FCA Building #4132
Description: Exterior of the Building.

The building has significant weed and debris buildup and are a fuel source for fire. Accumulated leaves at the base of structures create a significant fuel path to structure fires during wild land fire events. This project would provide for the removal and disposal of the weeds and debris around the structure site. Further site and structure enhancements to increase fire protection can be found on the Nevada State Fire Marshal's website.

The painted exterior finishes were in poor condition. It is important to maintain the finish, weather resistance and appearance of the building. This project would provide funding to protect the exterior of the building excluding the roof. Included in the cost is the caulking and sealing of the windows, flashing, fixtures and all other penetrations. It is recommended that the building be caulked and sealed in the next 2 - 3 years and that this project be scheduled on a cyclical basis to maintain the integrity of the structure.

The corrugated metal roof on this building has active leaks on the building. Light is showing through holes in the corrugated roofing. It is recommended that the holes be repaired / sealed immediately. Additional costs are included in the estimate due to the steep pitch of the roof and the historical nature of the building.

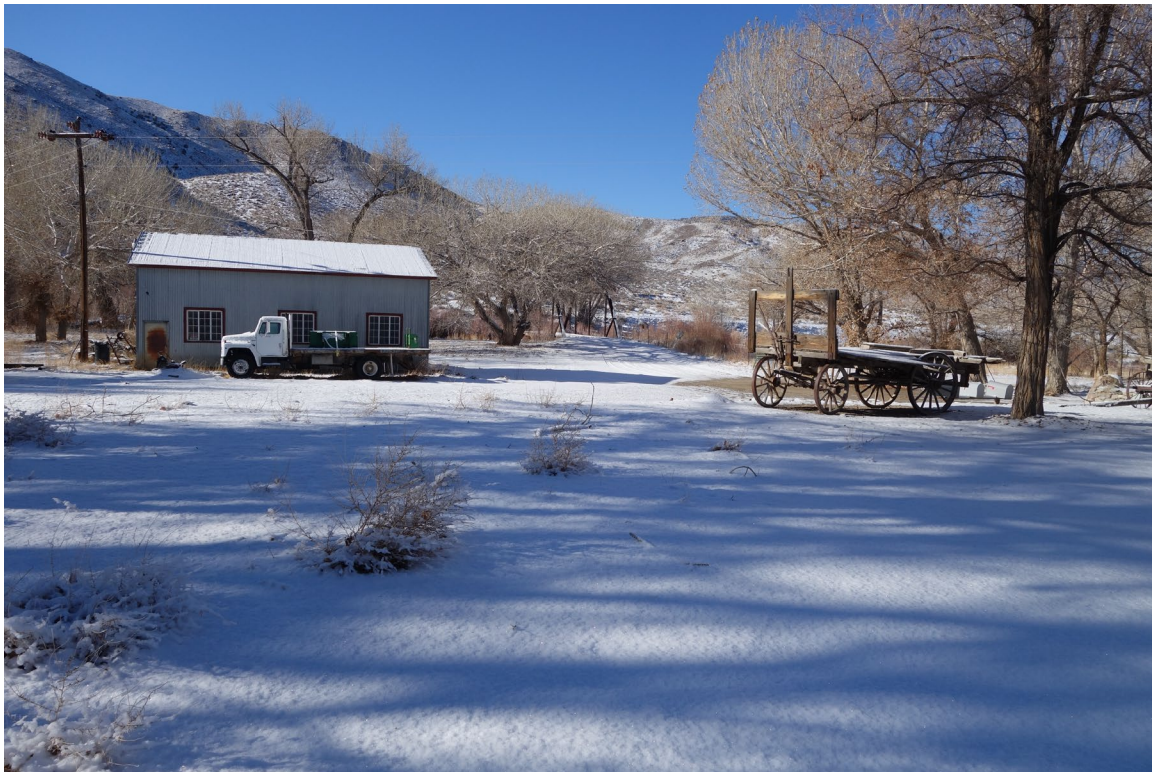
Morgan Shop - FCA Building #4131
Description: Exterior of the Building.

The building has significant weed and debris buildup and are a fuel source for fire. Accumulated leaves at the base of structures create a significant fuel path to structure fires during wild land fire events. This project would provide for the removal and disposal of the weeds and debris around the structure site. Further site and structure enhancements to increase fire protection can be found on the Nevada State Fire Marshal's website.

The air compressor disconnect/starter in the building does not have an inside cover (dead front) that properly protects individuals from touching the bus bar and the interior of the panel. This does not comply with NEC 2017 or OSHA 1910. This project would provide funds to replace and install a new dead front panel, or replace the disconnect in accordance with NEC 2017 and OSHA 1910.

The painted exterior finishes were in poor condition. It is important to maintain the finish, weather resistance and appearance of the building. This project would provide funding to protect the exterior of the building excluding the roof. Included in the cost is the caulking and sealing of the windows, flashing, fixtures and all other penetrations. It is recommended that the building be caulked and sealed in the next 2 - 3 years and that this project be scheduled on a cyclical basis to maintain the integrity of the structure.

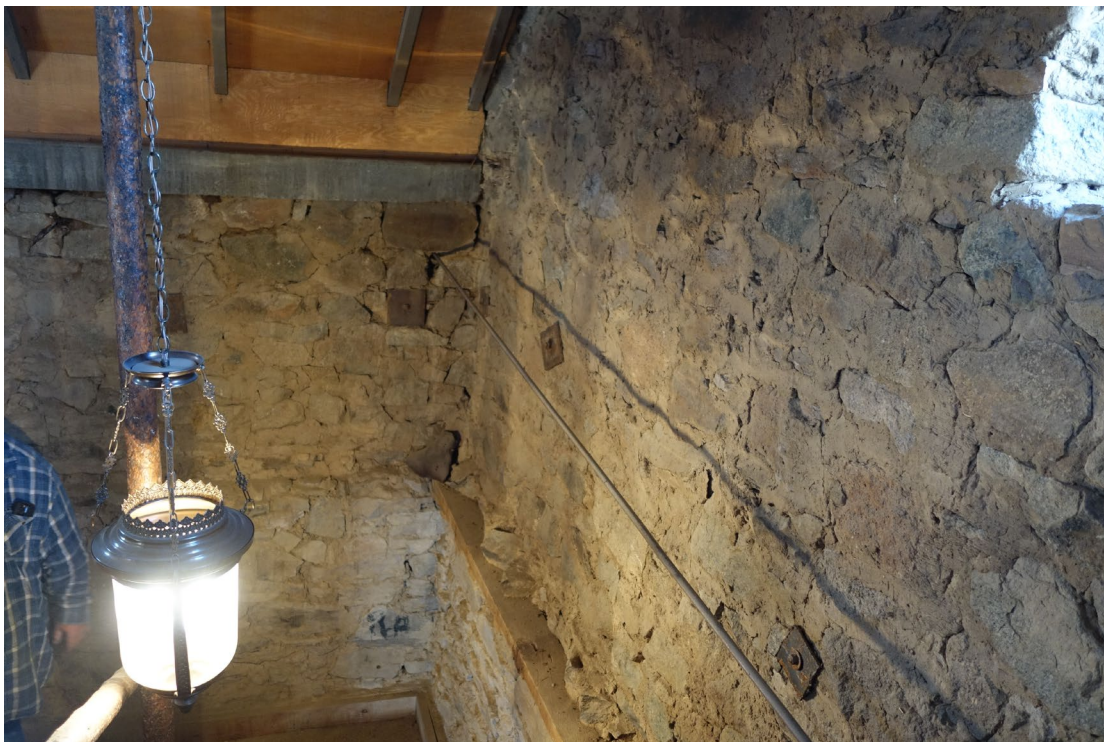
Stone Building – Game Room - FCA Building #4084
Description: View of the Limited Seismic Bracing.
