State of Nevada
Department of Conservation & Natural Resources
Division of State Parks

WALKER RIVER SRA RAFTER 7 RANCH SITE

Site Number: 9784
STATE OF NEVADA PUBLIC WORKS DIVISION
FACILITY CONDITION ANALYSIS

Report distributed in November 2021

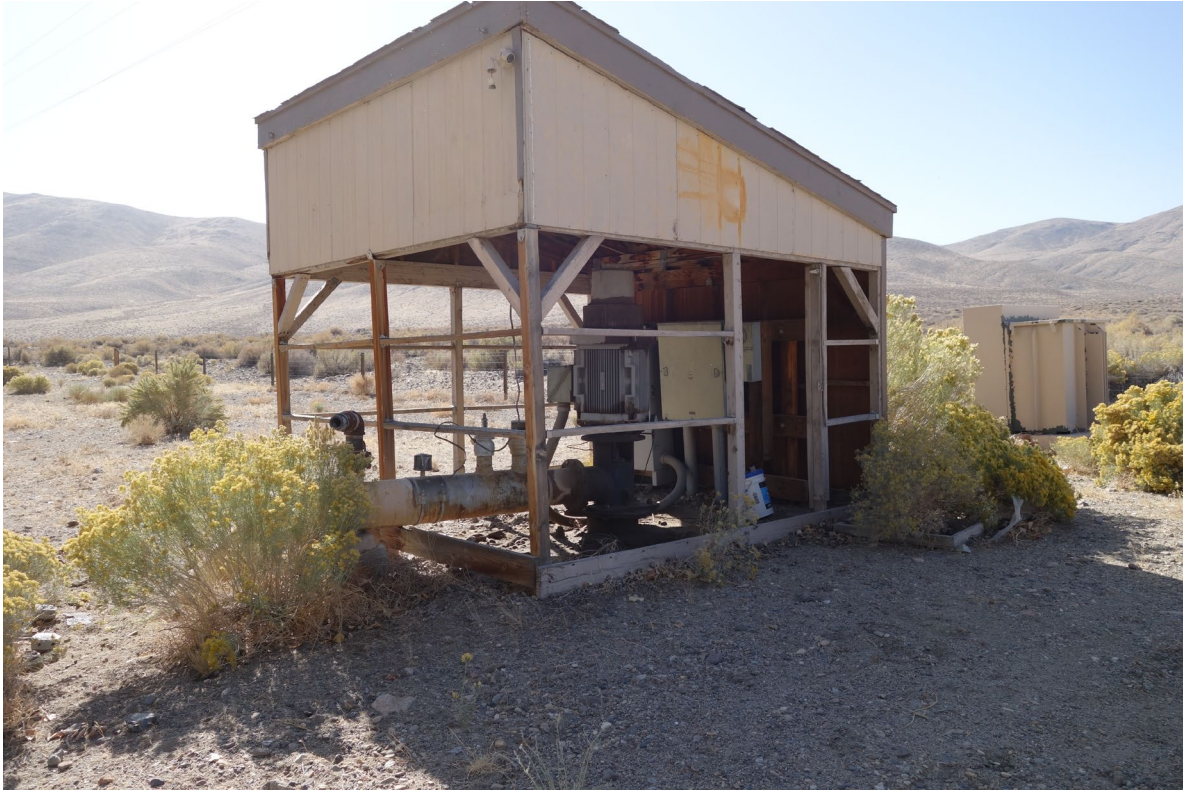
The exterior of the building is in poor condition. It is important to maintain the finish, weather resistance and appearance of the building. This project would provide funding to protect the exterior of the building excluding the roof. Included in the cost is sanding, priming and painting and caulking of the windows, flashing, fixtures and all other penetrations. It is recommended that the building be painted in the next 2 - 3 years and that this project be scheduled on a cyclical basis to maintain the integrity of the structure.

Shed 4 – FCA Building #4082
Description: Shed 4 Exterior Finishes.

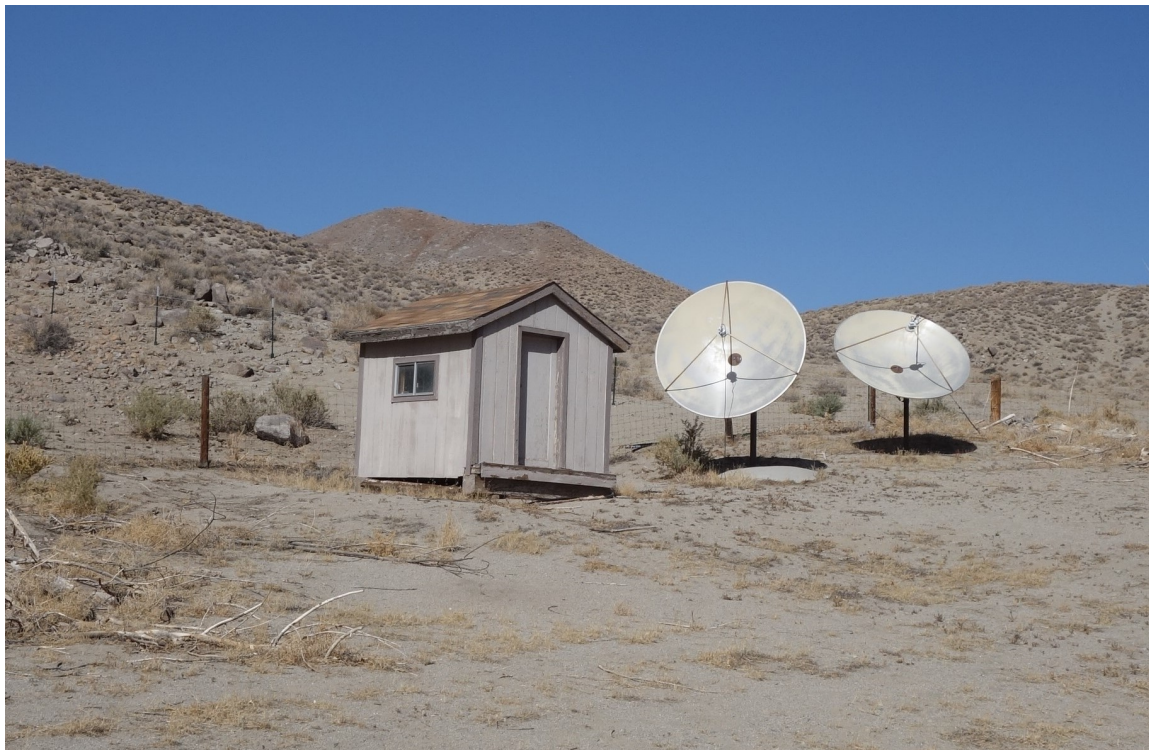
The structure is a shed set on a wood foundation that is no longer in use. A visual survey of the structure shows significant deterioration of the wood foundation, roofing, door and interior and exterior finishes. It is recommended that this structure be demolished due to safety concerns and cost of refurbishment.

Satellite Comm Hut (abandoned) – FCA Building #4081
Description: View of Satellite Comm Hut.

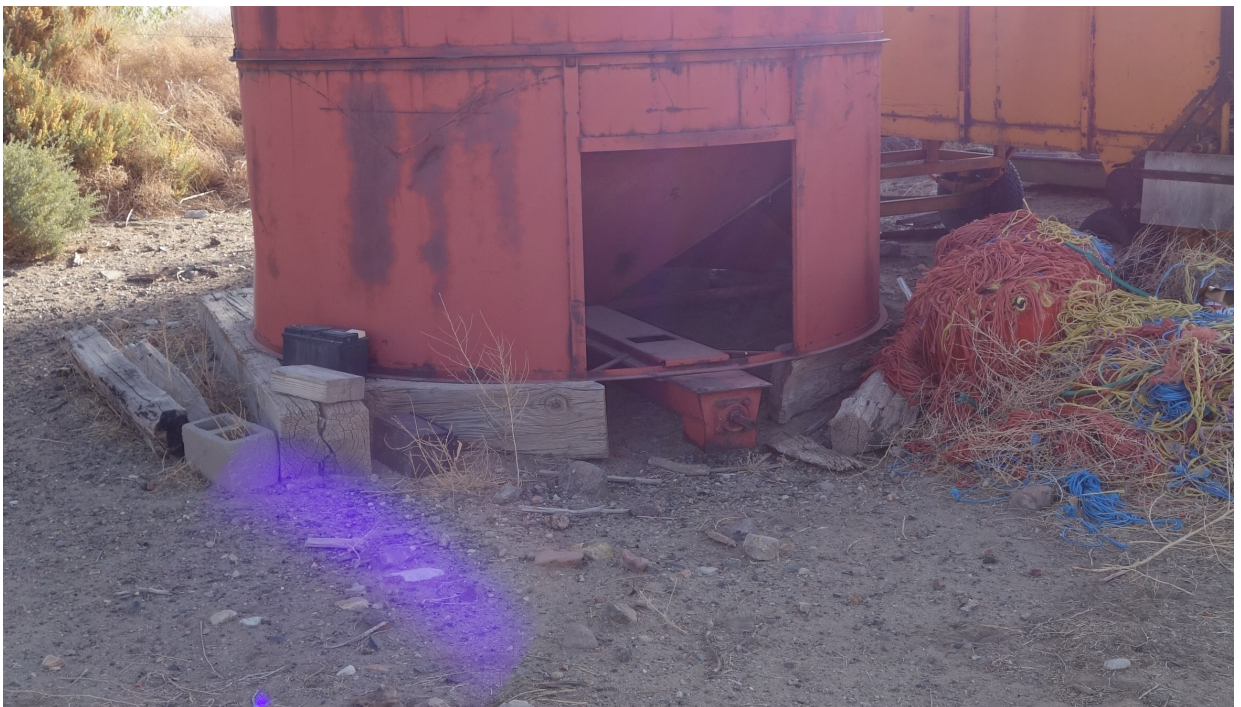
The structure is an old silo set on a wood foundation that is no longer in use. A visual survey of the structure shows no evidence of anchoring to the foundation. In addition, the wood foundation has split making the silo susceptible to toppling. It is recommended that this structure be demolished due to safety concerns.

Silo 2 – FCA Building #3868
Description: Silo 2 on Unstable Wood Foundation.

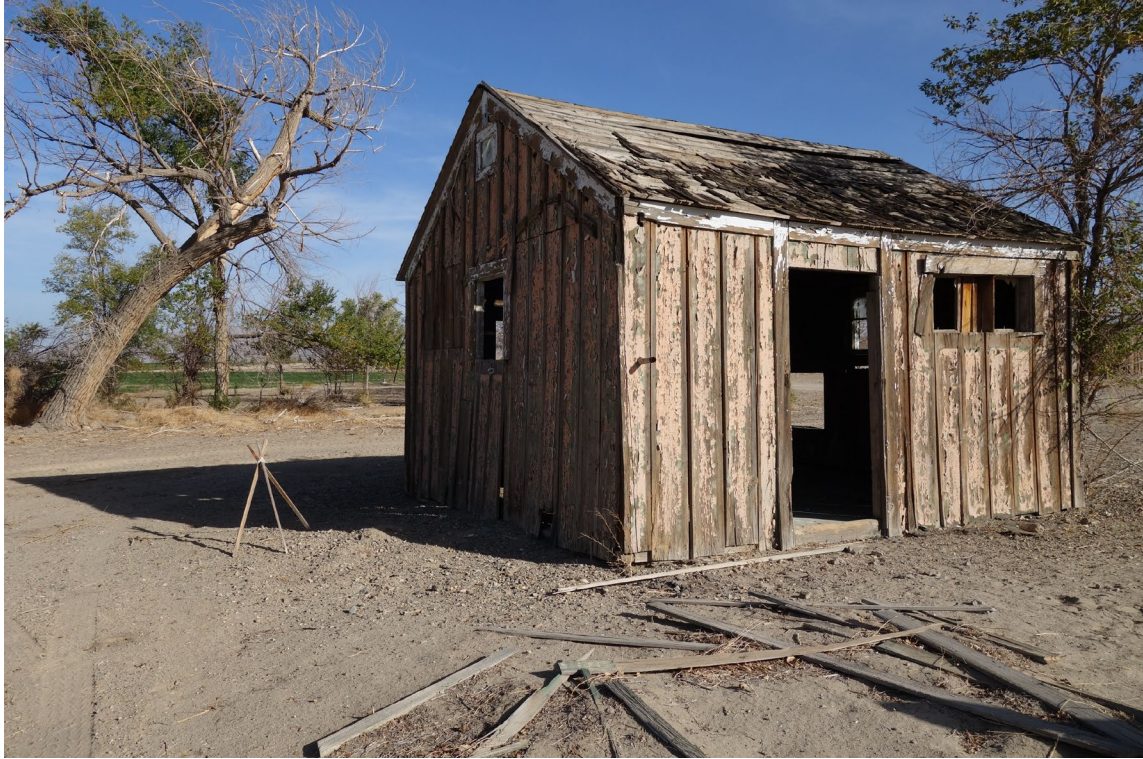
Shed 3 – FCA Building #3867
Description: Shed 3 Conserve and Protect.

Until the planning phase for this site is complete and a determination of demolition or rehabilitation is reached, preservation of the structure is recommended. This project recommends mothballing it in accordance with the U. S. Department of Interior Recommended Guidelines in Preservation Brief 31. Costs related to providing drainage away from the building to prevent future water accumulation, pest control and removal of accumulated waste are included. Also included is securing the exterior envelope against water penetration. Roof, windows and doors will be secured or covered, and some will include louvers to permit ventilation of the structure.

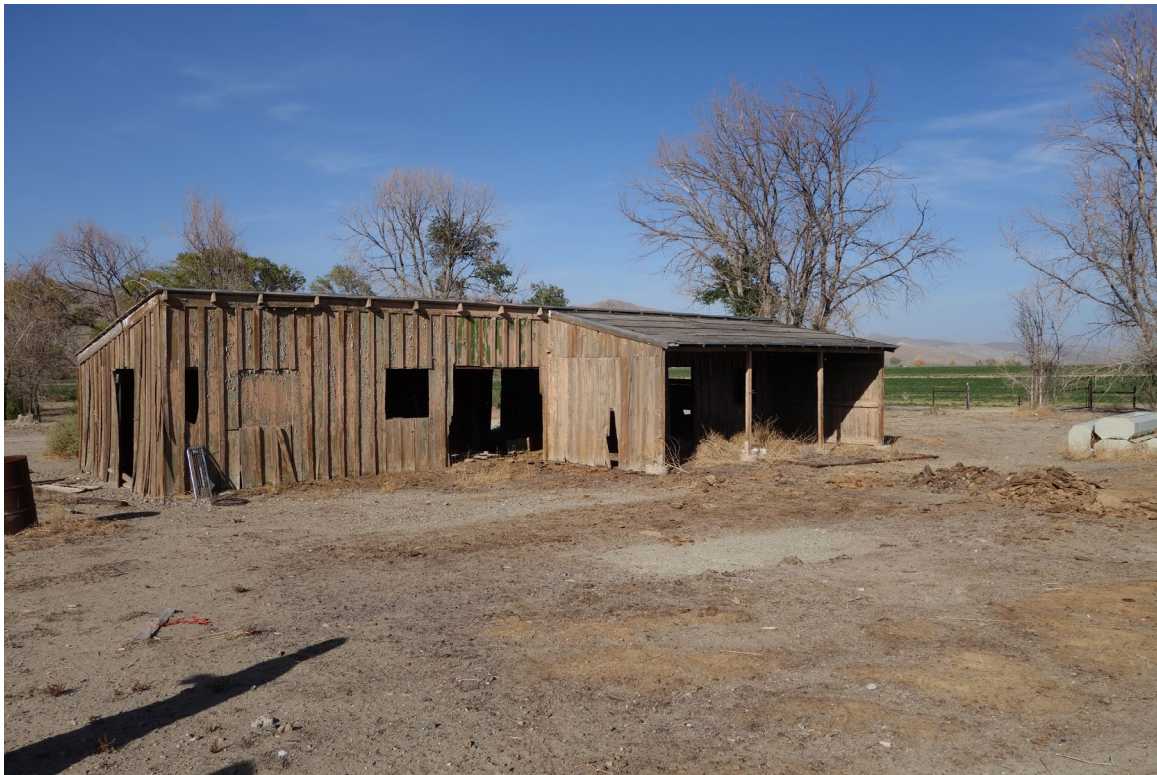
Shed 2 – FCA Building #3866
Description: Shed 2 Conserve and Protect.

Until the planning phase for this site is complete and a determination of demolition or rehabilitation is reached, preservation of the structure is recommended. This project recommends mothballing it in accordance with the U. S. Department of Interior Recommended Guidelines in Preservation Brief 31. Costs related to providing drainage away from the building to prevent future water accumulation, pest control and removal of accumulated waste are included. Also included is securing the exterior envelope against water penetration. Roof, windows and doors will be secured or covered, and some will include louvers to permit ventilation of the structure.

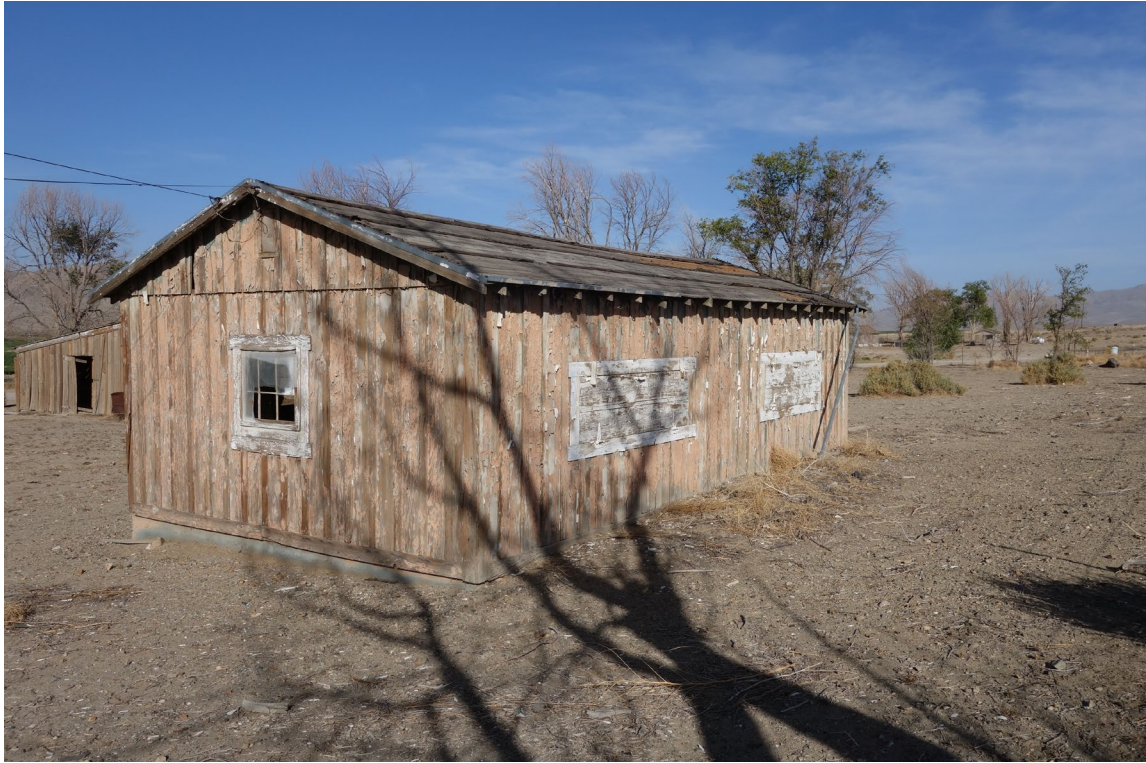
Shed – FCA Building #3865
Description: Shed Conserve and Protect.

Until the planning phase for this site is complete and a determination of demolition or rehabilitation is reached, preservation of the structure is recommended. This project recommends mothballing it in accordance with the U. S. Department of Interior Recommended Guidelines in Preservation Brief 31. Costs related to providing drainage away from the building to prevent future water accumulation, pest control and removal of accumulated waste are included. Also included is securing the exterior envelope against water penetration. Roof, windows and doors will be secured or covered, and some will include louvers to permit ventilation of the structure.

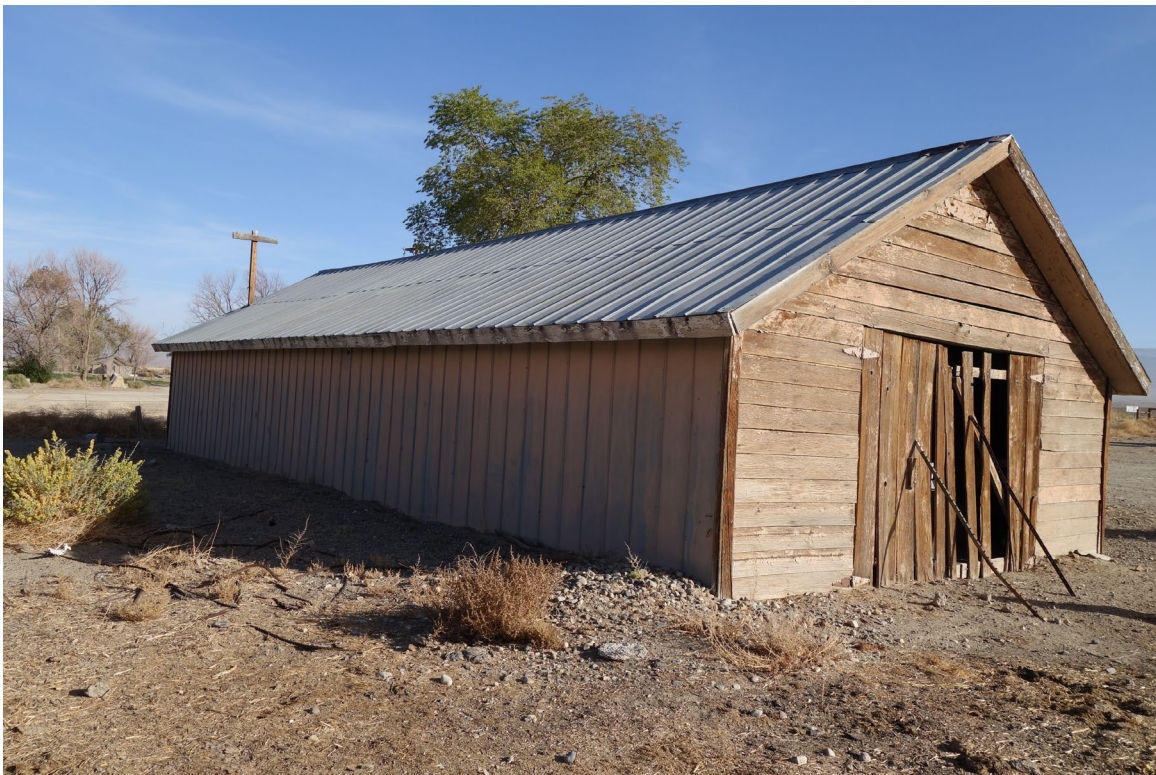
Barn 3 – FCA Building #3864
Description: Barn 3 Conserve and Protect.

Until the planning phase for this site is complete and a determination of demolition or rehabilitation is reached, preservation of the structure is recommended. This project recommends mothballing it in accordance with the U. S. Department of Interior Recommended Guidelines in Preservation Brief 31. Costs related to providing drainage away from the building to prevent future water accumulation, pest control and removal of accumulated waste are included. Also included is securing the exterior envelope against water penetration. Roof, windows and doors will be secured or covered, and some will include louvers to permit ventilation of the structure.

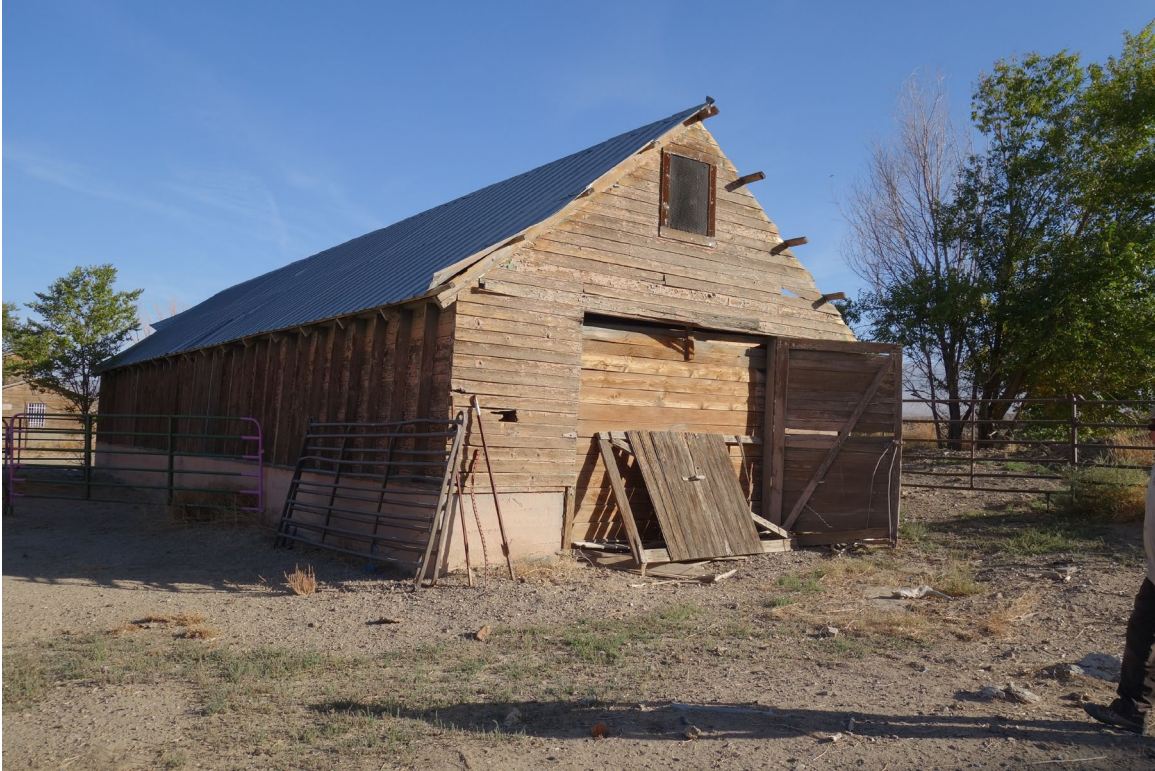
Barn 2 – FCA Building #3863
Description: Barn 2 Conserve and Protect.

Until the planning phase for this site is complete and a determination of demolition or rehabilitation is reached, preservation of the structure is recommended. This project recommends mothballing it in accordance with the U. S. Department of Interior Recommended Guidelines in Preservation Brief 31. Costs related to providing drainage away from the building to prevent future water accumulation, pest control and removal of accumulated waste are included. Also included is securing the exterior envelope against water penetration. Roof, windows and doors will be secured or covered, and some will include louvers to permit ventilation of the structure.

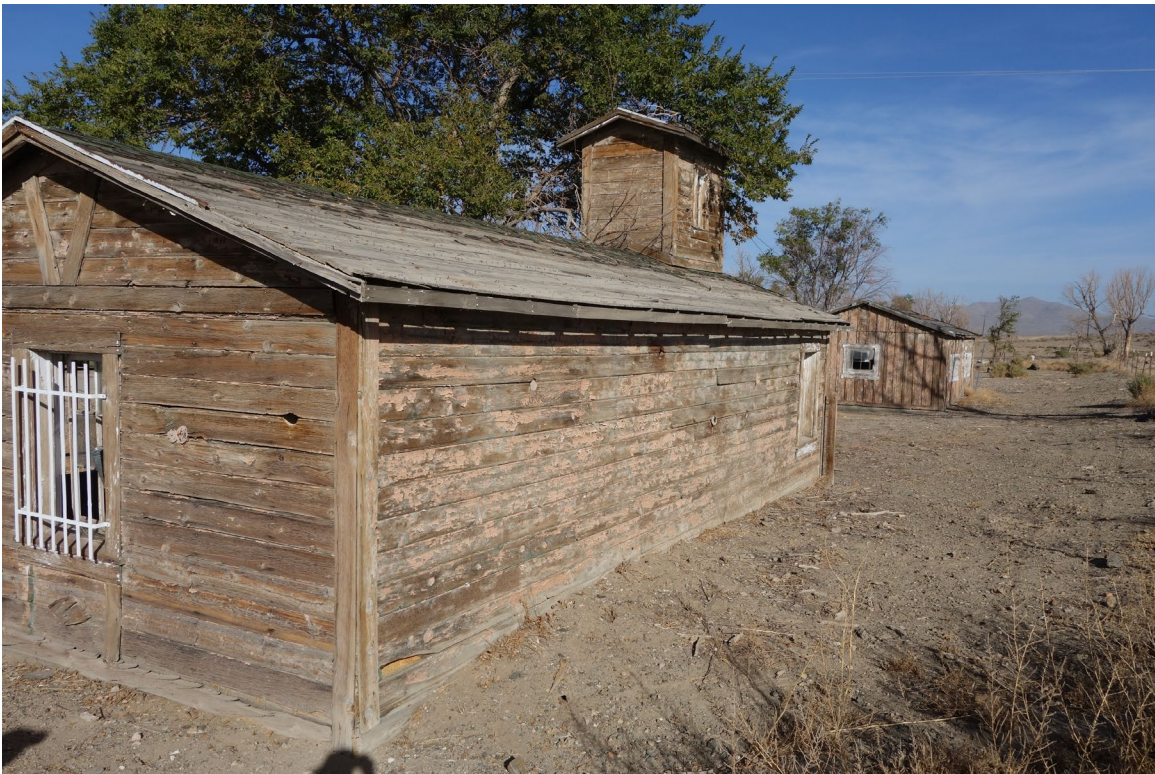
Schoolhouse – FCA Building #3862
Description: Schoolhouse Conserve and Protect.

Until the planning phase for this site is complete and a determination of demolition or rehabilitation is reached, preservation of the structure is recommended. This project recommends mothballing it in accordance with the U. S. Department of Interior Recommended Guidelines in Preservation Brief 31. Costs related to providing drainage away from the building to prevent future water accumulation, pest control and removal of accumulated waste are included. Also included is securing the exterior envelope against water penetration. Roof, windows and doors will be secured or covered, and some will include louvers to permit ventilation of the structure.

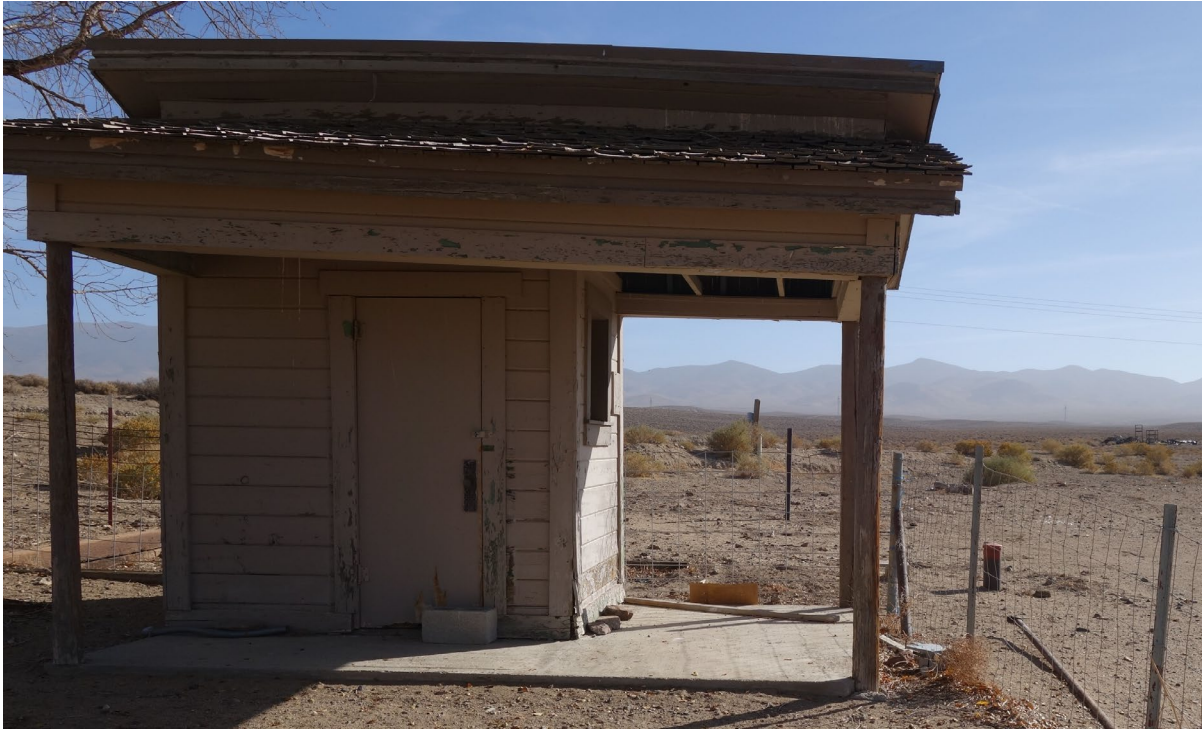
The Santa Margarita Well House is a small domestic well house. It is a wood framed structure with painted ship lap siding and a wood shingle roof. It is located east of the Santa Margarita House and the finishes are in poor condition.

Santa Margarita Well House – FCA Building #3861
Description: View of Well House.

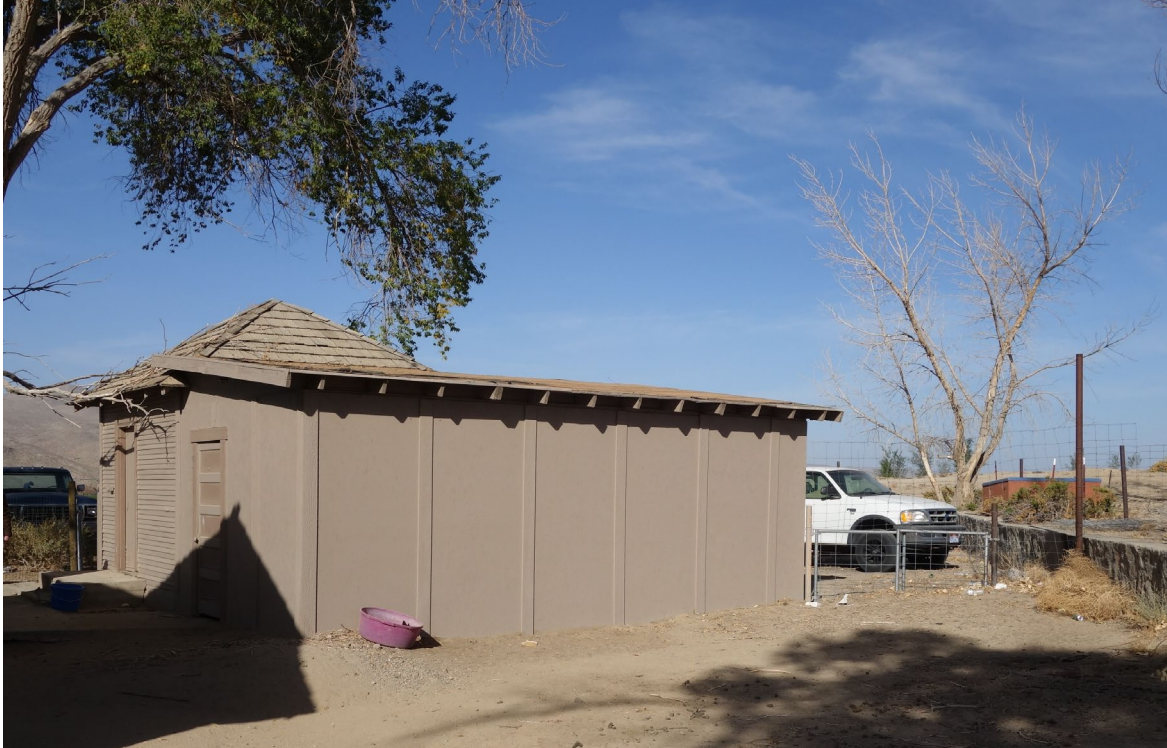
The grade does not slope away effectively from the shed and the earth is covering the bottom edge of the siding. It is recommended per IBC 1804.4 grading the ground immediately adjacent to the foundation shall be sloped away from the building at a slope of not less than one vertical unit in 20 units horizontal (5-percent slope). It is recommended that the grading be completed within 2 - 3 years.

Santa Margarita House Shed - FCA Building #3859
Description: Shed Drainage and Re-grading.

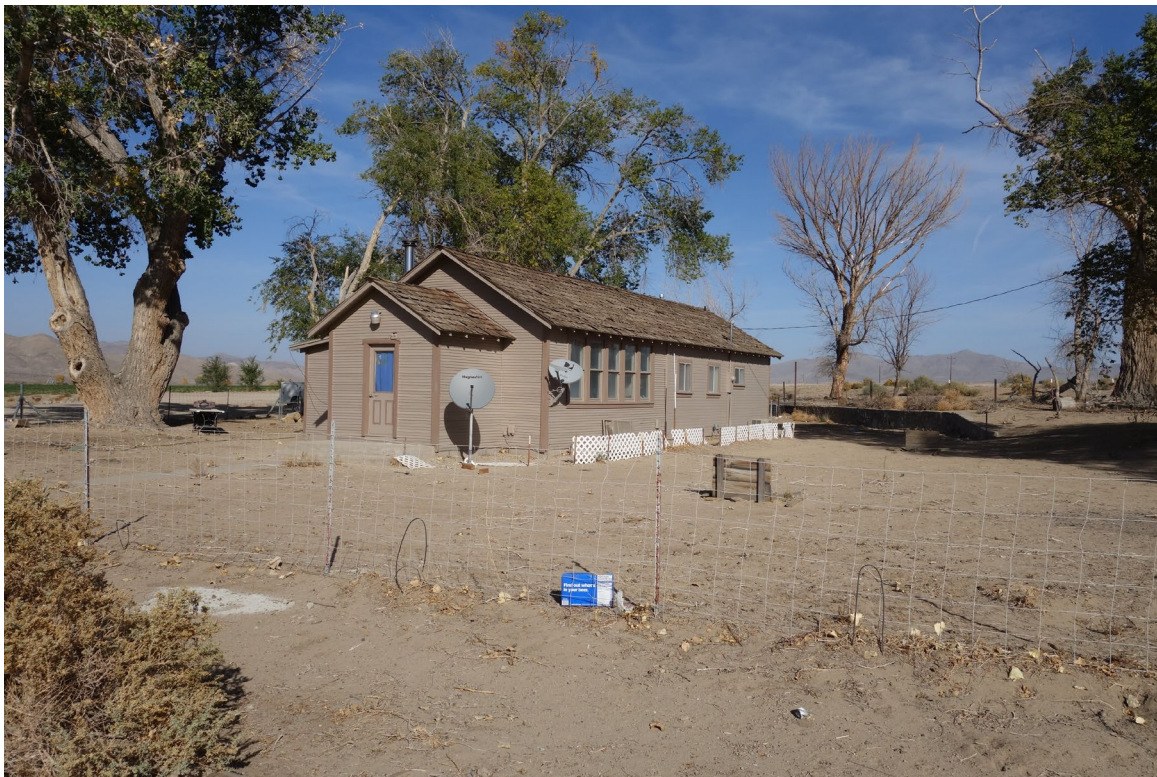
The exterior finishes are in poor condition. It is important to maintain the finish, weather resistance, and appearance of the building. This project recommends work to protect the exterior building envelope other than the roof, including painting, staining, or other applied finishes, and caulking around windows, flashing, fixtures, and other penetrations to maintain the building in good, weather tight condition. It is recommended that the building be painted in the next 3 - 4 years and that this project be scheduled on a cyclical basis to maintain the integrity of the structure.

Santa Margarita House – FCA Building #3858
Description: Exterior of the Building.

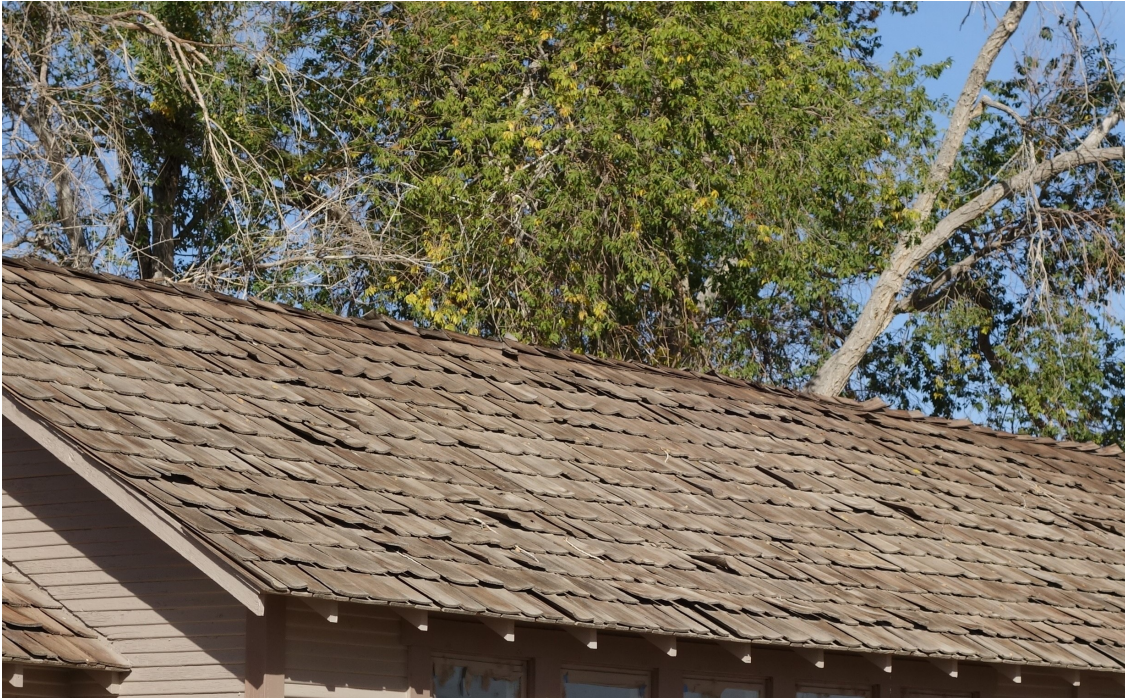
The building currently has a wood shake roofing system and it is weathered and deteriorating. It has reached the end of its useful life and planned for replacement. Due to its historic nature, the structure should be re-roofed with fire retardant treated wood shakes and underlayment. This project should be coordinated with the Nevada State Historical Preservation Office (SHPO) for possible restrictions or additional requirements. This project will fund the replacement of the wood shingle roofing systems. This estimate includes removal and disposal of the old roof.

Santa Margarita House – FCA Building #3858
Description: Roof Replacement.

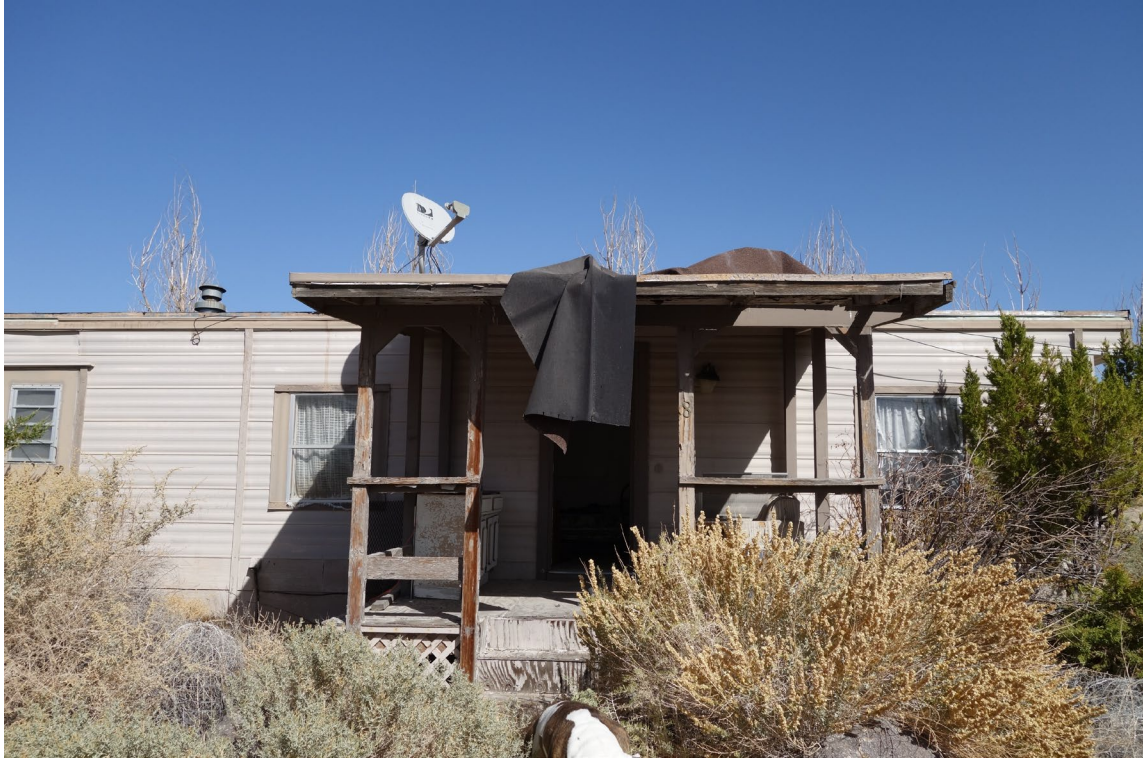
Roost – FCA Building #3852
Description: Demolish Structure.

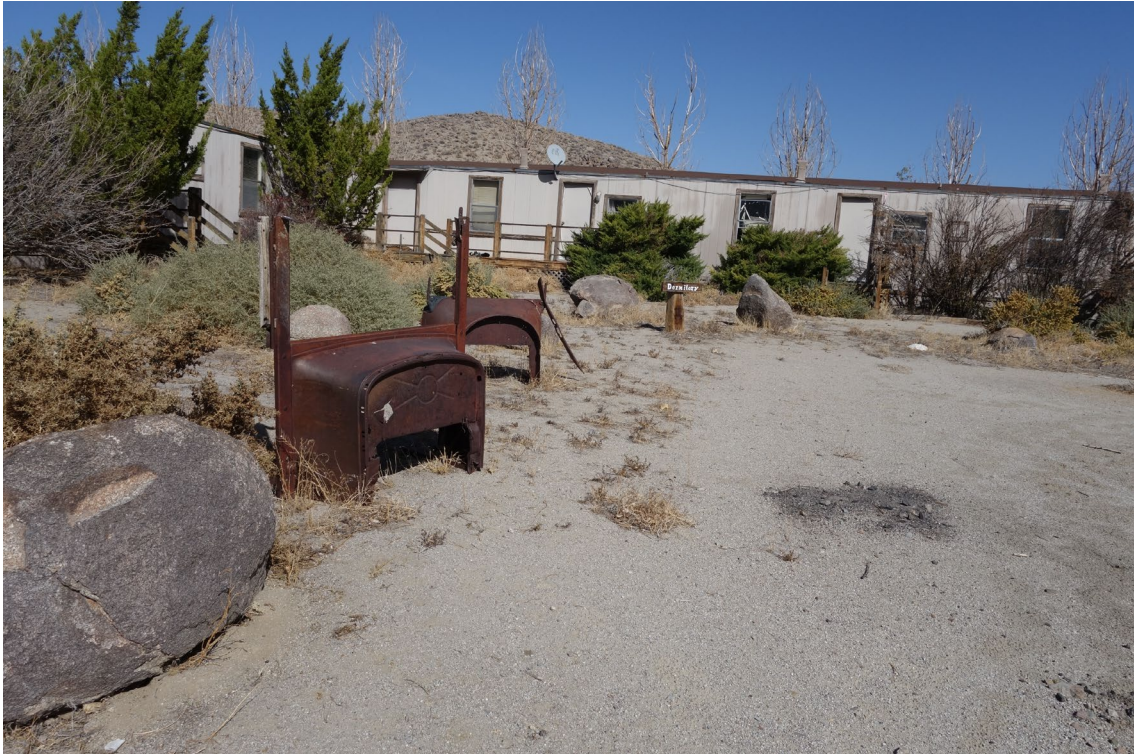
Dormitory – FCA Building #3850
Description: Demolish Structure.

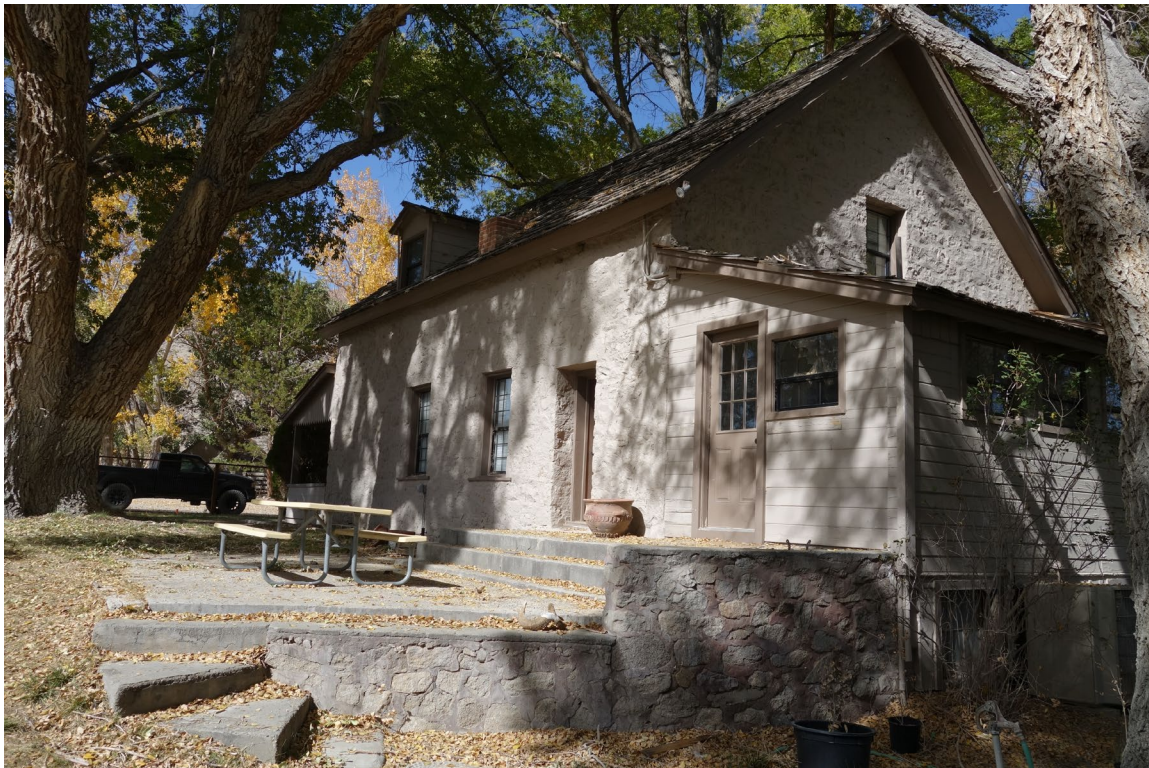
Stonehouse – FCA Building #3846
Description: Exterior of the Building and Guard Rail Installation.

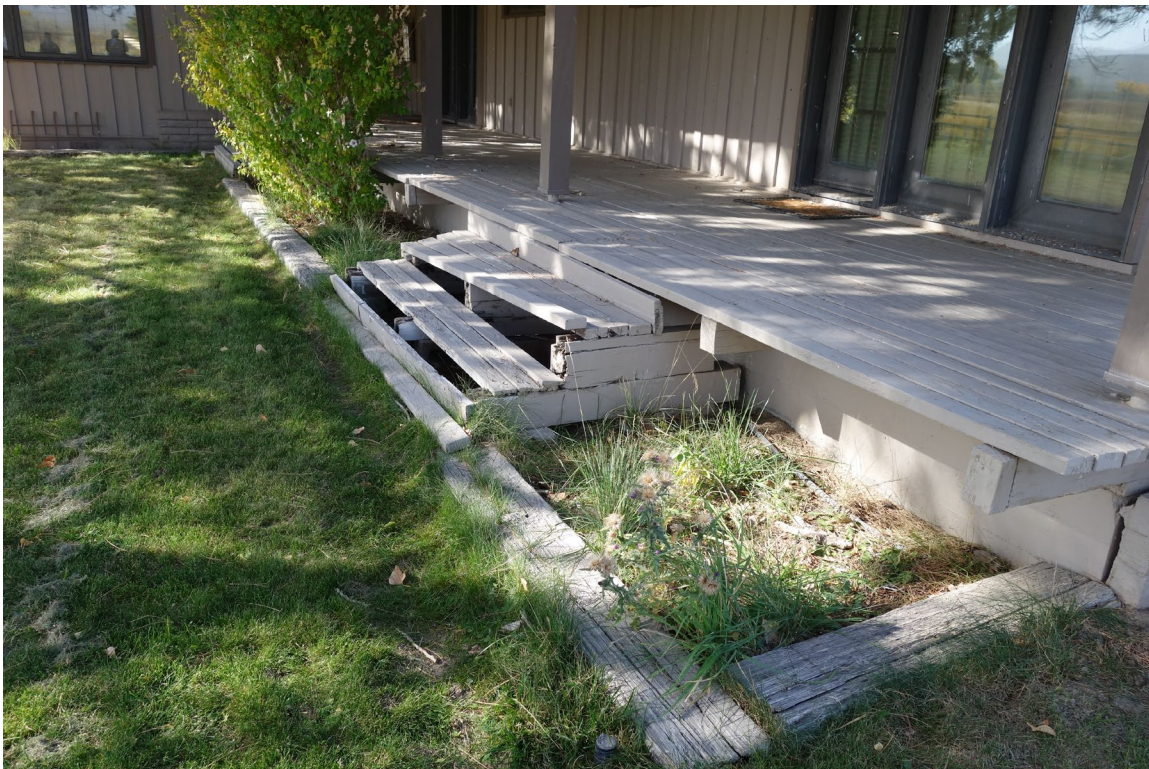
Rafterhouse – FCA Building #3842
Description: Exterior Stair Replacement.

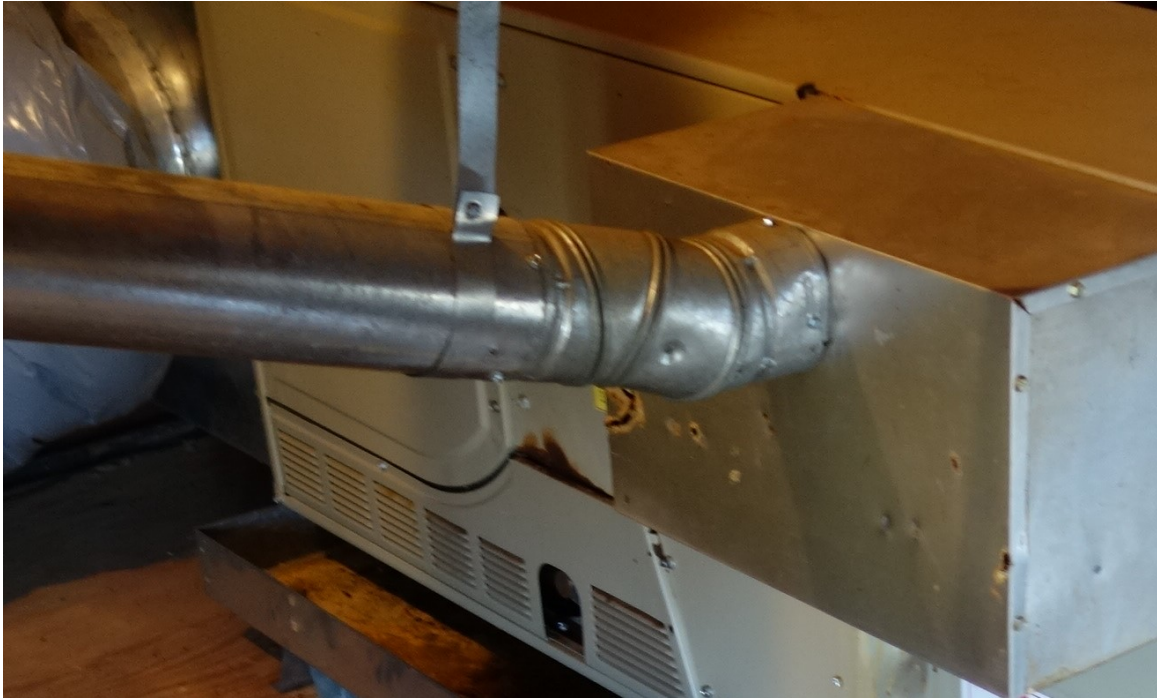
Rafterhouse – FCA Building #3842
Description: HVAC Equipment Replacement.

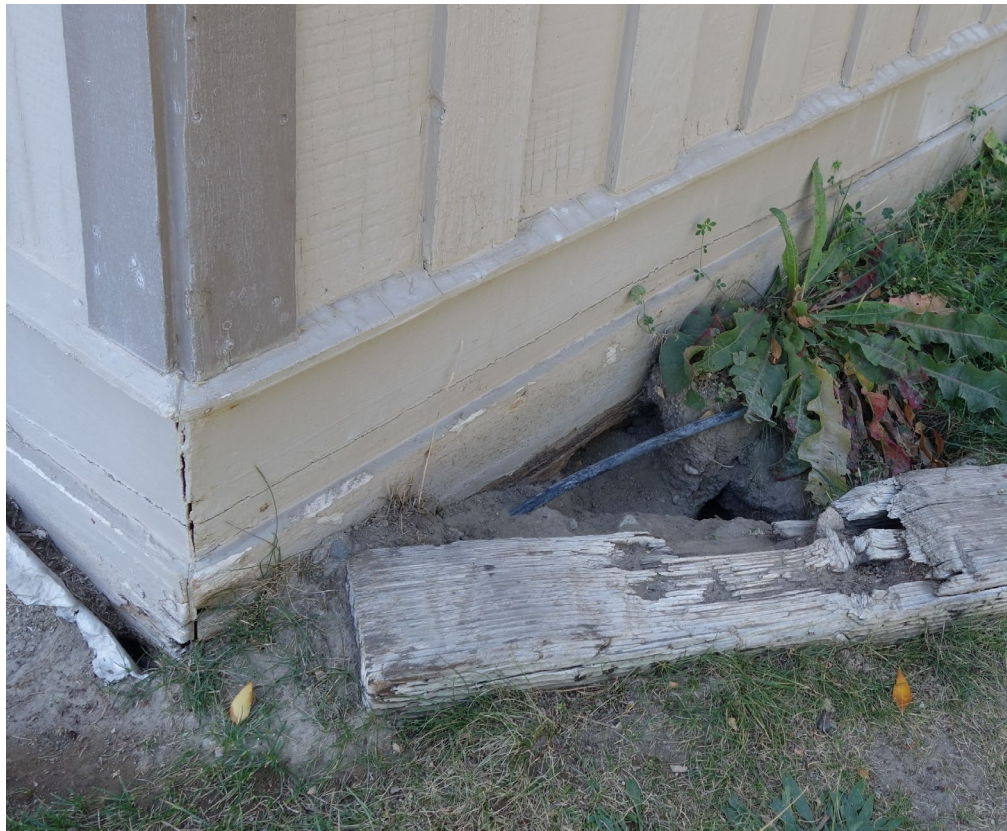
Rafterhouse – FCA Building #3842
Description: Structural Repairs and Pest Control.
