State of Nevada
Department of Conservation & Natural Resources
Division of State Parks

WALKER RIVER SRA PITCHFORK SITE

Site Number: 9875
STATE OF NEVADA PUBLIC WORKS DIVISION
FACILITY CONDITION ANALYSIS

Report distributed in January 2022

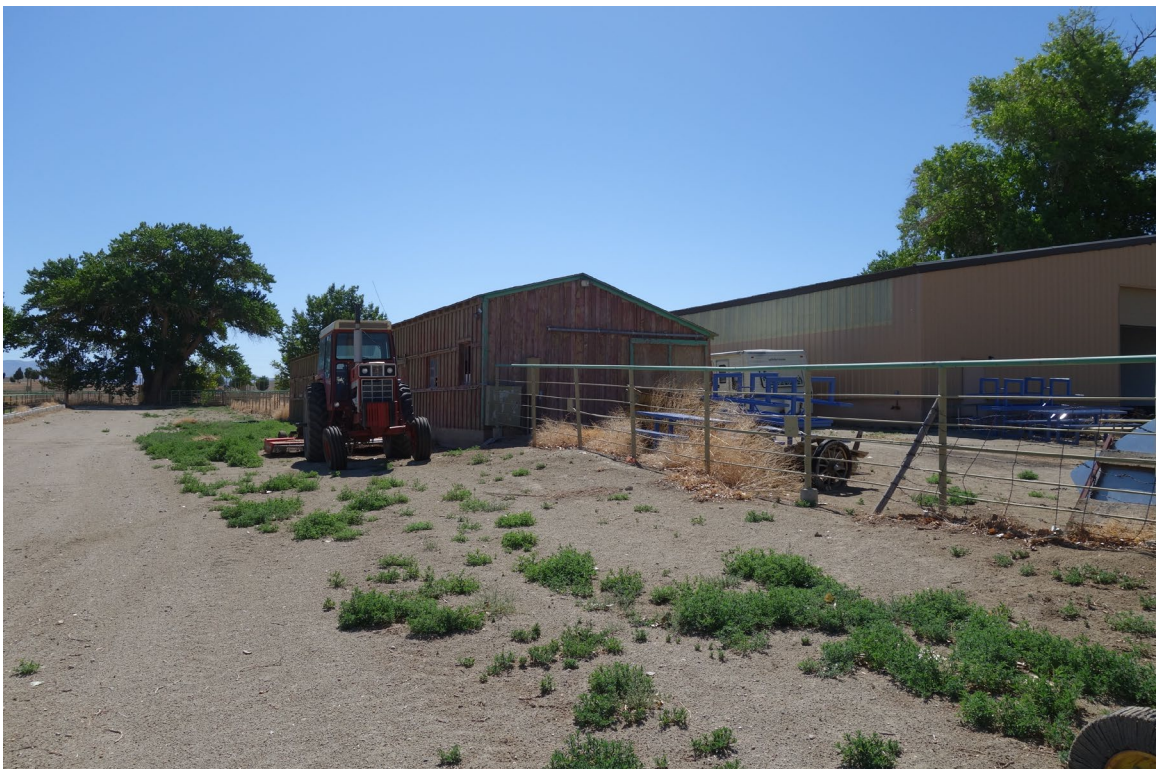
The site and certain buildings have significant weed and debris buildup and are a fuel source for fire. Accumulated leaves at the base of structures create a significant fuel path to structure fires during wild land fire events. This project would provide for the removal and disposal of the weeds and debris around all structures on the site. Further site and structure enhancements to increase fire protection can be found on the Nevada State Fire Marshal's website.

Walker River SRA - Pitchfork Site – FCA Site #9785
Description: Reduction of Site Combustibles Recommended.

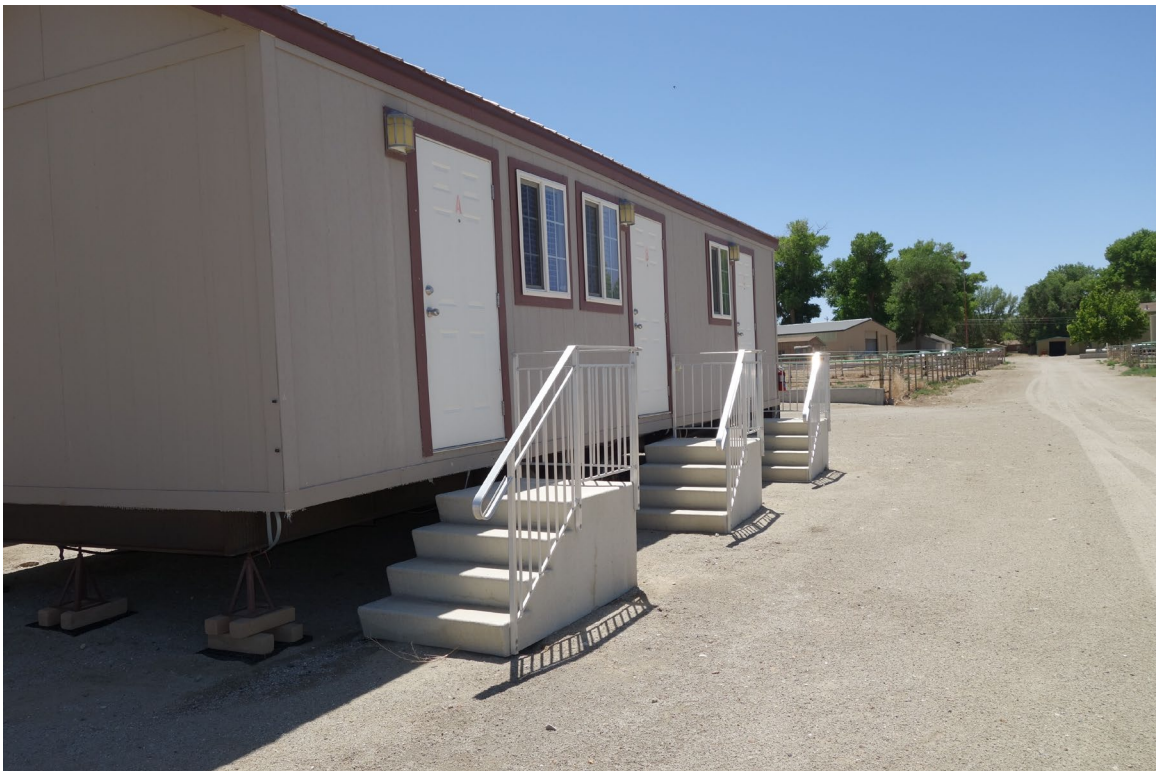
Man Camp Trailer #1 – FCA Building #4079
Description: Egress Door Landing Adjustment.

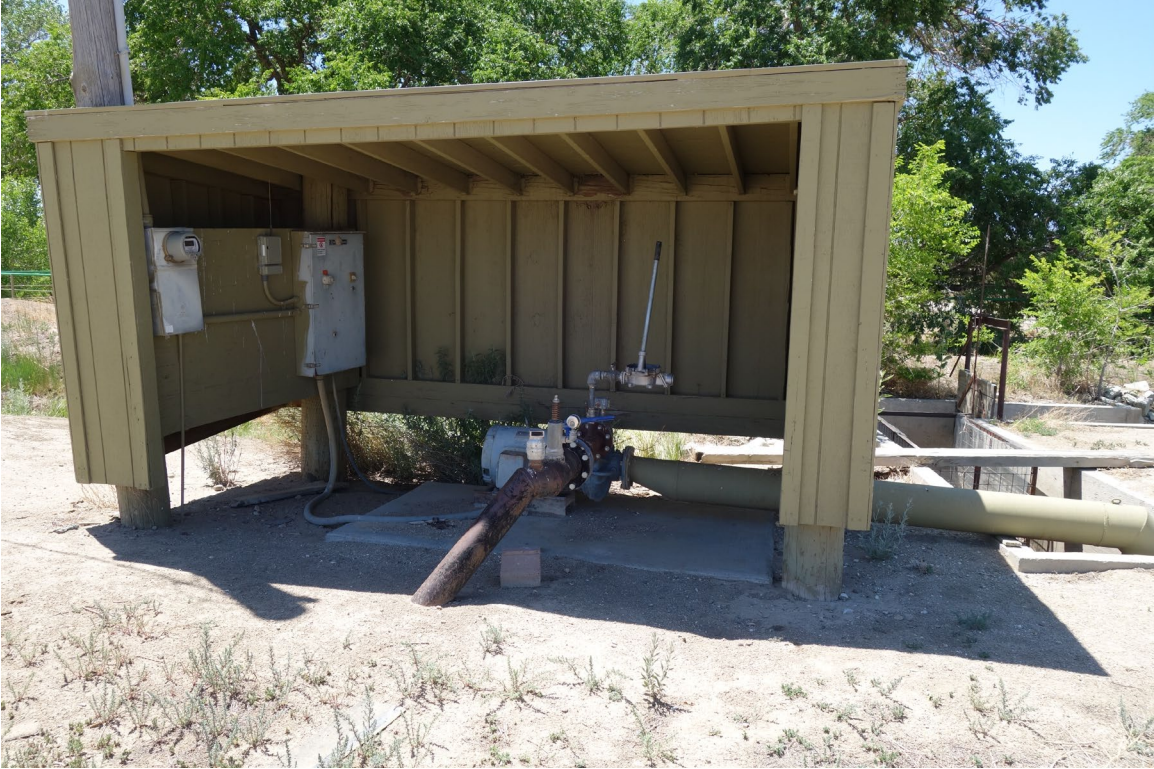
Until the planning phase for this site is complete and a determination of demolition or rehabilitation is reached, preservation of the structure is recommended. This project recommends mothballing it in accordance with the U. S. Department of Interior Recommended Guidelines in Preservation Brief 31. Costs related to providing drainage away from the building to prevent future water accumulation, pest control, removal of accumulated waste and painting the structure are included in this project.

Pump House 3 – FCA Building #3837
Description: View of the Structure.

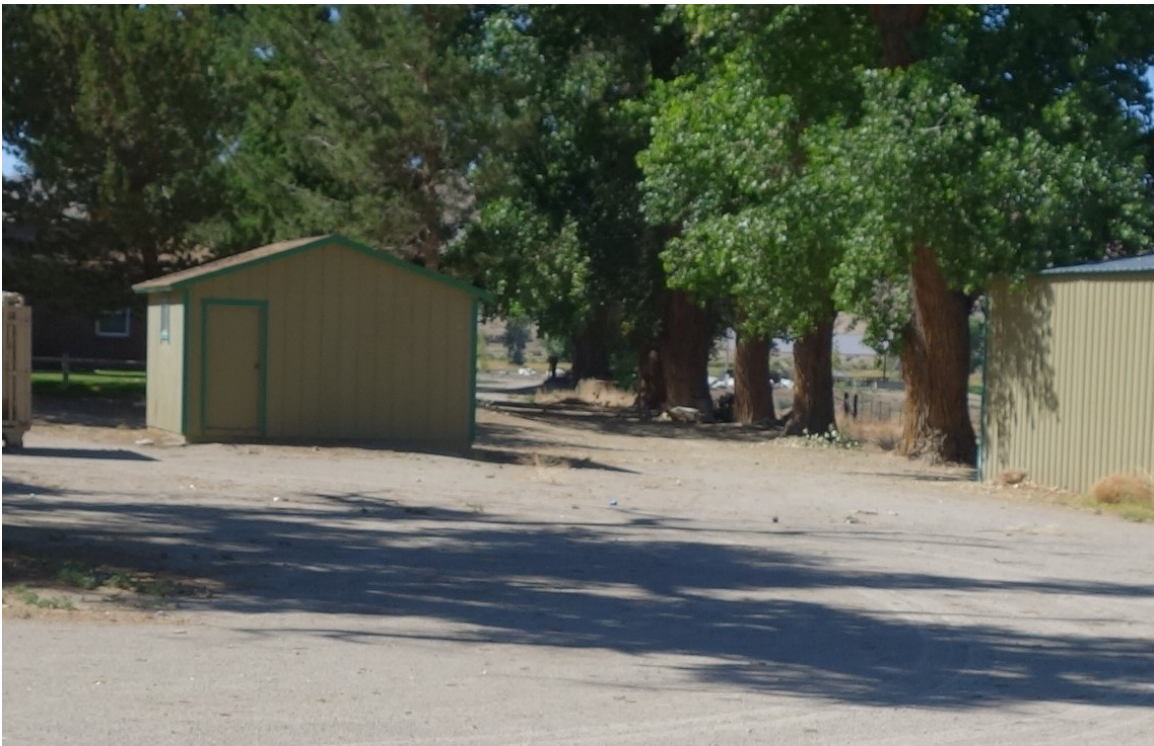
The exterior paint is in fair condition. It is important to maintain the finish, weather resistance, and appearance of the building. This project would provide funding to protect the exterior of the building excluding the roof. Included in the cost is power washing, priming and painting and caulking of the windows, flashing, fixtures and all other penetrations. It is recommended that the building be painted in the next 4 - 5 years and that this project be scheduled on a cyclical basis to maintain the integrity of the structure.

The asphalt composition shingle roof on this building was in fair condition at the time of the survey. It is recommended that this building be re-roofed in the next 4 - 5 years with a new 50 year asphalt composition shingle roofing system and new underlayment. This estimate includes removal and disposal of the old roofing system. Prior to re-roofing, it is recommended roof structural modifications be made to provide future access for the removal and replacement of the well pump.

It appears that the existing well and pressure tank are original and may not have been recently inspected. This project would provide funding to inspect and repair the well including the following projects. Investigate the well using a camera to inspect the casing and evaluate the well for the total depth and screened interval. Test the well pumping capacity and test the water quality to determine whether chemical treatment is necessary. Future projects may be based on the results of the investigation and are not part of this project. A future project recommendation is to upgrade the well pump and associated equipment considering the additional function to support fire suppression at the site. This recommendation is due to the distance between the site and the nearest volunteer Fire Department.

The windows appear to be original dual pane aluminum frame type with the outer pane broken on one of the two windows. This project recommends replacing the windows with dual pane, higher efficiency units. This estimate is for the replacement of 2 units. Removal and disposal of the existing windows is included in this estimate.

Pump House 2 – FCA Building #3836
Description: Exterior of the Building.

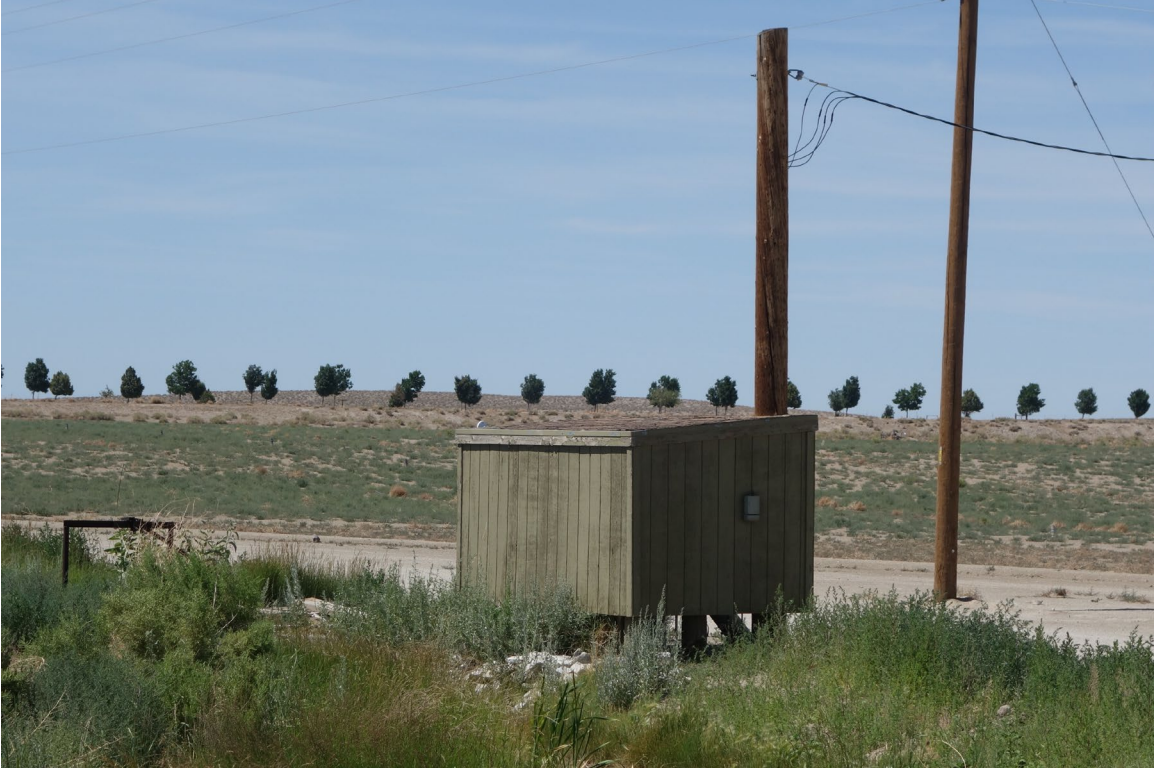
Until the planning phase for this site is complete and a determination of demolition or rehabilitation is reached, preservation of the structure is recommended. This project recommends mothballing it in accordance with the U. S. Department of Interior Recommended Guidelines in Preservation Brief 31. Costs related to providing drainage away from the building to prevent future water accumulation, pest control, removal of accumulated waste and painting the structure are included in this project.

Pump House 1 – FCA Building #3835
Description: Exterior of the Structure.

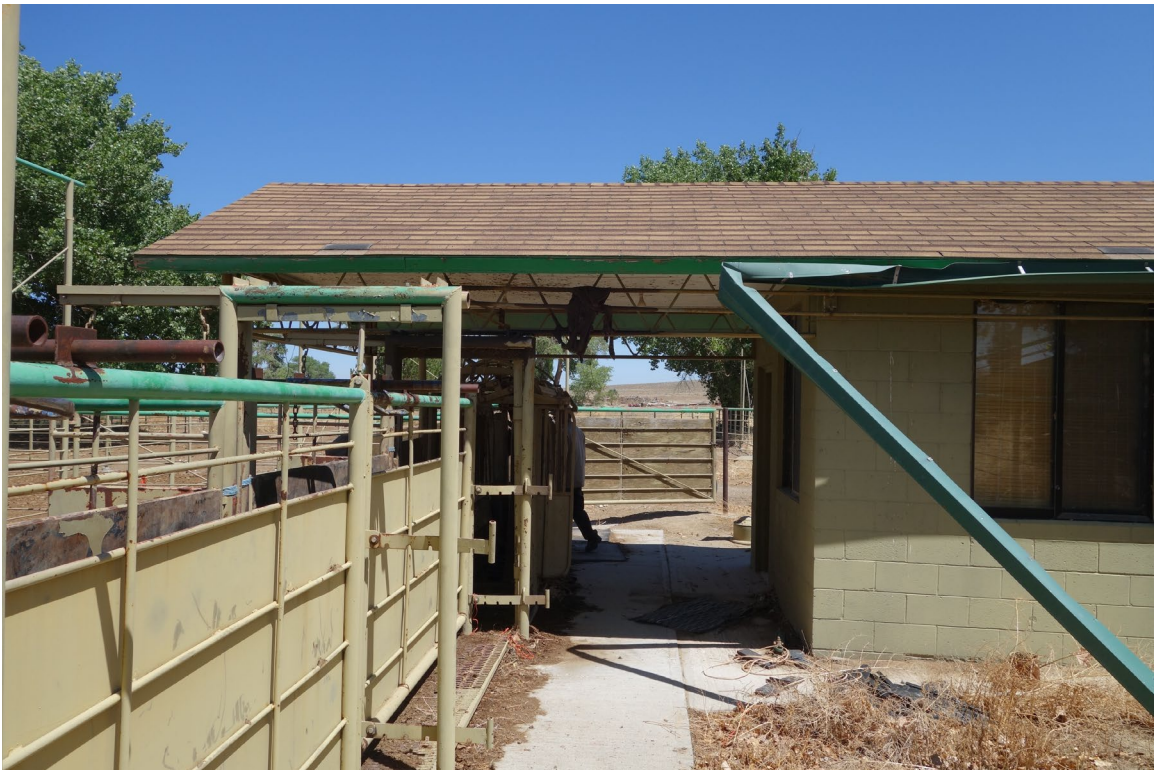
The existing gutter on the building eave has failed completely on the south side. This should be replaced to prevent premature deterioration to the building's finishes and the site's hardscape. This project would replace the existing gutter on both eaves with seamless gutter and new downspouts.

Veterinary Shed (Vacant) – FCA Building #3829
Description: Exterior of the Building.

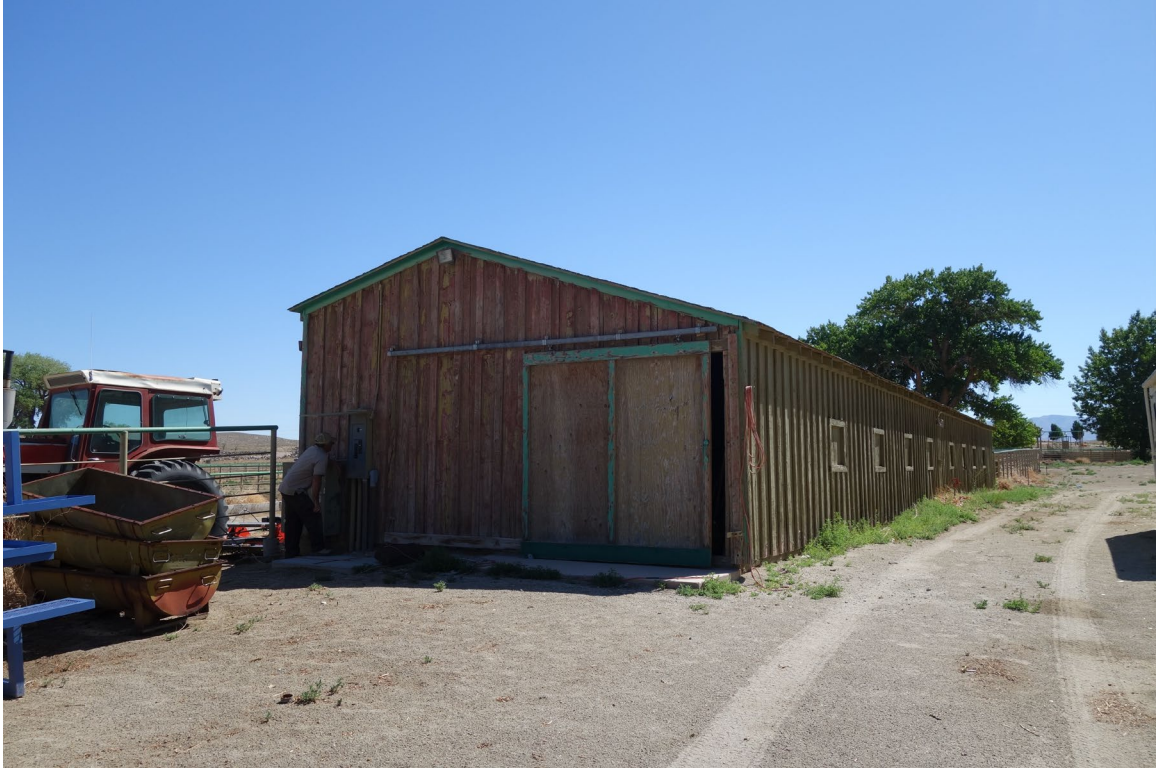
The exterior finishes are in poor condition and should be protected against further deterioration if the building is to be preserved. It is important to maintain the finish, weather resistance, and appearance of the building. This project recommends work to protect the exterior building envelope other than the roof, including painting, staining, or other applied finishes, and caulking around windows, flashing, fixtures, and other penetrations to maintain the building in good, weather tight condition. It is recommended that the building be painted in the next 2 - 3 years and that this project be scheduled on a cyclical basis to maintain the integrity of the structure.

The asphalt composition shingle roof on this building was in poor condition at the time of the survey. If the building is to be preserved, it is recommended that this building be re-roofed in the next 2 - 3 years with a new 50 year asphalt composition shingle roofing system and new underlayment. This estimate includes removal and disposal of the old roofing system.

Livestock Shed – FCA Building #3828
Description: Exterior of the Building.

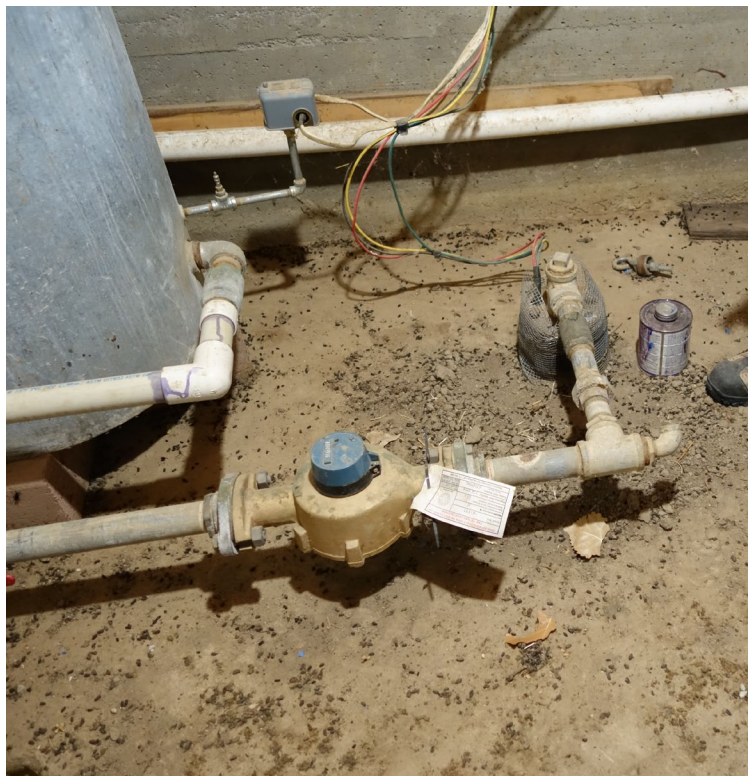
Bynum House Domestic Well Building – FCA Building #3821
Description: Well Refurbishment Recommended.

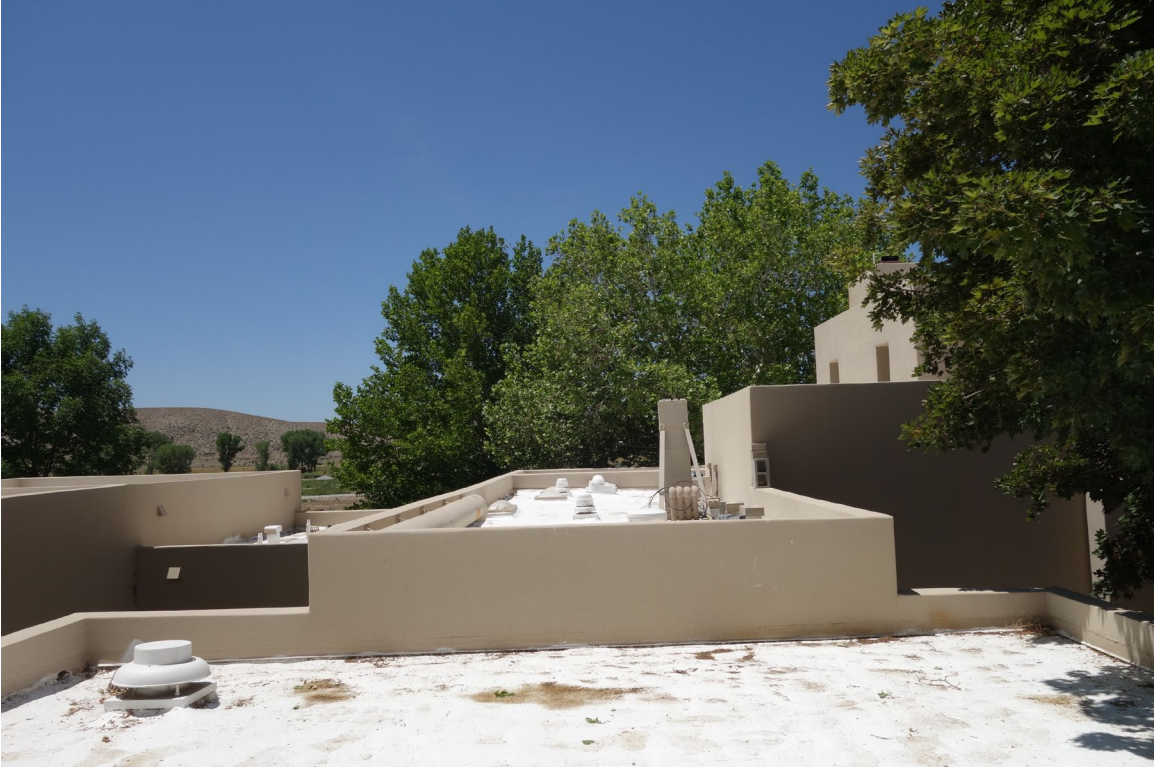
Visitor Center - FCA Building #3812
Description: Roof Repairs / Replacement Recommended.
