# MARLETTE LAKE WATER SYSTEM

**Site Number: 9788**  
**STATE OF NEVADA PUBLIC WORKS DIVISION**  
**FACILITY CONDITION ANALYSIS**

Report distributed in January 2022

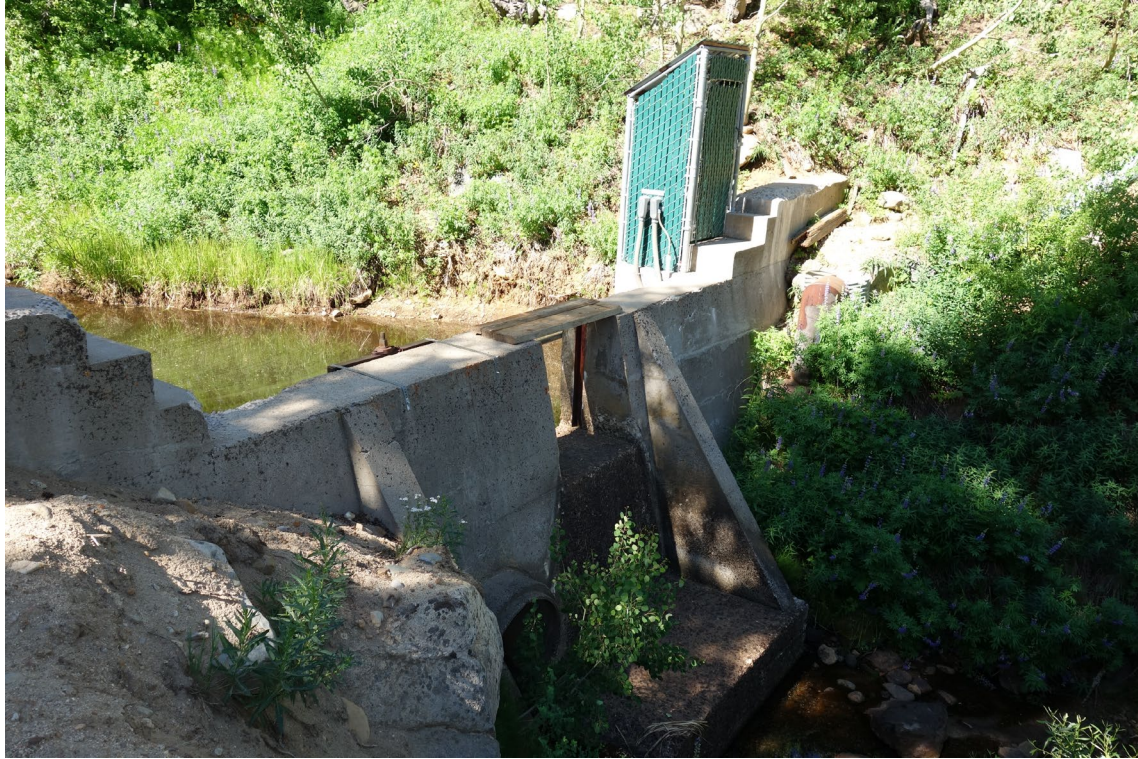
The Marlette Lake Water System Site has several dams, uneven walking surfaces and wet locations that don't have the proper slip resistant platform walking surfaces required by OSHA 1910.22(a)(2), Where wet processes are used, drainage shall be maintained and false floors, platforms, mats, or other dry standing places should be provided where practicable. There are several locations where it is required for employees to access dams, buildings and other locations where there is possible risk of falling into pits, dams and ditches. Per OSHA 1910.22(c), covers and/or guardrails shall be provided to protect personnel from the hazards of open pits, tanks, vats, ditches, etc. This project will provide funding for OSHA required nonslip platforms and railings to be installed across dams, ditches, and uneven surfacing throughout the site where necessary.

Marlette Lake Water System - Site #9788  
Description: Walking Surfaces / Guardrails Needed.

This project is in design under CIP 21-M15 and the estimate is based off that project.

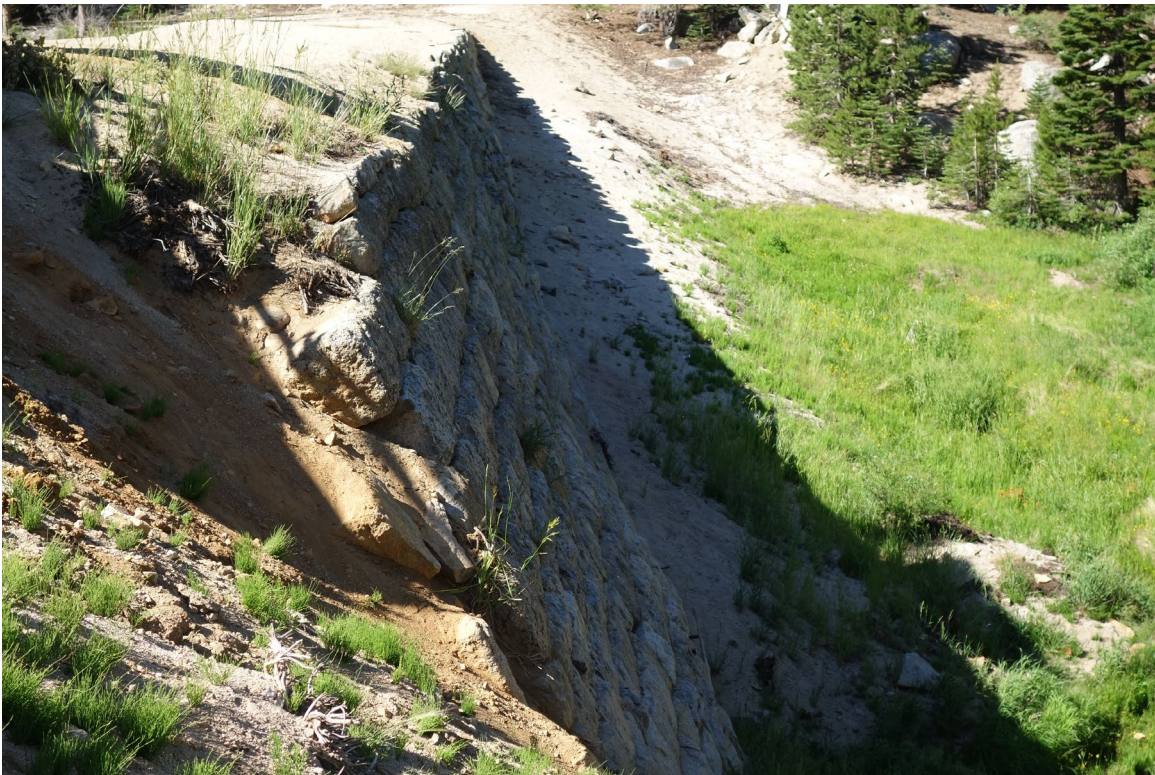
Dam Safety Inspection Reports were received by State Public Works Division in September 2018 indicating that major work should be undertaken in the near future. In addition the dam requires functional upgrades to outlet valves, piping and controls. This project will fund construction of structural and functional upgrades to the dam. The scope of work includes improvements against seismic events, spillway upgrades, access bridge construction and replacement of discharge piping and outlet valves.

Marlette Lake Water System - Site #9788  
Description: View of Hobart Dam.

This project is in design under CIP 21-C06 and the estimate is based off that project.

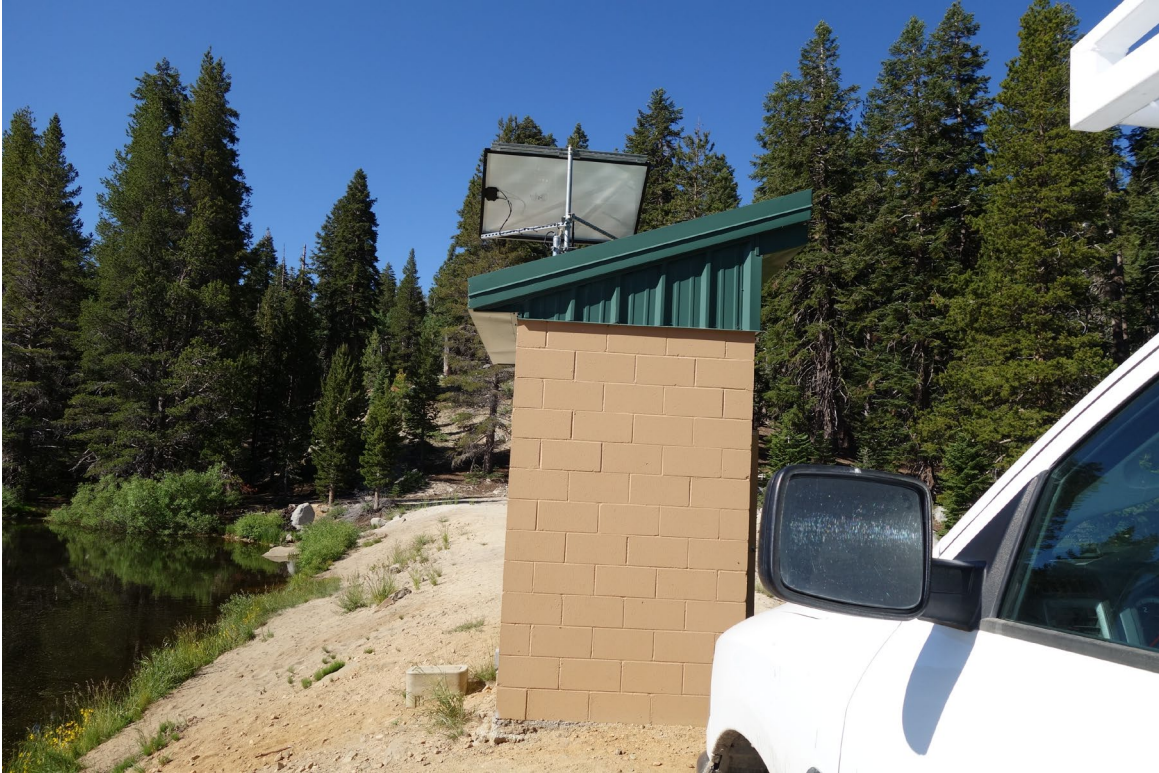
The exterior finishes were in good condition. It is important to maintain the finish, weather resistance and appearance of the building. This project would provide funding to protect the exterior of the building excluding the roof. Included in the cost is painting the concrete masonry unit walls and caulking of the flashing, fixtures and all other penetrations. It is recommended that the building be painted and caulked in the next 6 - 8 years and that this project be scheduled on a cyclical basis to maintain the integrity of the structure.

Hobart Meter Building - Building #3765  
Description: View of the Building.

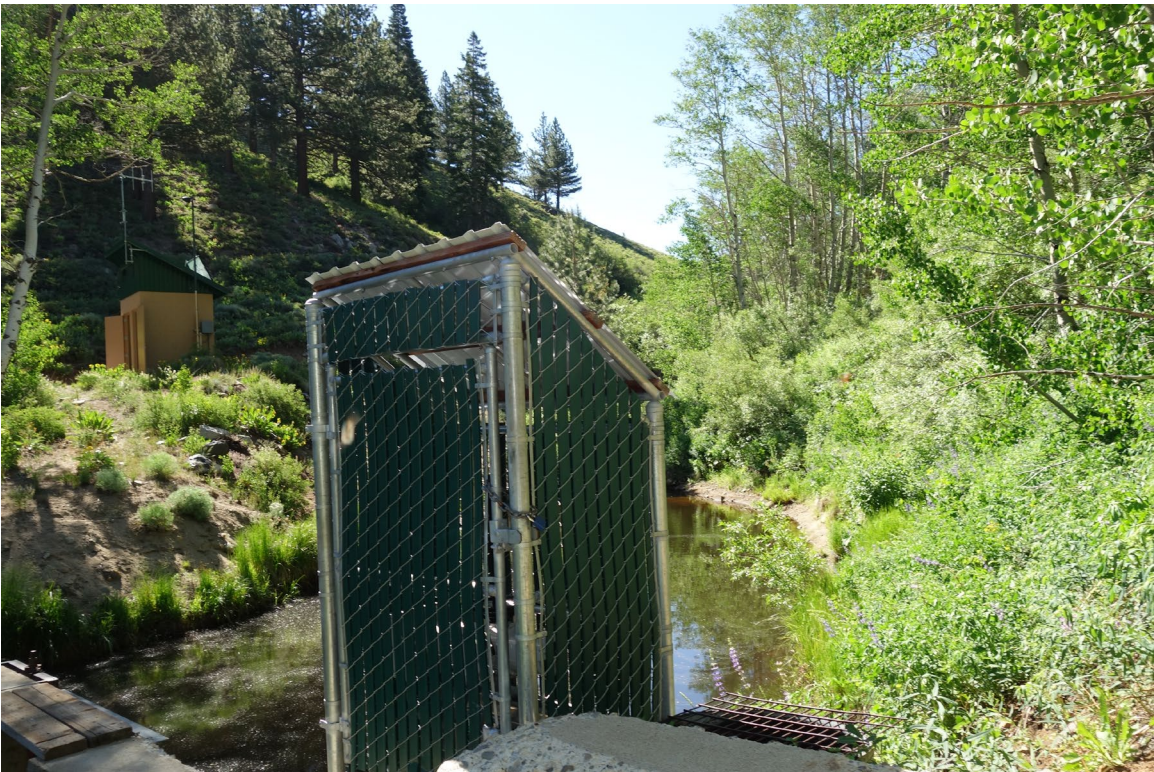
The exterior finishes were in good condition. It is important to maintain the finish, weather resistance and appearance of the structure. This project recommends work to protect the exterior building envelope including repairs to the exterior fencing, privacy slats, fence posts and hardware. This project would provide funding to protect the exterior of the building excluding the roof. It is recommended that this project be implemented in the next 8 - 10 years and it is also recommended that this project be scheduled on a cyclical basis to maintain the integrity of the structure.

Diversion Dam Actuator Building - Building #3764  
Description: View of the Structure.

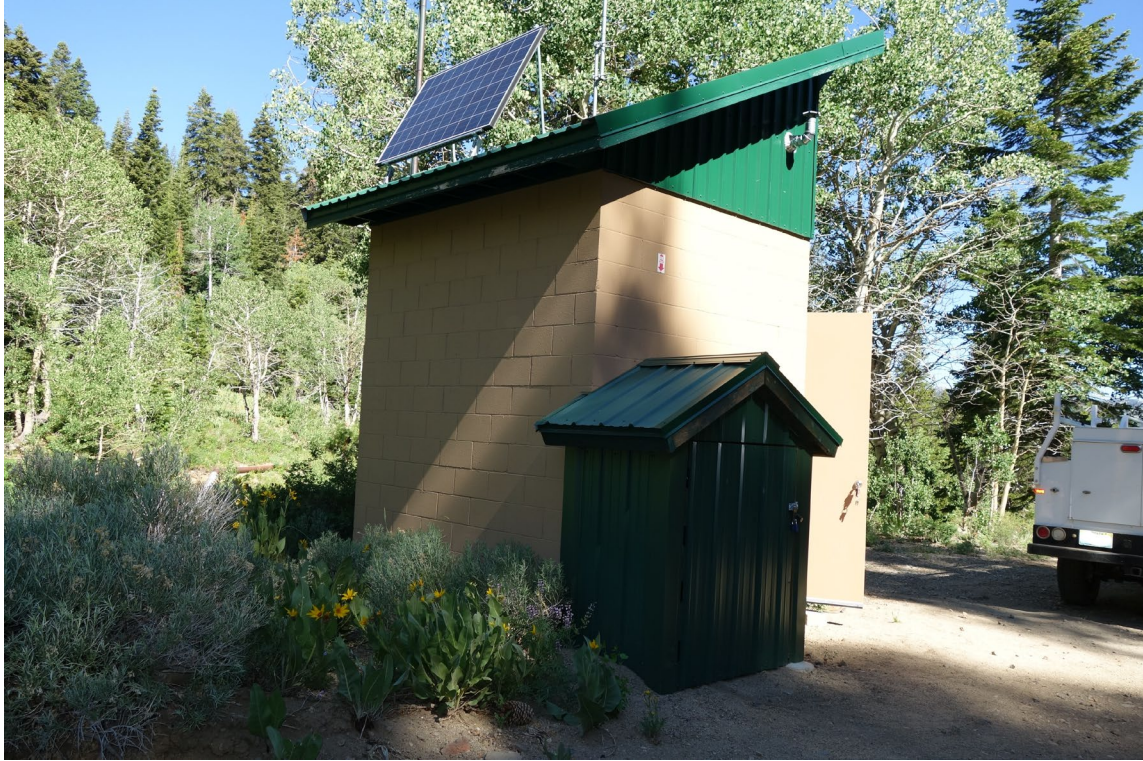
The exterior finishes were in good condition. It is important to maintain the finish, weather resistance and appearance of the building. This project would provide funding to protect the exterior of the building excluding the roof. Included in the cost is painting the concrete masonry unit walls and caulking of the flashing, fixtures and all other penetrations. It is recommended that the building be painted and caulked in the next 6 - 8 years and that this project be scheduled on a cyclical basis to maintain the integrity of the structure.

Diversion Dam Meter Building – Building #3763  
Description: View of the Building.

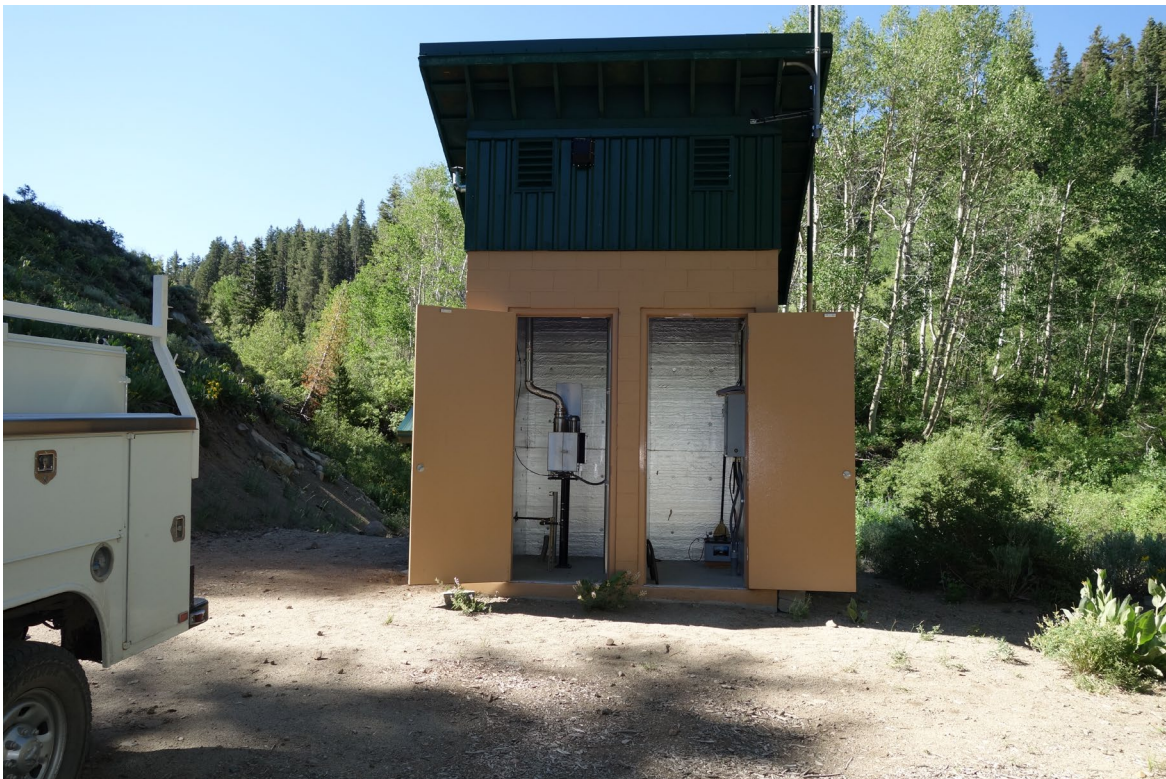
There is an out-swinging exterior door from the building that swings out over a step and does not have a landing that complies with IBC 2018. IBC Section 1008 which requires a landing to be not more than 1/2" below the threshold. This project would provide for the installation of a compliant landing for the door.  
 This project or a portion thereof was previously recommended in the FCA report dated 10/03/2016. It has been amended accordingly to reflect conditions observed during the most recent survey date of 06/29/2021.

Diversion Dam Meter Building – Building #3763  
Description: Exterior Landing Installation Needed.

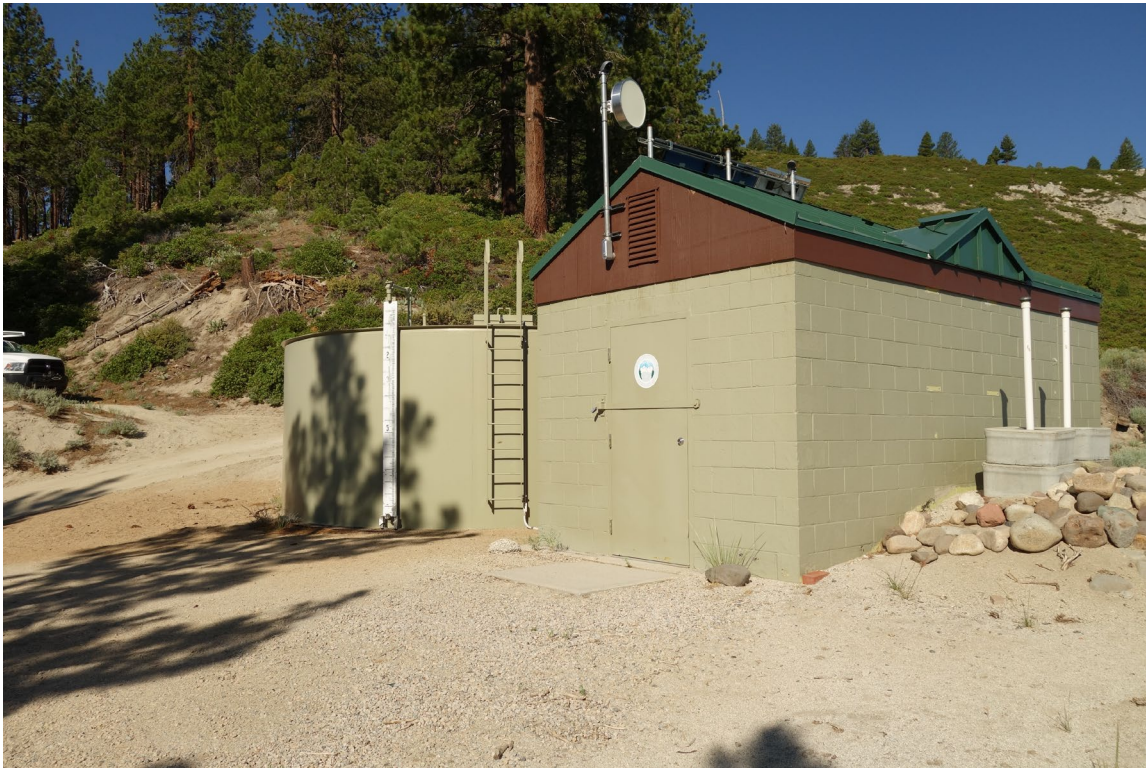
The exterior finishes were in fair condition with a little paint flaking starting on the north side that should be addressed. It is important to maintain the finish, weather resistance and appearance of the building. This project would provide funding to protect the exterior of the building excluding the roof. Included in the cost is painting the concrete masonry unit and T1-11 walls, and caulking of the flashing, fixtures and all other penetrations. It is recommended that the building be painted and caulked in the next 4 - 6 years and that this project be scheduled on a cyclical basis to maintain the integrity of the structure.

Lakeview Meter Building - Building #3761  
Description: View of the Building.

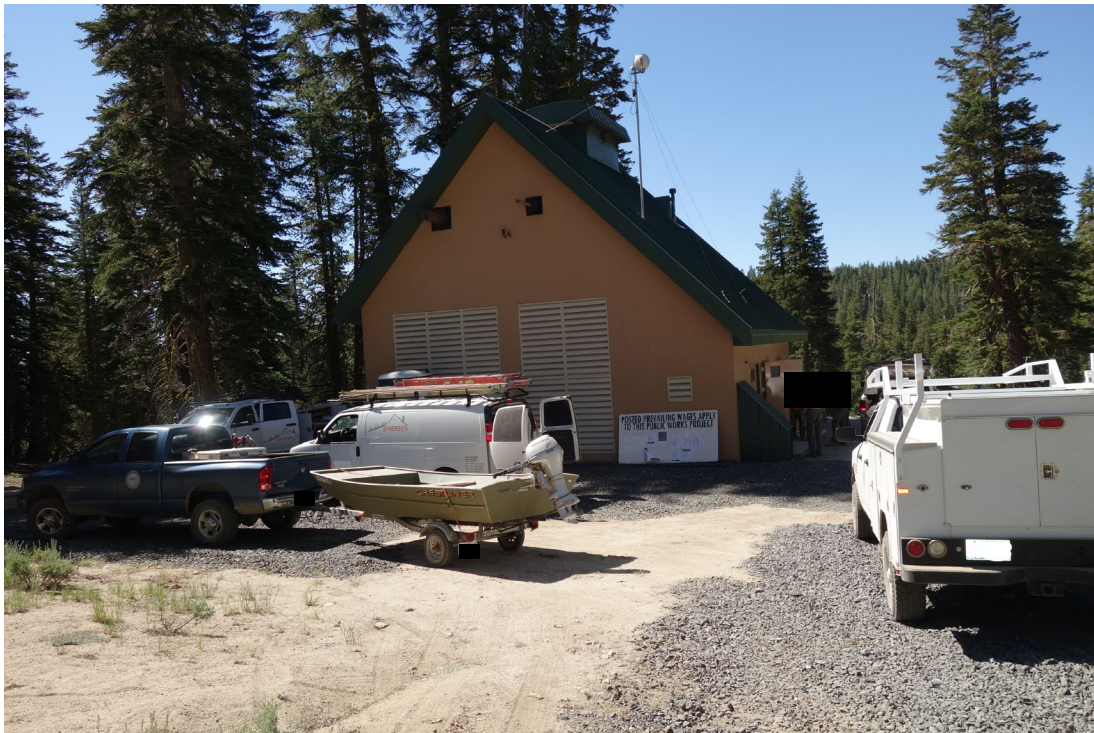
The exterior finishes were in good condition. It is important to maintain the finish, weather resistance and appearance of the building. This project would provide funding to protect the exterior of the building excluding the roof. Included in the cost is painting the concrete masonry unit walls and caulking of the flashing, fixtures and all other penetrations. It is recommended that the building be painted and caulked in the next 6 - 8 years and that this project be scheduled on a cyclical basis to maintain the integrity of the structure.

Generator Building - Building #3031  
Description: View of the Building.
