State of Nevada Department of Administration – Fleet Services Division Fleet Services Office – Las Vegas Facility Condition Analysis

FLEET SERVICES OFFICE LAS VEGAS

7060 La Cienega Street Las Vegas, Nevada 89119

Site Number: 9790 STATE OF NEVADA PUBLIC WORKS DIVISION FACILITY CONDITION ANALYSIS

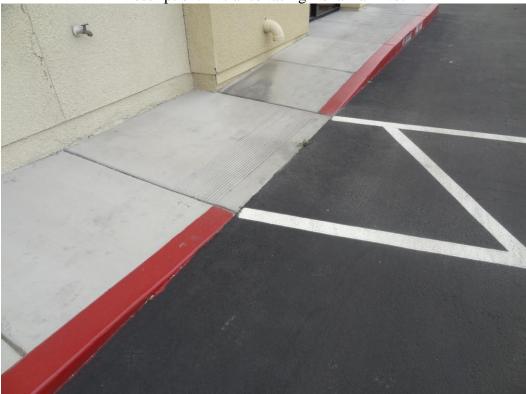
The Americans with Disabilities Act (ADA) provides for accessibility to sites and services for people with physical limitations. A compliant path of travel from the accessible parking spaces and from the public right of way to the entrance are necessary to comply with ADA accessibility requirements. The current path from the parking spaces is not in compliance due to a curb ramp that is too small and the downspout protruding into the path. There is also no path from the public right of way. This project would provide for complaint concrete walkways and curb ramps. This will require regrading, placement of P.C. concrete, signage, striping and any other necessary upgrades. The 2012 IBC, ICC/ANSI A117.1 - 2009, NRS 338.180 and the most current version of the ADA Standards For Accessible Design were used as a reference for this project.

Fleet Services – Las Vegas – FCA Building #3155 Description: ADA Path of Travel

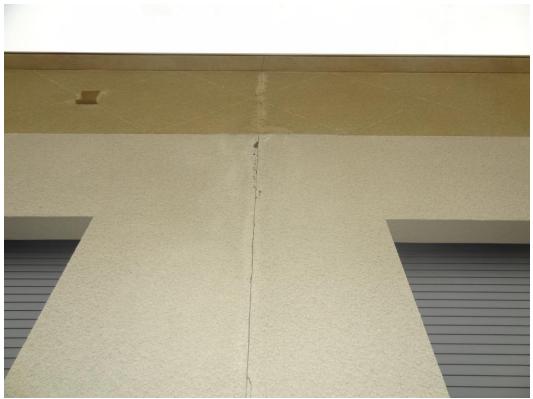
The exterior of the building is covered by an Exterior Insulation Finishing System (EIFS). There are at least 3 large cracks in the EIFS that should be repaired in order to maintain a waterproof envelope around the building. This project would provide funding to repair the cracks and bring the finish back to its original condition.

Fleet Services – Las Vegas – FCA Building #3155 Description: EIFS Damage

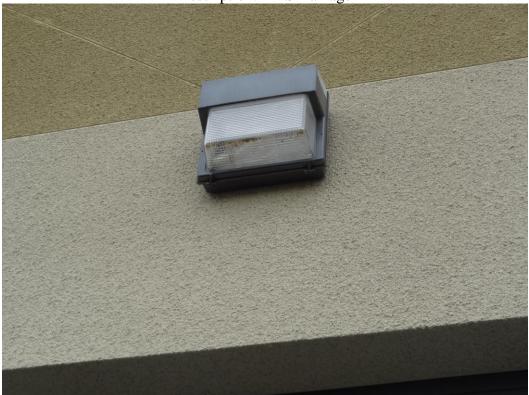
There are 12 wall pack lighting fixtures mounted on the exterior of the building. These light fixtures are old, failing and not energy efficient. This project would provide for the replacement of the 12 exterior lighting fixtures with new LED light fixtures, using existing wiring.

Fleet Services – Las Vegas – FCA Building #3155 Description: Exterior Wall Pack Light Fixtures

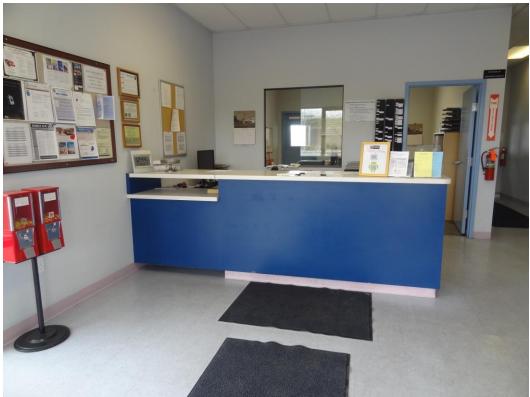
The interior finishes are in fair condition. It is recommended to paint the interior walls and ceilings at least once in the next 2-3 years and that this project be scheduled on a cyclical basis to maintain the integrity of the structure. Prior to painting, all surfaces should be repaired and prepped. An epoxy-based paint should be utilized in wet areas for durability.

Fleet Services – Las Vegas – FCA Building #3155 Description: Interior Finishes
