STATE OF NEVADA  
STATE PUBLIC WORKS DIVISION

FACILITY CONDITION ASSESSMENT REPORT FOR:

AGRICULTURE LAS VEGAS SITE  
2300 E SAINT LOUIS AVE  
LAS VEGAS, NV 89104-4211

Survey Date: 3/6/2023  
Distribution Date: 12/5/2023

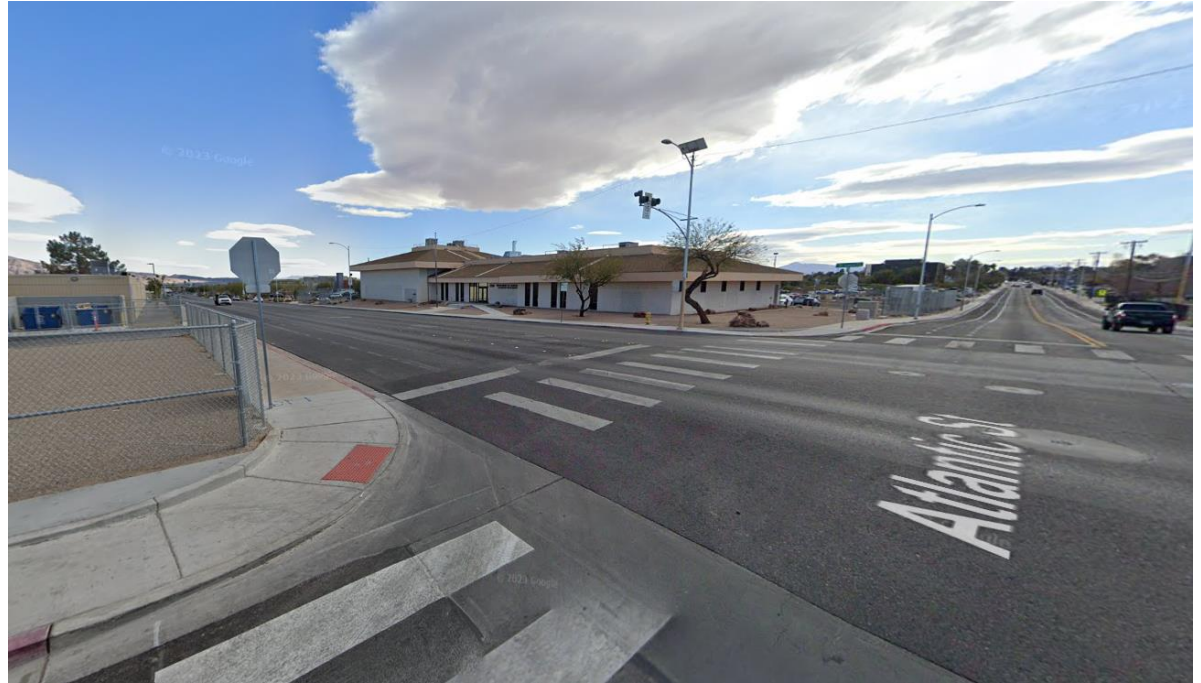
PROJECT ID: 9793-ENR-1

### DEFERRED EXTERIOR SITE LIGHTING UPGRADE

There are four existing light poles in the parking lot. They are the older metal halide type fixtures and are not energy efficient. In addition, the site lighting levels are insufficient to reduce security and safety concerns. This project would provide for the purchase and installation of 4 LED exterior light fixtures on the existing poles and installation of 5 additional light poles, trenching, bases, fixtures and electrical. This project or a portion thereof was previously recommended in the FCA report dated 04/10/2012. It has been amended accordingly to reflect conditions observed during the most recent survey date of 03/06/2023.

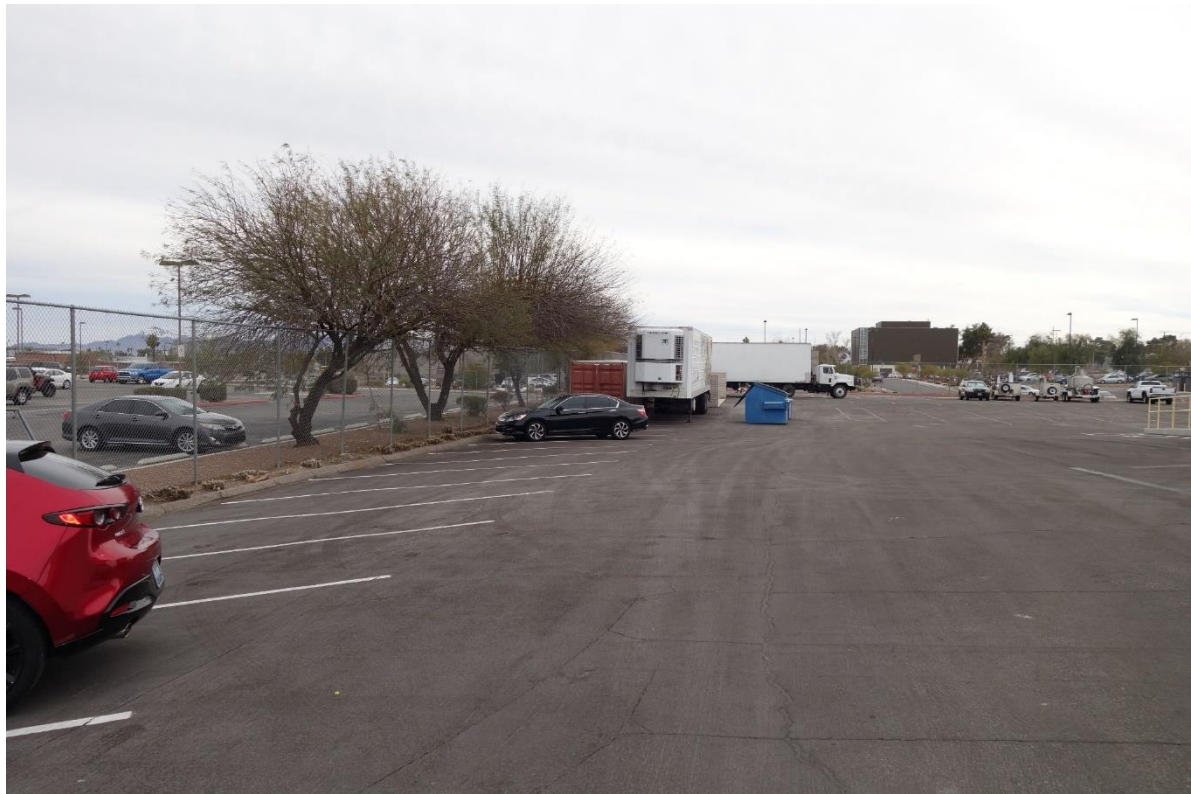
PROJECT ID: 9793-SIT-2

### DEFERRED LANDSCAPING AND IRRIGATION UPGRADE

The existing landscaping consists of limited trees and shrubs, rocks, and an irrigation system. The west side of the building is devoid of vegetation and one of the trees on the north side is damaged. This project would provide for vegetation replacement as needed, add new shrubbery, trees and improve the irrigation systems. This project or a portion thereof was previously recommended in the FCA report dated 04/10/2012. It has been amended accordingly to reflect conditions observed during the most recent survey date of 03/06/2023.

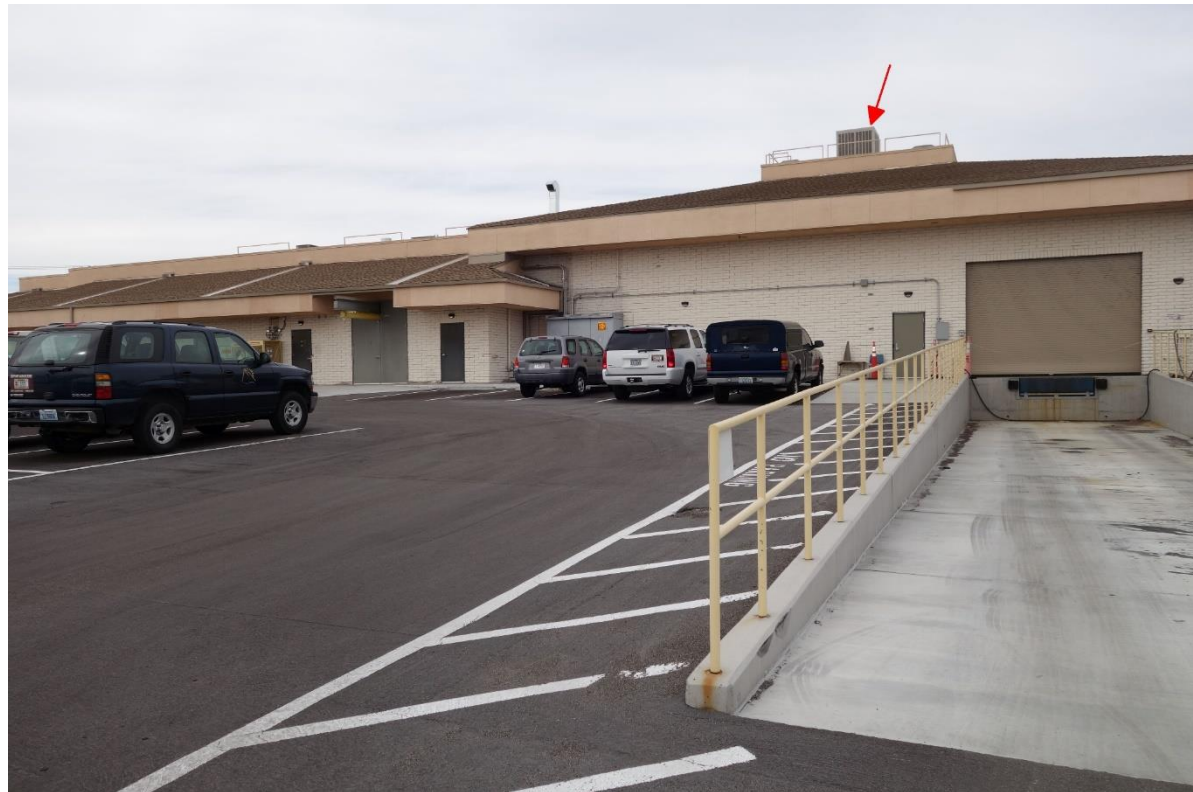
PROJECT ID: 3113-EXT-1

### DEFERRED EXTERIOR FINISHES

The exterior finishes were in poor condition. The exterior wall paint is faded and discolored in many areas. It is important to maintain the finish, weather resistance and appearance of the building. This project would provide funding to protect the exterior of the building excluding the roof. Included in the cost is painting the brick masonry and stucco and caulking of the windows, flashing, fixtures and all other penetrations. It is recommended that the building be painted and caulked in the next 2 - 3 years and that this project be scheduled on a cyclical basis to maintain the integrity of the structure.
