State of Nevada
Department of Administration
Public Works Division / Buildings & Grounds Section
Old Las Vegas Metro Police Station
Facility Condition Analysis

OLD LAS VEGAS METRO POLICE STATION

2300 East St. Louis
Las Vegas, Nevada 89104

Site Number: 9793
STATE OF NEVADA PUBLIC WORKS DIVISION
FACILITY CONDITION ANALYSIS

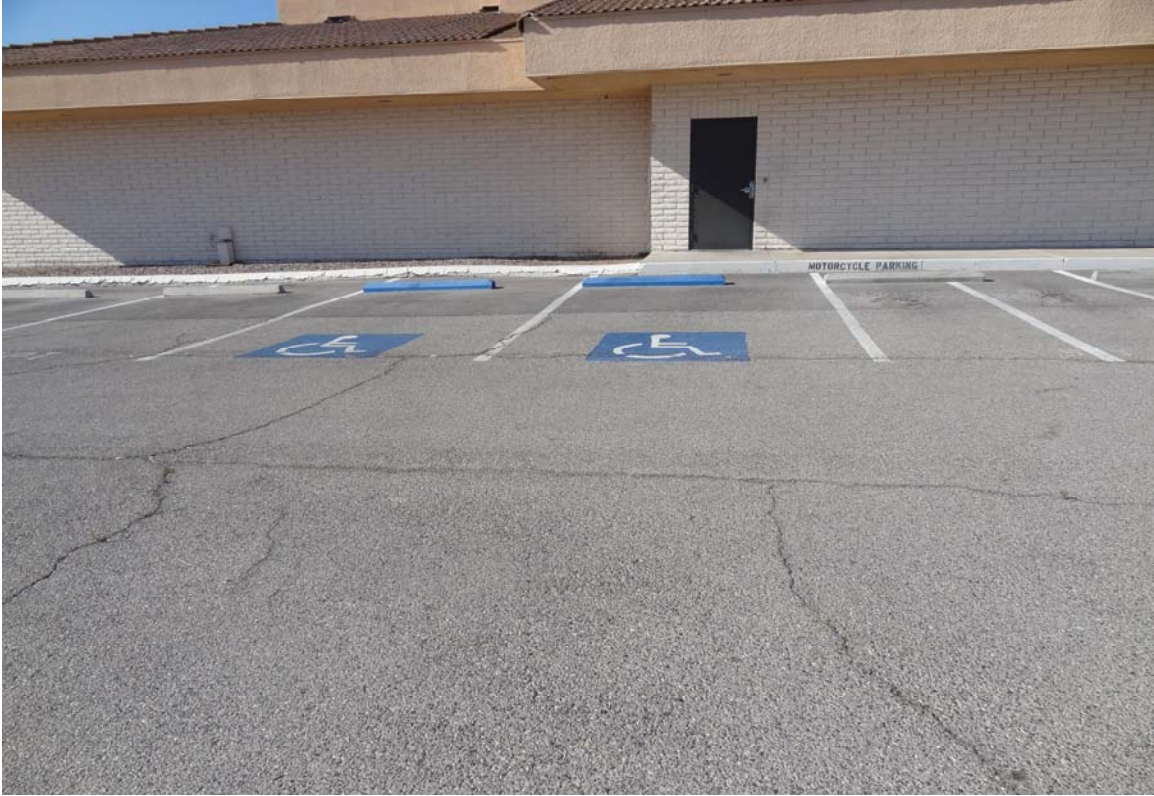
Old Las Vegas Metro Police Station Site - Site #9793

The Old Metro Police Station site is located in the northwest corner of the East Sahara State Complex. The site is mostly AC paving for parking and is fully fenced. There are no ADA compliant parking areas and the pavement is in need of crack filling and sealing. It is served by city water with backflow prevention, city sewer, electrical and natural gas. The site was vacant at the time of survey.

Description: View of Non ADA compliant parking spaces, south parking area.

PRIORITY CLASS 1 PROJECTS**Total Construction Cost for Priority 1 Projects: \$25,000****Currently Critical****Immediate to Two Years****ADA PARKING SPACES AND PATH OF TRAVEL****Project Index #: 9793ADA1****Construction Cost \$25,000**

The Americans with Disabilities Act (ADA) provides for accessibility to sites and services for people with physical limitations. Concrete parking spaces, a passenger loading area and path of travel to the accessible entrance are necessary to comply with ADA accessibility requirements. This project would provide for two ADA parking spaces including a concrete van accessible ADA parking and loading space and walkway to the existing sidewalk. This will require regrading, installing P.C. concrete, striping, signage and any other necessary upgrades. NRS 338.180, IBC - 2006, ICC/ANSI A117.1 - 2003 and the most current version of the Americans with Disabilities Act Accessibility Guidelines (ADAAG) were used as a reference for this project. This project should be implemented concurrently with the ACCESSIBLE ENTRANCE MODIFICATIONS project.

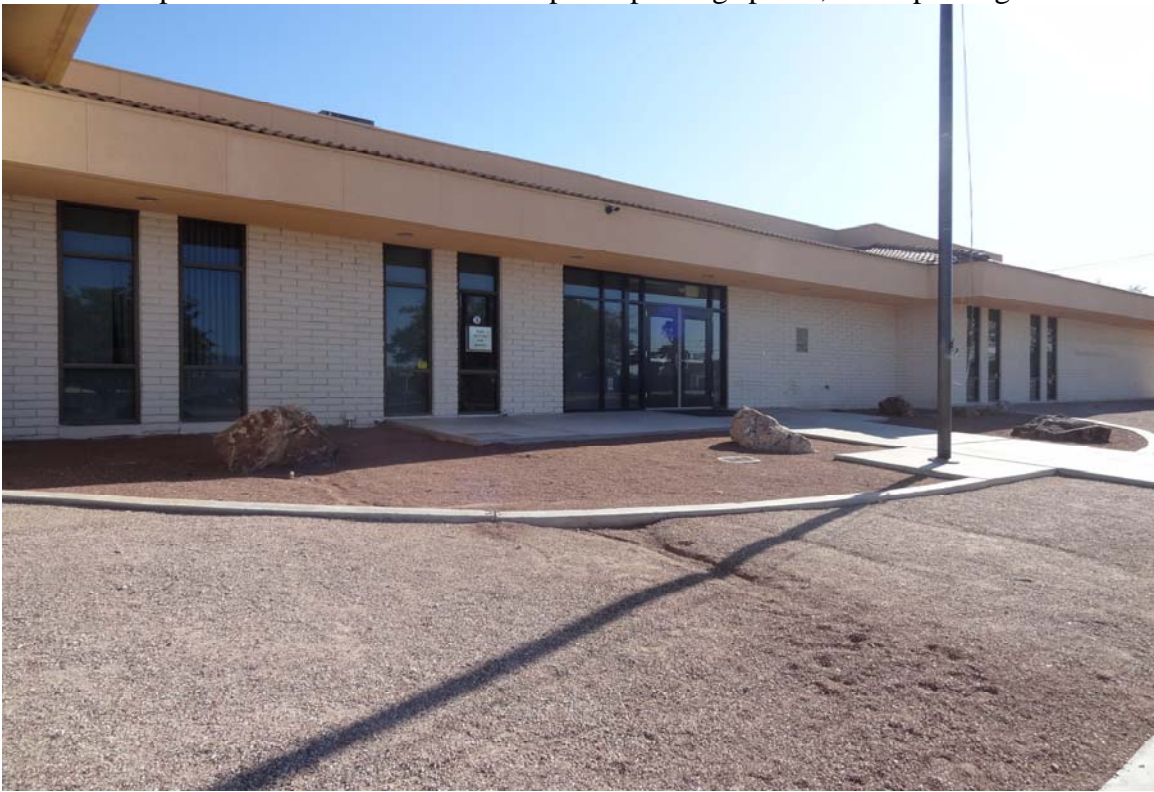
Old Las Vegas Metro Police Station Site - Site #9793

The current entrance to the building is on the north elevation and is not ADA compliant. There were no accessible entrances to the building at the time of the survey. The Americans with Disabilities Act (ADA) provides for accessibility to sites and services for people with physical limitations. In order to comply with the ADA, it is recommended to modify the building and site to provide a compliant entrance from the ADA parking spaces and from the public right of way. The 2006 IBC, ICC/ANSI A117.1 - 2003 and the most current version of the Americans With Disabilities Act Accessibility Guidelines (ADAAG) were used as a reference for this project. This project should be implemented concurrently with the ADA PARKING SPACES AND PATH OF TRAVEL project.

Description: Public entrance, north side of building, non ADA compliant.

PRIORITY CLASS 1 PROJECTS**Total Construction Cost for Priority 1 Projects: \$510,634****Currently Critical****Immediate to Two Years****ACCESSIBLE ENTRANCE MODIFICATIONS****Project Index #: 3113ADA4****Construction Cost \$100,000**

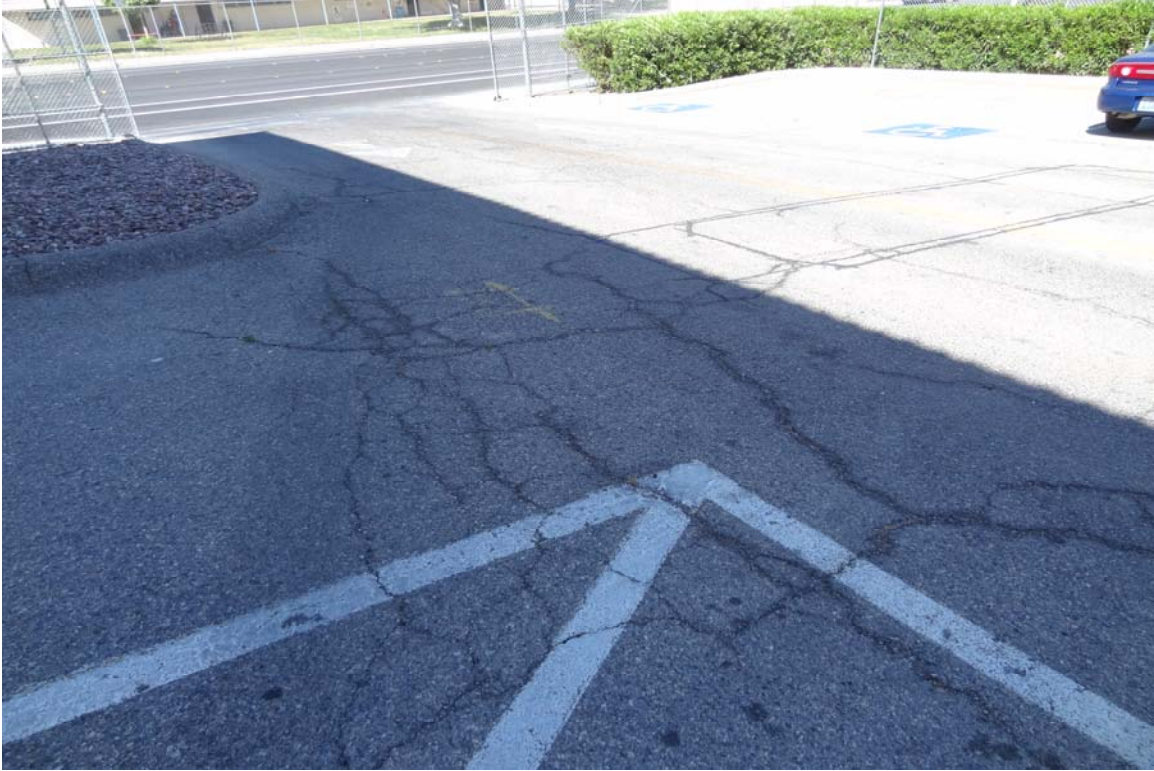
Old Las Vegas Metro Police Station Site - Site #9793
Description: View of Non ADA compliant parking spaces, east parking area.

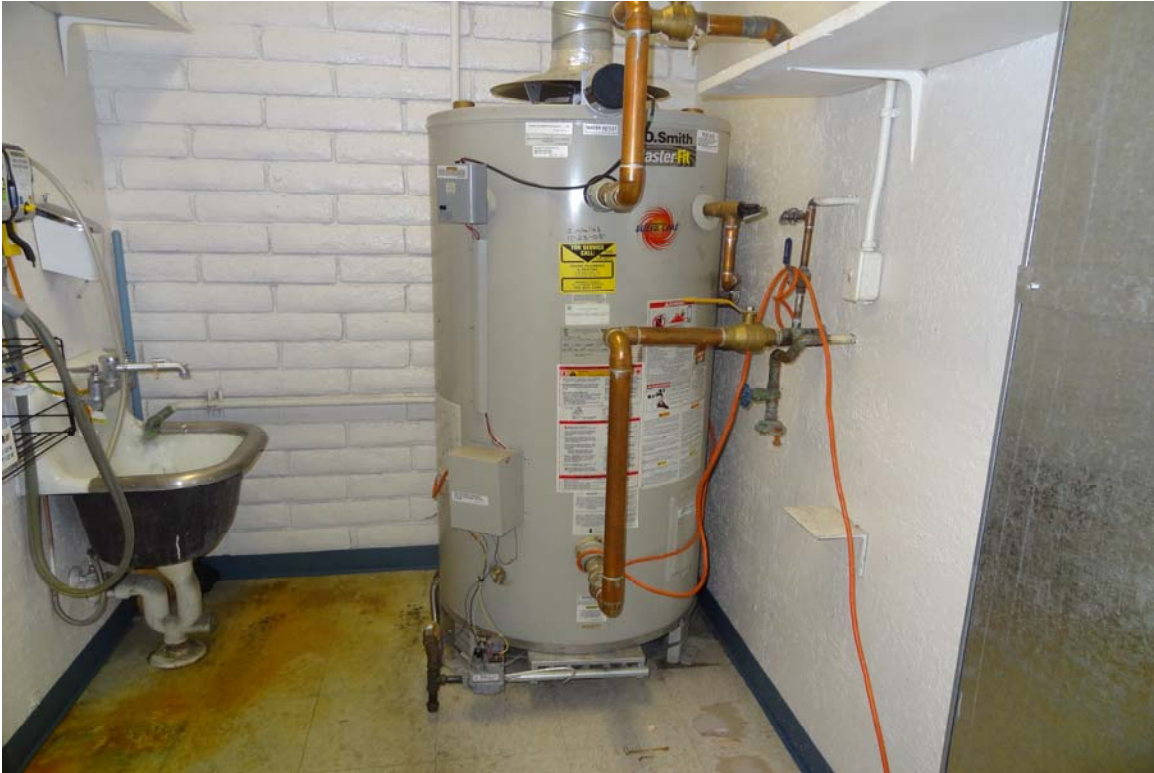
The existing gas fired water heater appears to not have proper combustion air and is larger than needed. The closet where it is located used to contain the roof access ladder which has been modified and no longer is usable. This project would provide for the removal of the gas fired water heater, installation of a gas fired tankless water heater and a new roof access ladder including all required gypsum board repairs and painting.

Old Las Vegas Metro Police Station - Building #3113
Description: View of the water heater.

WATER HEATER / ROOF ACCESS MODIFICATIONS**Project Index #: 3113PLM3**
Construction Cost \$9,500

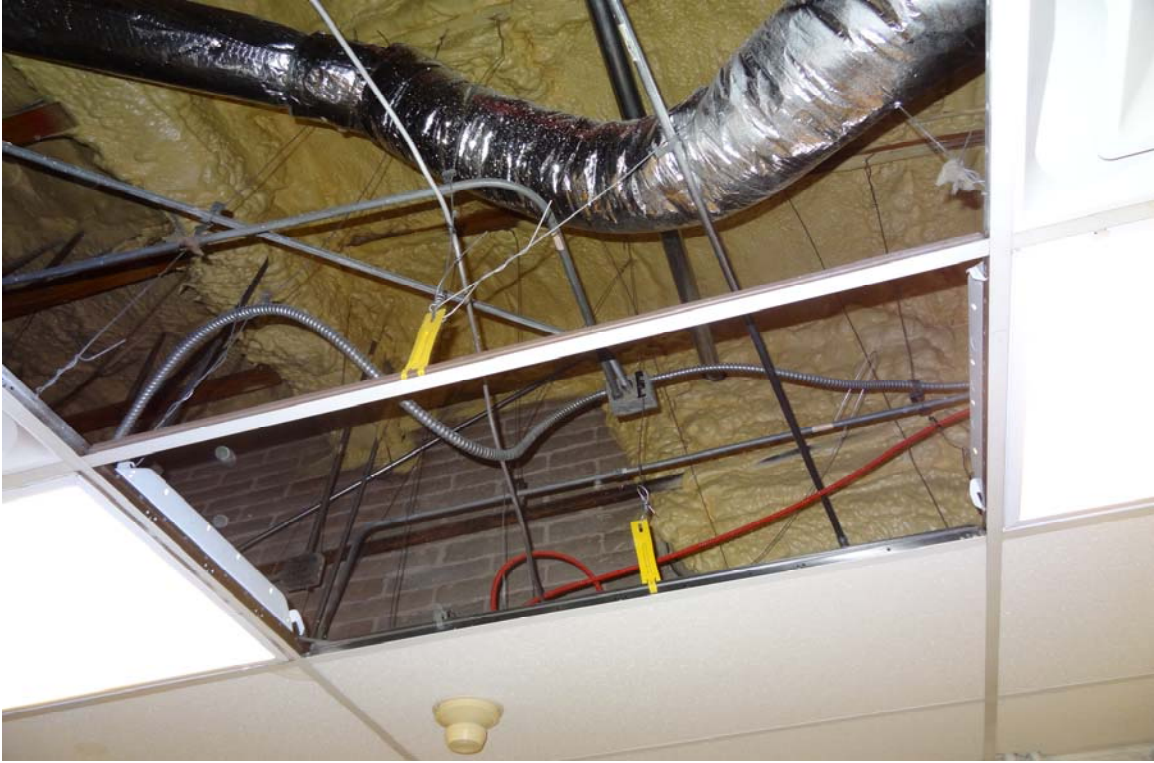
There are several areas of stained and / or damaged ceiling tiles in the building. This project would provide for the replacement of stained or missing tiles throughout the building. It is recommended that this project be executed after the roof is replaced.

Old Las Vegas Metro Police Station - Building #3113
Description: Missing ceiling tiles.

CEILING TILE REPLACEMENT

Project Index #: 3113INT4
Construction Cost \$2,500

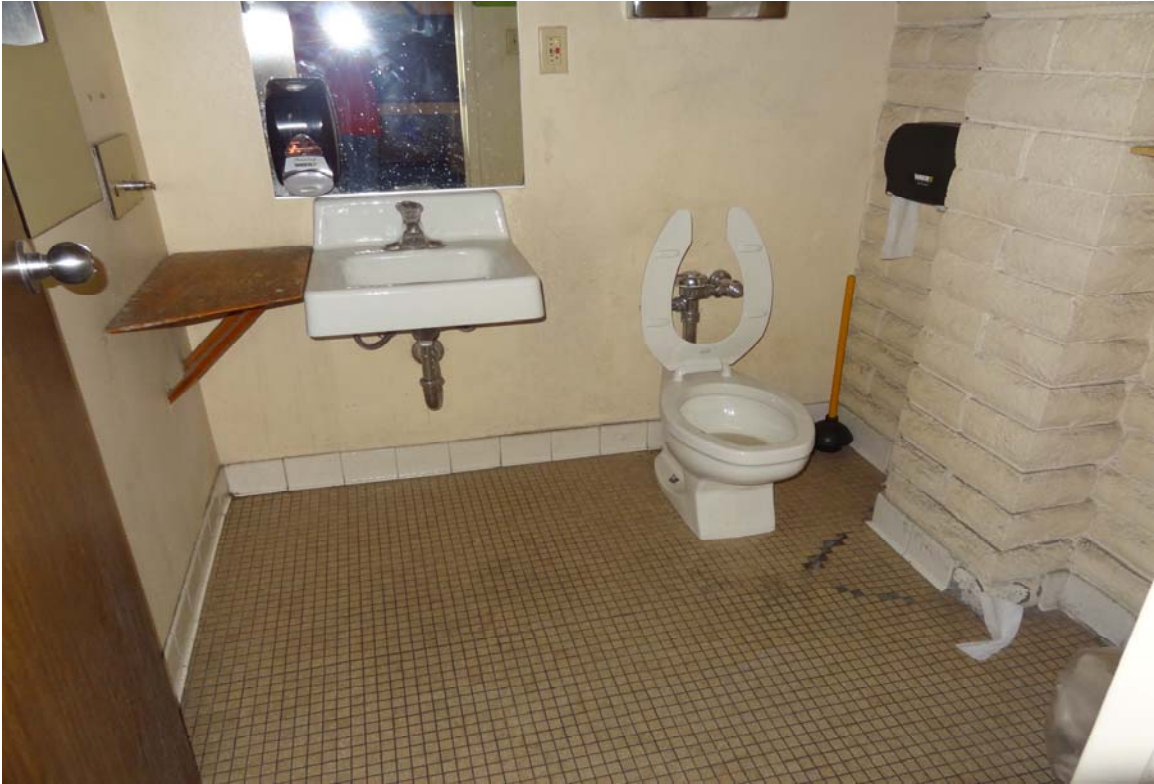
The building does not have fully compliant ADA accessible restrooms. The existing restrooms do not meet all of the Americans with Disabilities Act (ADA) requirements. A complete retrofit may be necessary. This project would provide funding for remodeling the Men's and Women's restrooms into ADA compliant restrooms. These items may include a new sink, toilet, hardware, mirrors, fixtures, flooring and paint. NRS 338.180, IBC - 2006, ICC/ANSI A117.1 - 2003 and the most current version of the Americans with Disabilities Act Accessibility Guidelines (ADAAG) were used as a reference for this project.

Old Las Vegas Metro Police Station - Building #3113
Description: Restroom in shop area.

ADA RESTROOM UPGRADE**Project Index #: 3113ADA3****Construction Cost \$30,000**

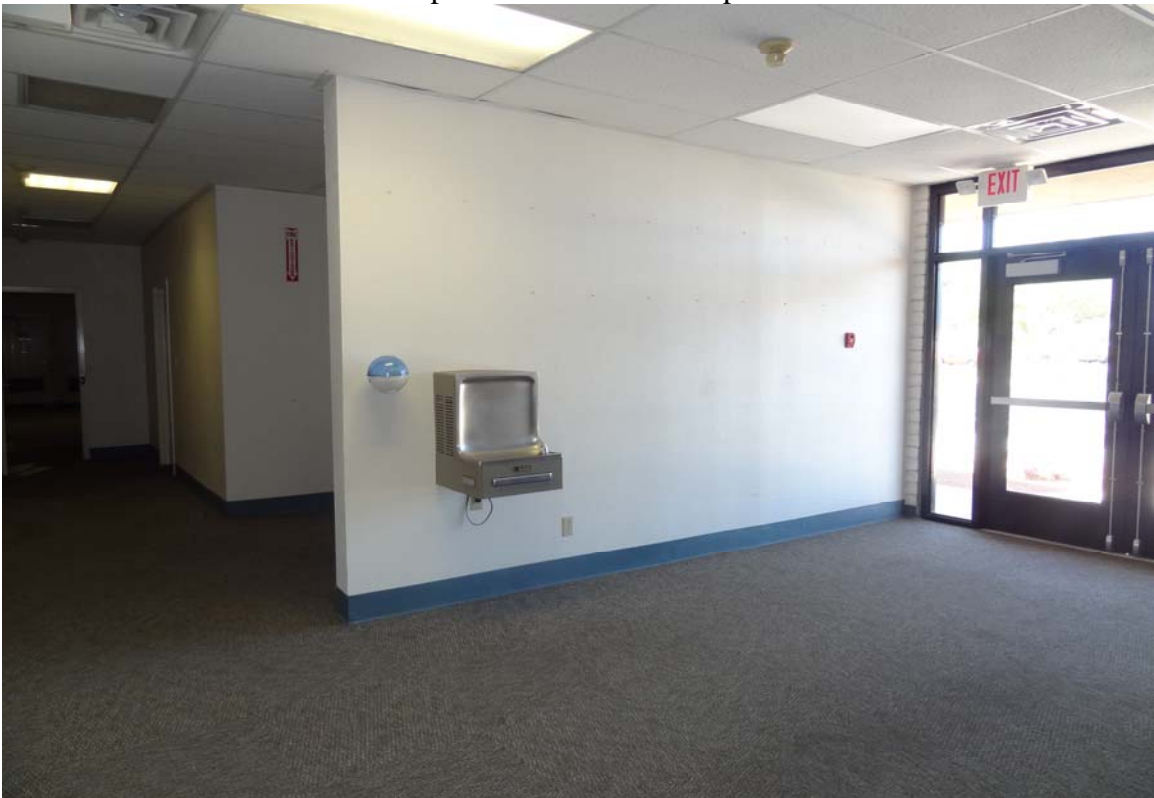
This building contains a water fountain near the main entrance. The 2006 IBC Section 1109.5 states where a water fountain is provided, at least half should be accessible. This project would provide funding for the purchase and installation of a new accessible fixed high/ low ADA drinking fountain.

Old Las Vegas Metro Police Station - Building #3113
Description: Lobby & non ADA compliant drinking fountain.

DUAL LEVEL DRINKING FOUNTAIN INSTALLATION**Project Index #: 3113ADA2****Construction Cost \$4,000**
