CAMPOS OFFICE & PARKING COMPLEX SITE

Site Number: 9794
STATE OF NEVADA PUBLIC WORKS DIVISION
FACILITY CONDITION ANALYSIS

Report distributed in September 2022

SPWD Facility Condition Analysis - 9794

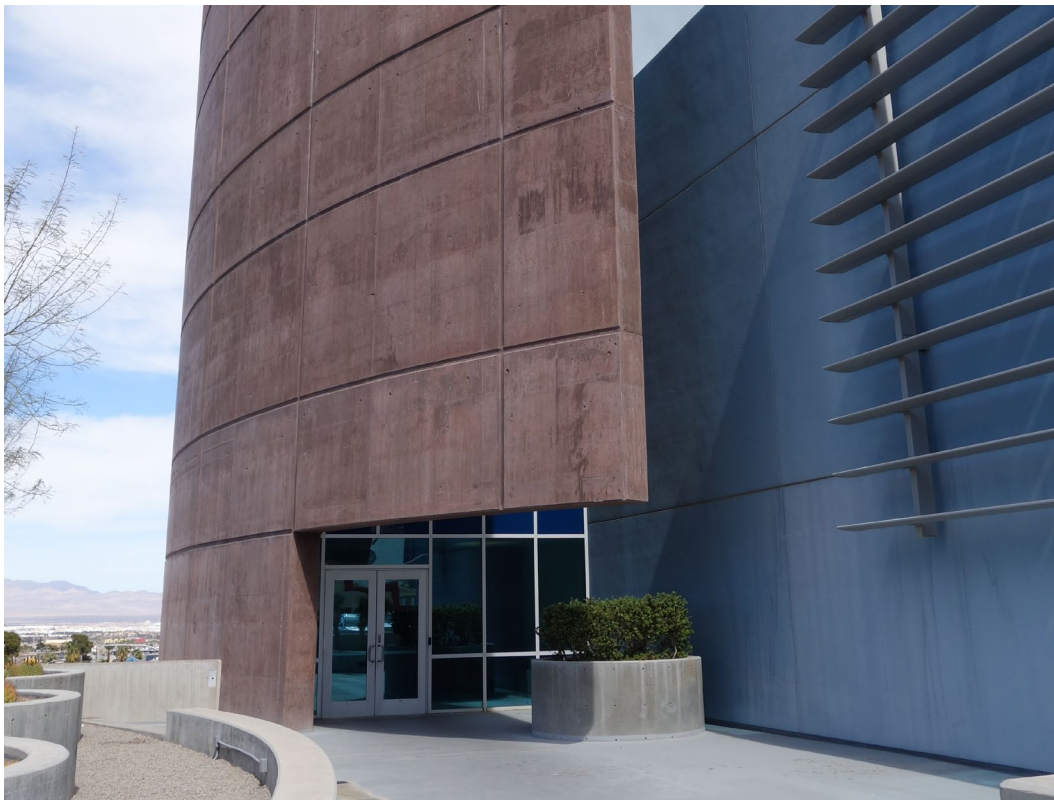
The exterior finishes were fading and in need of re-coating. It is important to maintain the finish, weather resistance and appearance of the building. This project would provide funding to protect the exterior of the building excluding the roof. Included in the cost is power washing, priming and painting and caulking of the joints, windows, flashing, fixtures and all other penetrations. It is recommended that the building be painted in the next 2 - 3 years and that this project be scheduled on a cyclical basis to maintain the integrity of the structure.

Campos Office & Parking Complex – FCA Building #2790
Description: Exterior Finishes of the Building.

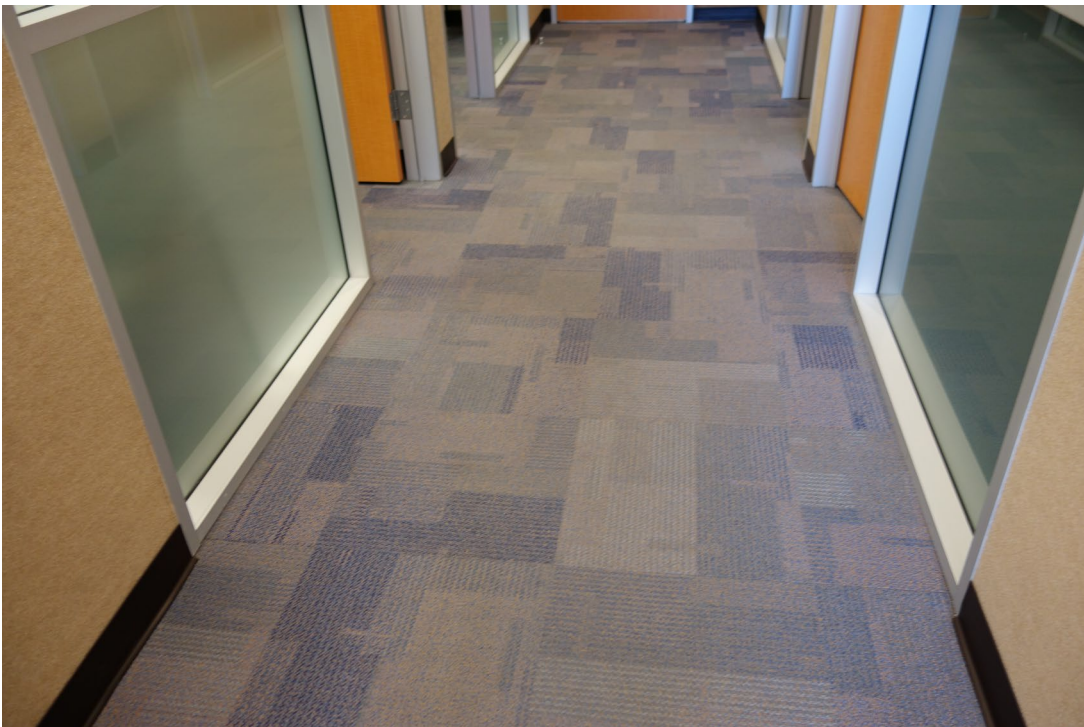
The carpet in the building is showing signs of wear and should be scheduled for replacement. It is recommended that the carpet be replaced with heavy duty commercial grade carpet in the next 4 - 5 years.

Campos Office & Parking Complex – FCA Building #2790
Description: Office Carpeting Showing Wear.

Project Index #: 2790INT2**FLOORING REPLACEMENT****Construction Cost \$678,000**

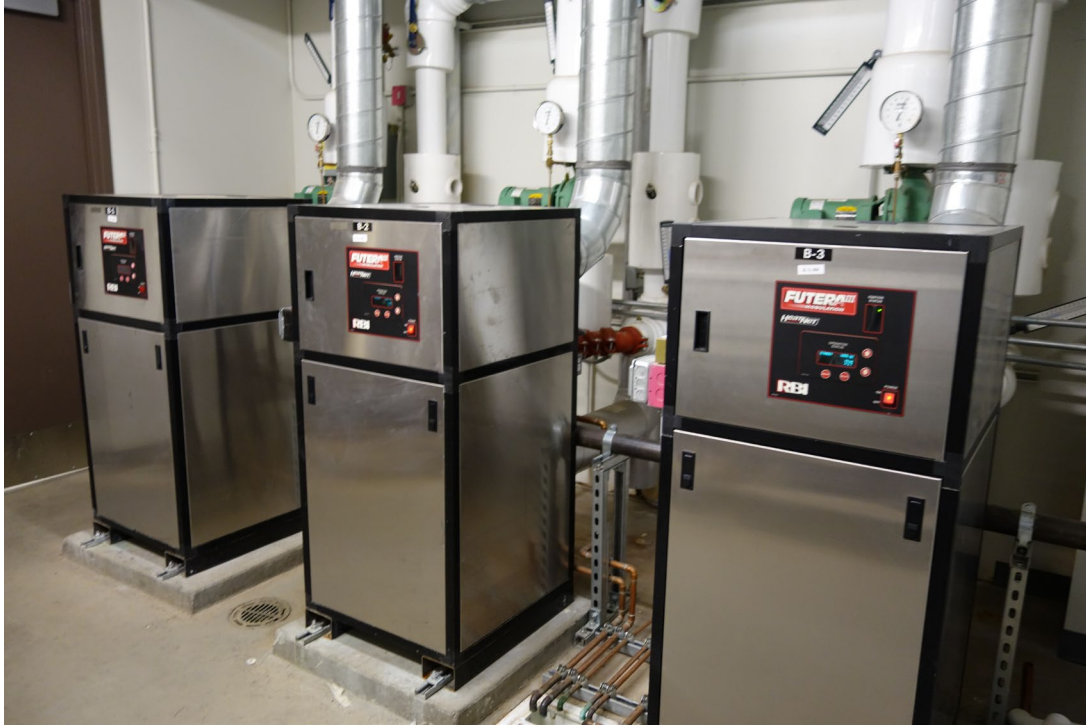
The hot water boilers servicing the building were in fair condition at the time of the survey, however they are approaching the end of their expected life cycle and planned for replacement. This project would provide for the removal and disposal of the existing boilers and controls with new equipment including all required connections to utilities and equipment in the next 10 years. The estimate is based on two-1,000 Mbh maximum output hot water boilers.

Campos Office & Parking Complex – FCA Building #2790
Description: Boiler Replacement Planning Recommended.

PRIORITY CLASS 3 PROJECTS**Total Construction Cost for Priority 3 Projects: \$1,597,700****Long-Term Needs****Four to Ten Years****Project Index #: 2790HVA1****BOILER REPLACEMENT****Construction Cost \$495,700**
