FACILITY CONDITION ASSESSMENT REPORT FOR:

OFFICE OF THE MILITARY NATIONAL GUARD

BATTLE BORN YOUTH CHALLENGE ACADEMY SITE 100 UNIVERSITY AVE CARLIN, NV 89822-

Survey Date: 5/9/2022

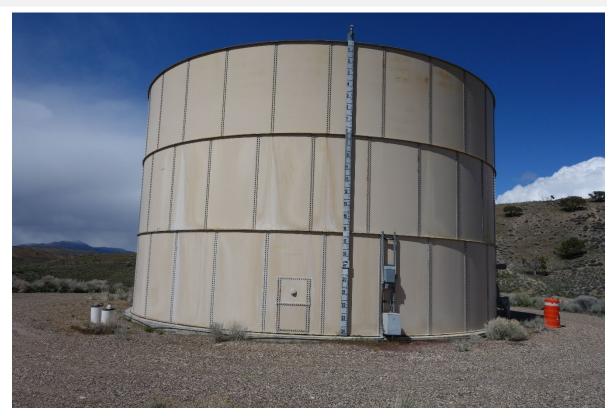
4266 WATER TANK

The interior and exterior finishes on the water storage tank are original and show signs of corrosion and deterioration. This project recommends a complete recondition of the 246,000-gallon tank's interior and exterior and complete sanitization of tank interior at the conclusion of the project.

This project is in design under CIP 21-M47, and the estimate is based off that project.

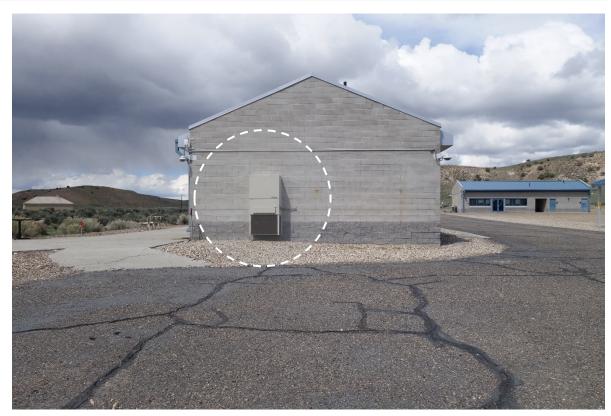
DEFERRED HVAC SYSTEMS REPLACEMENT

The HVAC system is original to the building and should be planned for replacement. It is not energy efficient and has reached the end of its expected and useful life. The R-22 refrigerant in the cooling system is no longer EPA compliant and its production was phased out completely January 1, 2020. This project would provide for installation of a new HVAC system and cleaning of the existing duct work and grilles. This project includes removal and disposal of the existing HVAC system and all required connections to utilities.

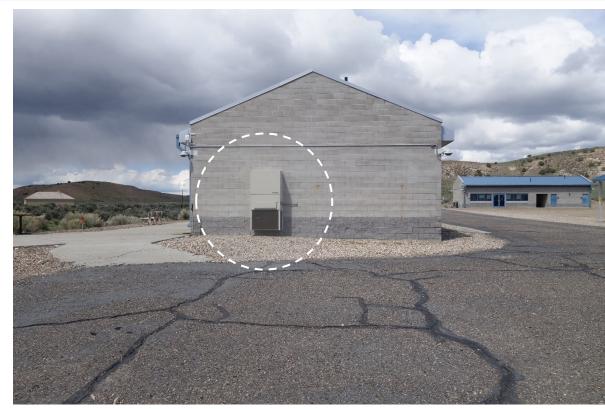
DEFERRED HVAC SYSTEMS REPLACEMENT

The HVAC system is original to the building and should be planned for replacement. It is not energy efficient and has reached the end of its expected and useful life. The R-22 refrigerant in the cooling system is no longer EPA compliant and its production was phased out completely January 1, 2020. This project would provide for installation of a new HVAC system and cleaning of the existing duct work and grilles. This project includes removal and disposal of the existing HVAC system and all required connections to utilities.

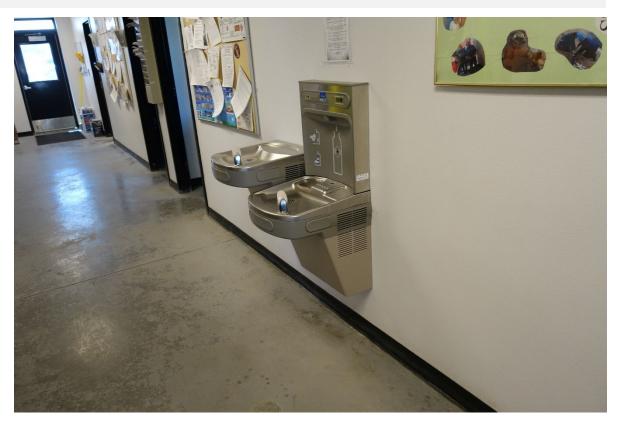
DEFERRED FLOORING REPAIRS

The sealed concrete in the building is damaged and reaching the end of its useful life. It is recommended that the concrete be sealed in order to extend its useful life. This project would provide for stripping the concrete and applying a new coat of sealant in the next two to three years.

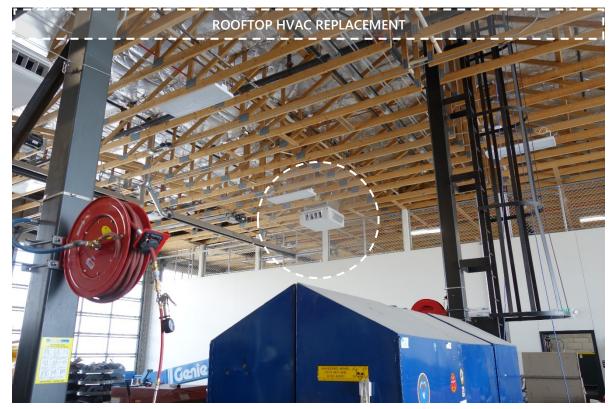
IN PROGRESS HVAC REPLACEMENT

The three packaged rooftop units (RTU's) and make-up air systems have reached the end of their useful life. This project recommends the replacement of the RTU's and two indirect fired makeup air units including cleaning the existing duct work and grilles and test balance. This project includes removal and disposal of the existing HVACsystem and all required connections to utilities. This project is in design under CIP 21-M19 and the estimate is based off that project.

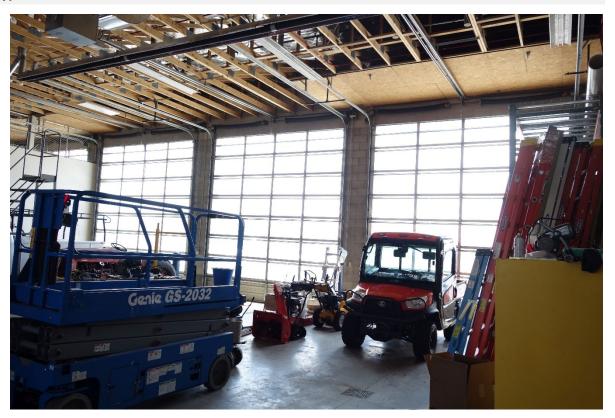
DEFERRED OVERHEAD DOOR REPLACEMENT

The existing overhead sectional doors are original to the building, thermally inefficient and have reached the end of their useful life. This project recommends the replacement of all 9 overhead doors.

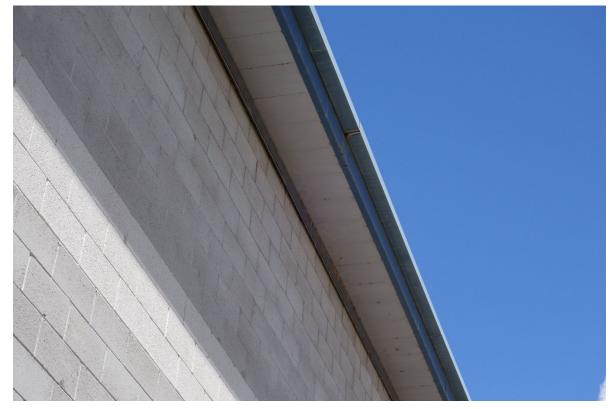
DEFERRED RAIN GUTTER REPLACEMENT

The rain gutters for the building are failing and causing sidewalk deterioration on the southeast side of the building. This project would fund the replacement of the gutter system. Removal and disposal of the existing gutter system is included in this estimate.

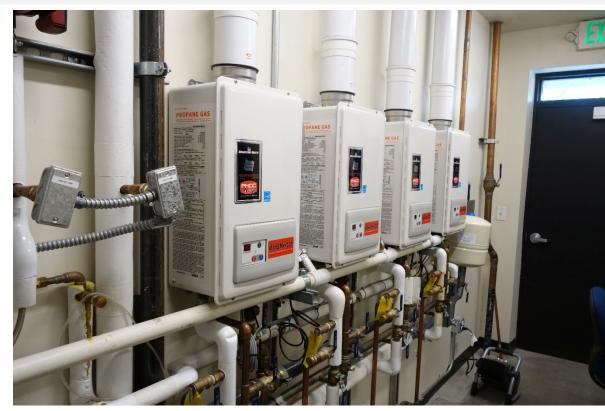
DEFERRED WATER HEATER REPLACEMENT

There are 4 tankless water heaters and one electric water heater that are not keeping uр with demand and recommended to be replaced. The average life span of a water heater is eight to ten years. With the passage of time and constant use, this unit is showing signs of wear and should be scheduled for replacement in the next 2 - 3 years. It is recommended that new propane-fired water heaters installed. Removal and disposal of the existing equipment is included in this estimate.

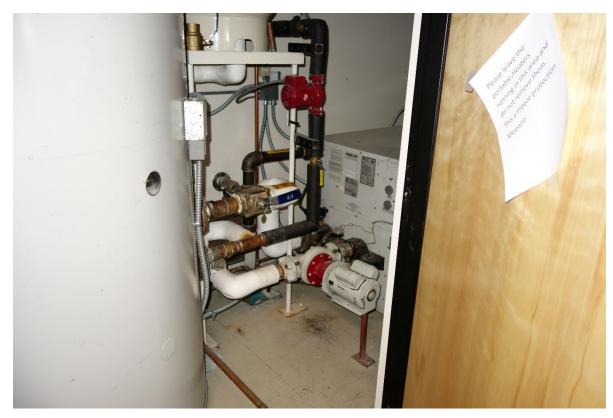
IN PROGRESS WATER HEATER REPLACEMENT

There is a 432 gallon, 985 MBH input propane-fired water heater in the building. The average life span of a water heater is eight to ten years. With the passage of time and constant use, this unit is showing signs of wear and should be scheduled for replacement in the next 2 - 3 years. It is recommended that a new propane-fired water heater be installed. Removal and disposal of the existing equipment is included in this estimate.
