STATE OF NEVADA
STATE PUBLIC WORKS DIVISION

FACILITY CONDITION ASSESSMENT REPORT FOR:

OFFICE OF THE MILITARY
NATIONAL GUARD

SITE #: 9796 BATTLE BORN YOUTH CHALLENGE ACADEMY SITE
100 UNIVERSITY AVE
CARLIN, NV 89822-

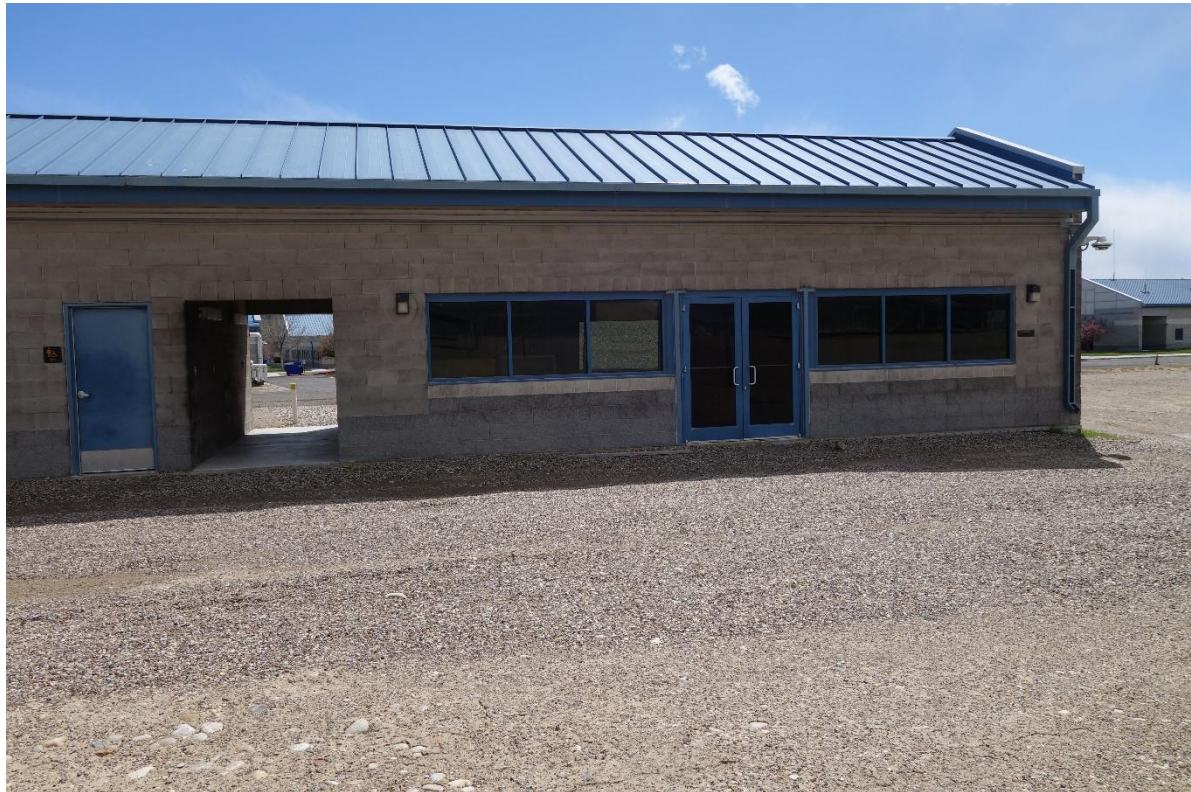
The HVAC system is original to the building and should be planned for replacement. It is not energy efficient and has reached the end of its expected and useful life. The R-22 refrigerant in the cooling system is no longer EPA compliant and its production was phased out completely January 1, 2020. This project would provide for installation of a new HVAC system and cleaning of the existing duct work and grilles. This project includes removal and disposal of the existing HVAC system and all required connections to utilities.

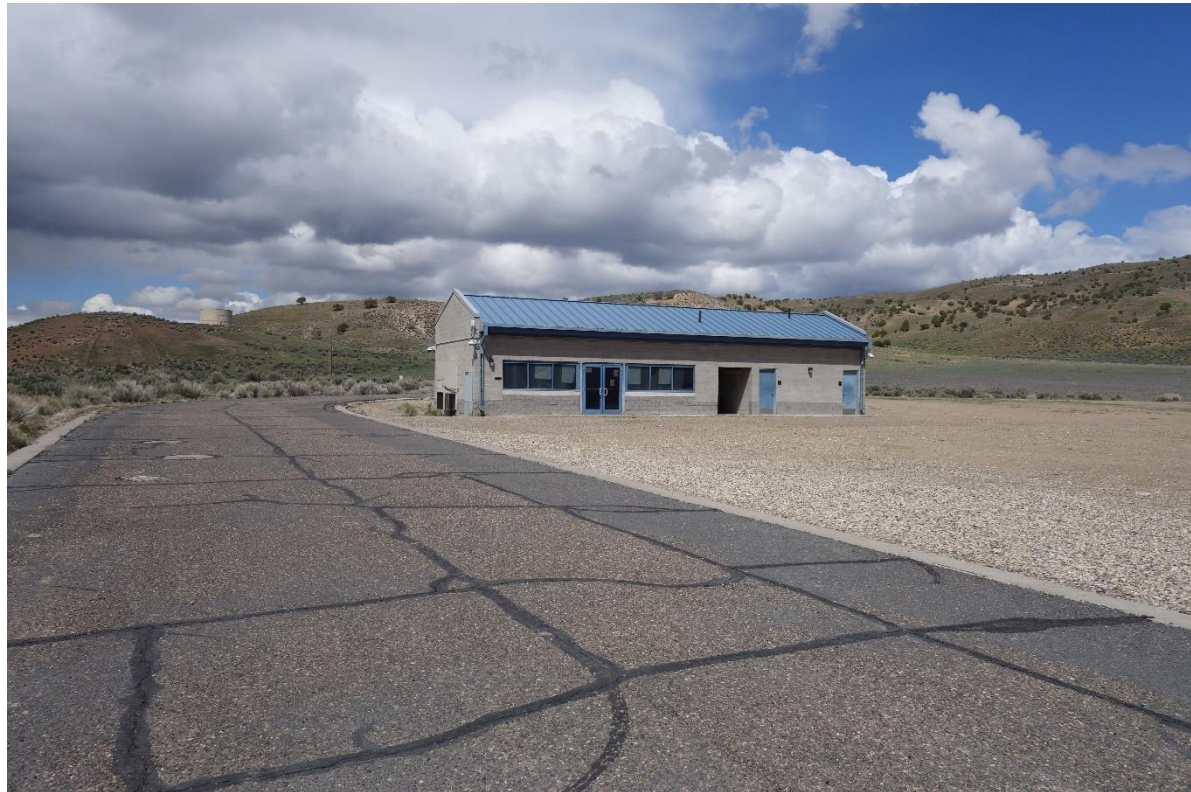
The HVAC system is original to the building and should be planned for replacement. It is not energy efficient and has reached the end of its expected and useful life. The R-22 refrigerant in the cooling system is no longer EPA compliant and its production was phased out completely January 1, 2020. This project would provide for installation of a new HVAC system and cleaning of the existing duct work and grilles. This project includes removal and disposal of the existing HVAC system and all required connections to utilities.

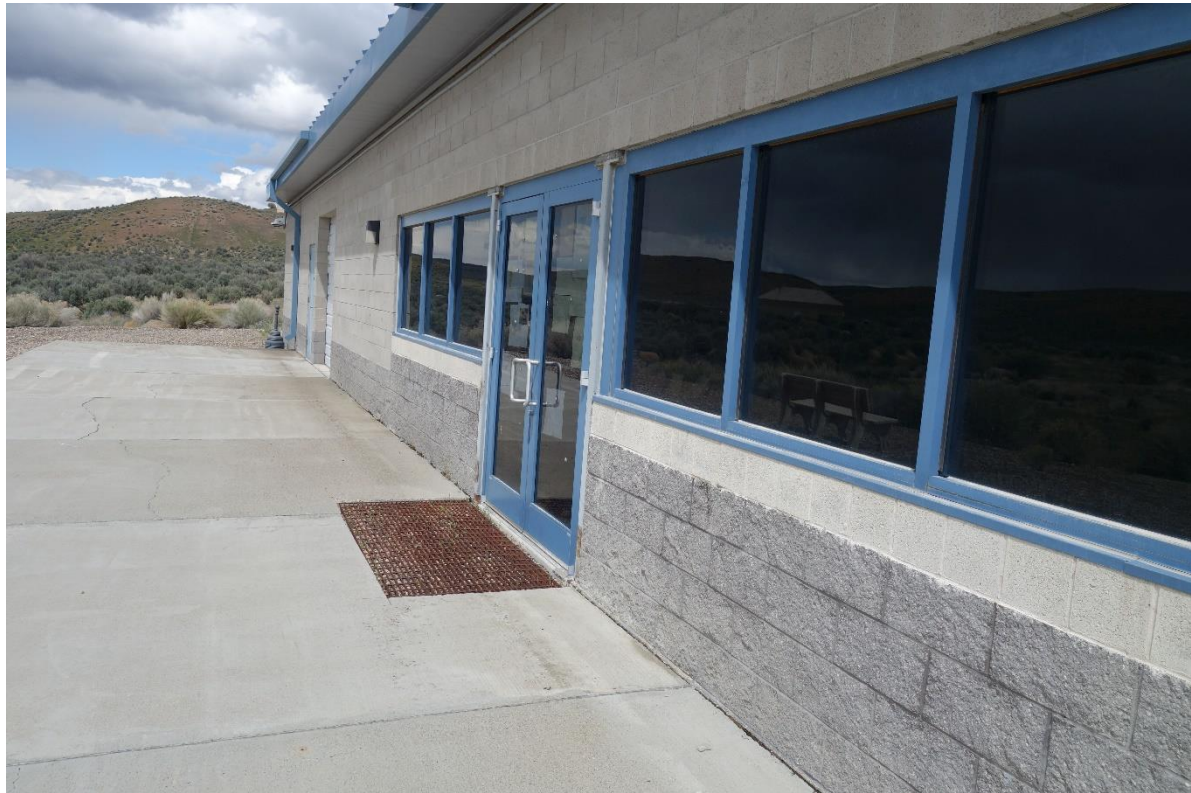
The HVAC system is original to the building and should be planned for replacement. It is not energy efficient and has reached the end of its expected and useful life. The R-22 refrigerant in the cooling system is no longer EPA compliant and its production was phased out completely January 1, 2020. This project would provide for installation of a new HVAC system and cleaning of the existing duct work and grilles. This project includes removal and disposal of the existing HVAC system and all required connections to utilities.

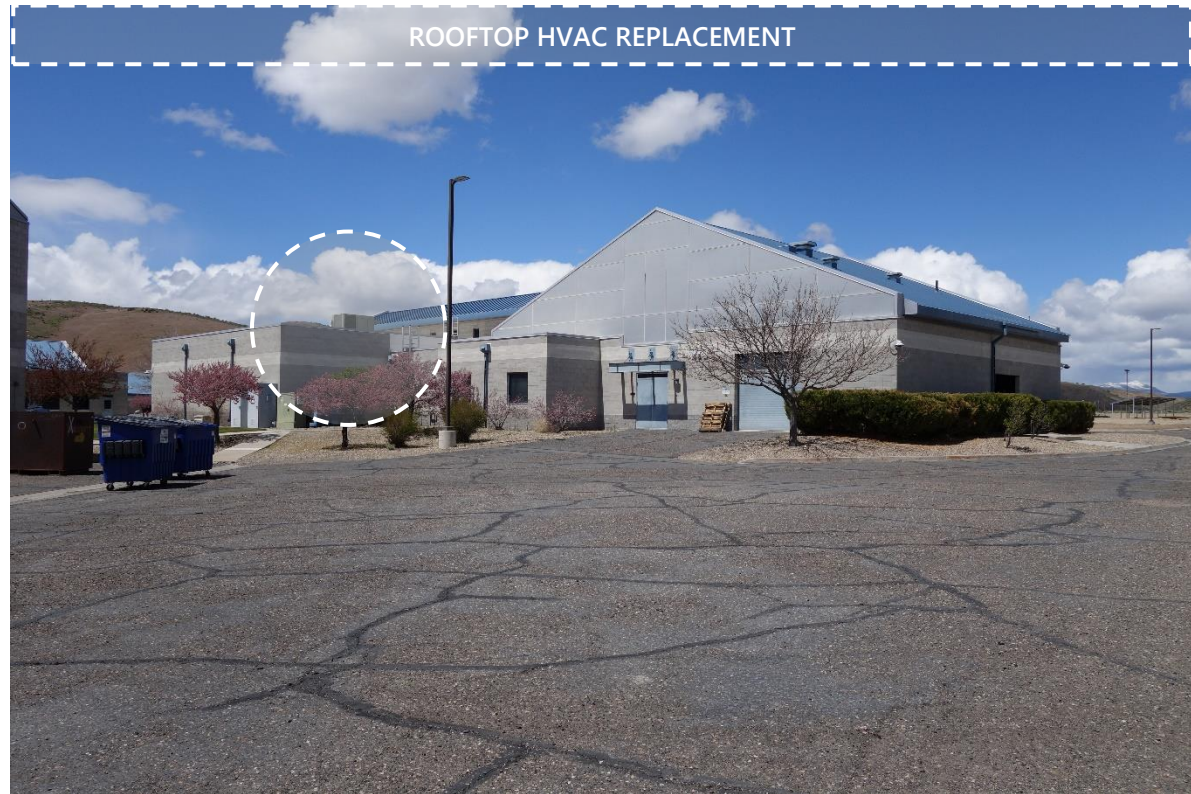
The water source heat pumps (WSHE's) and one rooftop unit (RTU) are original to the building and have reached the end of their useful life. This project recommends the replacement of the WSHP's including cleaning the existing duct work and grilles and test & balance. This project includes removal and disposal of the existing HVAC system and all required connections to utilities.

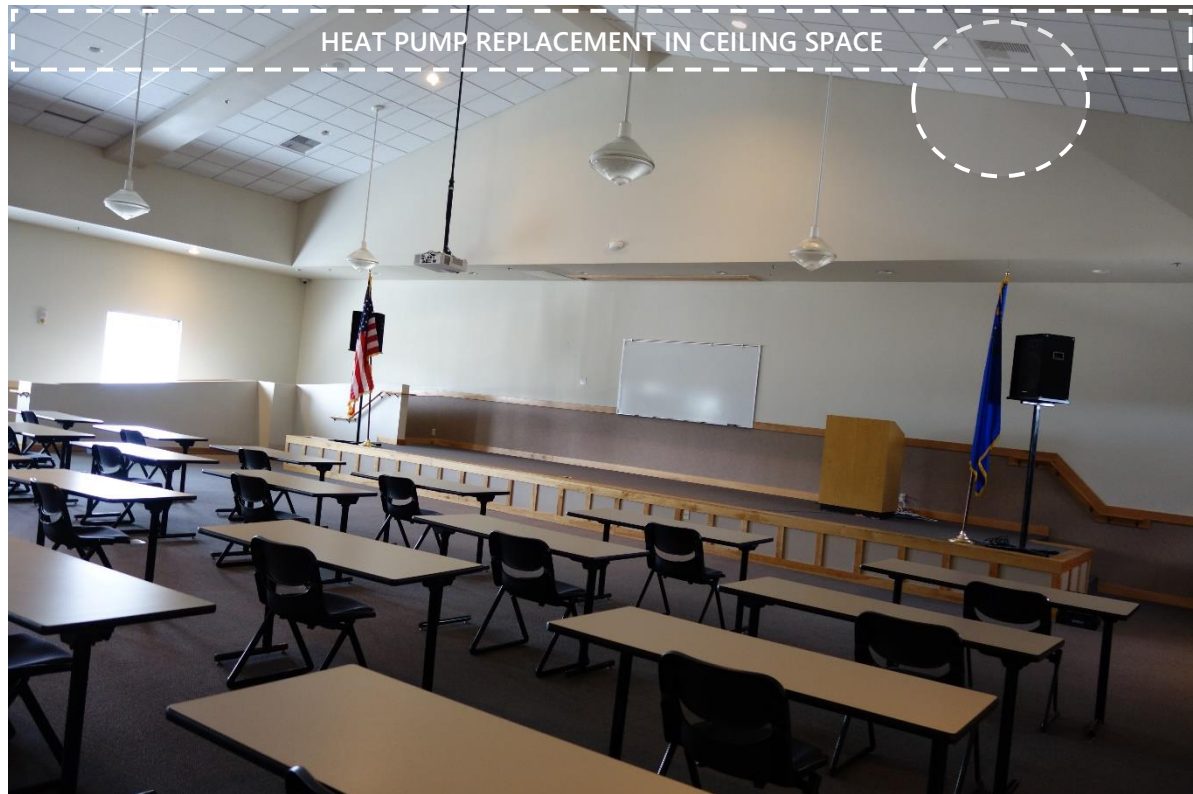
The water source heat pumps (WSHP's) located in the ceiling space of the building are original and have reached the end of their useful life. This project recommends the replacement of the WSHP's including cleaning the existing duct work and grilles and test & balance. This project includes removal and disposal of the existing HVAC system and all required connections to utilities. This project is in design under CIP 21-M19 and the estimate is based off that project.
