STATE OF NEVADA
STATE PUBLIC WORKS DIVISION

FACILITY CONDITION ASSESSMENT REPORT FOR:

DEPT OF TOURISM AND CULTURAL AFFAIRS
DIVISION OF MUSEUMS AND HISTORY
LVSTATE

Survey Date: 4/8/2024
Distribution Date: 9/25/2024

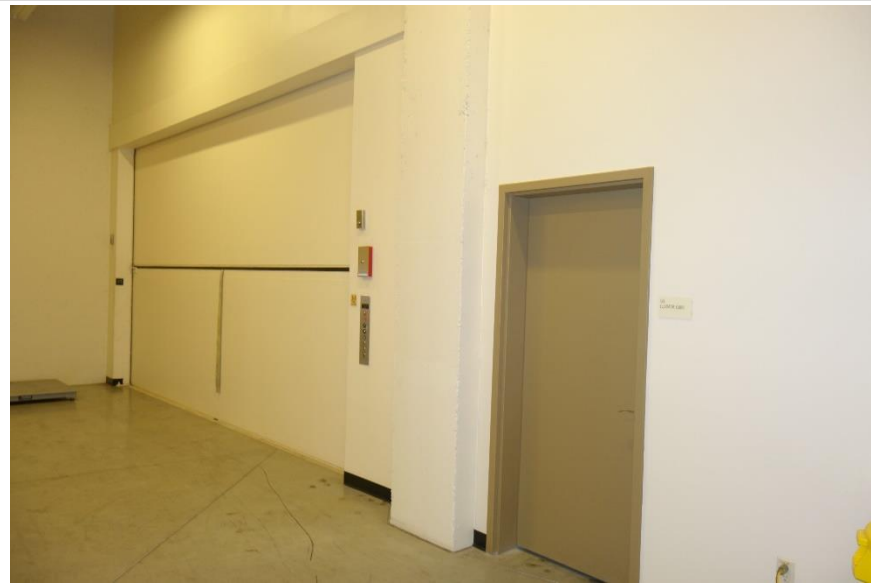
PROJECT # 2811INT2 - BUILDING INTERIOR

FREIGHT ELEVATOR REPAIRS

QUANTITY	UNITS	TOTAL	SF COST
The freight elevator in the building has become problematic including leaking oil around the lift ram, car misalignment and elevator controls that require periodic resetting. Current troubleshooting discussions include the lift ram possibly being bent and misaligned in addition to being grooved causing the oil leaks. The project recommends the replacement of the lift ram, re-calibrating the car guiderails and associated controls.	1	Package	\$87,000.00	\$ 1.00

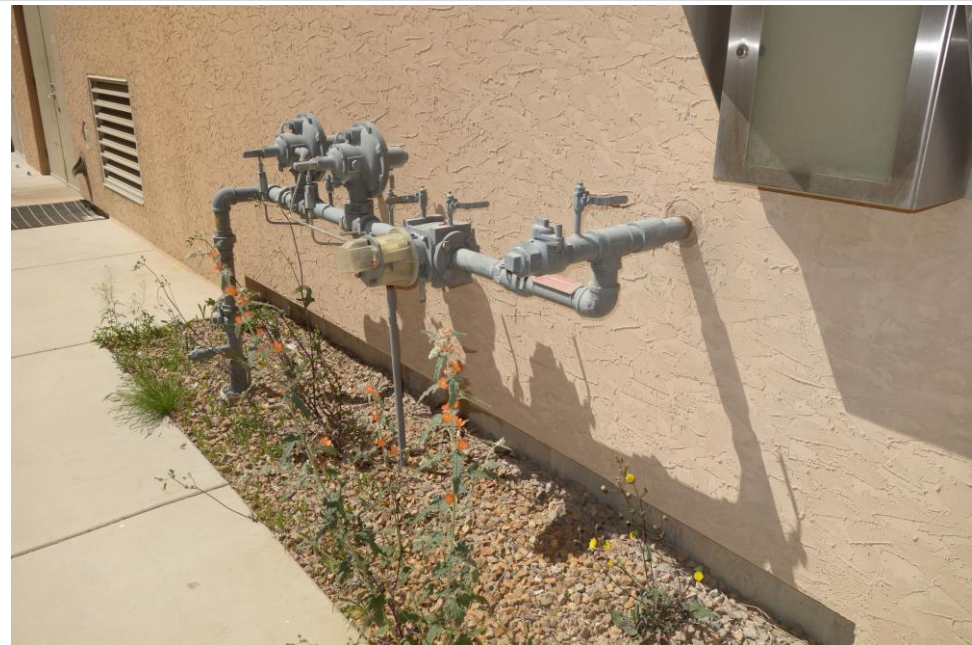
PROJECT # 2811SFT3 - SAFETY ISSUES

SEISMIC GAS SHUT-OFF VALVE INSTALLATION

QUANTITY	UNITS	TOTAL	SF COST
This project would provide for the installation of a seismic gas shut-off valve on the main gas service piping prior to entering the building. Alternately, for propane services or a site gas services with a single site metering station, consider installation at the tank or main meter service if it feeds multiple buildings. This estimate is based on the manufacturer Pacific Seismic Products or approved equal, equipped with the optional Model MS remote monitoring switch (to be interfaced with the direct digital control system and/or with an audible alarm). The gas piping immediately adjacent to the seismic gas valve shall be secured to the building utilizing unistrut channel bracing.	1	Package	\$10,000.00	\$ 0.00

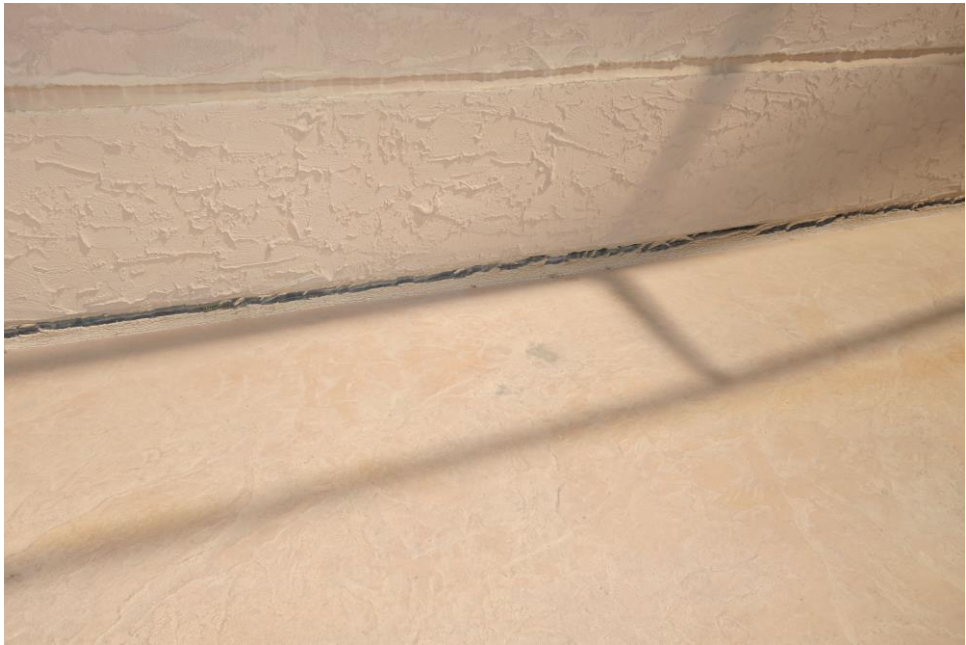
PROJECT # 2811EXT5 - BUILDING EXTERIOR

EXTERIOR WEATHERPROOFING

QUANTITY	UNITS	TOTAL	SF COST
The building exterior weatherproofing is failing in many areas including the windows and exterior wall expansion joint caulking. This has allowed infiltration of water and pests. This project will repair or replace the weather stripping at the windows and remove and replace all of the exterior wall expansion joint caulking.	1	Package	\$159,500.00	\$ 2.00

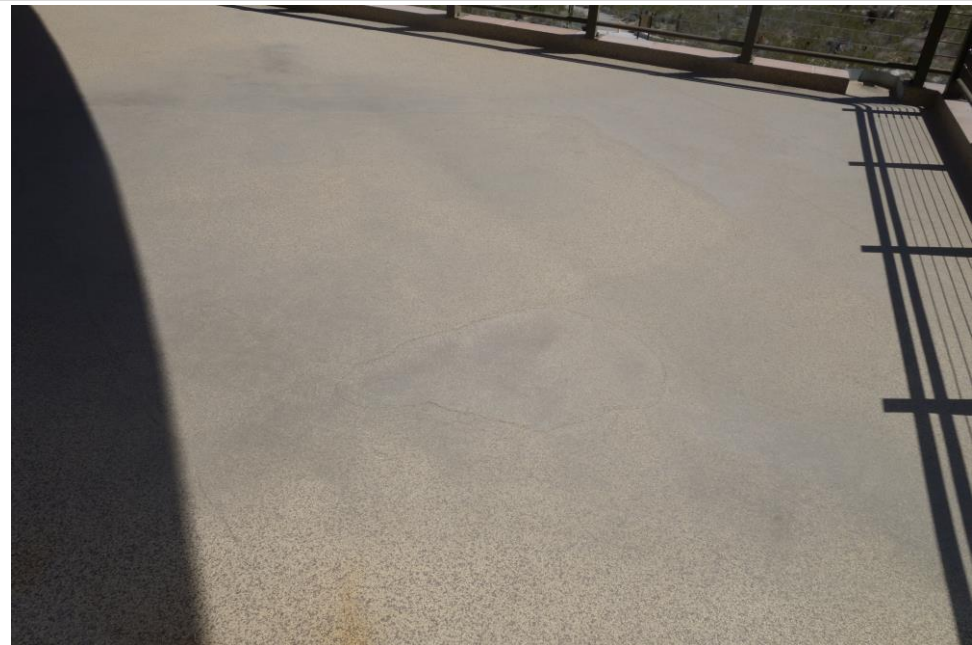
PROJECT # 2811EXT6 - BUILDING EXTERIOR

SPECIAL EVENTS DECK REPAIRS

QUANTITY	UNITS	TOTAL	SF COST
The special events deck is located over occupied space on the 1st floor. The deck acts as the roofing system over this space. The deck concrete has cracked and appears to have a very low slope to the single drain scupper at the perimeter. The concrete deck cracks and ponding water (due to low deck slope) have resulted in water infiltration on the 1st floor. This project recommends a complete analysis of the deck slope and structural impacts of repair solutions. A possible solution, contingent upon approval by the authorities, is grind the deck to increase slope to eliminate water ponding and overlay the prepped surface with a slip resistant waterproofing membrane.	1	Package	\$100,000.00	\$ 1.00

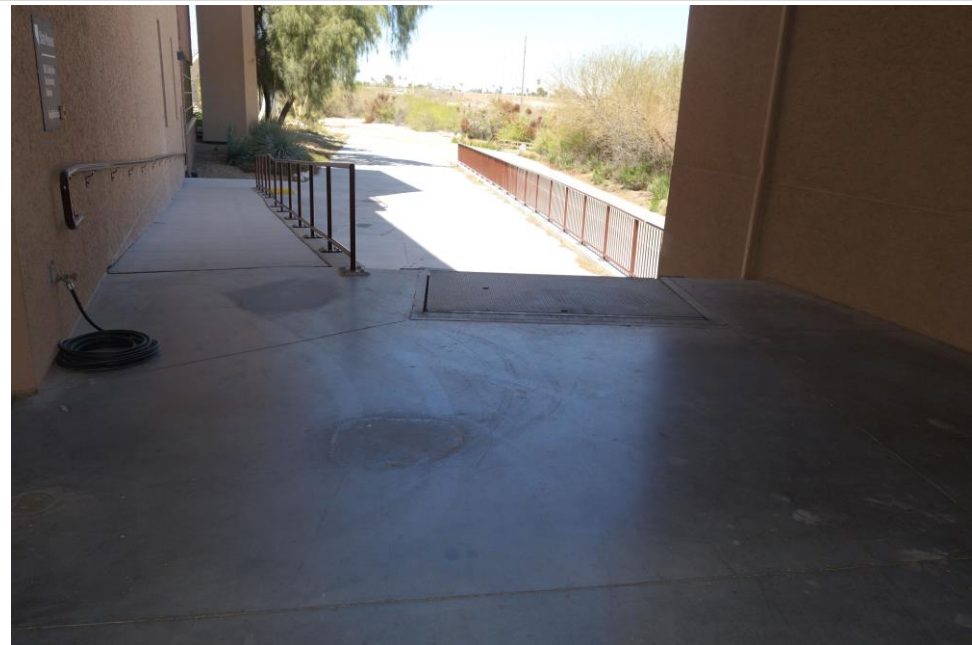
PROJECT # 2811EXT7 - BUILDING EXTERIOR

LOADING DOCK REPLACEMENT

QUANTITY	UNITS	TOTAL	SF COST
Repairs to the loading dock area were made under CIP 17-M74 enhancing safety. However, the actual loading dock itself was not replaced. Currently, the dock edge and corresponding dock leveler are not perpendicular to the dock ramp causing freight drivers to awkwardly jackknife the truck on the narrow ramp to align the rear trailer door to the dock ramp. This is very difficult for the driver and creates a high risk of damage to the ramp curb and guard rail. This project recommends a complete removal of the existing dock and leveler, pour a new dock ramp perpendicular to the ramp and install a new manual dock leveler.	1	Package	\$210,000.00	\$ 3.00

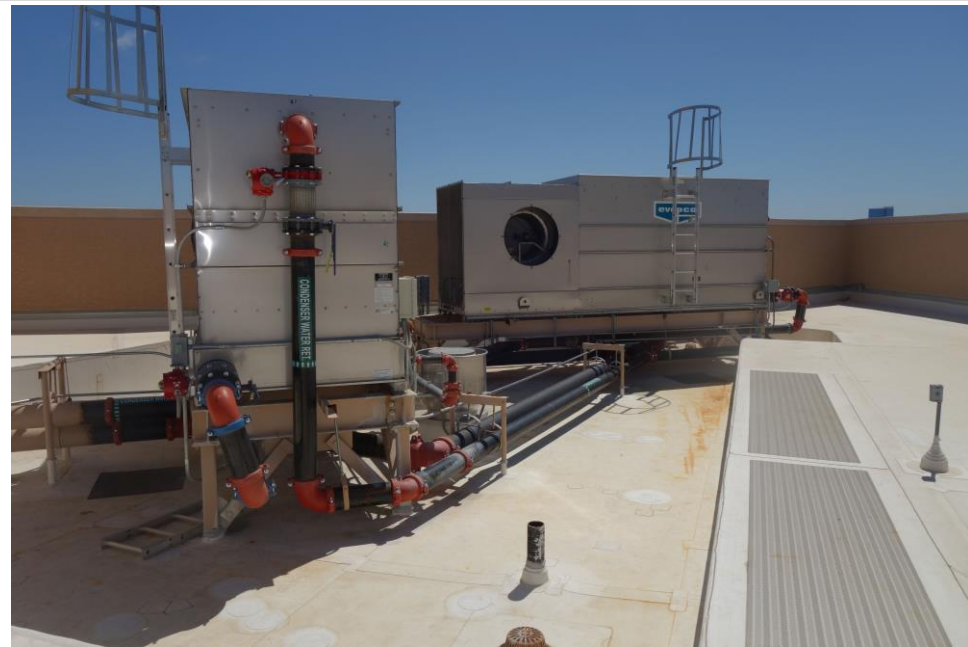
PROJECT # 2811EXT8 - BUILDING EXTERIOR

ROOF REPLACEMENT

The roof on this building was in poor condition at the time of the survey. The statewide roofing program has set the useful life of an average roof at 20 - 25 years. Typically, the roof warranty expires in 20 years. The temperature fluctuations throughout the year, consistent wind which blows sand and dirt on to the roof membrane, and constant exposure to the sun are contributing factors to wear and deterioration. The current roofing system was installed in 2008. It is recommended that this building be re-roofed in the next 2 - 4 years to be consistent with the roofing program and the end of the warranty period.

This project should be implemented concurrently with the HVAC REPLACEMENT project.

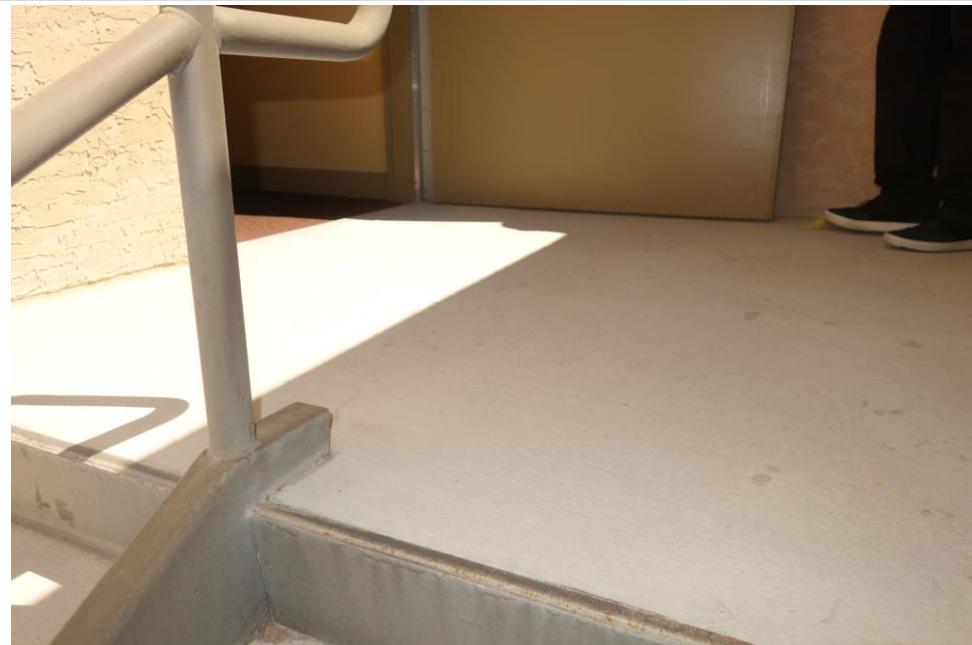
PROJECT # 2811EXT9 - BUILDING EXTERIOR

STAIR LANDING REFURBISHMENT

QUANTITY	UNITS	TOTAL	SF COST
There is a stair landing on an exterior door into the special events hallway where the slope of the landing is toward the door. During storm events water infiltrates under the door into the hallway. This project recommends replacement of the concrete landing to provide a proper landing slope and drainage.	1	Package	\$40,000.00	\$ 1.00

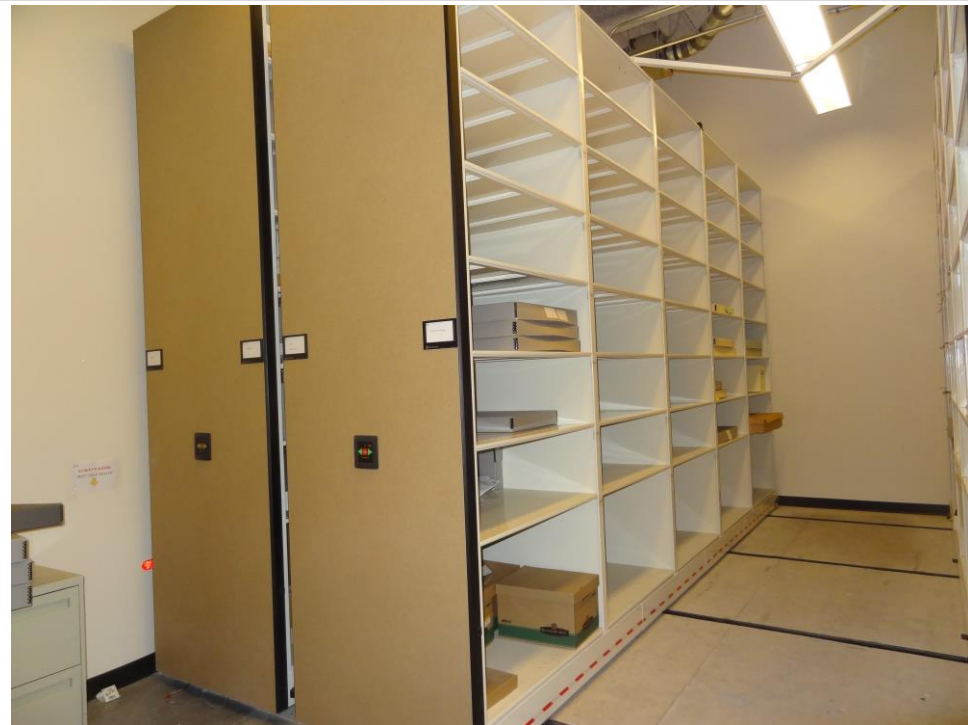
PROJECT # 2811HVA1 - HVAC

COLLECTION AREAS HVAC INSTALLATION

QUANTITY	UNITS	TOTAL	SF COST
Two separate artifact collection areas, previously identified as "Future Collection Storage", have been fit out for use. The spaces are missing HVAC systems. The Collections area also require humidification control. This project recommends the design and installation of air handling units, air distribution, humidification, DDC controls. Excluded from this estimate is any additional required chiller, cooling tower or boiler capacity which are assumed to have been provided at the time of construction for the undeveloped spaces. The combined area for the two collection rooms was estimated at 9,350 square feet.	9350	Square Foot	\$701,300.00	\$ 9.00

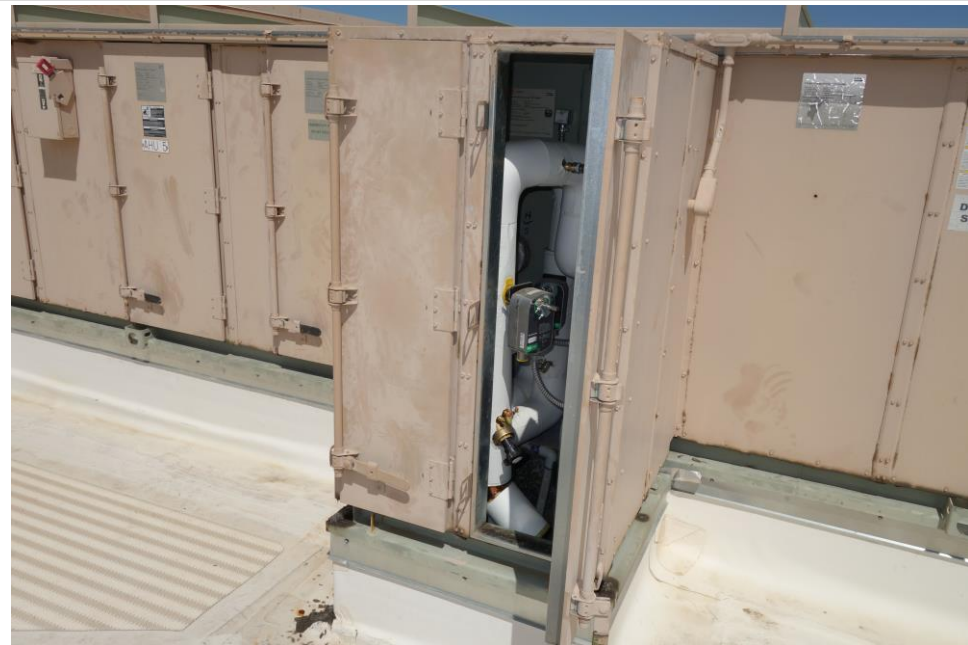
PROJECT # 2811HVA2 - HVAC

HVAC REPLACEMENT

The existing rooftop air handling units (AHU's) and air handling systems are 16 years in operation. However, the AHU exterior casings have been compromised and the internal panel sealants appear to have failed and are leaking onto the roof membrane. Without an air tight exterior casing, the museum is exposed to the outside elements affecting air quality and operational efficiency. This project recommends the replacement of rooftop air handling systems, cleaning the existing ductwork and connection to the required utilities.

This project should be implemented concurrently with the ROOF REPLACEMENT project.

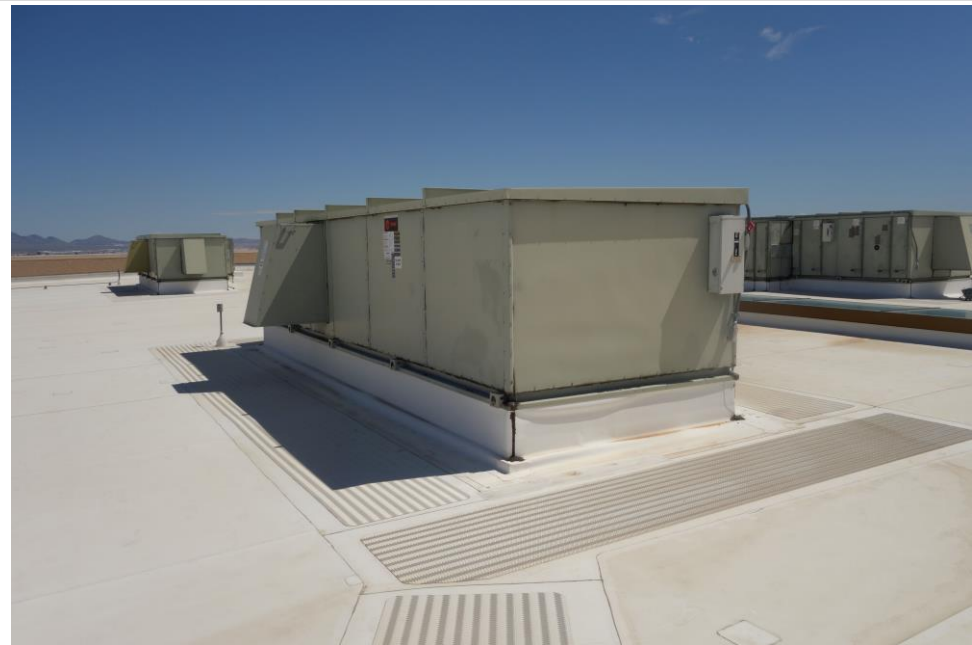
PROJECT # 2811PLM3 - PLUMBING

ADD HOSE BIBBS TO ROOF

QUANTITY	UNITS	TOTAL	SF COST
Currently there is no water available on the roof to clean the coils of the air handling units (AHU's). A water hose has to be brought up through the roof hatch and extended 150 feet to reach the furthest AHU. This project recommends the installation of 2 hose bibbs, one on each level of the roof.	1	Package	\$ 5,000.00	\$ 0.00

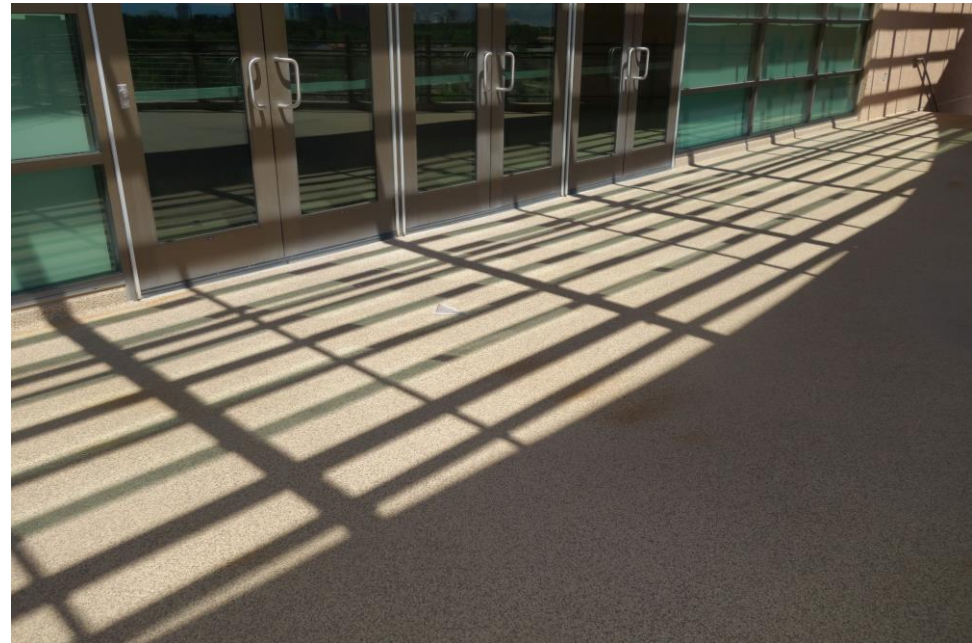
PROJECT # 2811SEC2 - SECURITY

SURVEILLANCE SYSTEMS INSTALLATION

QUANTITY	UNITS	TOTAL	SF COST
The museum does not have an intrusion detection and alarm system. In addition the existing surveillance camera system is outdated and obsolete. This project recommends the design and installation an intrusion detection and alarm system and replacement of the video surveillance system to the current digital standard.	1	Package	\$1,399,400.00	\$ 18.00

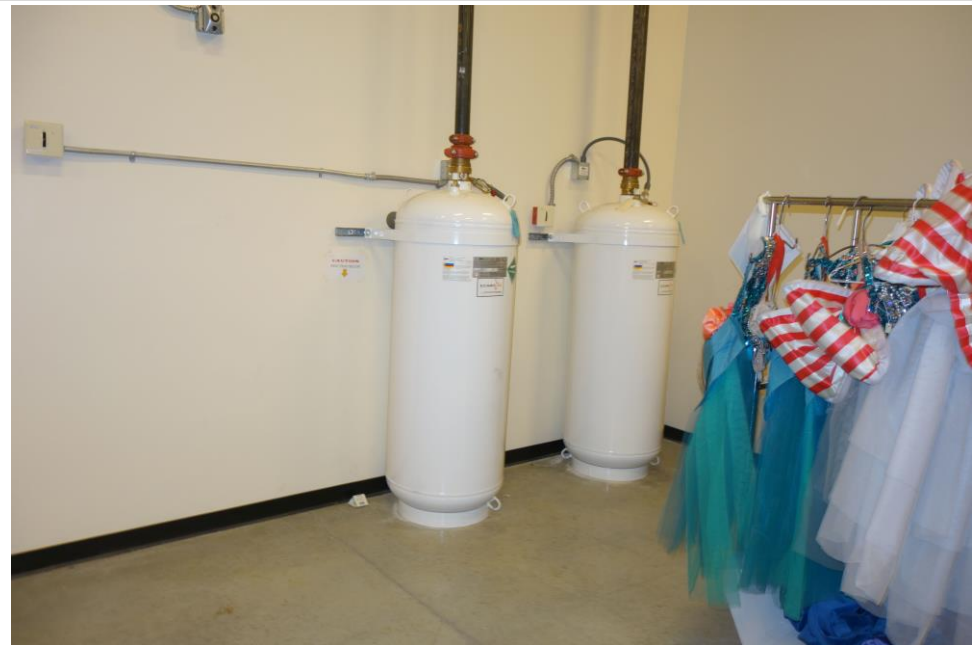
PROJECT # 2811SFT4 - SAFETY ISSUES

COLLECTION AREAS FIRE SUPPRESSION REPLACEMENT

QUANTITY	UNITS	TOTAL	SF COST
Two separate artifact collection areas, previously identified as "Future Collection Storage", have been fit out for use. The spaces are currently protected by fire suppression. In the event of a fire event or broken sprinkler head, the artifacts would be damaged and potentially destroyed. This project recommends replacing the existing system with a clean agent fire suppression system.	1	Package	\$1,611,000.00	\$ 21.00

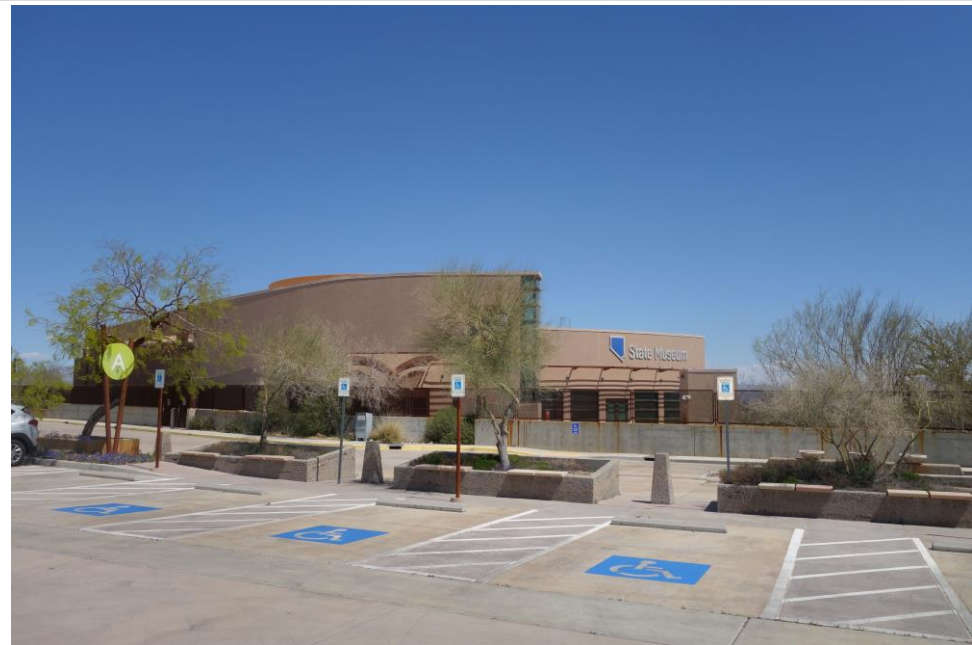
PROJECT # 2811EXT1 - BUILDING EXTERIOR

EXTERIOR FINISHES

QUANTITY	UNITS	TOTAL	SF COST
The exterior finishes were in fair condition. It is important to maintain the finish, weather resistance and appearance of the building. This project would provide funding to protect the exterior of the building excluding the roof. Included in the cost is power washing, priming and painting and caulking of the windows, flashing, fixtures and all other penetrations. It is recommended that the building be painted in the next 4 - 6 years and that this project be scheduled on a cyclical basis to maintain the integrity of the structure.	78145	Square Foot	\$1,406,600.00	\$ 18.00

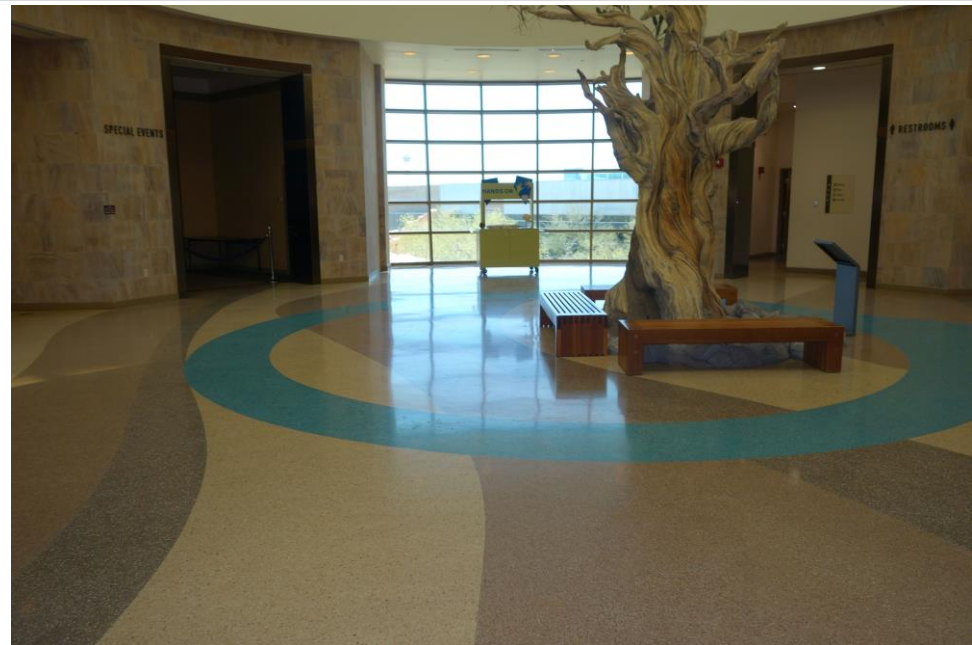
PROJECT # 2811INT1 - BUILDING INTERIOR

INTERIOR FINISHES

QUANTITY	UNITS	TOTAL	SF COST
The interior finishes were in good condition. It is recommended to paint the interior walls and ceilings at least once in the next 4 - 6 years and that this project be scheduled on a cyclical basis to maintain the integrity of the structure. Prior to painting, all surfaces should be repaired and prepped. An epoxy-based paint should be utilized in wet areas for durability.	78145	Square Foot	\$781,450.00	\$ 10.00
