State of Nevada
Department of Administration – State Public Works Division
Buildings and Grounds Section

LV B&G – PUBLIC WORKS OFFICE

Site Number: 9818
STATE OF NEVADA PUBLIC WORKS DIVISION
FACILITY CONDITION ANALYSIS

Report distributed in September 2022

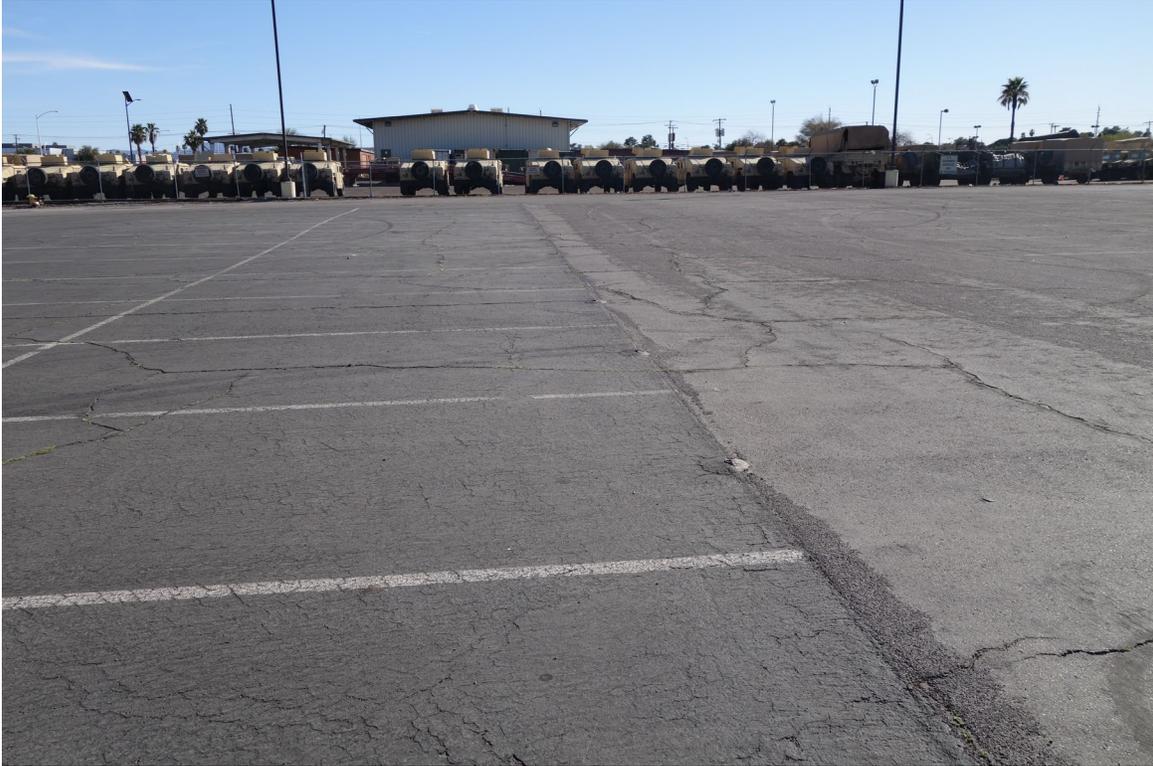
LV B&G – Public Works Site – FCA Site #9818
Description: Parking Area Crack Fill & Seal Needed .

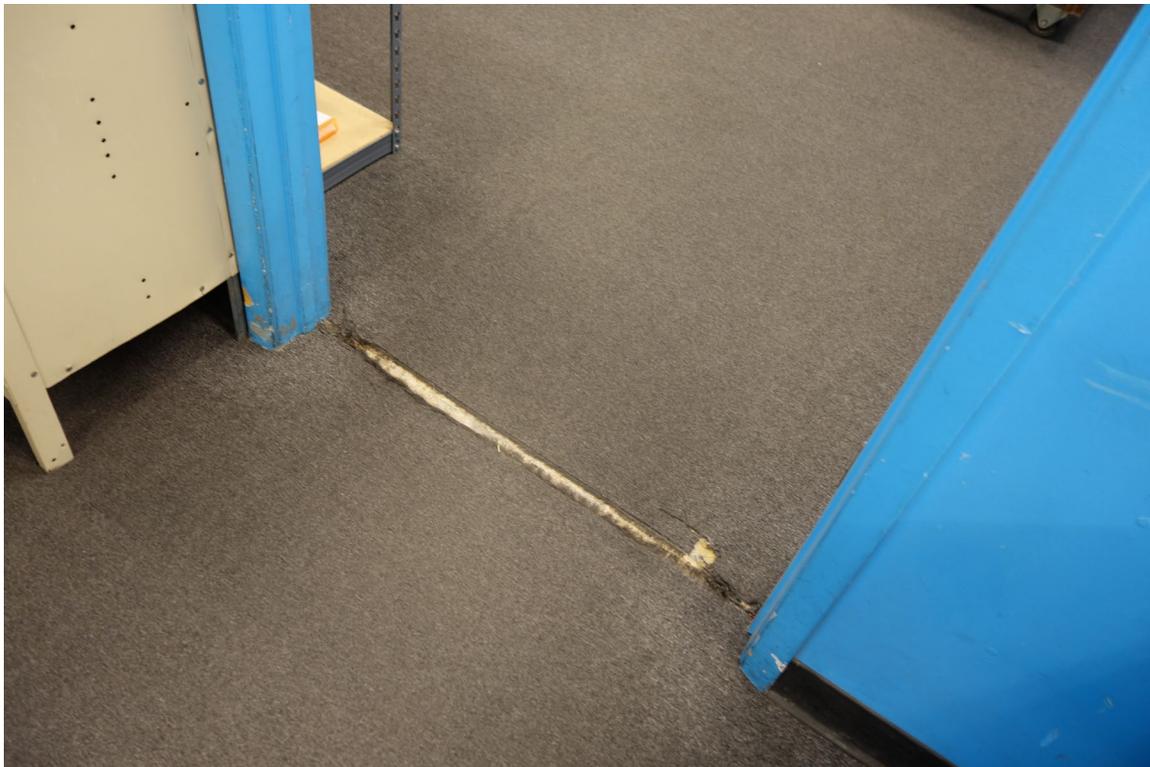
The carpet in the building is heavily damaged and reaching the end of its useful life. It is recommended that the flooring be replaced. This project would provide for removal and disposal of the existing flooring and installation of new heavy duty commercial grade carpet in the next 2 - 3 years.

B&G HVAC Garage – FCA Building #2062
Description: Flooring Replacement Needed.

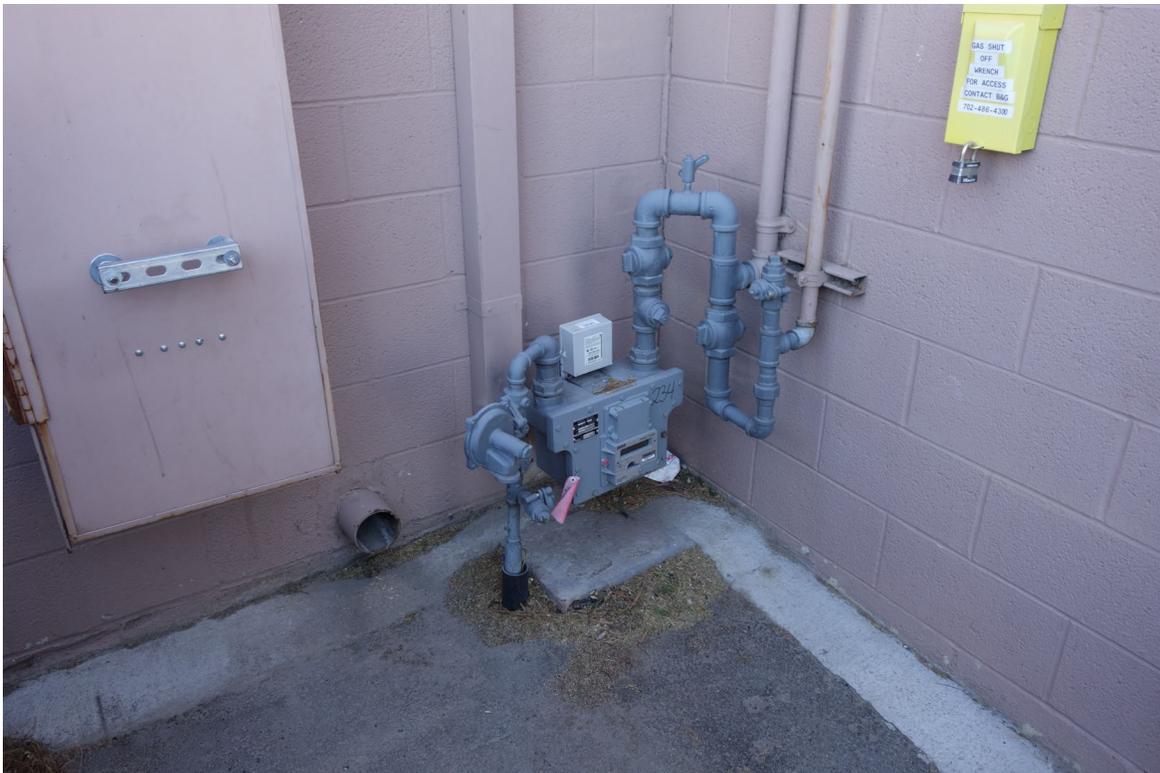
LV B&G – Public Works Office – FCA Building #0418
Description: Seismic Gas Shut-Off Valve Needed.

This project would provide for the installation of a seismic gas shut-off valve on the main gas service piping just prior to entering the building. This estimate is based on the manufacturer Pacific Seismic Products or approved equal, equipped with the optional Model MS remote monitoring switch (to be interfaced with the energy management system and/or with an audible alarm). The gas piping immediately adjacent to the seismic gas valve shall be secured to the building utilizing unistrut channel brace.

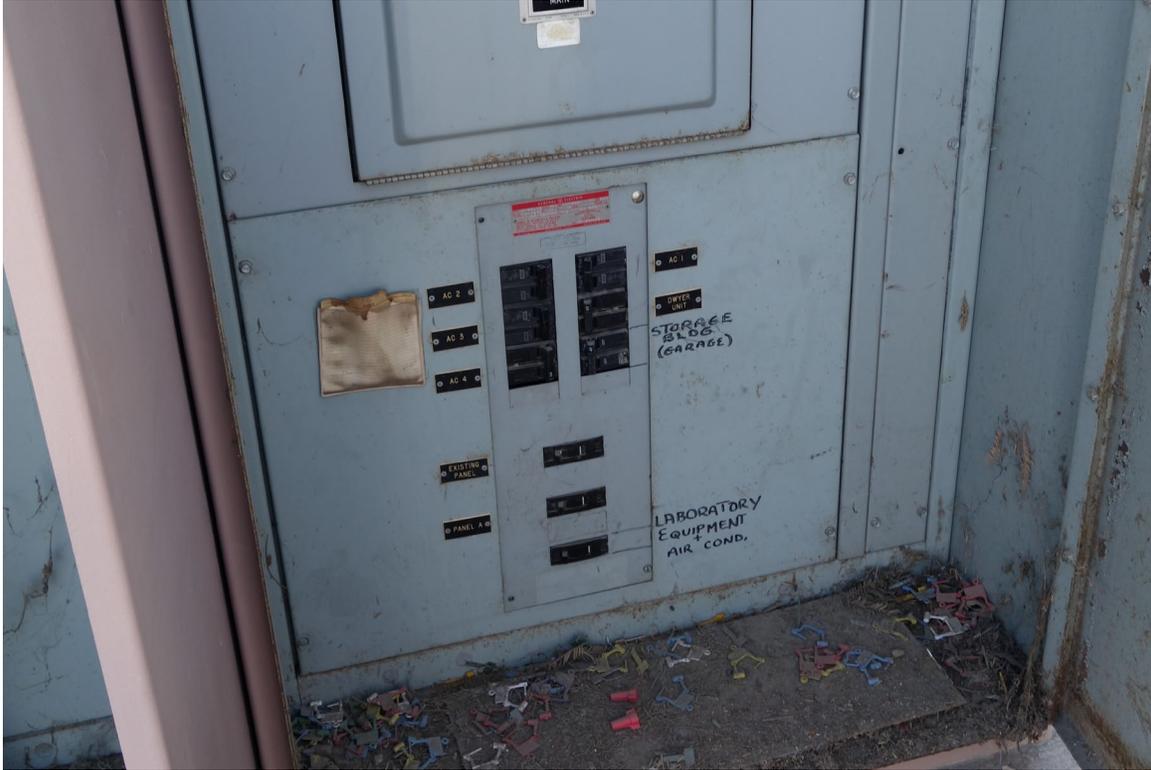
This building is over 45 years old and the electrical system has reached the end of its useful life. Additionally, it was constructed before the requirements for NEC 70e electrical Arc Flash Assessments. As a consequence, the original subpanels, distribution boards and breakers are not labeled with available fault current (AIC Rating). In order to comply with the NEC 70e requirements, it is recommended that the original electrical equipment be replaced with new to facilitate the required Breaker Coordination and Arc Flash studies. Removal and disposal of the existing equipment is included in this project.

LV B&G – Public Works Office – FCA Building #0418
Description: Electrical Upgrade Needed.

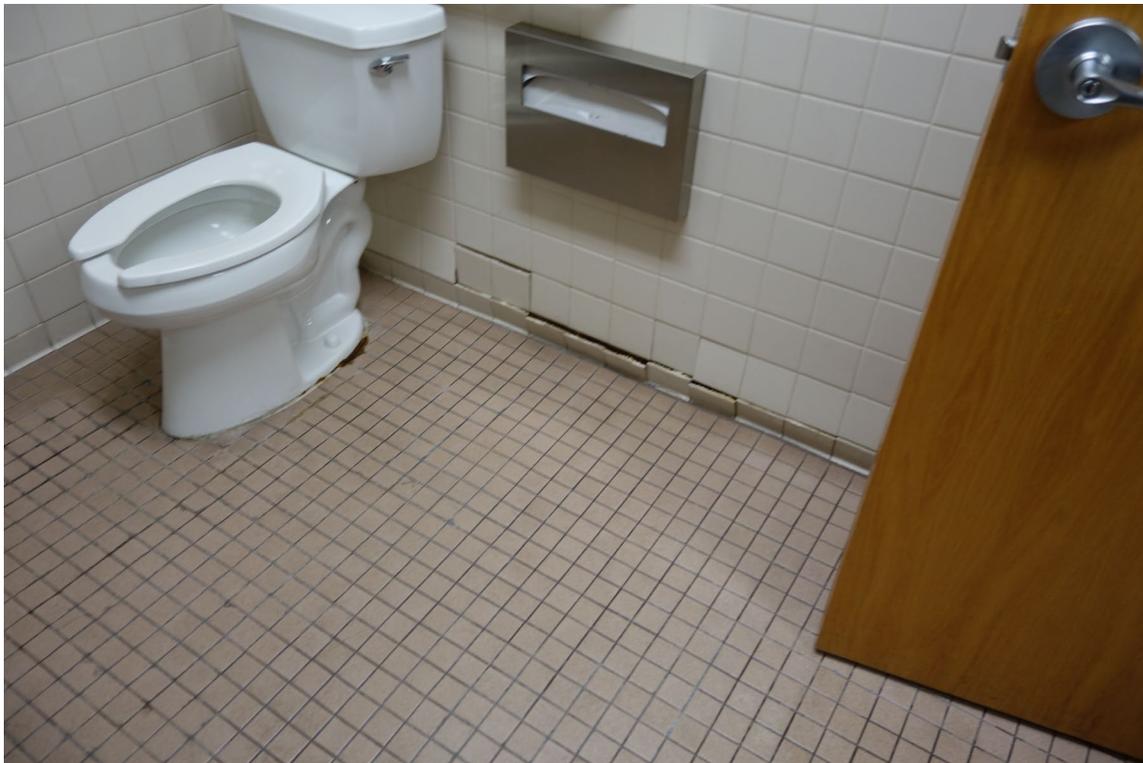
The restrooms in this building appear to be original. One shows multiple failures of the floor and wall tile indicating moisture is present, likely from leaky plumbing. This project would provide for a complete remodel and rehabilitation of the restrooms including fixtures, casework, floor and wall finishes and hardware. The 2018 IBC, ICC/ANSI A117.1, NRS 338.180 and the most current version of the ADA Standards for Accessible Design were used as a reference for this project.

LV B&G – Public Works Office – FCA Building #0418
Description: Restroom Remodel Needed.
