State of Nevada  
Department of Agriculture  
Agriculture Office  
Facility Condition Analysis

2300 McLeod Street  
Las Vegas, Nevada 89102

**Site Number: 9818, Building Numbers: 0418 & 1900**  
**STATE OF NEVADA PUBLIC WORKS BOARD**  
**FACILITY CONDITION ANALYSIS**

Report Printed in March 2008

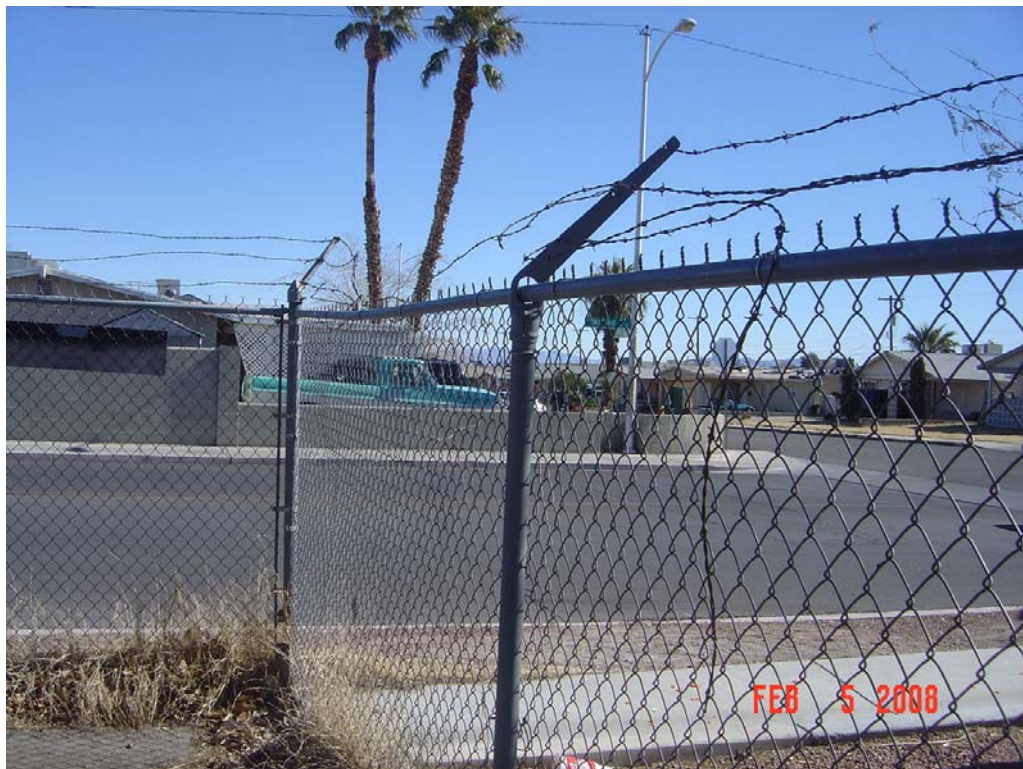
Agriculture - Site #9818  
Description: Damaged perimeter fencing.

The facility currently does not have a security system installed. Access on or off of the property is uncontrolled and there have been security problems including the homeless inhabiting areas of the property. This project recommends card-access control, security fencing, security cameras and additional site lighting be installed to remedy this problem.

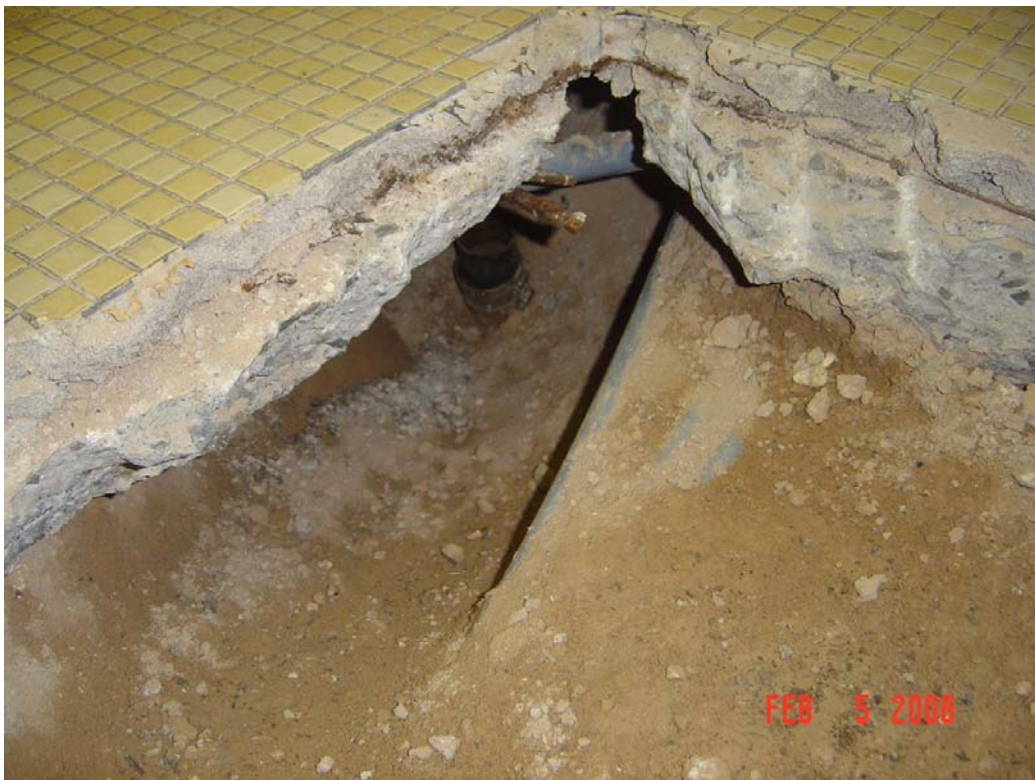
The plumbing / waste lines are original to the building and major failures are beginning to surface including broken waste lines and corroded flanges. This project recommends that a licensed plumbing contractor perform a camera scope to assess the condition of the piping especially the waste lines. Future projects would be based on this report.

Agriculture Office - Building #0418  
Description: Restroom drain repair.

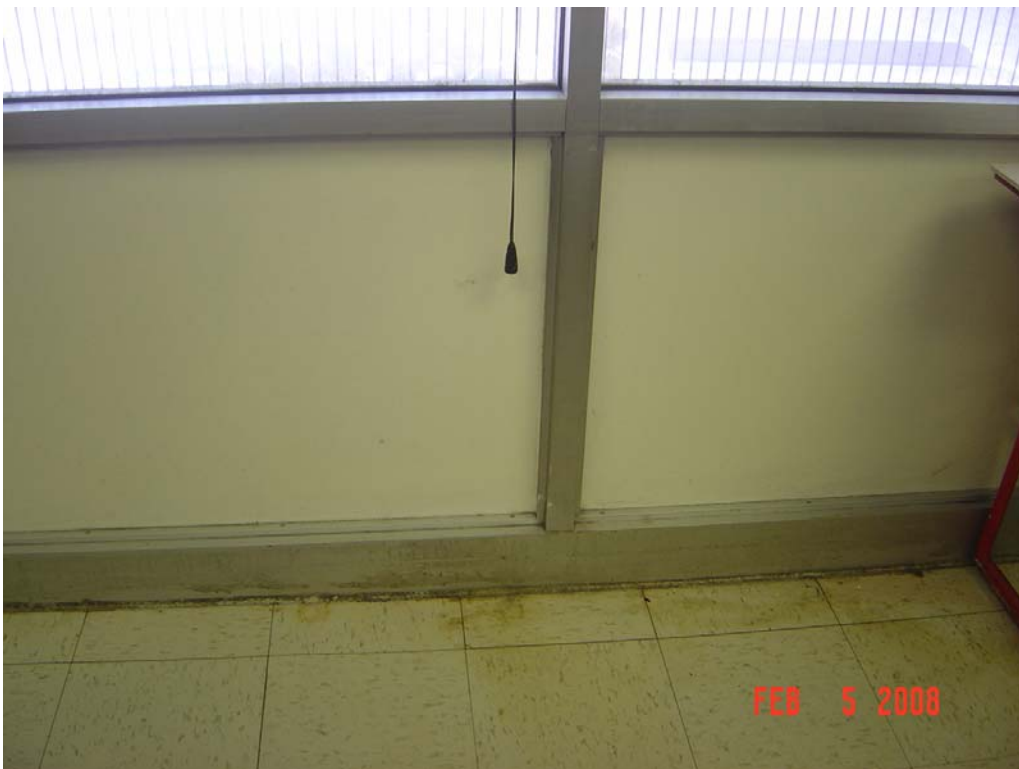
The windows in the original building are original, single pane construction in a metal frame. These older windows are drafty and not energy efficient. Several of the windows also have a metal wall panel below them that should be removed and replaced with a framed and insulated wall to match the adjacent walls. This project recommends replacing the windows with dual pane, higher efficiency units. This estimate is for the replacement of 20 units and does not include the windows in the storefront entrance systems which are addressed in a separate project.

Agriculture Office - Building #0418  
Description: Single pane window system.

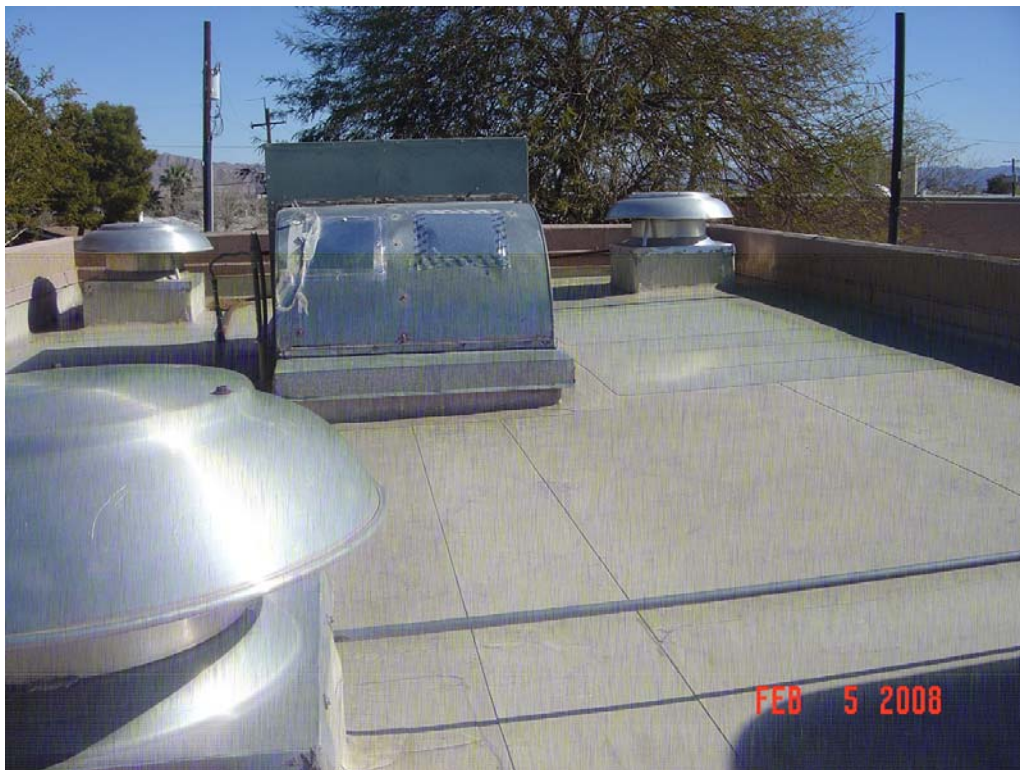
The heating and cooling to this building is provided by several rooftop packaged units of which 3 appear to be original equipment. They are in poor condition and have reached the end of their expected life. This project would provide for the installation of 3 new rooftop packaged HVAC units including connections to existing utilities. Removal and disposal of the old units is included in this estimate. This project is recommended to be undertaken at the same time as the energy management system installation.

Agriculture Office - Building #0418  
Description: Roof top equipment.

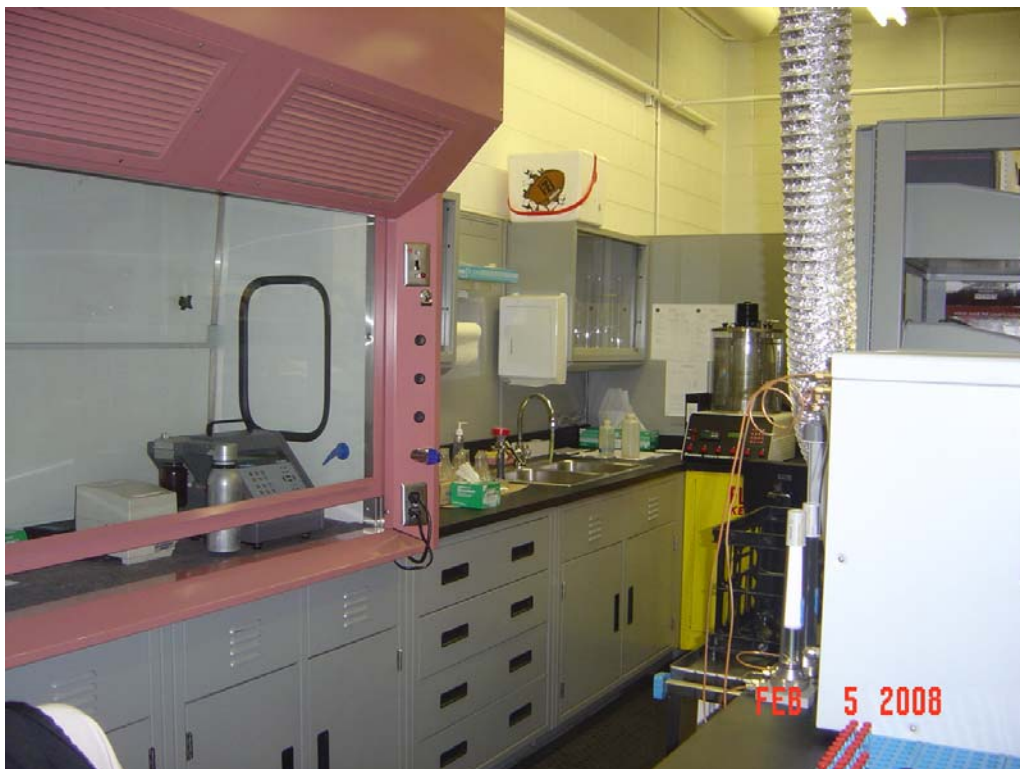
The Metrology laboratory on the North side of the building was built in an existing garage that does not have proper insulation. The heating and cooling is not efficient in the room, the sensitive measuring and testing equipment is affected by the inconsistent temperatures and the staff working in the lab do not have a comfortable work environment. This project would provide for the furring of the interior side of the CMU, board insulation, 5/8" Type X gypsum board, paint and ceiling insulation to bring the room up to the appropriate "R" value to match the rest of the building.

Agriculture Office - Building #0418  
Description: Lab area.

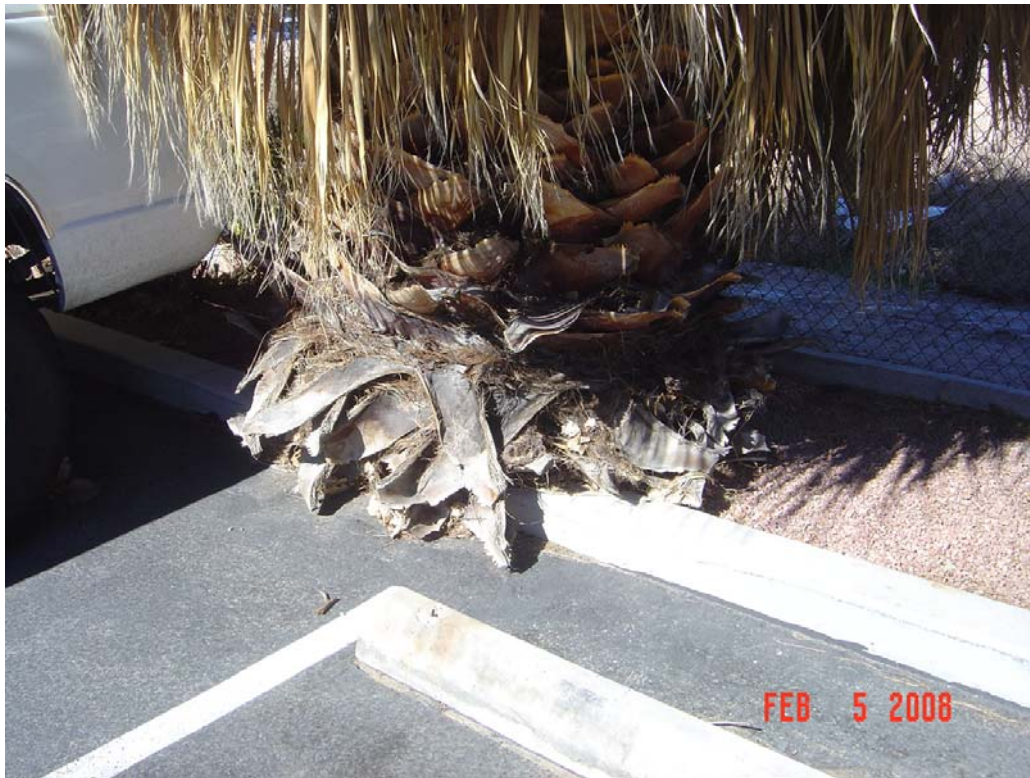
There are numerous palm trees along the perimeter of the paved parking along the north side of the site. They are damaging the concrete curbing and are in need of removal. This project would provide for the removal of the palm trees and repair of the damaged curbing.

Agriculture Site - Site #9818  
Description: Curb damage from palm tree.
