STATE OF NEVADA  
STATE PUBLIC WORKS DIVISION

FACILITY CONDITION ASSESSMENT REPORT FOR:

SITE #: 9793

AGRICULTURE LAS VEGAS SITE  
2300 E SAINT LOUIS AVE  
LAS VEGAS, NV 89104-4211

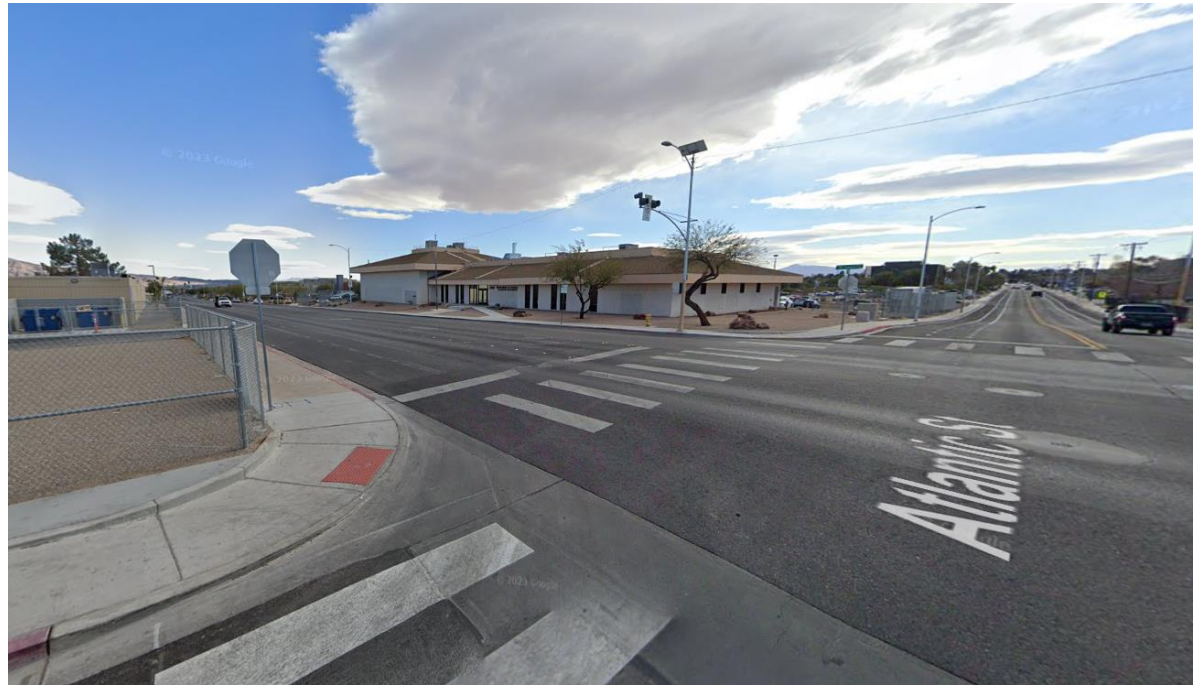
The Agriculture Las Vegas site, formerly Old Metro Police Station site, is located in the northwest corner of the East Sahara State Complex. The site is mostly paved, fully fenced with accessible parking and path of travel to the building. It is served by city water with backflow prevention, city sewer, electrical and natural gas.

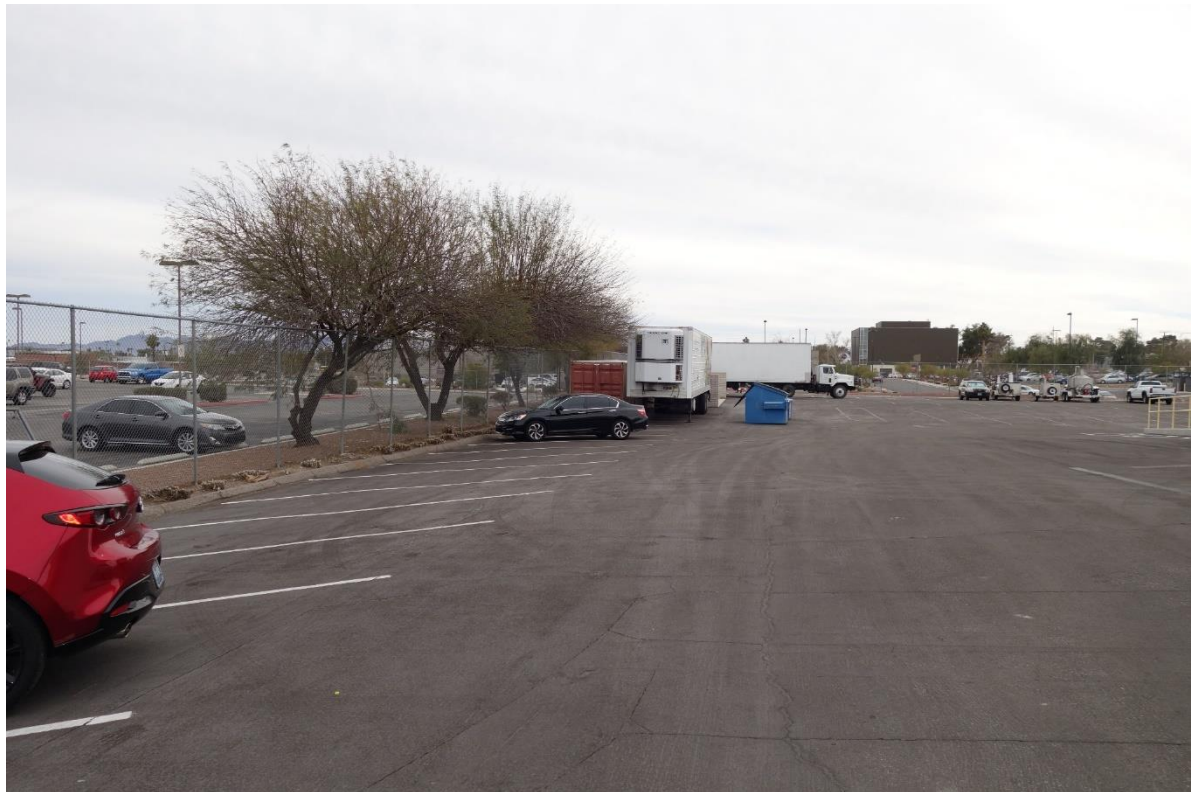
PROJECT ID: 9793-SIT-3

The site paving is in good condition and will be due for re-sealing in the next 5 - 6 years. It is important to maintain the asphalt concrete paving on the site. This project would provide for minor crack filling and slurry sealing of the paving site-wide including the access road and parking areas. Striping is included in this estimate. This project should be scheduled on a 5-year cyclical basis to maintain the integrity of the paving and prevent premature failure. 75,000 square feet of asphalt area was used to generate this estimate.

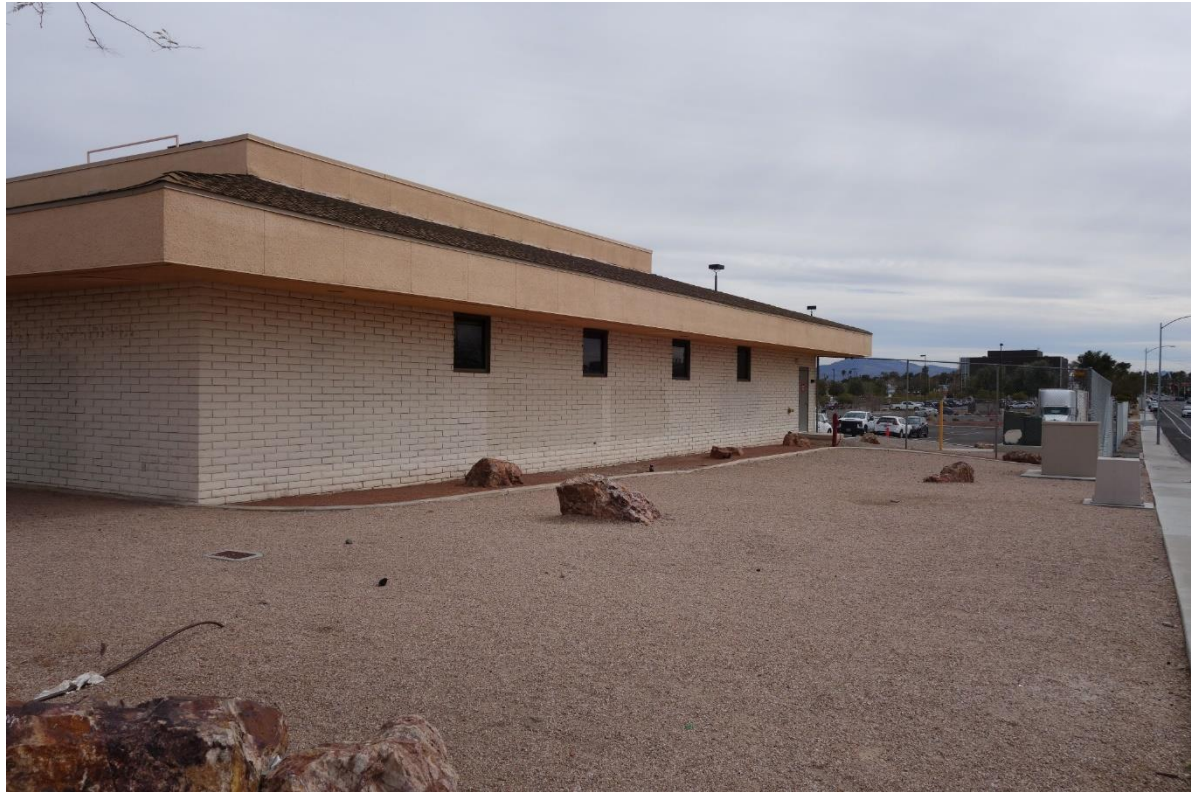
PROJECT ID: 9793-SIT-2

The existing landscaping consists of limited trees and shrubs, rocks, and an irrigation system. The west side of the building is devoid of vegetation and one of the trees on the north side is damaged. This project would provide for vegetation replacement as needed, add new shrubbery, trees and improve the irrigation systems. This project or a portion thereof was previously recommended in the FCA report dated 04/10/2012. It has been amended accordingly to reflect conditions observed during the most recent survey date of 03/06/2023.

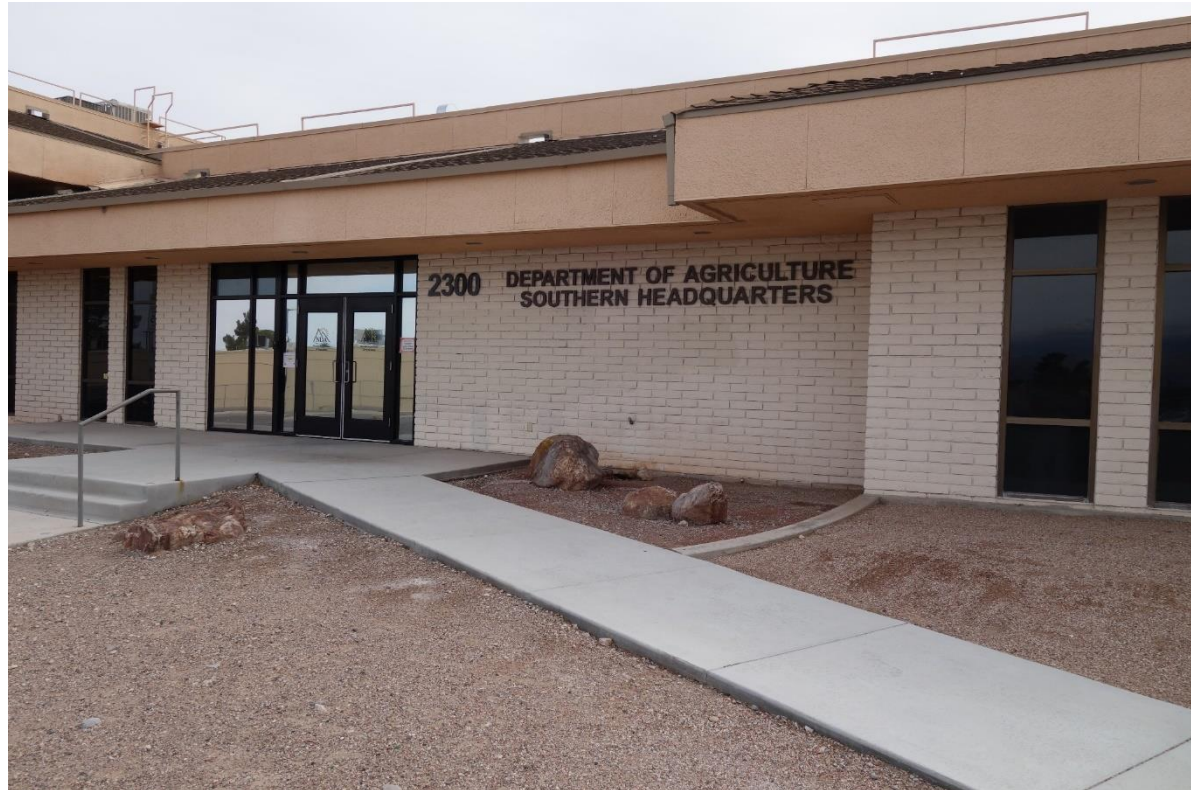
The Las Vegas Department of Agriculture building, formerly the Old Metro Police Station building, is an insulated concrete and brick masonry structure with a mix of asphalt composition and singly ply roofing systems on a concrete foundation. During the survey of 2012, the building was vacant, and ownership was in the process of reverting back to the State of Nevada. In 2016, the building underwent a substantial interior renovation including insulating the exterior walls of the office space and making the building and site accessible. It is a mix of offices, restrooms, conference rooms, a break area, public lobby, storage and a large warehouse area. The building is protected by a legacy fire alarm system with some components that are obsolete. The 2016 renovation included adding fire sprinklers. The HVAC system consists of roof mounted packaged units also replaced in 2016. The large warehouse area has evaporative cooling via roof mounted units. The building is overall in good condition.

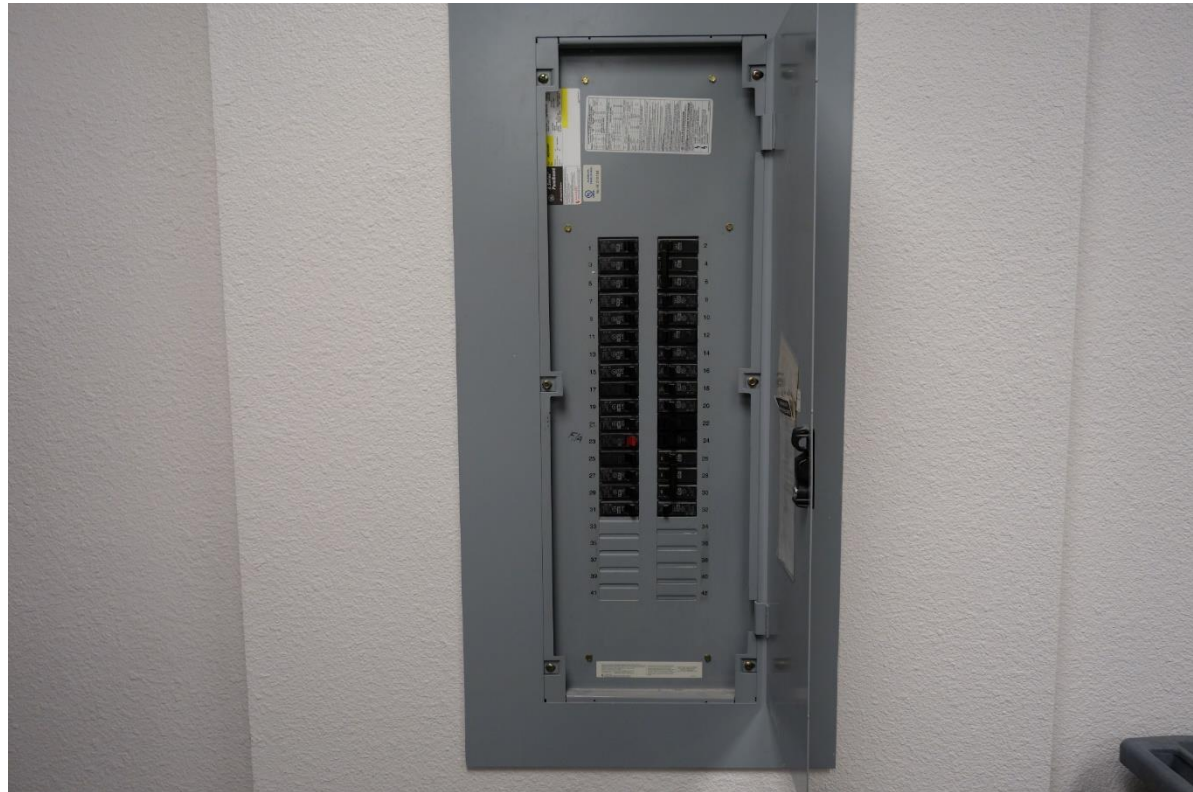
PROJECT ID: 3113-ELE-1

Arc flash and electrical breaker coordination studies have not been performed or it has been more than 5 years since the last coordination study. Safety requirements for maintenance personnel and the latest electrical code require coordination studies to be verified and performed every 5 years, along with arc flash labeling on all electrical panels. This project will perform the required coordination study, evaluation, adjustments and labeling for the building's electrical distribution system.

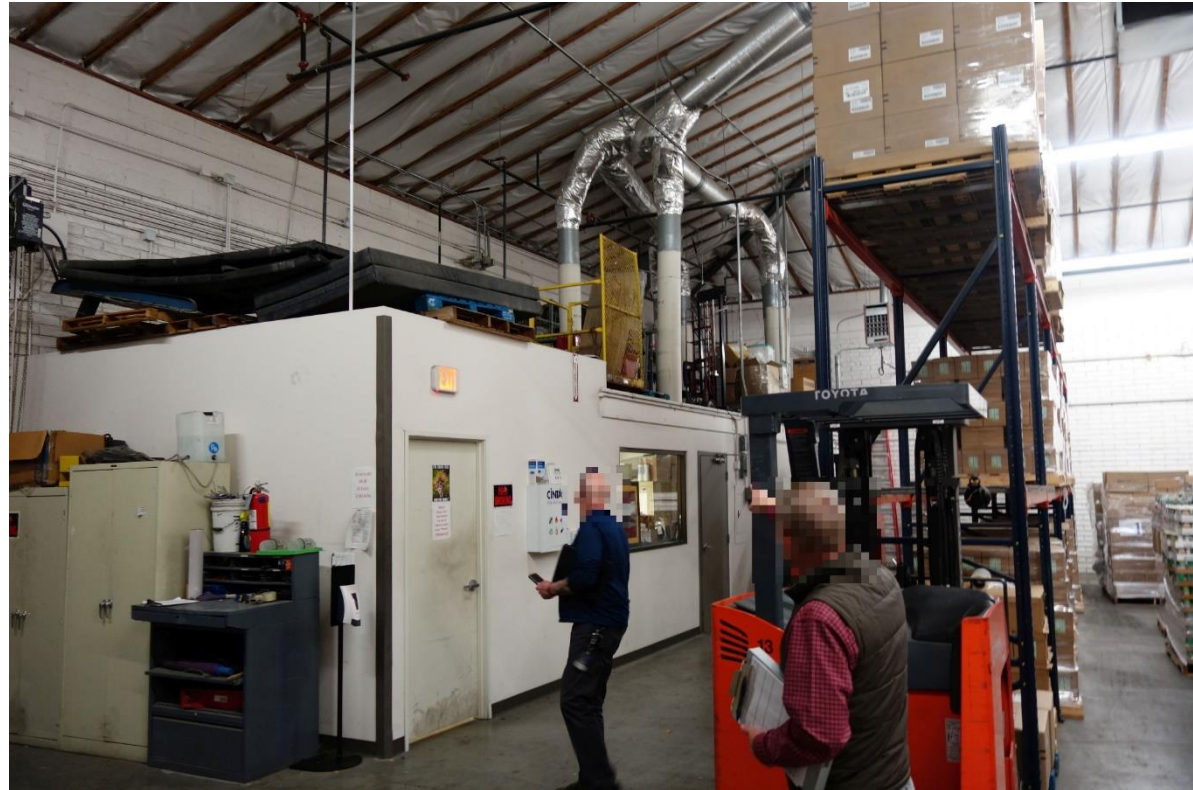
PROJECT ID: 3113-SFT-3

There is an area used as a storage mezzanine in the warehouse area. The sides are unprotected. The height at which a guardrail is required is 30" per IBC 2018 Section 1015.2 Where Required: "Guards shall be located along open-sided walking surfaces, including mezzanines, equipment platforms, aisles, stairs, ramps and landings that are located more than 30 inches measured vertically to the floor or grade below..." This project would provide for the purchase and installation of new guardrails meeting the requirements of Section 1015.

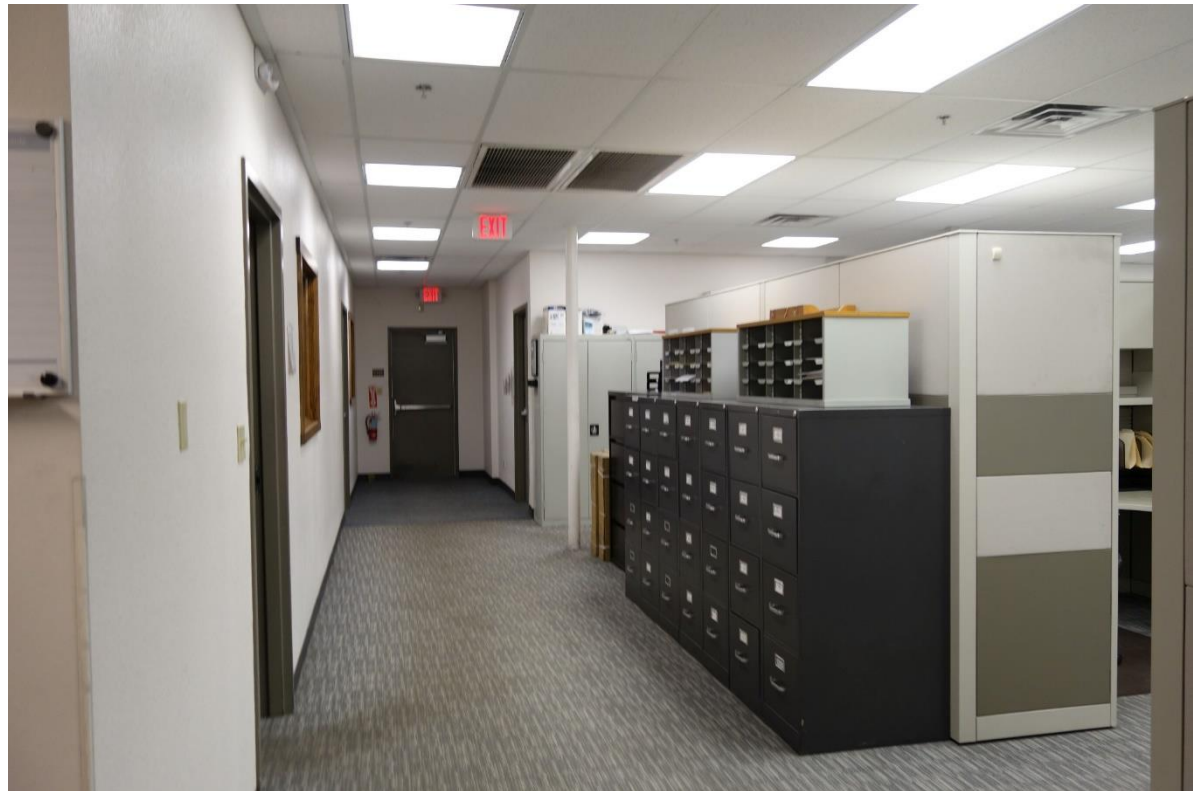
PROJECT ID: 3113-INT-1

The interior finishes are in good condition. It is recommended that the interior walls and ceilings be painted at least once in the next 6 - 8 years and that this project be scheduled on a cyclical basis to maintain the integrity of the structure. Prior to painting, all surfaces should be repaired and prepped. An epoxy-based paint should be utilized in wet areas for durability.
