State of Nevada Department of Employment, Training and Rehabilitation Facility Condition Analysis

ELKO DETR OFFICE

Site Number: 9823 STATE OF NEVADA PUBLIC WORKS DIVISION FACILITY CONDITION ANALYSIS

Report distributed in November 2017

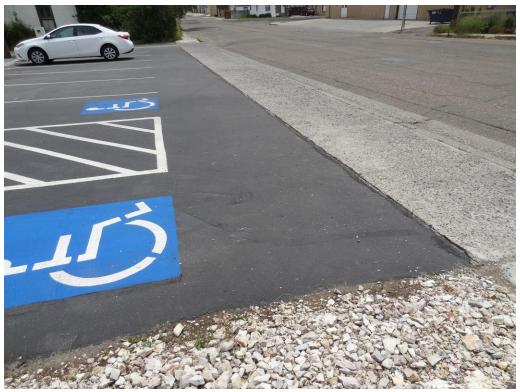
It is important to maintain the asphalt concrete paving on the site. This project would provide for minor crack filling and sealing of the paving site wide including access roads and parking areas. Striping is included in this estimate. This project should be scheduled on a 5 year cyclical basis to maintain the integrity of the paving and prevent premature failure. 10,000 square feet of asphalt area was used to generate this estimate.

Elko DETR - Site #9823
Description: Craft fill and seal of asphalt paving needed.

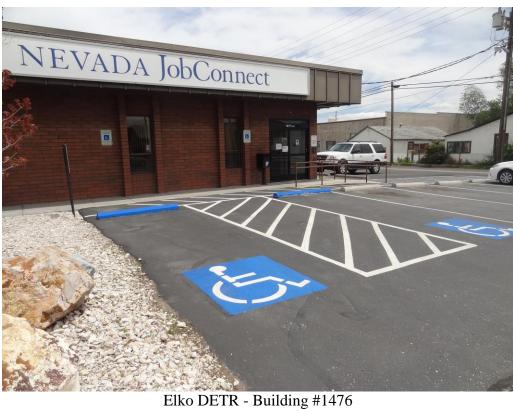
The ADA provides for accessibility to sites and services for people with physical limitations. A concrete parking area, passenger loading area and path of travel to the office are necessary to comply with ADA accessibility requirements. This project would provide for a concrete van accessible ADA parking and loading space and concrete walkway to the existing sidewalk. This will require regrading, placement of P.C. concrete, signage, striping and any other necessary upgrades. The 2012 IBC, ICC/ANSI A117.1 - 2009, NRS 338.180 and the most current version of the ADA Standards for Accessible Design were used as references for this project. 750 square feet of concrete was used for this estimate. It is recommended that this project coincide with the paving project.

Elko DETR - Building #1476 Description: ADA accessible path of travel.

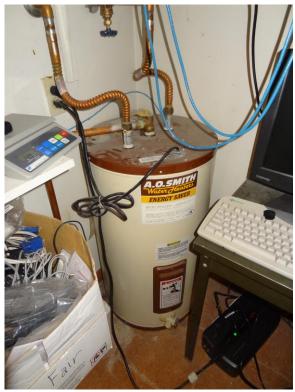
There are two electric water heaters in the building. One water heater is a 12 gallon and the other is a 19 gallon. The average lifespan of a water heater is eight to ten years. The units were installed in 1992. It is recommended that 2 new electric water heaters, seismic straps, braided steel hose, expansion tanks, ball valves, hardwire electric lines and pans be installed in the next 2-3 years. Removal and disposal of the existing equipment is included in this estimate.

Elko DETR - Building #1476 Description: Water heater replacement needed.

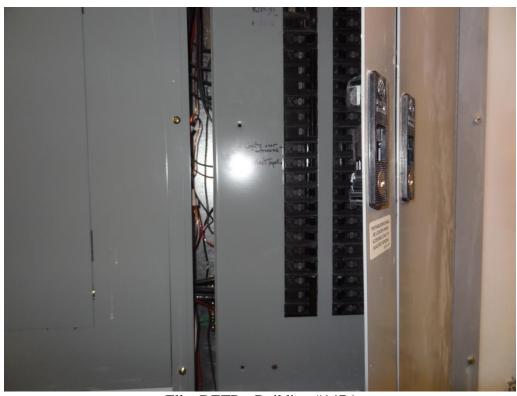
The electrical panel in the building does not have an inside cover (dead panel) that properly protects individuals from touching the bus bar and the interior of the panel. This does not comply with NEC 2011 or OSHA 1910. This project would provide funds to fabricate and install a new dead panel in accordance with NEC 2011 and OSHA 1910.

Elko DETR - Building #1476 Description: Electrical panel upgrades needed.

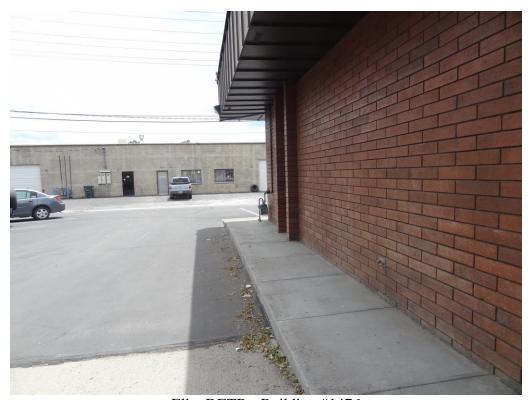
It is important to maintain the finish, weather resistance and appearance of the building. This project would provide funding to protect the exterior of the building excluding the roof. Included in the cost are cleaning and sealing the brick masonry and caulking of the windows, flashing, fixtures and all other penetrations. It is recommended that the building be sealed and caulked in the next 4-5 years and that this project be scheduled on a cyclical basis to maintain the integrity of the structure.

Elko DETR - Building #1476 Description: Exterior finishes needed.

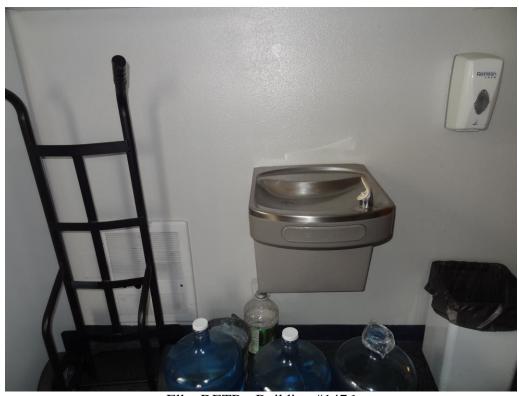
This building contains a water fountain that is not ADA compliant. The 2012 IBC Section 1109.5 states where drinking fountains are provided on an exterior site, on a floor or within a secured area, no fewer than two drinking fountains shall be provided. One shall comply with the requirements for people who use a wheelchair and one shall comply with the requirements for standing persons. This project would provide funding for the purchase and installation of two drinking fountains to meet the ADA requirements.

Elko DETR - Building #1476
Description: Dual level drinking fountain installation needed.

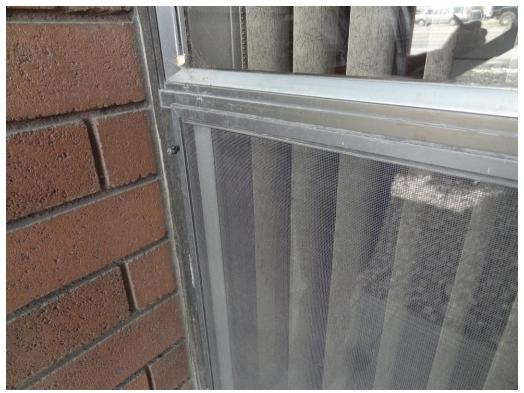
The windows are original, double pane construction in metal frames. These older windows are drafty and not energy efficient. This project recommends replacing the windows with dual pane, higher efficiency units. This estimate is for the replacement of 20 units. Removal and disposal of the existing windows is included in this estimate.

Elko DETR - Building #1476 Description: Window replacement needed.
