DEPARTMENT OF ADMINISTRATION
STATE PUBLIC WORKS DIVISION
FACILITY CONDITION ASSESSMENT

# PROPERTY PORTFOLIO REVIEW PROJECT ADDENDUM

9823 - ELKO DETR OFFICE SITE 172 6TH ST ELKO, NV 89801-3708 ELKO COUNTY

SURVEY DATE: 04/25/2024

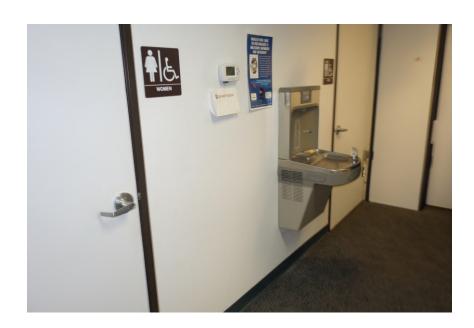
1476-ADA-5: DUAL LEVEL DRINKING FOUNTAIN

This building contains a water fountain that is not ADA compliant. The 2018 IBC Section 1109.5 states where drinking fountains are provided on an exterior site, on a floor or within a secured area, no fewer than two drinking fountains shall be provided. One shall comply with the requirements for people who use a wheelchair and one shall comply with the requirements for standing persons. This project would provide funding for the purchase and installation of 2 drinking fountains to meet the ADA requirements. Note that a

bottle filler integrated into a drinking fountain does not make the water fountain accessible. If drinking fountains are located in an exit access, it is recommended to review exit access requirements for projections into exit access width.

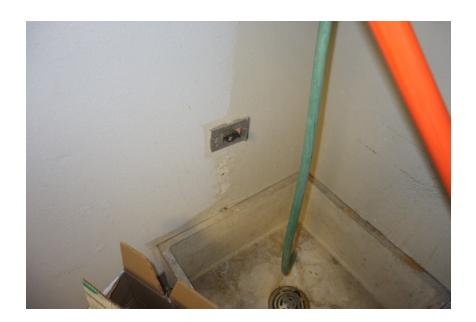
1476-INT-7: JANITORS CLOSET REPAIRS

The mop sink in the Janitors Closet is mounted adjacent to gypsum board and is showing signs of water damage. Drywall nails are now exposed above the sink due to water damage. This project would provide Fiberglass Reinforced Panels (FRP) to be installed on the walls adjacent to the mop sink. The FRP shall extend two feet beyond the edge of the sink and a minimum of 54" above the floor finish.

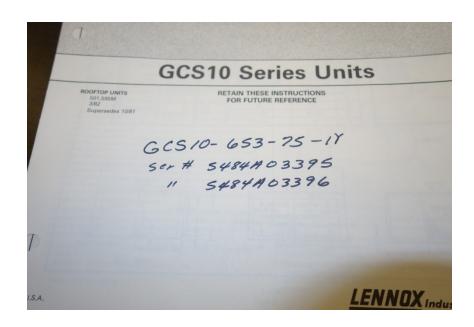
1476-HVA-2: HVAC ROOFTOP UNIT REPLACEMENT

There are 2 rooftop packaged HVAC units that are original to the building and are not energy efficient. The packaged HVAC units have reached the end of their expected and useful life. The R-22 refrigerant in the cooling system is no longer EPA compliant and its production was phased out completely January 1, 2020. This project would provide for the installation of two new packaged HVAC rooftop units. Also included in this estimate is new curb adapters, roofing modifications, 100 feet of new condensate line, crane and

rigging removal and installation and all required connections to utilities. Additional recommended features include outside air economizer and direct digital controls (DDC).

This project should be implemented concurrently with the ROOF REPLACEMENT project in order to provide an integrated, water tight roofing solution.

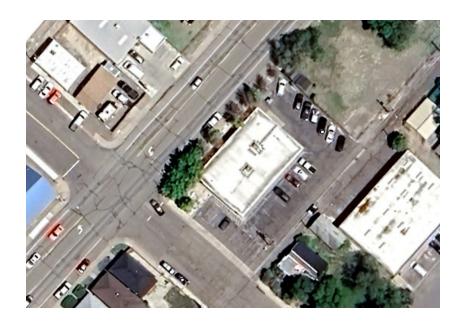
1476-EXT-5: ROOF REPLACEMENT

The roof on this building was in fair condition at the time of the survey. The statewide roofing program has set the useful life of an average roof at 20 years. The roof warranty expires at the end of the same time-frame. The temperature fluctuations throughout the year, consistent wind which blows sand and dirt on to the roof membrane, and constant exposure to the sun are contributing factors to wear and deterioration. The roofing was replaced in 2002. It is recommended that this building be re-roofed in the next 3 - 4 years to be consistent with the roofing program and the end of the warranty period. Implement concurrently with the HVAC

ROOFTOP UNIT REPLACEMENT project in order to provide an integrated, water tight roofing solution.

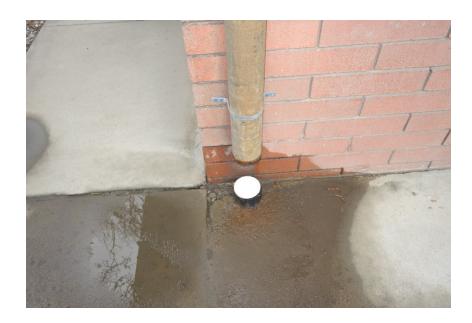
9823-SIT-3: STORM DRAIN IMPROVEMENTS

The site underground storm drain appears to be plugged and downspouts have been cut and capped above grade. It is not good practice to allow storm water to sheet flow over sidewalks, especially in cold climates and icy conditions. This project recommends cleaning out the storm drains, and if required, replaced any underground collapsed pipes that have caused the downspouts to be capped. In addition, it was noted that the municipal storm drain may also be blocked and the probable source of this issue.

Further discussions with the county public works are needed to get the municipal storm drains cleared.

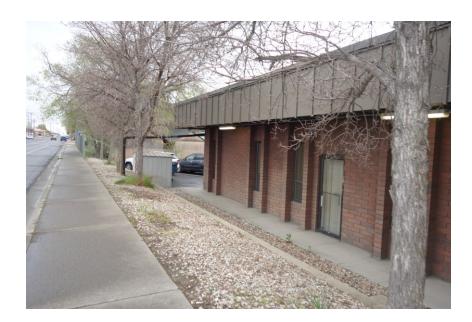
9823-ENR-1: EXTERIOR LIGHTING REPLACEMENT

The building has perimeter lighting on the exterior of the building, but the light fixtures are old, failing and not energy efficient. This project would provide for the replacement of the exterior lighting fixtures with new LED light fixtures, using existing wiring.

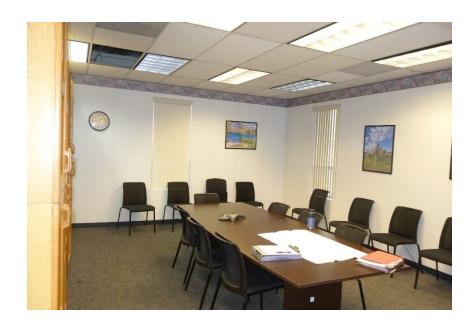
1476-ENR-2: LIGHTING UPGRADE

The existing lighting fixtures are the older fluorescent type and are not energy efficient. This project will upgrade fixtures to higher efficiency units with a longer life cycle. 5,000K LED lamps, without the ballasts are suggested, and new tombstones (if needed). Occupancy sensors will be installed in low occupancy areas for additional savings. Any electrical wiring upgrades are not included in this estimate.

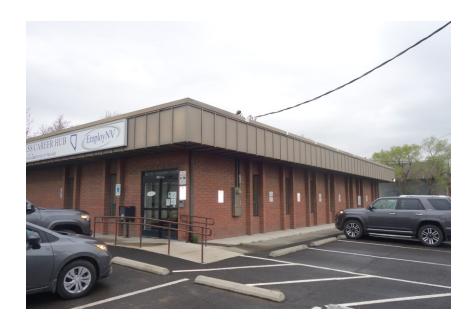
1476-EXT-4: EXTERIOR FINISHES

The exterior finishes were in good condition. It is important to maintain the finish, weather resistance and appearance of the building. This project would provide funding to protect the exterior of the building excluding the roof. Included in the cost are cleaning and sealing the brick masonry and caulking the windows, flashing, fixtures and all other penetrations. Sealing the exterior brick masonry will help in preventing efflorescence. It is recommended that the building be sealed and caulked in the next 8 - 10 years and

that this project be scheduled on a cyclical basis to maintain the integrity of the structure.

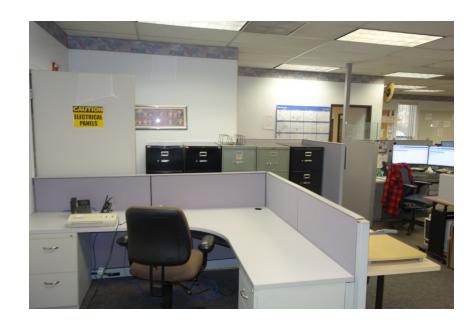
1476-INT-8: INTERIOR FINISHES

The interior finishes were in good condition. It is recommended the interior walls and ceilings be painted in the next 7 - 9 years. All surfaces should be repaired and prepped prior to painting. For durability in wet areas, an epoxy-based paint should be used. Building maintenance should be scheduled on a cyclical basis to maintain the integrity of the structure

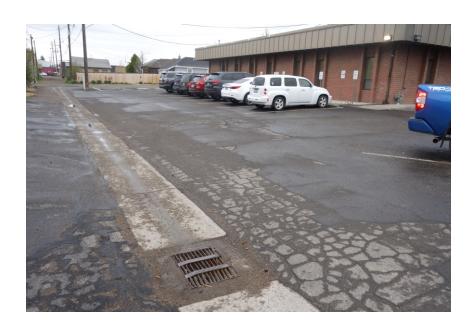
9823-SIT-4: CRACK SEAL AND SLURRY SEAL

The parking lot was re-sealed and striped in 2023 and in good condition. It is important to maintain the asphalt concrete paving on the site.

This project would provide for minor crack filling and sealing of the paving site wide including access roads, parking areas and the maintenance yard. Striping is included in this estimate.

This project should be scheduled on a 5 year cyclical basis to maintain the integrity of the paving and prevent premature failure. 10,000 square feet of asphalt area was used to generate this estimate.
