State of Nevada
Department of Wildlife

ELY WILDLIFE FIELD OFFICE SITE

Site Number: 9825

**STATE OF NEVADA PUBLIC WORKS DIVISION
FACILITY CONDITION ANALYSIS**

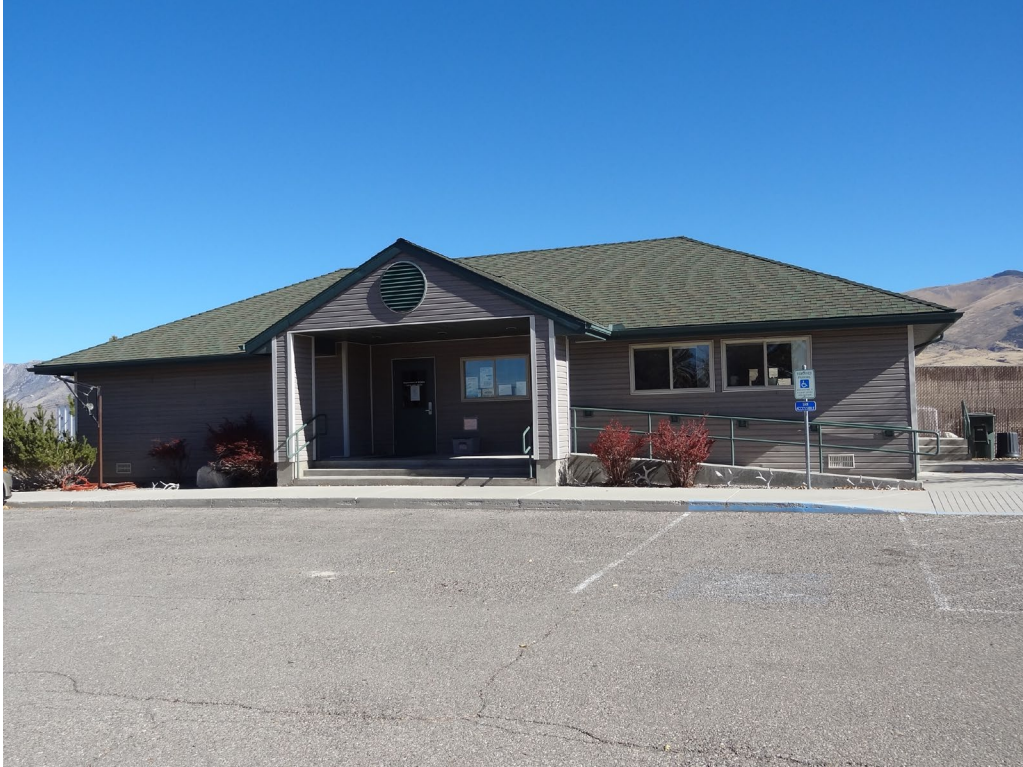
The ADA provides for accessibility to sites and services for people with physical limitations. A concrete parking area, passenger loading area and path of travel to the office are necessary to comply with ADA accessibility requirements. This project would provide for a concrete van accessible ADA parking and loading space and concrete walkway to the existing sidewalk. This will require regrading, placement of concrete, signage, striping and any other necessary upgrades. The 2018 IBC, ICC/ANSI A117.1, NRS 338.180 and the most current version of the ADA Standards for Accessible Design were used as a reference for this project. 750 square feet of concrete was used for this estimate. It is recommended that this project coincide with the paving project.

Ely Wildlife Field Office Site - Site #9825
Description: ADA Parking Upgrade.

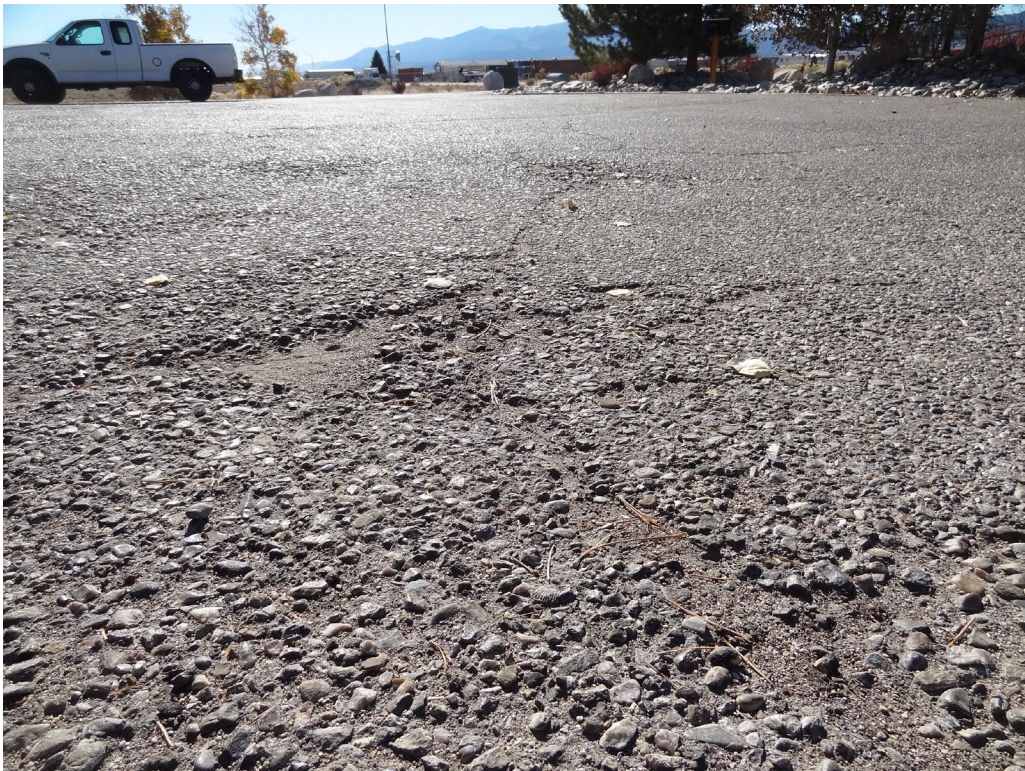
It is important to maintain the asphalt concrete paving on the site. This project would provide for minor crack filling and sealing of the paving site wide including the access roads and parking lot. Striping is included in this estimate. This project should be scheduled on a 5 year cyclical basis to maintain the integrity of the paving and prevent premature failure. 10,000 square feet of asphalt area was used to generate this estimate.

Ely Wildlife Field Office Site - Site #9825
Description: AC Paving Crack Fill & Seal.

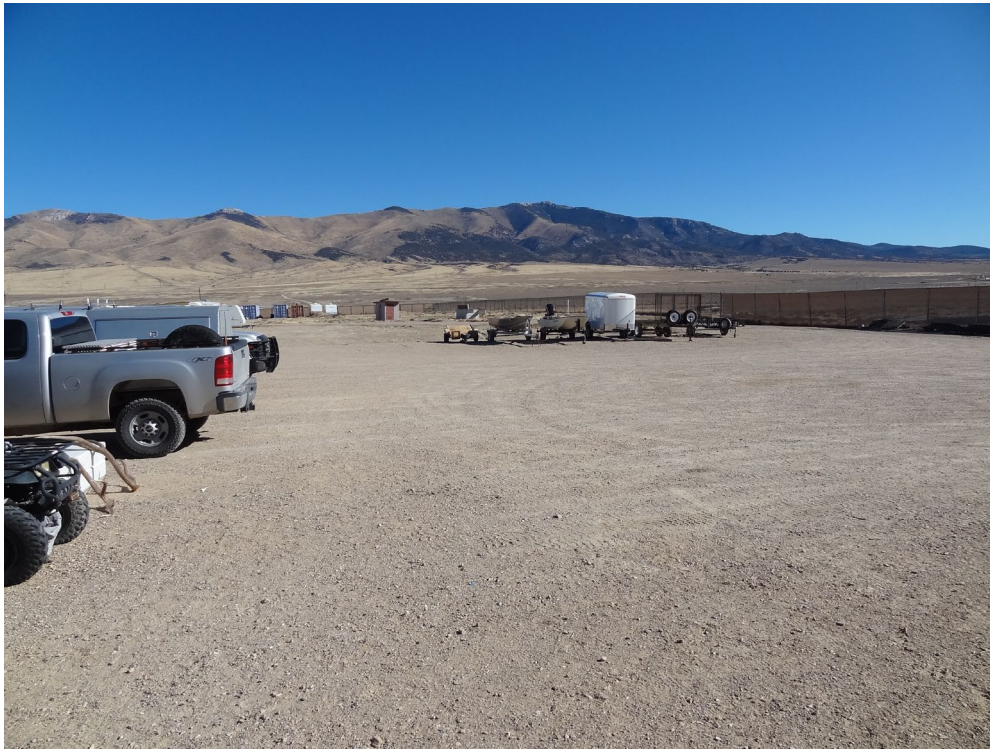
There are approximately 10 state vehicles parked in the rear parking area at any given time including trucks, boats, trailers and quads. Some of these vehicles carry sensitive measuring and testing equipment which can deteriorate quickly due to exposure to the elements. This project would provide a steel carport capable of protecting 10 vehicles to be built on the east side of the site.

Ely Wildlife Field Office Site - Site #9825
Description: View of East Parking Area.

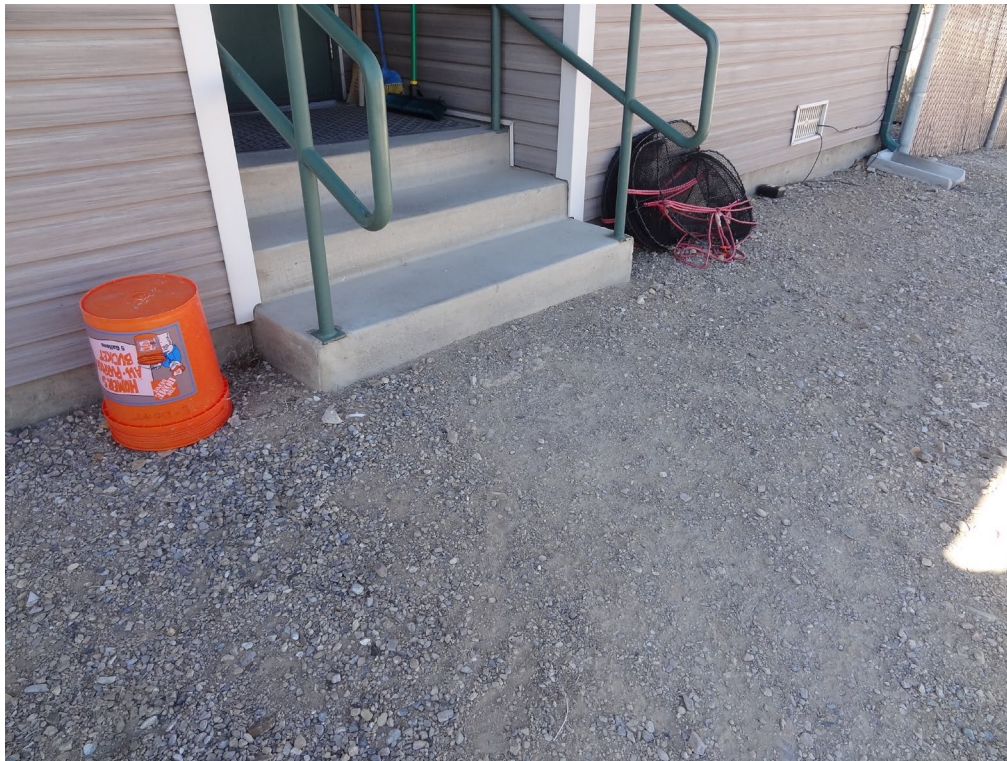
There is an exterior stairway at the rear of the building which does not have a landing. This does not comply with 2018 IBC Section 1008.1 which describes the requirements for landings including that the width of the landing shall not be less than the width of the stairway. This project addresses installing a landing designed to current code.

Ely Wildlife Field Office - Building #2127
Description: East Side Exterior Landing Needed.

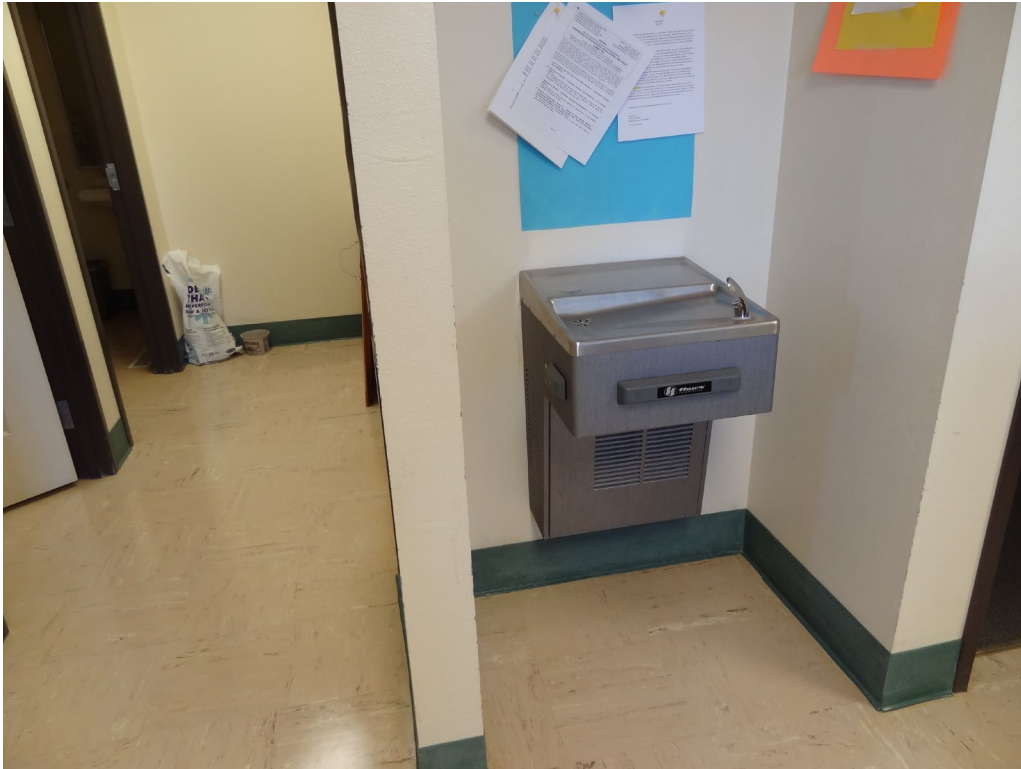
This building contains a water fountain that is not ADA compliant. The 2018 IBC Section 1109.5 states where drinking fountains are provided on an exterior site, on a floor or within a secured area, no fewer than two drinking fountains shall be provided. One shall comply with the requirements for people who use a wheelchair and one shall comply with the requirements for standing persons. This project would provide funding for the purchase and installation of four drinking fountains to meet the ADA requirements, two on each floor. If drinking fountains are located in an exit access, it is recommended to review exit access requirements for projections into exit access width.

Ely Wildlife Field Office - Building #2127
Description: Dual Level Drinking Fountain Needed.

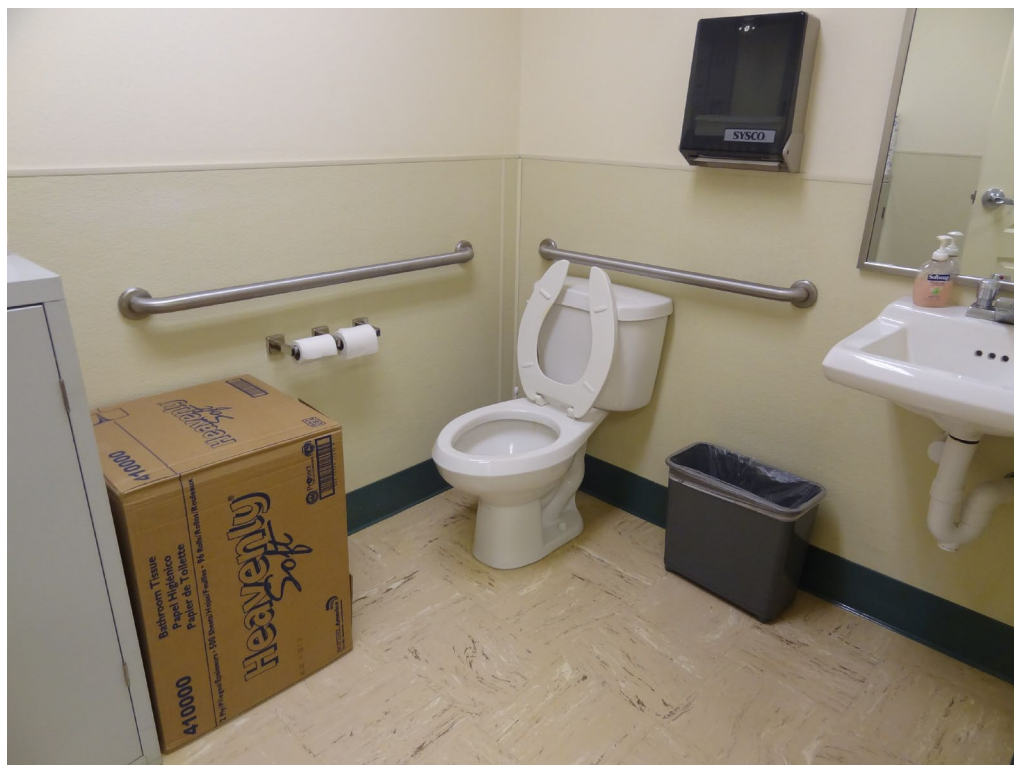
The designated ADA accessible restroom is not fully compliant. It is missing a grab bar and the toilet flush handle is located incorrectly. A partial retrofit is necessary. This project would provide funding to bring the restroom into full ADA compliance. The 2018 IBC, ICC/ANSI A117.1, NRS 338.180 and the most current version of the ADA Standards for Accessible Design were used as a reference for this project.

Ely Wildlife Field Office - Building #2127
Description: ADA Restroom Minor Upgrades Needed.

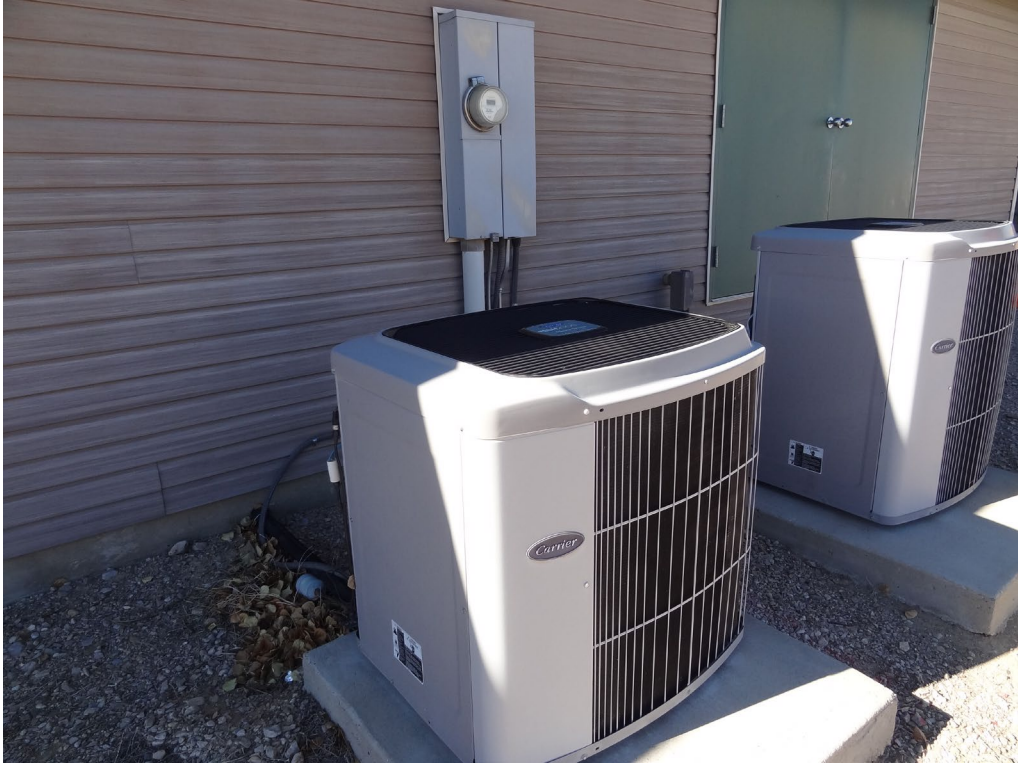
The HVAC system is original to the building and should be scheduled for replacement. It is reaching the end of its expected and useful life. The R-22 refrigerant in the cooling system is no longer EPA compliant and its production is mandated to be phased out completely by January 1, 2020. This project would provide for installation of a new HVAC system and cleaning of the existing duct work and grilles. This project includes removal and disposal of the existing HVAC system and all required connections to utilities.

Ely Wildlife Field Office - Building #2127
Description: HVAC R-22 Equipment Replacement Needed.

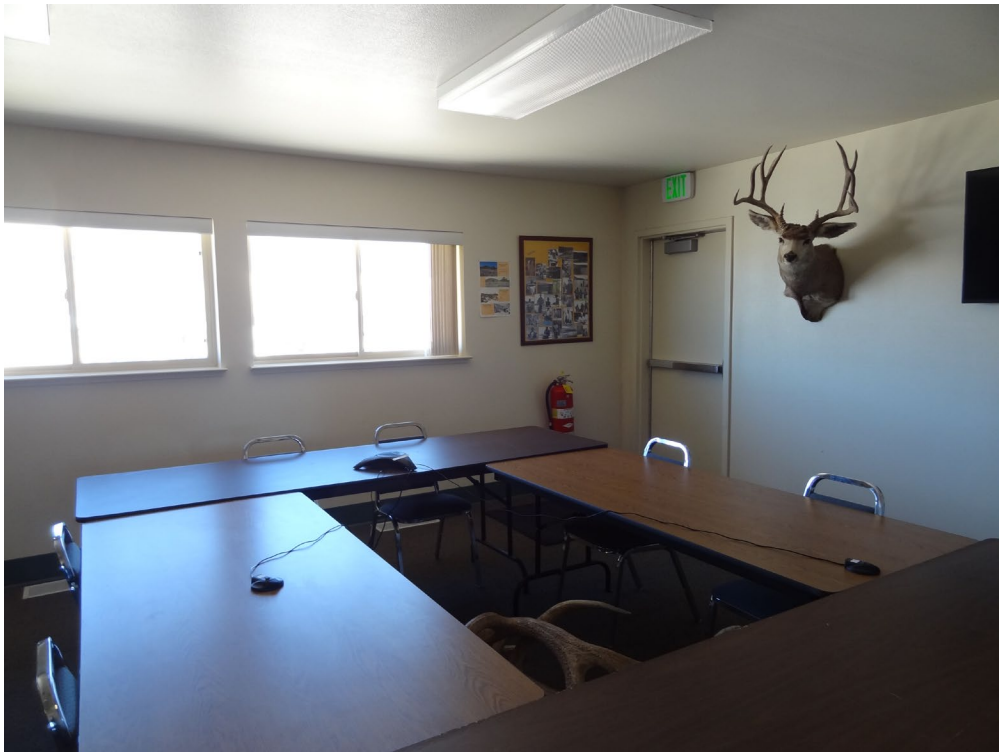
The emergency egress lighting is insufficient. This project would provide for the purchase and installation of self-illuminated or LED style exit signs with battery-backed internal systems as well as emergency egress lighting to provide illumination along the egress route. IBC - 2018 Chapter 10 was referenced for this project.

Ely Wildlife Field Office - Building #2127
Description: Emergency Egress Lighting Needed.
