State of Nevada
Public Safety
Henderson Highway Patrol Substation
Facility Condition Analysis

NEVADA HIGHWAY PATROL SUBSTATION
Henderson, NV

BUILDING NUMBER: 1945

FACILITY CONDITION ANALYSIS

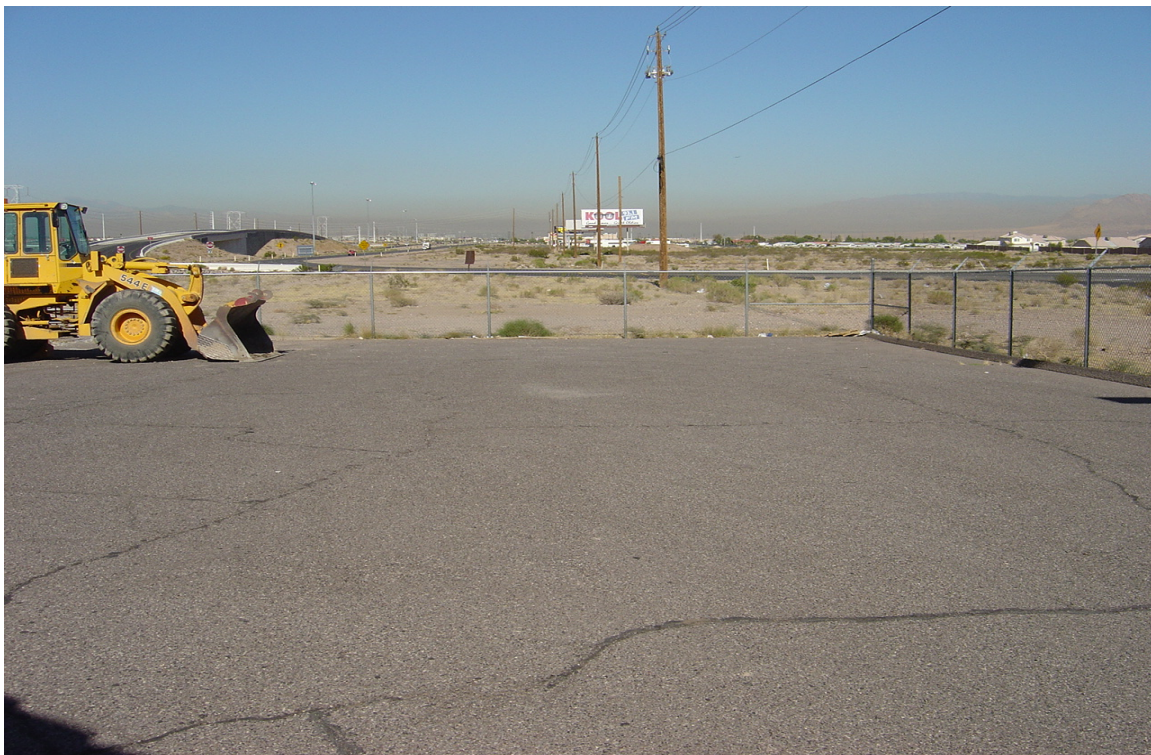
There is no accessible parking. CABO/ANSI A117.1 - 1992 Section 4.6.2 states, "...accessible parking spaces shall be identified by a sign showing the international symbol of accessibility..." The lot will be re-stripped, accessible routes of travel identified, and signage is included.

Henderson Highway Patrol Substation - Building #1945
Description: View of parking area.

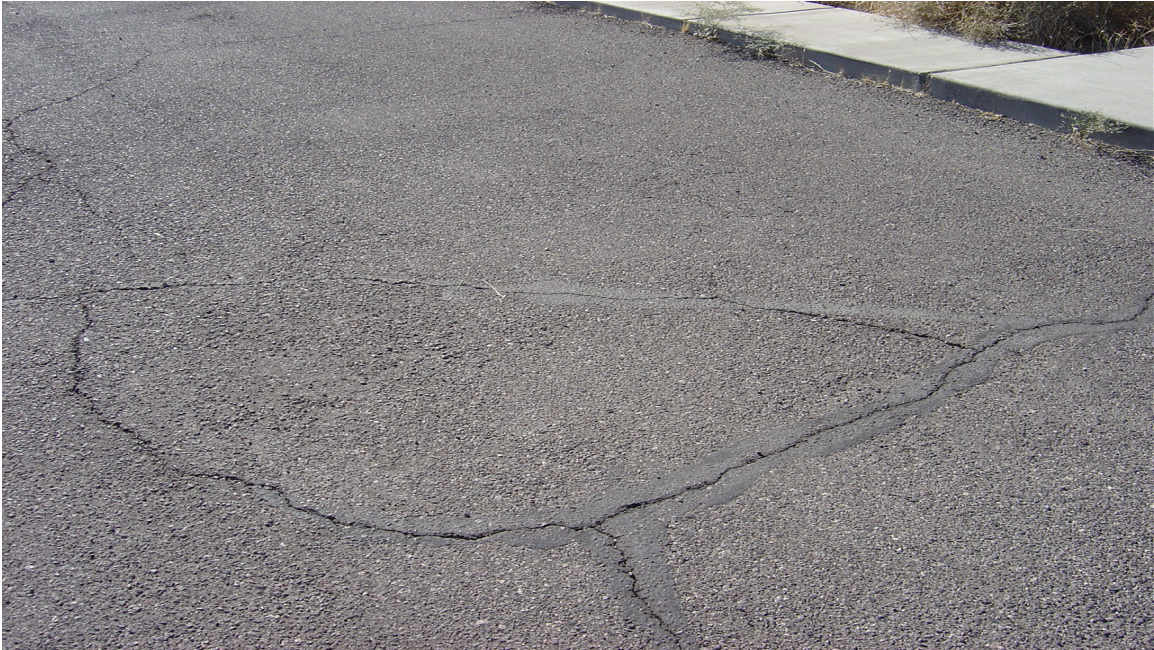
The site paving is in fair condition. It is recommended the parking area and driveway be fog sealed and re-striped to extend the life of the asphalt.

Description: View of parking area condition.

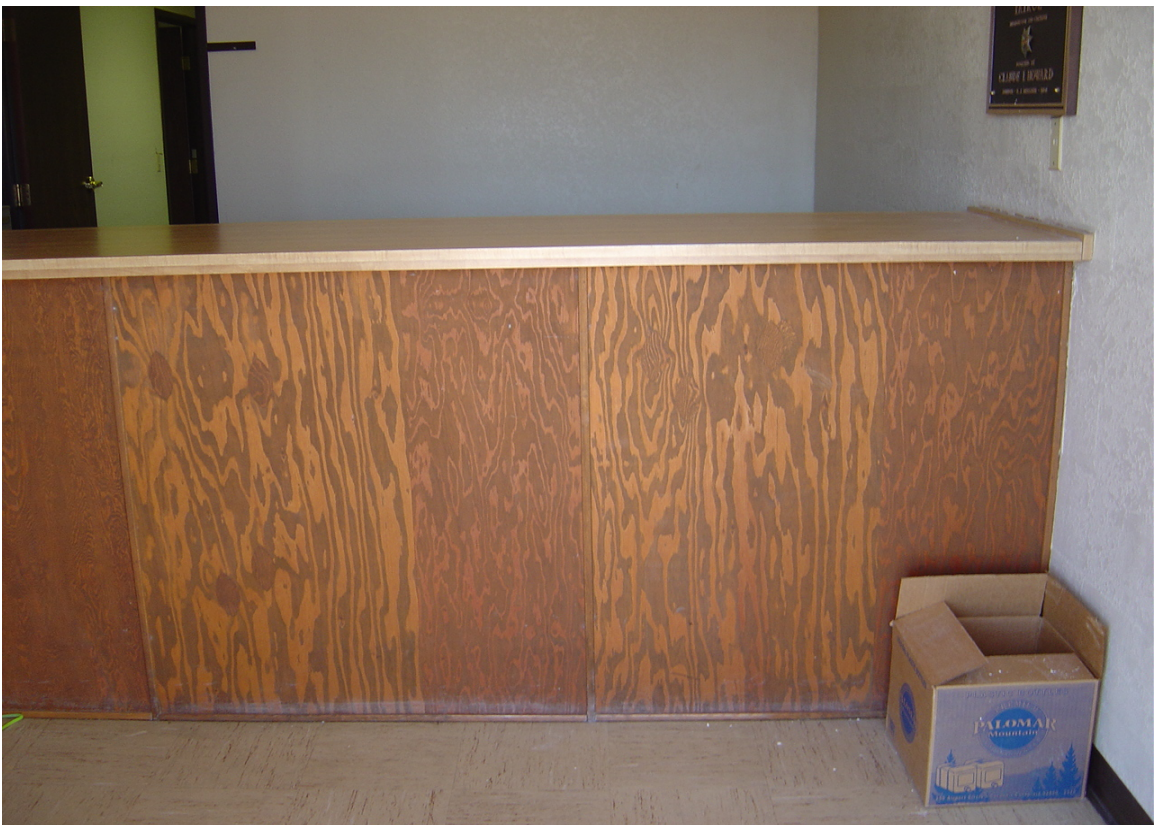
This building contains a counter which does not meet current codes. UBC Section 1105.4.4.2 requires that where a service counter is provided, a portion of the counter be accessible. This project will provide an accessible counter space at the main lobby location.

Description: View of main counter.

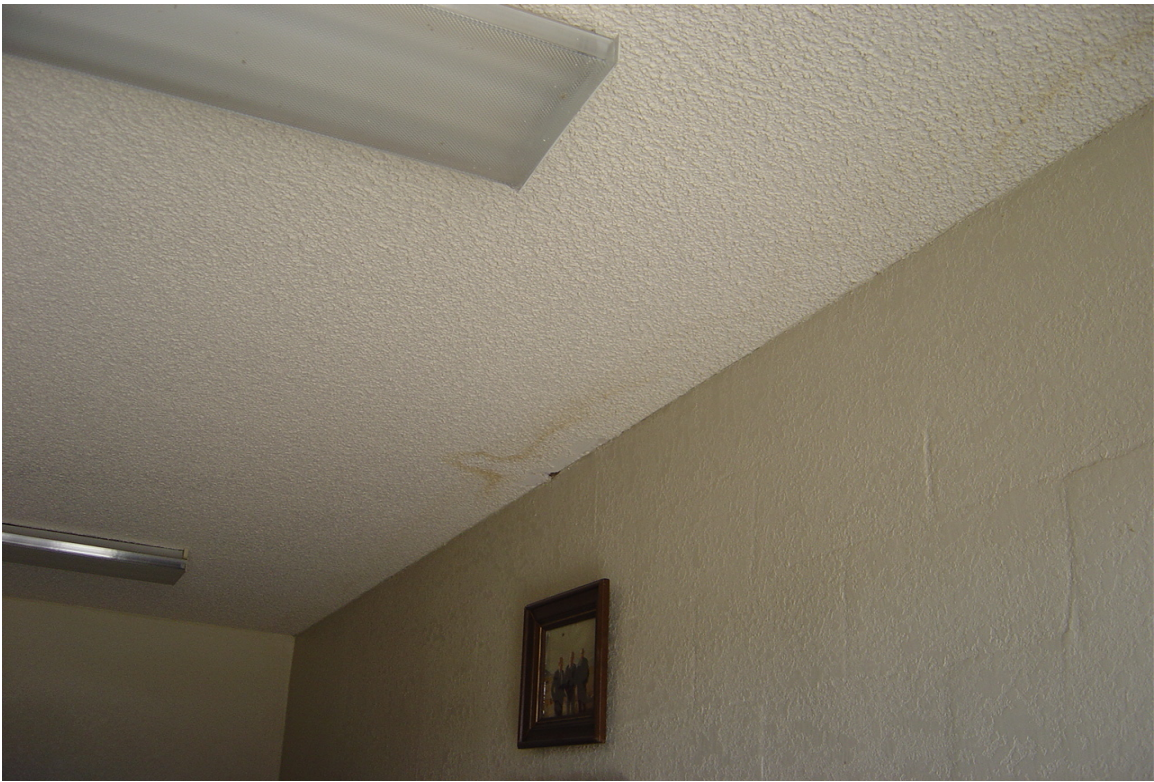
The roof on this building was reported in poor condition at the time of the survey, with evidence of recent leaks.

Description: View of stained ceiling due to roof leak.

This project recommends the building be re-roofed as soon as possible, to minimize further deterioration and damage to the building.
