BELROSE OFFICE

620, 628 Belrose Street
Las Vegas, Nevada

Site Number: 9831
STATE OF NEVADA PUBLIC WORKS DIVISION
FACILITY CONDITION ANALYSIS

Survey Date: 12/10/2018

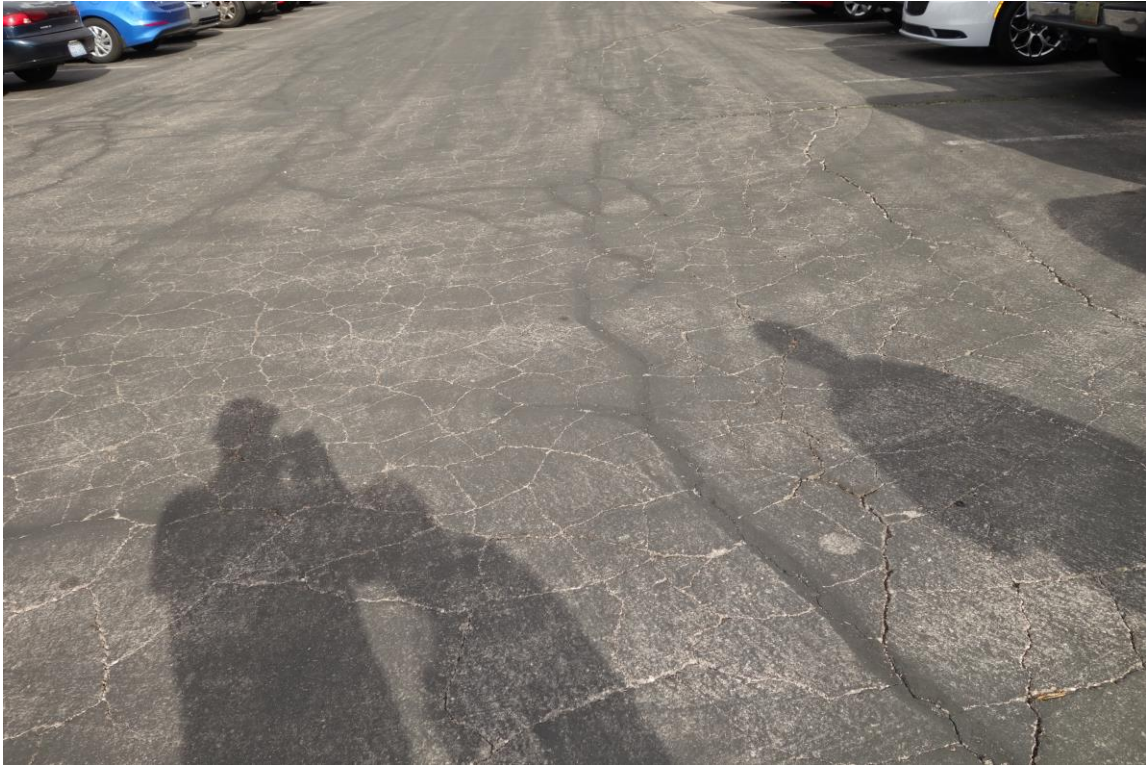
The asphalt parking area west of the building is failing, with significant alligating, settling and cracks observed. It was not included in the 2014 asphalt replacement for the rest of the site. This project covers the removal and replacement of the existing asphalt and any drainage improvements including concrete gutter for parking and driveway access. Striping for safety, parking and loading zones is included in this estimate. 18,000 square feet was used to generate this estimate.

Belrose Office Building Site - Site #9831
Description: Damaged Paving in West Parking Area Needing Replacement.

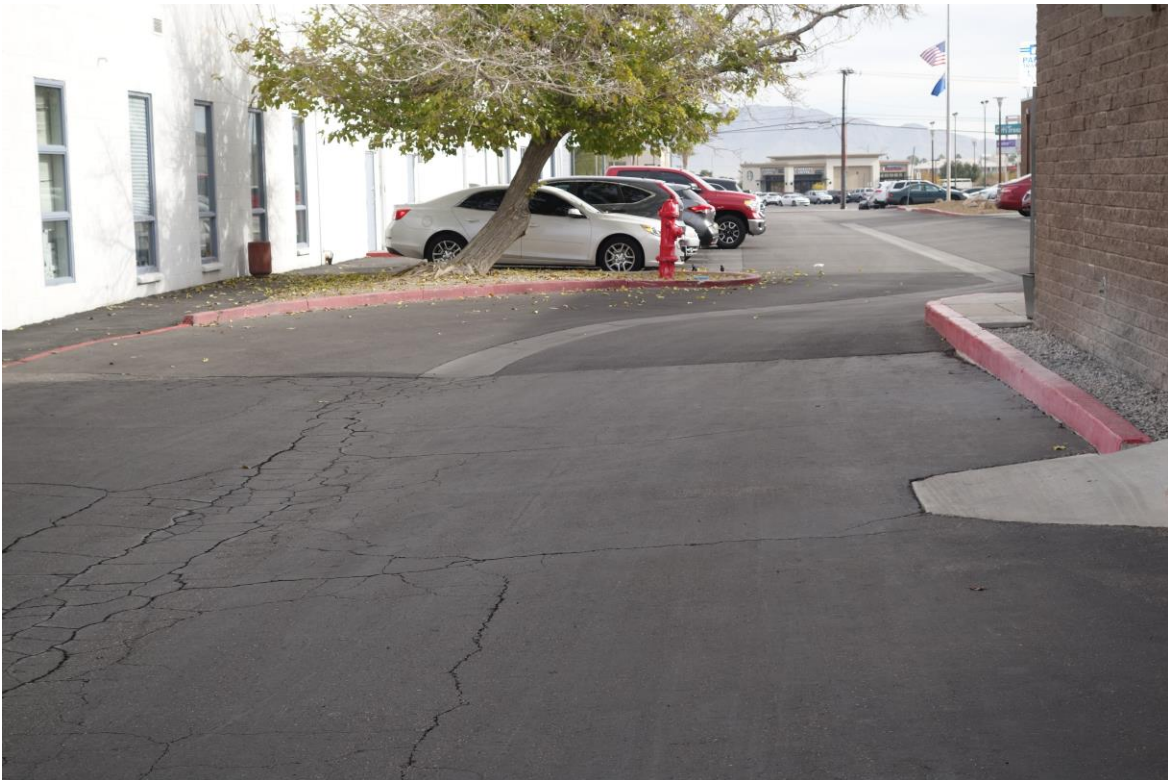
Belrose Office Building Site - Site #9831
Description: Slurry Seal Paving in East Parking Area.

It is important to maintain the asphalt concrete paving on the site. This project would provide for minor crack filling and sealing of the paving in the front portion of the site previously re-paved. Striping is included in this estimate. This project should be scheduled on a 5 year cyclical basis to maintain the integrity of the paving and prevent premature failure. 32,000 square feet of asphalt area was used to generate this estimate. This project or a portion thereof was previously recommended in the FCA report dated 11/01/2011. It has been amended accordingly to reflect conditions observed during the most recent survey date of 12/10/2018.

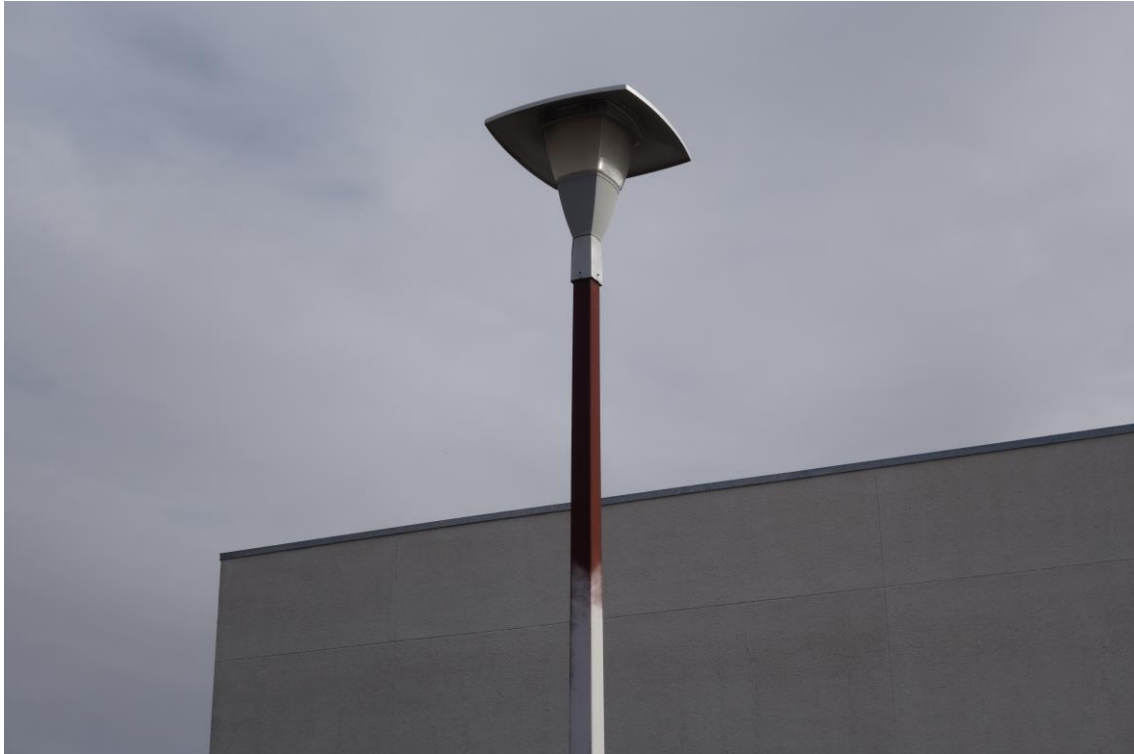
The parking area and site have insufficient, poor and nonfunctional lighting that should be replaced. Considering the environment of the site, this area needs to be well lit. This project will provide funding for the purchase and installation of LED fixtures, 30' light poles and 30" diameter raised concrete bases utilizing the existing underground conduit and wiring. The light poles should match the existing light poles located in the surrounding area. This project or a portion thereof was previously recommended in the FCA report dated 11/01/2011. It has been amended accordingly to reflect conditions observed during the most recent survey date of 12/10/2018.

Belrose Office Building Site - Site #9831
Description: Exterior Site Lighting Upgrade Needed.

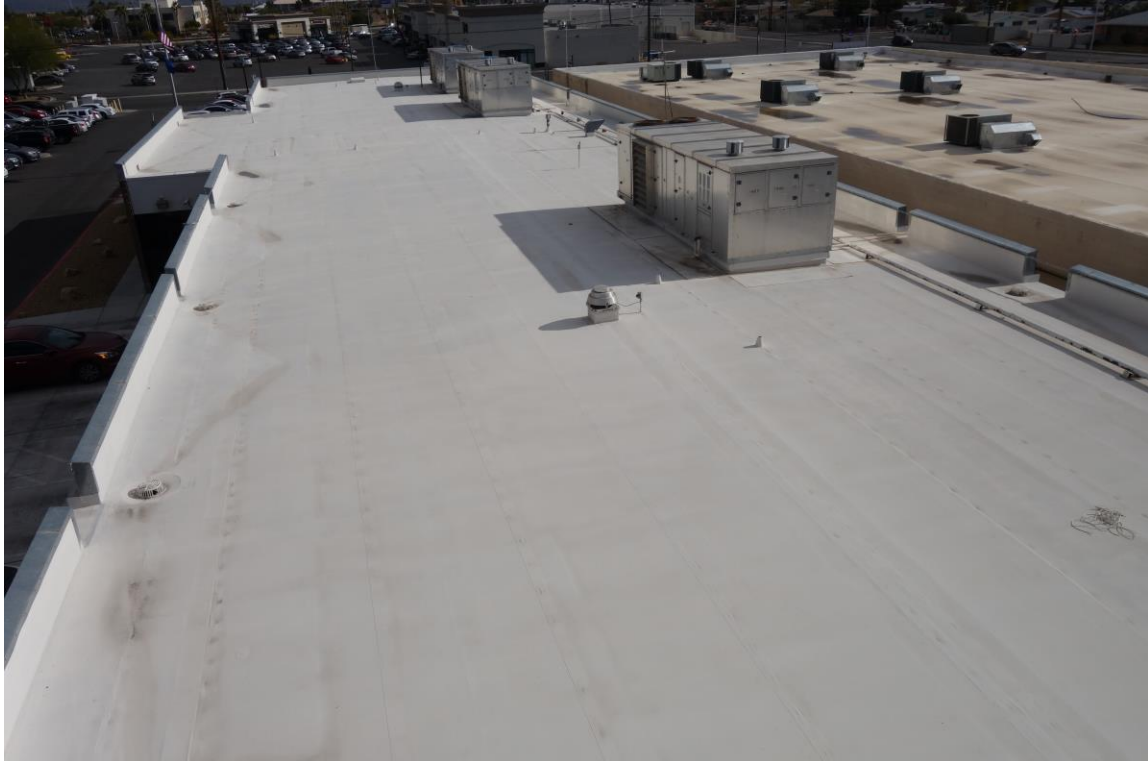
Multiple locations on the roof have equipment located near unprotected roof edges. This project recommends the installation of guards along the low parapet walls to form a protective barrier in accordance with the 2018 IBC Chapter 10, Section 1015.

Belrose Office Building - Building #0286
Description: Guard Installations at Unprotected Edges Near Equipment.

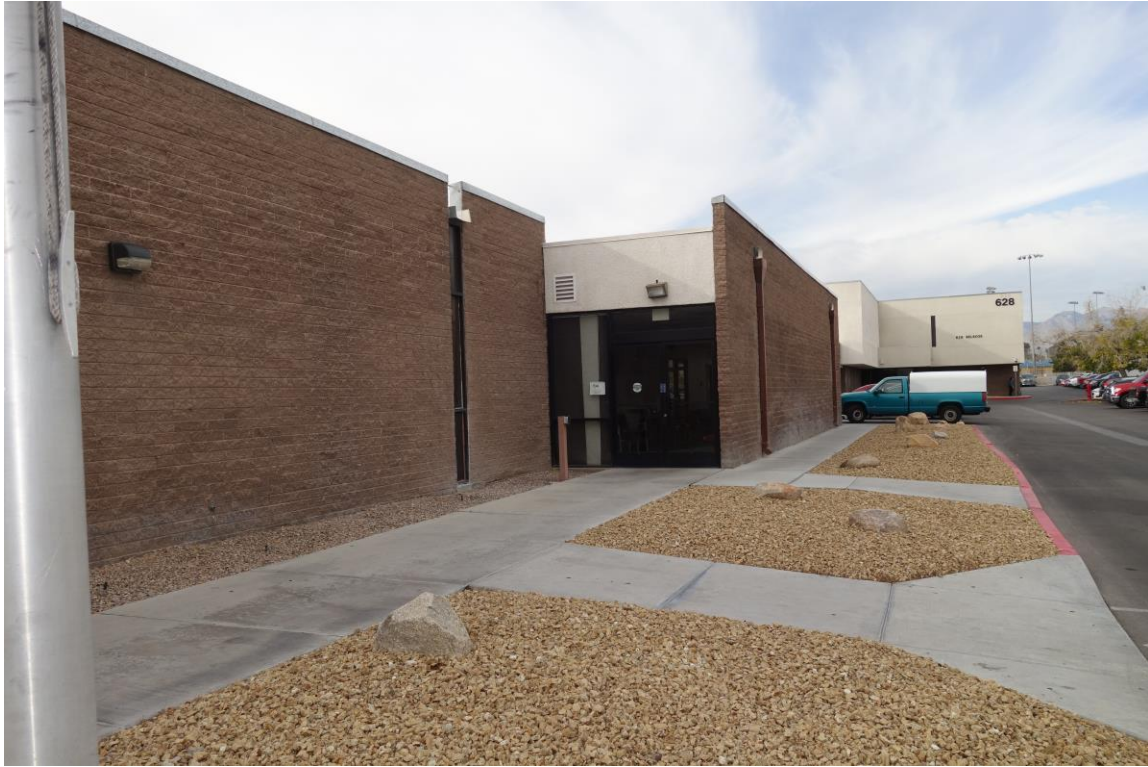
The building mounted wall pack lights appear to be original to the building. These fixtures have High Pressure Sodium (HPS) lamps and are less efficient. This project would provide for the replacement of the existing wall pack fixtures with LED wall packs using the existing wiring.

Belrose Office Building - Building #0286
Description: Exterior Wall Pack Lighting Upgrade Recommended.

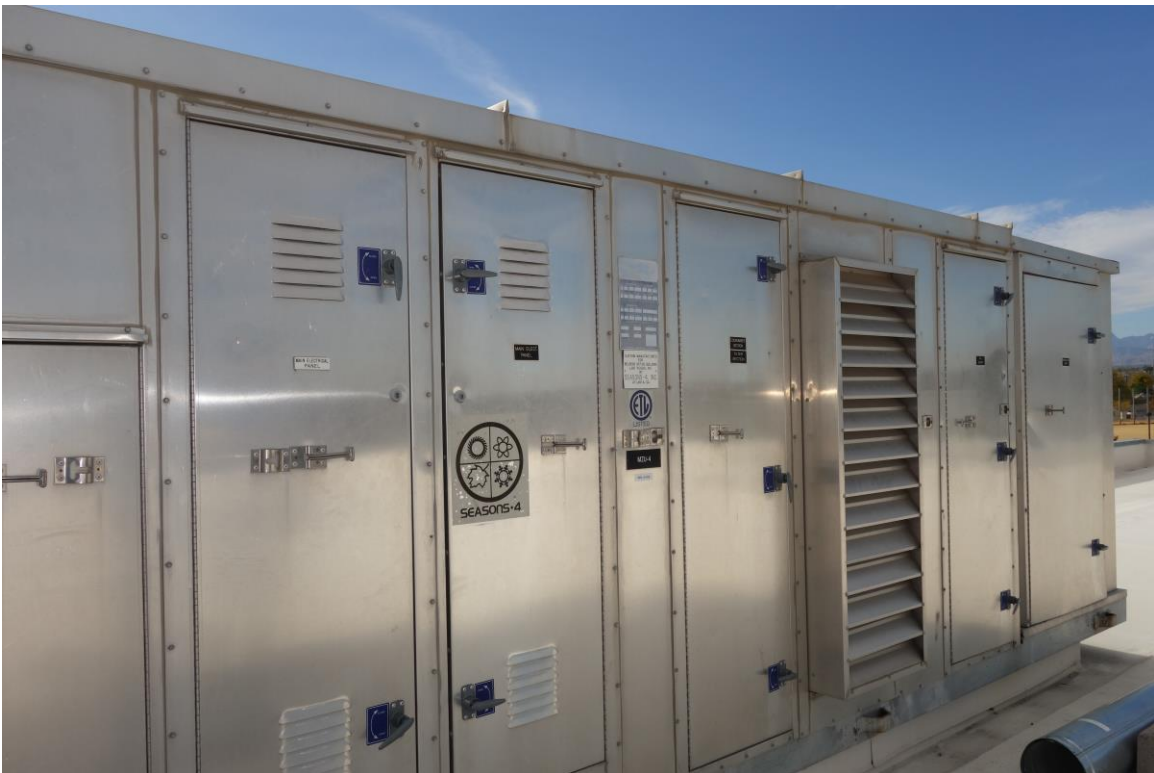
The six large multi-zone roof top units were installed in 1998. In addition, 7 of the 10 smaller Rooftop Units and two split systems are old and have reached the end of their useful life. The R-22 refrigerant in the cooling systems is no longer EPA compliant and its production is mandated to be phased out completely by January 1, 2020. This project would provide for installation of new HVAC packaged units and cleaning of the existing duct work and grilles. This project includes removal and disposal of the existing equipment and all required connections to utilities.

Belrose Office Building - Building #0286
Description: HVAC Equipment Replacement.

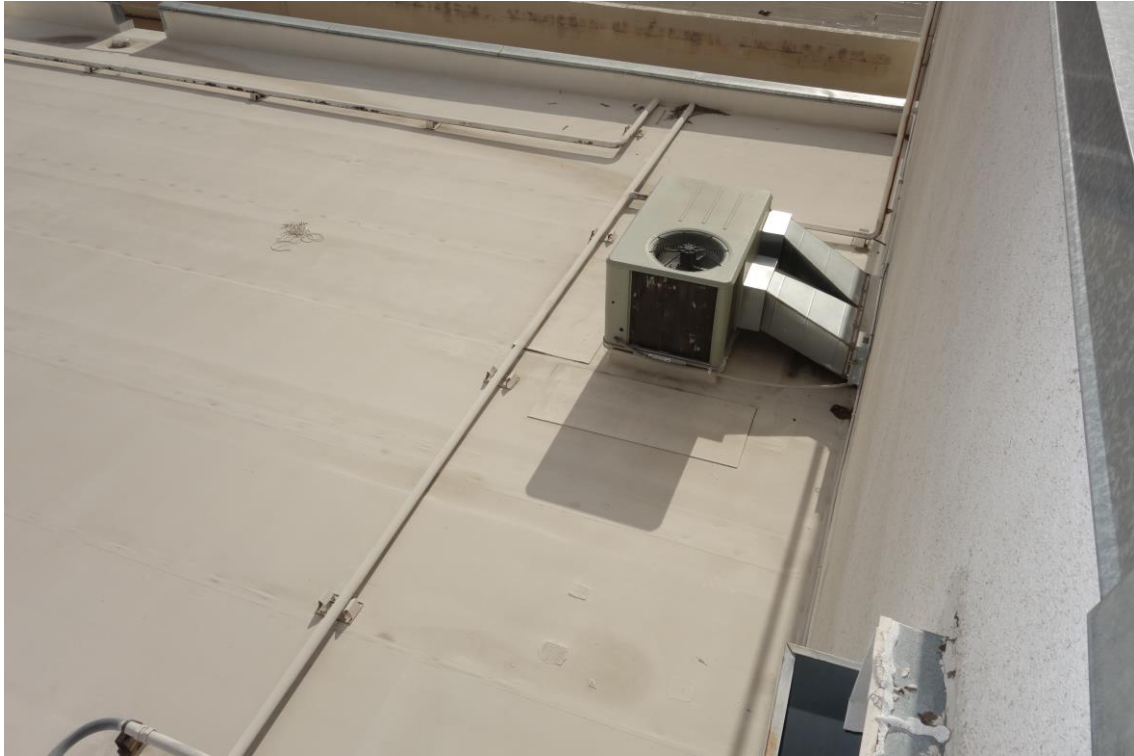
The statewide roofing program has set the useful life of an average roof at 20 years. The roof warranty expires at the end of the same time frame. The temperature fluctuations throughout the year, consistent wind which blows sand and dirt on to the roof membrane, and constant exposure to the sun are contributing factors to wear and deterioration. The current roofing system was installed in 1995. It is recommended that this building be re-roofed in the next 2-3 years to be consistent with the roofing program and the end of the warranty period. In addition, the existing roof ladders are old and should be replaced with new safe ladders.

Belrose Office Building - Building #0286
Description: Roof Replacement Needed.

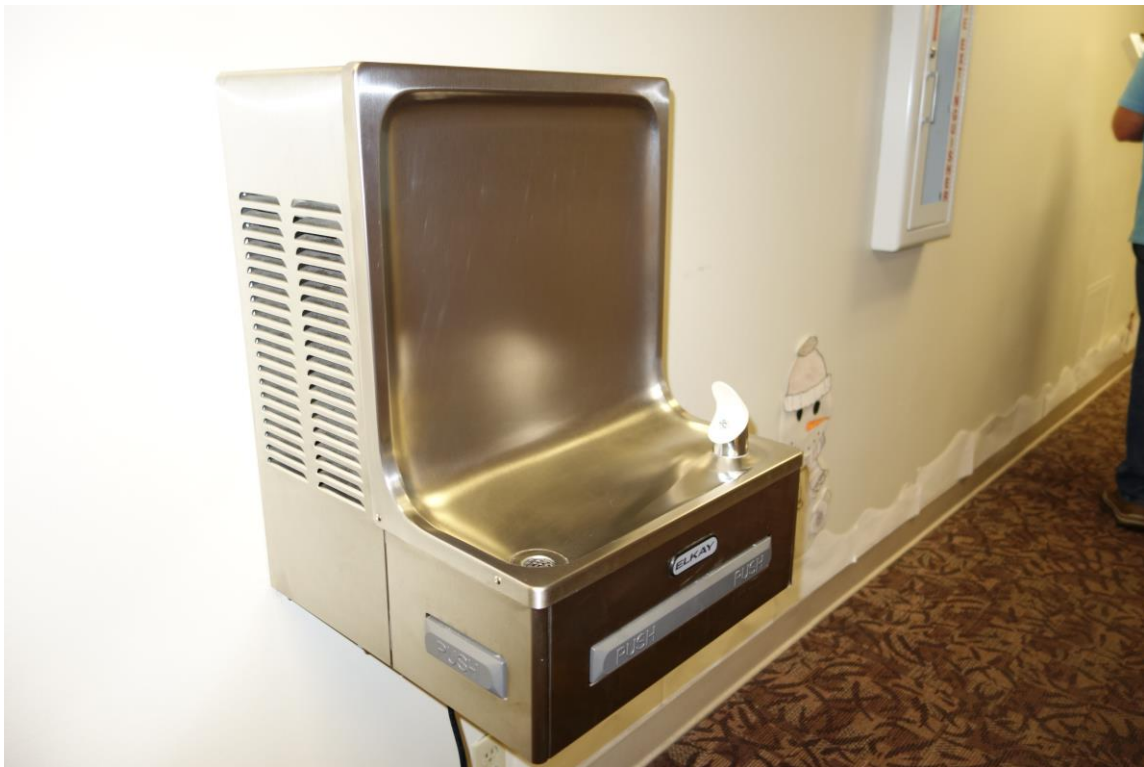
This building contains several drinking water fountains on the first and second floors. The 2018 IBC Section 1109.5 states where a water fountain is provided, at least half should be accessible. Due to the layout of the building and that the various offices are separated from each other, four accessible fountains are required. This project would provide funding for the purchase and installation of four new accessible fixed high/ low ADA drinking fountains, three on the first floor and one on the second floor. NRS 338.180, IBC - 2018, ICC/ANSI A117.1 and the most current version of the Americans with Disabilities Act Accessibility Guidelines (ADAAG) were used as a reference for this project. This project or a portion thereof was previously recommended in the FCA report dated 11/01/2011. It has been amended accordingly to reflect conditions observed during the most recent survey date of 12/10/2018.

Belrose Office Building - Building #0286
Description: Dual Level Drinking Fountains Needed.

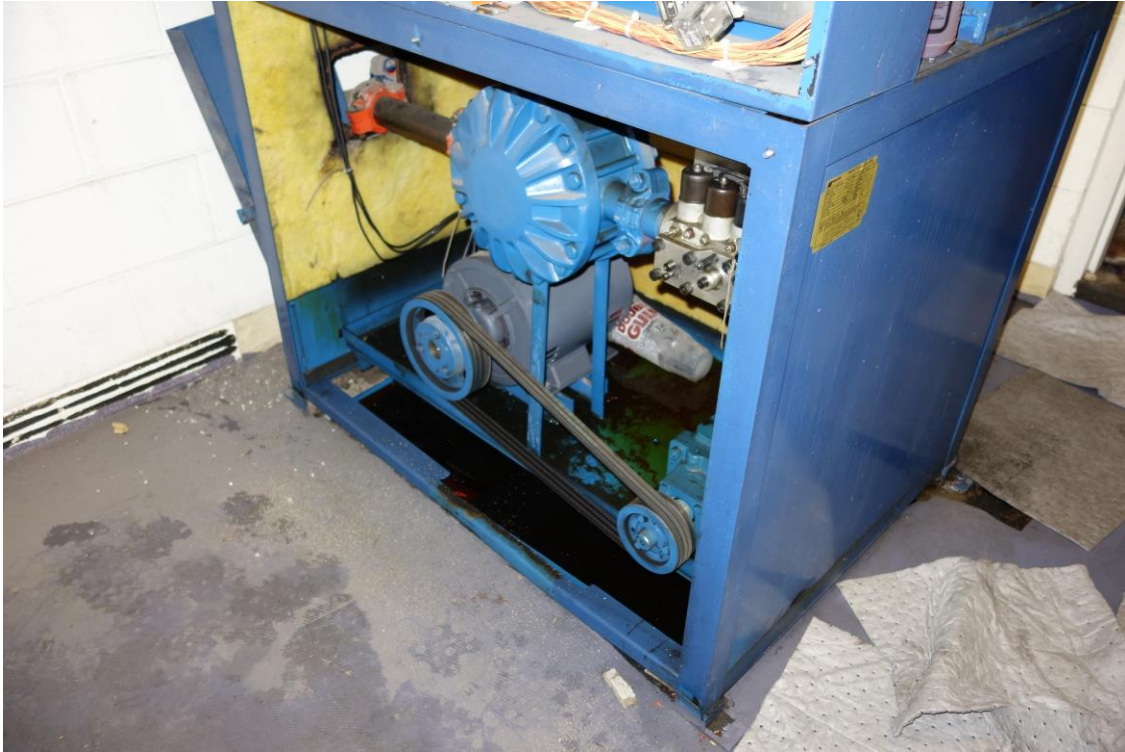
The two existing elevators are original to the building and beyond their useful service life and were installed prior the Americans with Disability Act requirements. Neither elevator can be retrofitted to make them accessible. A new elevator and elevator shaft is needed. This project will provide funding for the removal of the existing elevators, construction of a new elevator shaft, and all necessary building modifications to infill the existing elevator shafts and renovate the lobby access to the new elevator. All utility connections and interfaces are included in this estimate.

Belrose Office Building - Building #0286
Description: Elevators in Need of Replacement.

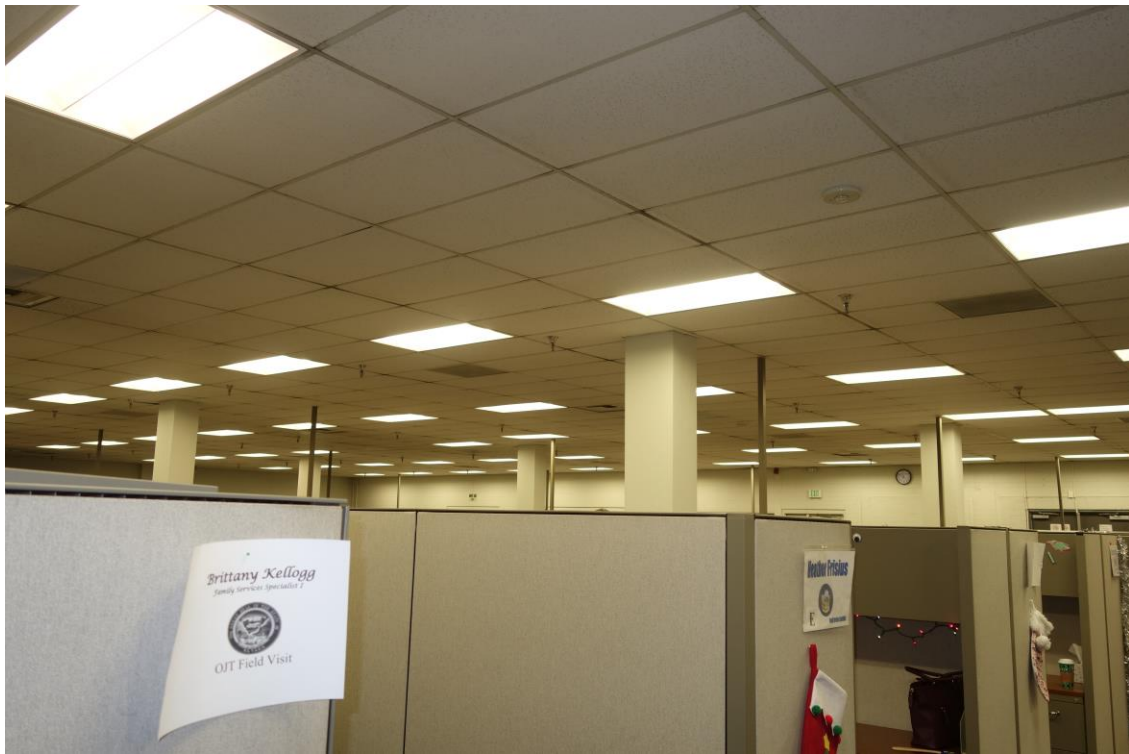
The existing lighting fixtures are the older fluorescent type, and are not energy efficient. This project will upgrade fixtures to higher efficiency units with a longer life cycle. 5,000K LED lamps, without the ballasts are suggested, and new tombstones (if needed). Occupancy sensors will be installed in low occupancy areas for additional savings. Electrical wiring upgrades are not included in this estimate.

The entire building has a suspended acoustical tile ceiling system that is original dating back to 1973. The T-bar framing is bent and rusted in some areas and some of the acoustical tiles are damaged and stained. This project would provide for the replacement of the suspended acoustical tile ceiling system including framing, bracing, acoustical tiles and HVAC grilles. Removal and disposal of the existing ceiling system is included in this estimate. This project or a portion thereof was previously recommended in the FCA report dated 11/01/2011. It has been amended accordingly to reflect conditions observed during the most recent survey date of 12/10/2018.

Belrose Office Building - Building #0286
Description: Suspended Ceiling and Lighting Upgrade Needed.

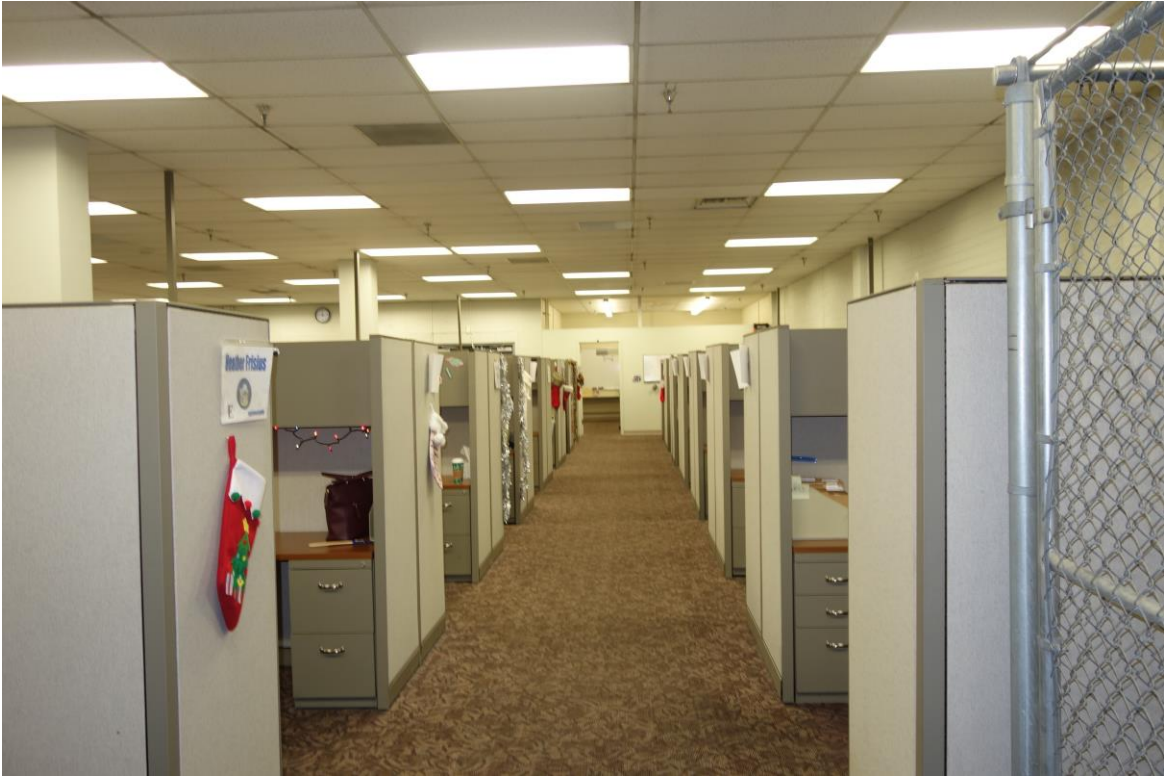
The VCT (vinyl composite tile) and carpet in the building are damaged and reaching the end of their useful life. It is recommended that the flooring be replaced. This project would provide for removal and disposal of the existing flooring and installation of new 12x12 VCT with a 6" base and heavy duty commercial grade carpet in the next 4 - 5 years.

Belrose Office Building - Building #0286
Description: Flooring Replacement Needed.

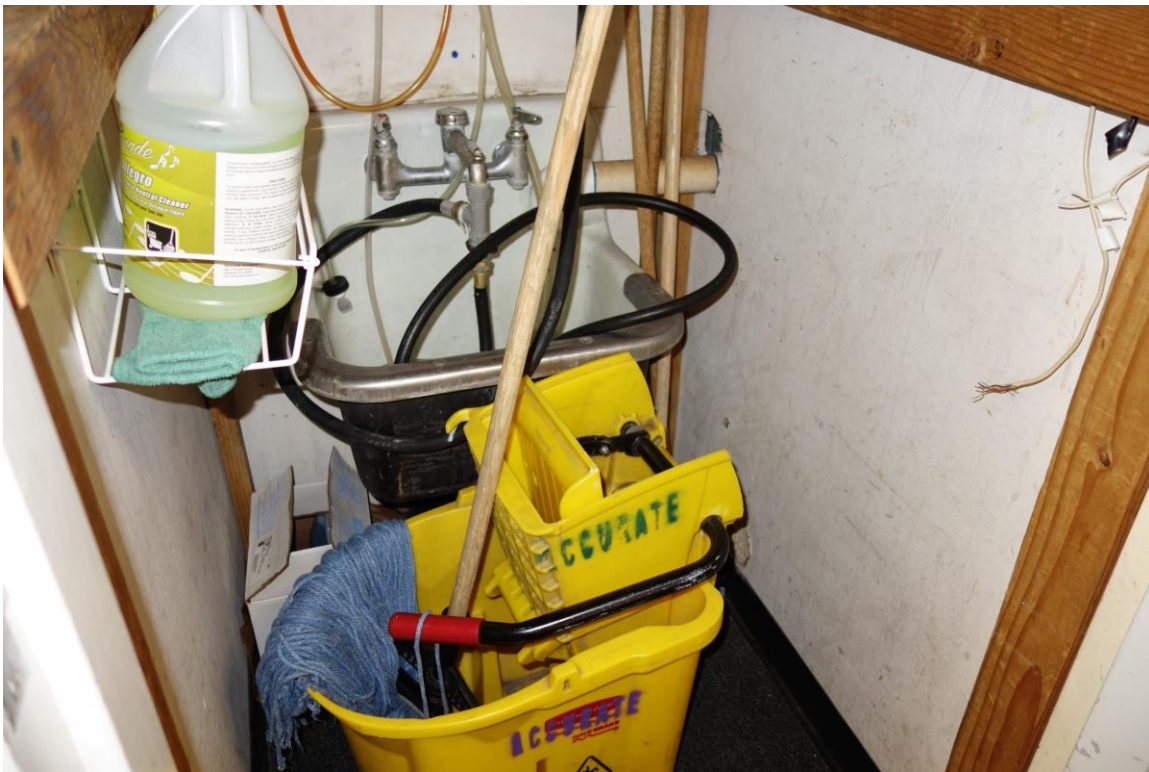
The mop sinks in the Janitors Closets are mounted adjacent to gypsum board and are showing signs of water damage. This project would provide fiberglass reinforced plastic (FRP) to be installed on the walls adjacent to the mop sink. The FRP shall extend two feet beyond the edge of the sink and a minimum of 54" above the floor finish. Typical of four Janitors Closets.

Belrose Office Building - Building #0286
Description: Janitor's Closet Upgrades Needed.

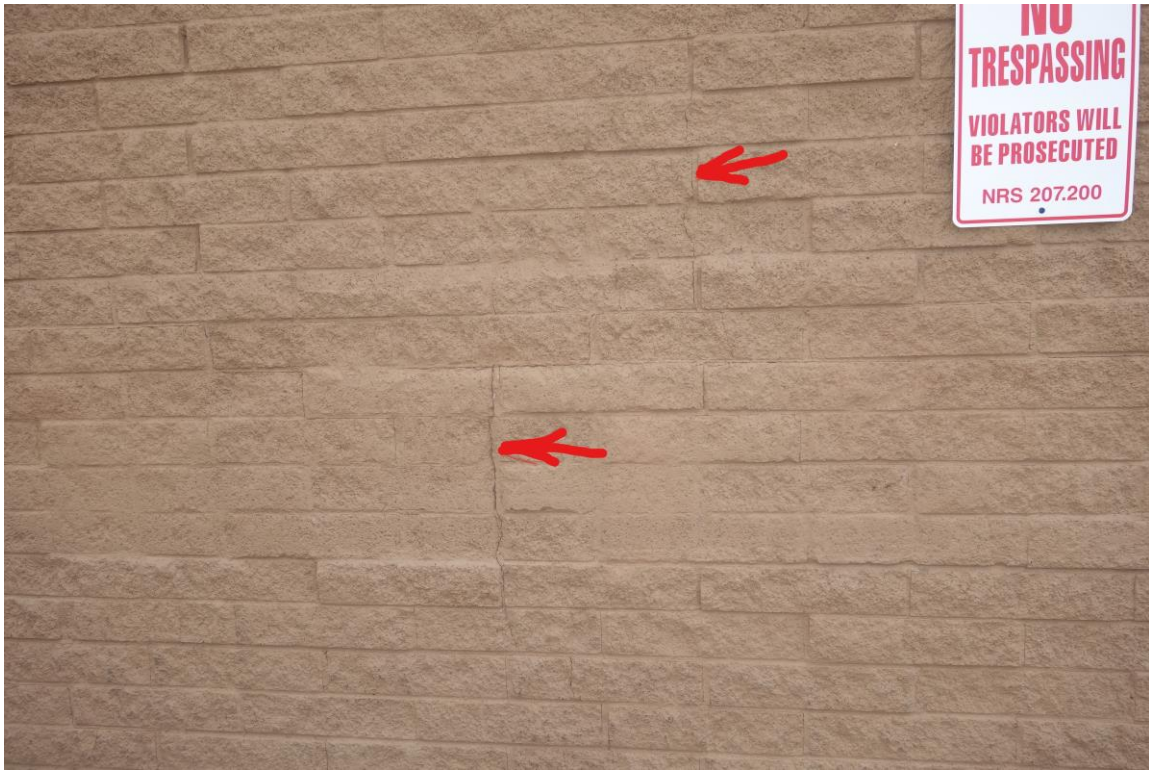
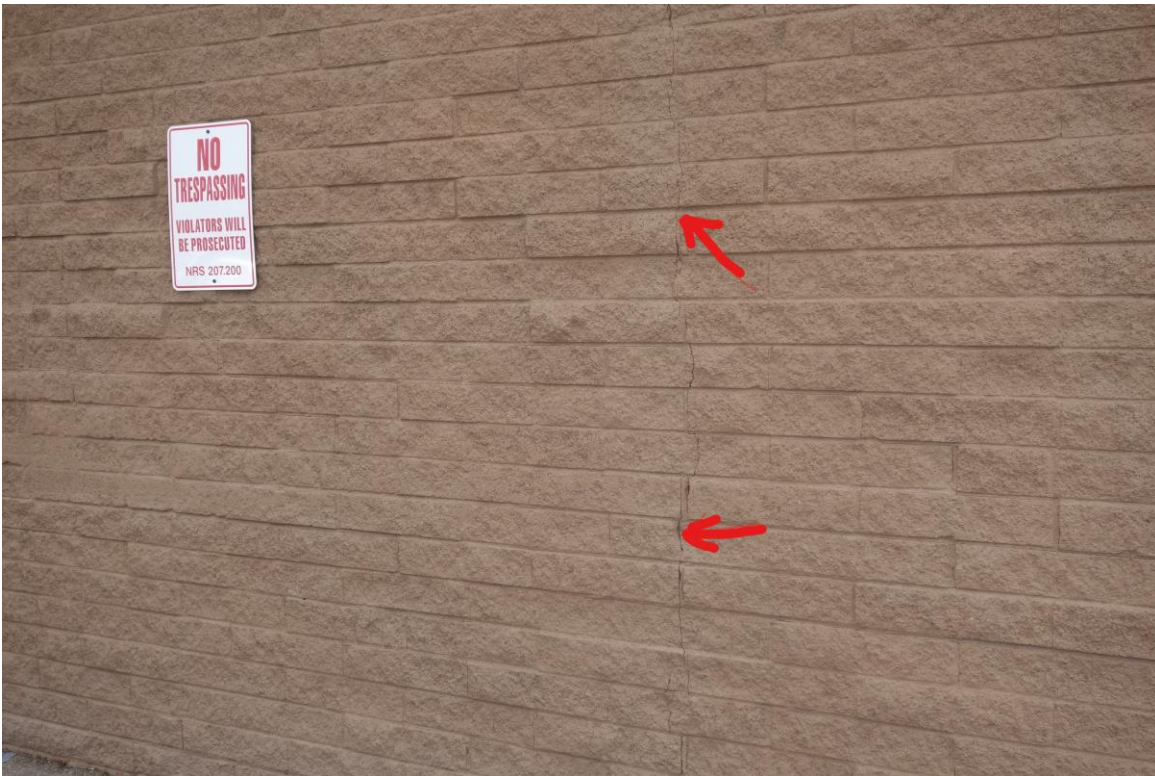
The Belrose Office is a concrete masonry unit and steel framed structure with a single-ply roofing system on a concrete foundation. The two level facility provides offices for the Division of Welfare Supportive Services. There are numerous offices, break rooms, conference rooms, storage areas and ADA accessible restrooms as well as mechanical spaces. There are two elevators that serve the upper level which are not ADA compliant and will be addressed in the project portion of this report. The facility is served by 6 roof mounted HVAC multi-zone units and multiple small package rooftop units. The building has a fire alarm and is fully sprinklered. The facility is showing its age and needs major building elements replaced such as roofing and HVAC systems. Additionally, a couple of small cracks were noted in the west exterior masonry wall that should be monitored periodically. Pictures of the cracks are noted in the photolog at the end of this report.

Belrose Office Building - Building #0286
Description: CMU Wall Crack in West Exterior Wall.
