State of Nevada
Department of Motor Vehicles
Department of Administration - Buildings & Grounds Section
DMV Express Office
Facility Condition Analysis

DMV EXPRESS OFFICE

4110 Donovan Way
Las Vegas, Nevada 89030

Site Number: 9832
STATE OF NEVADA PUBLIC WORKS DIVISION
FACILITY CONDITION ANALYSIS

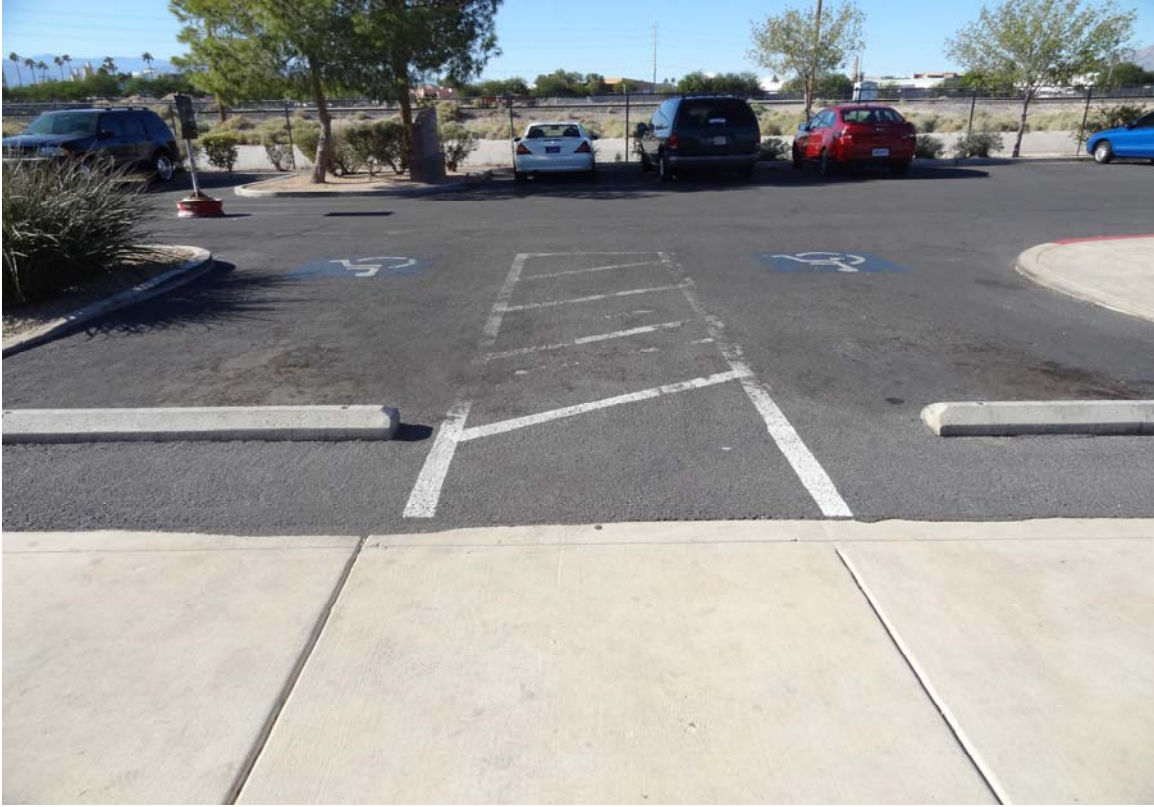
DMV Express Office Site - Site #9832
Description: View of ADA accessible parking.

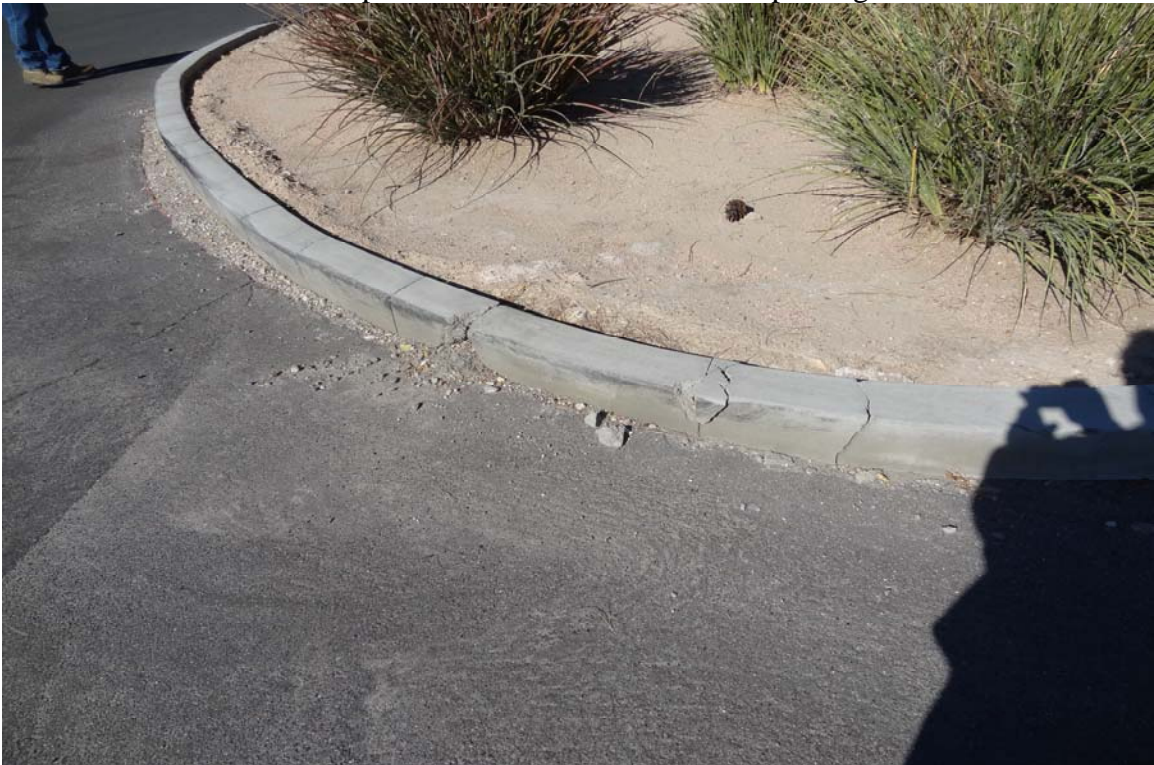
The concrete curbing in the parking lot has been damaged and is failing in many areas. There is extensive cracking, crumbling and failure due to vehicles colliding with the curbs. Some replacements have been done recently, but these areas are already failing as well. Due to the high traffic volume and higher percentage of large commercial vehicles in this parking lot, it is recommended to replace the curbs with a more appropriate system. This project would provide for the installation of concrete curbing with a deeper footing throughout and a high strength concrete mix to ensure a longer life cycle of the new curbing. Removal and disposal of the existing curbing is included in this estimate. This project should be implemented concurrently with the Seal Asphalt Paving project.

DMV Express Office Site - Site #9832
Description: Damaged curb at entrance to parking area.

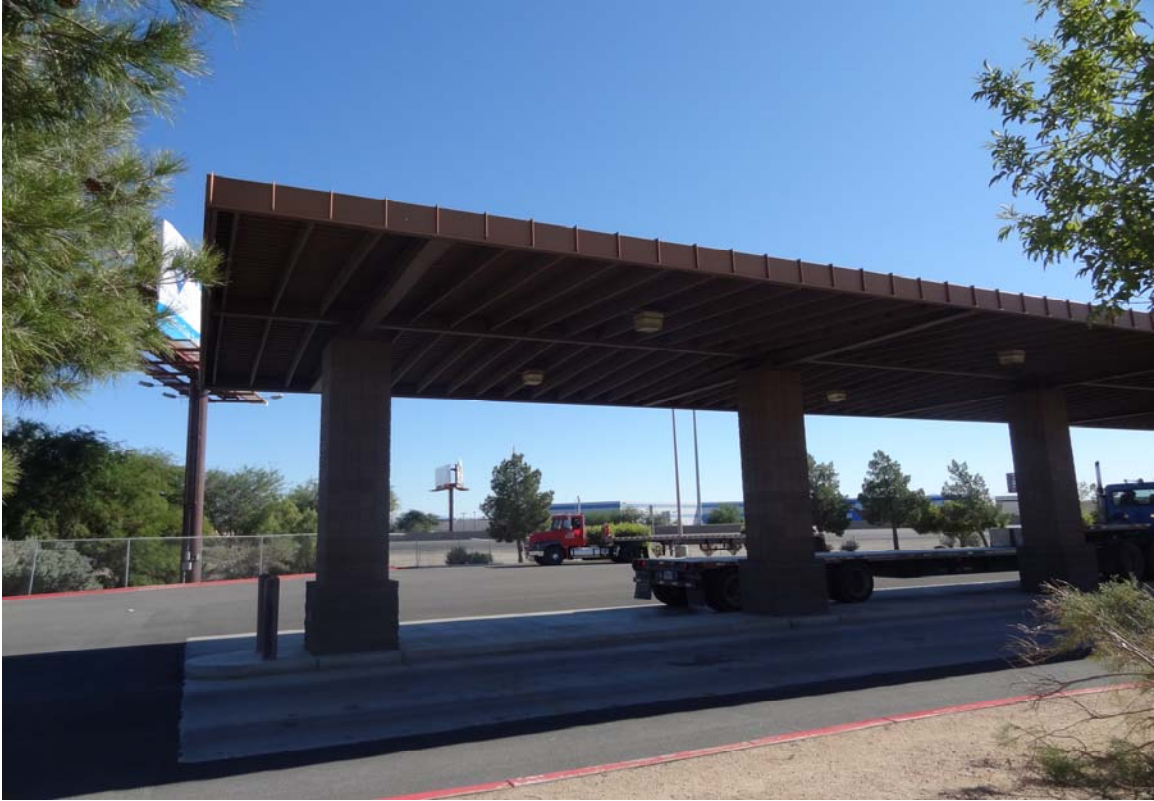
It is important to maintain the finish, weather resistance and appearance of the structure. This project would provide funding for repairing, sealing and caulking of the exterior of the structure. Included in the cost is repairing the damaged concrete masonry units (CMU) and sealing and caulking the CMU, flashing, fixtures and all other penetrations. It is recommended that the building be repaired in the next 2-3 years and that this project be scheduled on a cyclical basis to maintain the integrity of the structure.

Inspection Station Canopy - Building #3106
Description: Exterior of the structure.

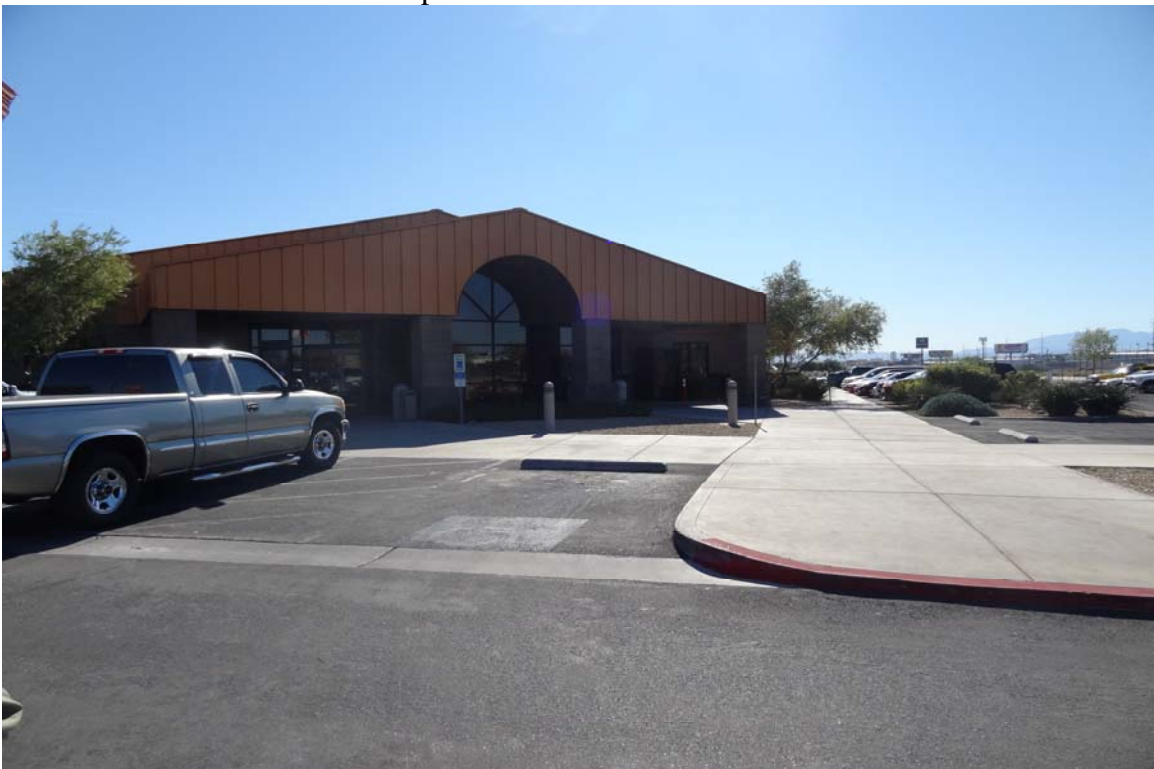
It is important to maintain the finish, weather resistance and appearance of the building. This project would provide funding to protect the exterior of the building excluding the roof. Included in the cost is painting the stucco and sealing and caulking the CMU, windows, flashing, fixtures and all other penetrations. This includes repairing the broken masonry caps on the employee parking sign and the condenser enclosure. It is recommended that the building be repaired in the next 2-3 years and that this project be scheduled on a cyclical basis to maintain the integrity of the structure.

DMV Express Office - Building #0265
Description: View of exterior and public entrance.

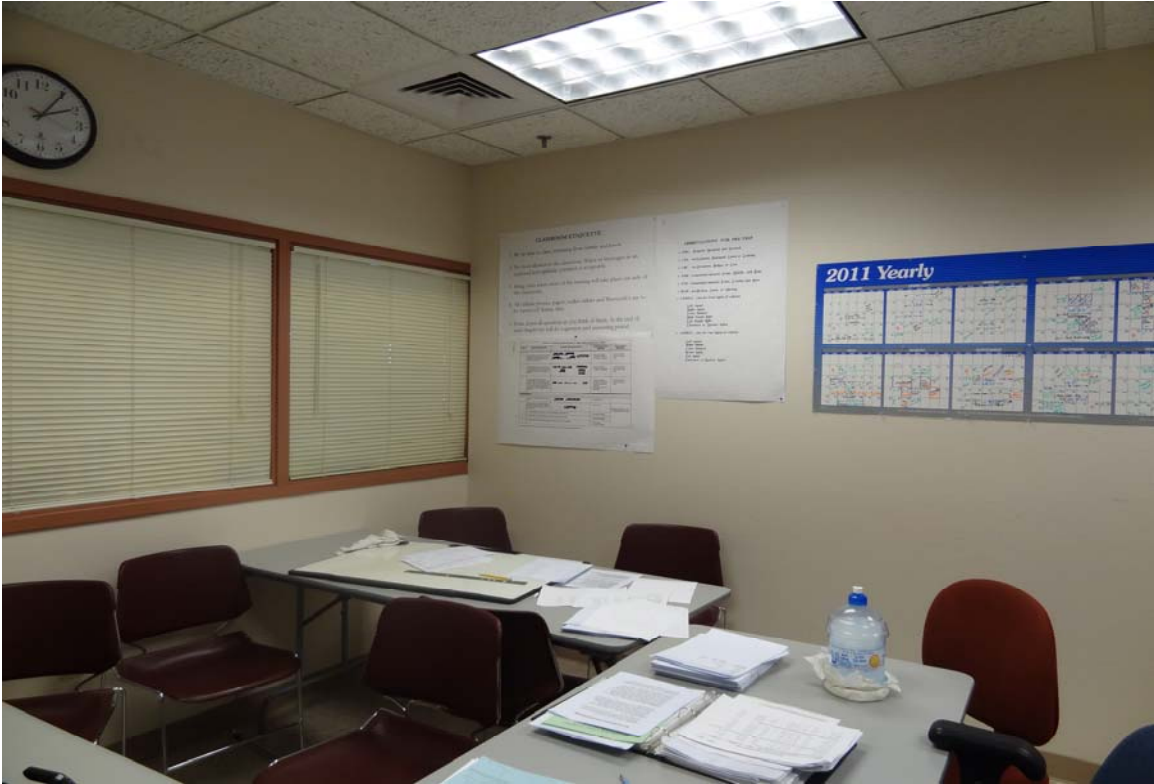
The interior finishes are in fair condition. It is recommended that the interior walls and ceilings be painted at least once in the next 2-3 years and that this project be scheduled on a cyclical basis to maintain the integrity of the structure. Prior to painting, all surfaces should be repaired and prepped. An epoxy-based paint should be utilized in wet areas for durability.

DMV Express Office - Building #0265
Description: Typical interior office space.

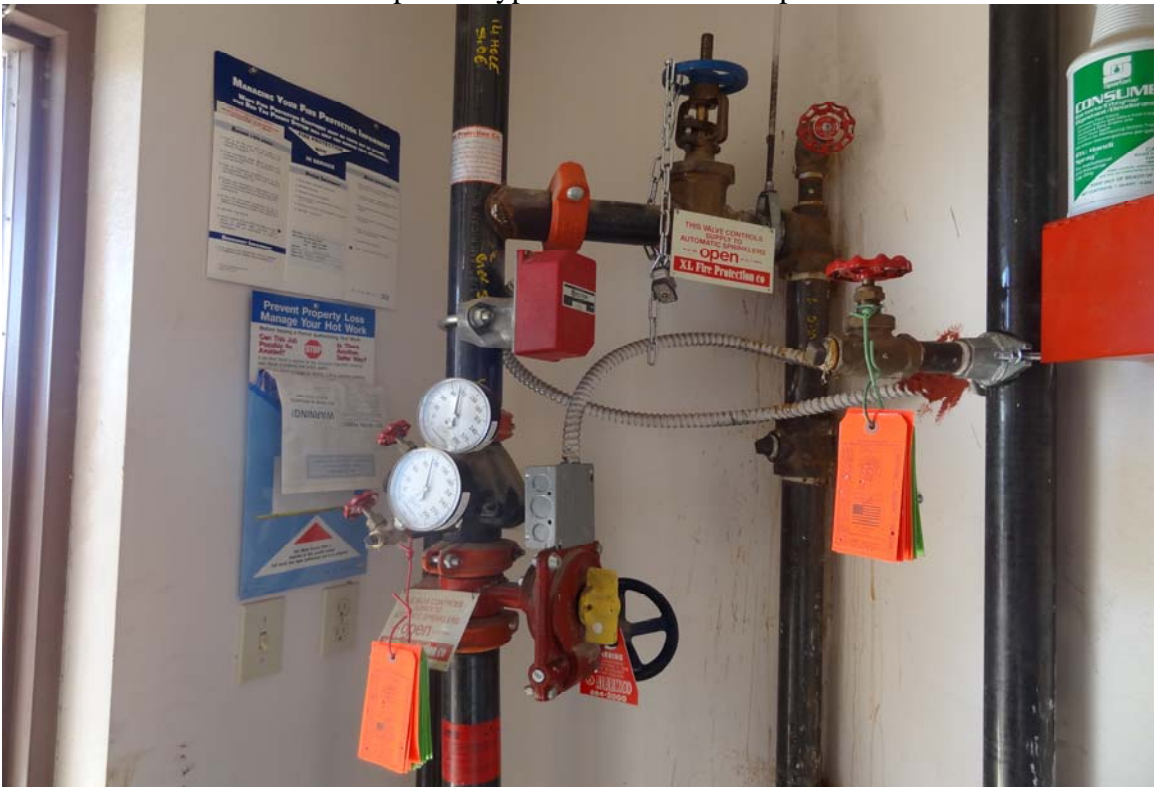
DMV Express Office - Building #0265
Description: Fire sprinkler riser.
