LAS VEGAS CASUAL LABOR OFFICE SITE

Site Number: 9833
STATE OF NEVADA PUBLIC WORKS DIVISION
FACILITY CONDITION ANALYSIS

SPWD Facility Condition Analysis - 9833

SPWD Facility Condition Analysis - 0257

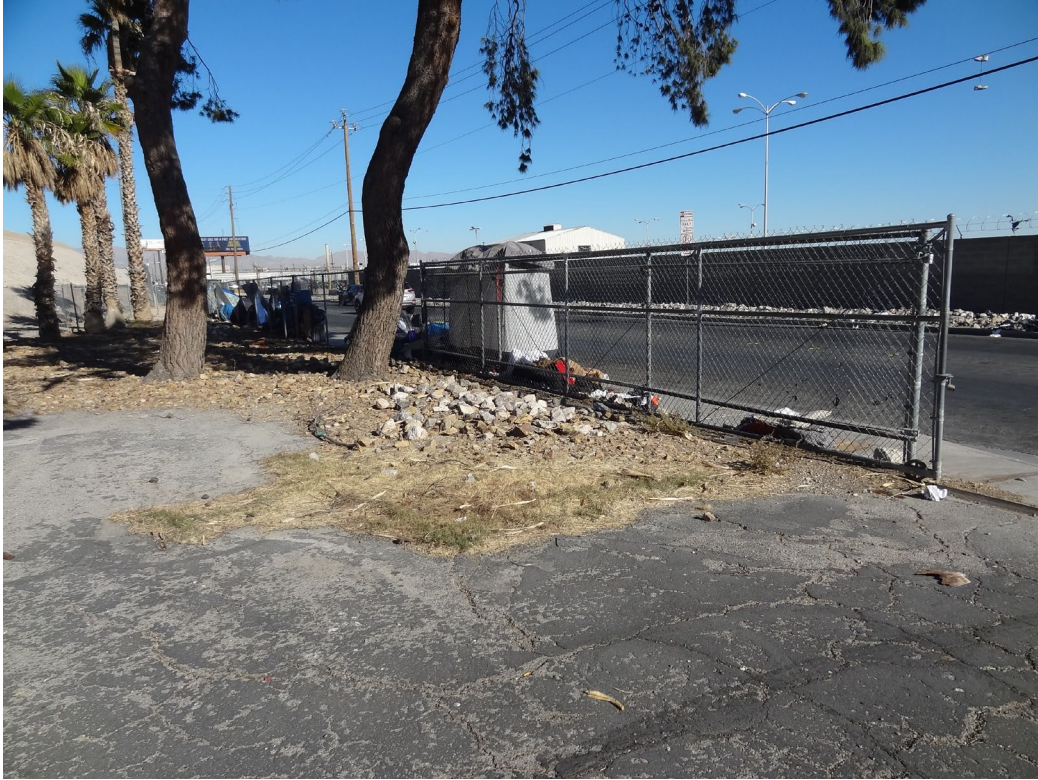
The asphalt parking lots are failing, with significant alligatoring, settling and general deterioration observed. The settling on the south side has caused drainage problems with standing water in the middle of the parking lot. This project covers the removal and replacement of the existing asphalt for parking and site access. Striping for safety, parking and loading zones is included in this estimate as well as perimeter curbing and parking curbs as needed. 18,000 square feet was used to generate this estimate.

Las Vegas Casual Labor Office Site - Site #9833
Description: Asphalt Parking Lot Replacement Needed.

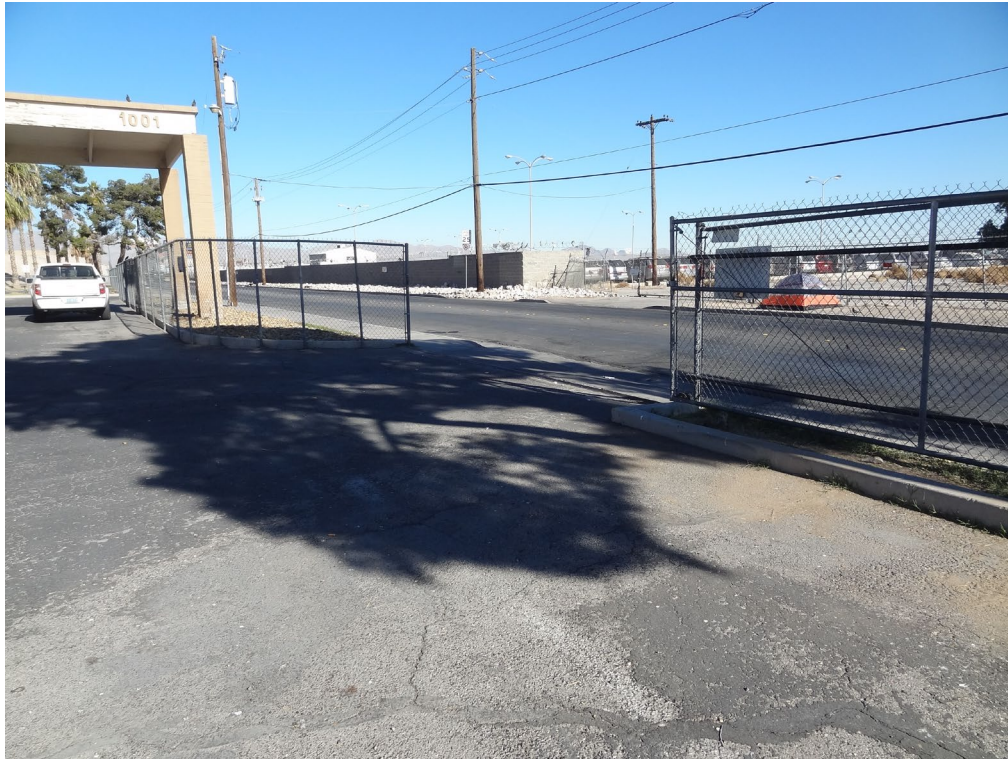
The chain link perimeter fence does not keep vagrants out and has several areas that are in need of repair. This project recommends the installation of a 6 foot high 6 gauge wire perimeter chain link fence around the entire site and two vehicle gates with hardware. A three wire barbed fence is also recommended to be installed along the top of the chain link fence to prevent vagrants from entering the property. The cost estimate includes demolition and disposal of the existing fence.

Las Vegas Casual Labor Office Site - Site #9833
Description: Fencing Replacement Needed.

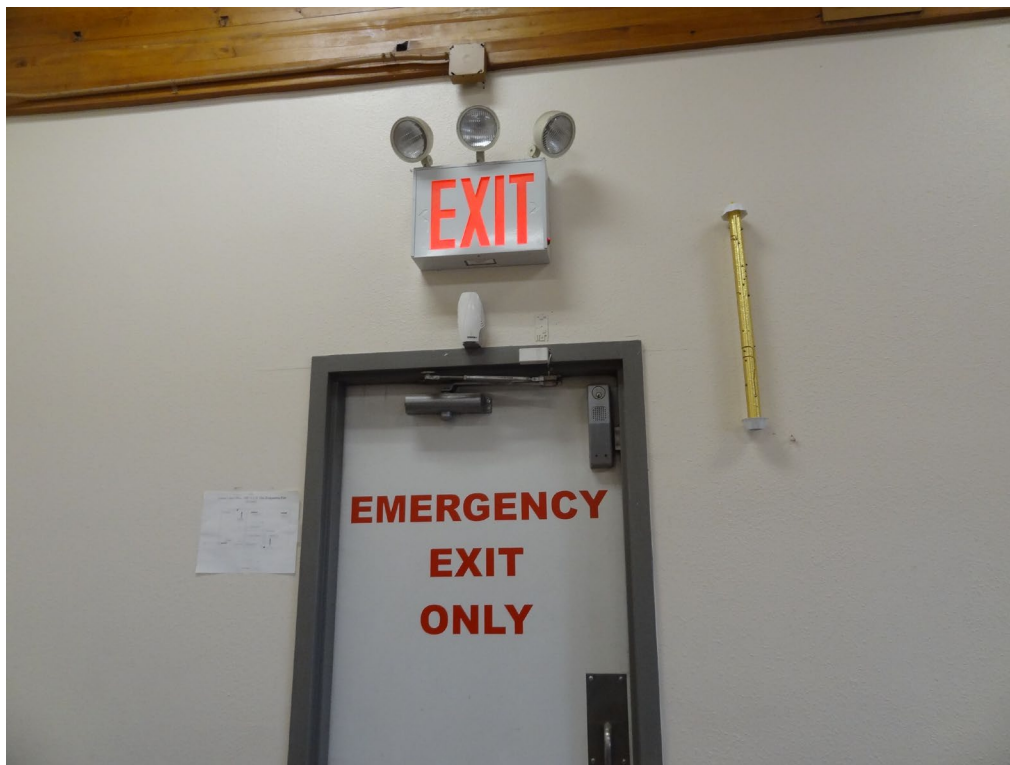
The emergency egress lighting is insufficient and the exit signs do not meet current standards. This project would provide for the purchase and installation of self-illuminated or LED style exit signs with battery-backed internal systems as well as emergency egress lighting to provide illumination along the egress route. IBC - 2018 Chapter 10 was referenced for this project.

Las Vegas Casual Labor Office - Building #0257
Description: Exit Sign and Egress Lighting Upgrade Needed.

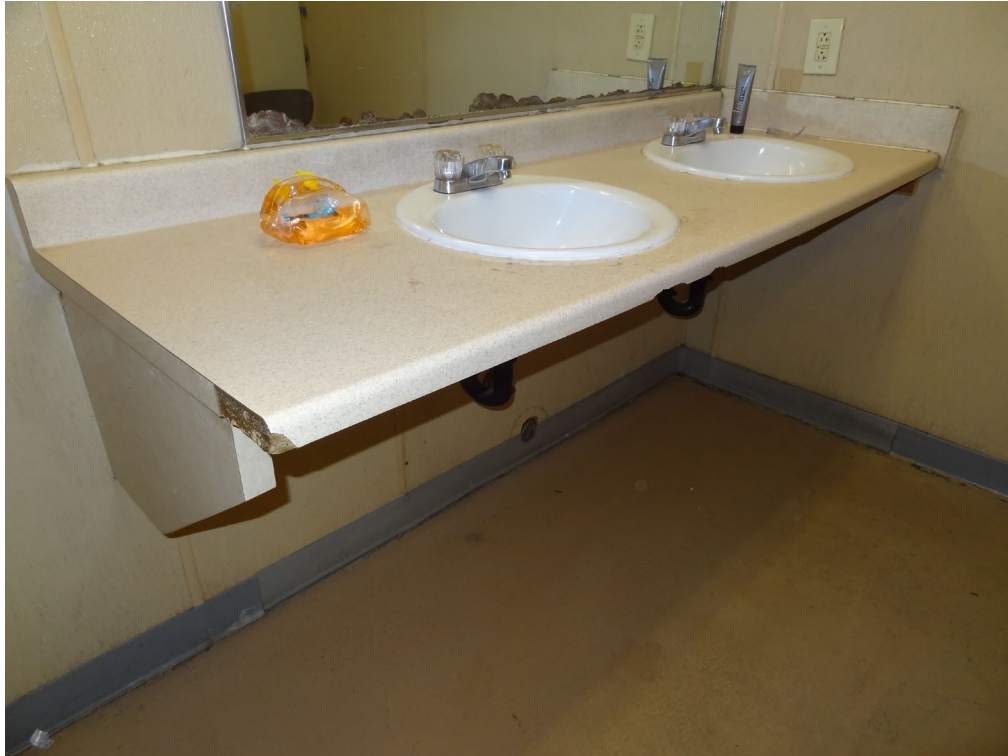
The Men's and Women's designated ADA restrooms in the Job Seeker Room do not meet the Americans with Disabilities Act (ADA) requirements. A complete retrofit is necessary. This project would provide funding for construction of two unisex accessible restrooms. These items may include a new sink, toilet, hardware, mirrors, fixtures, flooring and paint. NRS 338.180, IBC - 2006, ICC/ANSI A117.1 - 2003 and Americans with Disabilities Act Accessibility Guidelines (ADAAG) - 2003 were referenced for this project.

Las Vegas Casual Labor Office - Building #0257
Description: Public Restroom ADA Remodel.

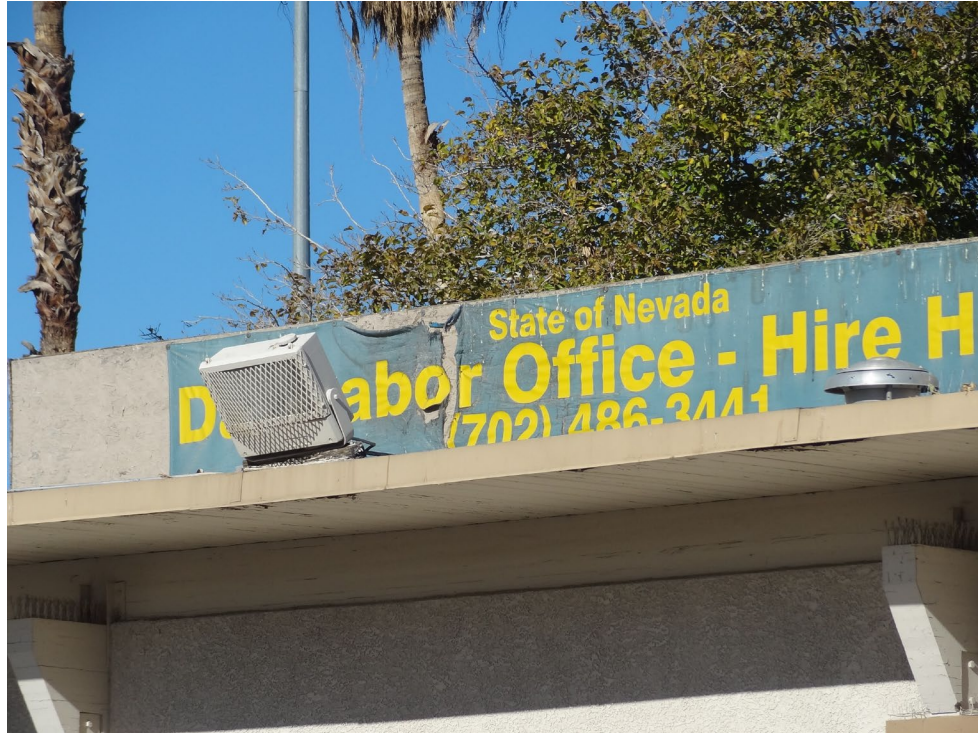
The building mounted wall pack lights appear to be original to the building. These fixtures have High Pressure Sodium (HPS) lamps and are less efficient. This project would provide for the replacement of the existing wall pack fixtures with LED wall packs using the existing wiring.

Las Vegas Casual Labor Office - Building #0257
Description: Exterior Lighting Upgrade.
