COMSTOCK OFFICE BUILDING SITE

20 North E Street
Virginia City, Nevada 89440

Site Number: 9840
STATE OF NEVADA PUBLIC WORKS DIVISION
FACILITY CONDITION ANALYSIS

Report distributed in September 2021

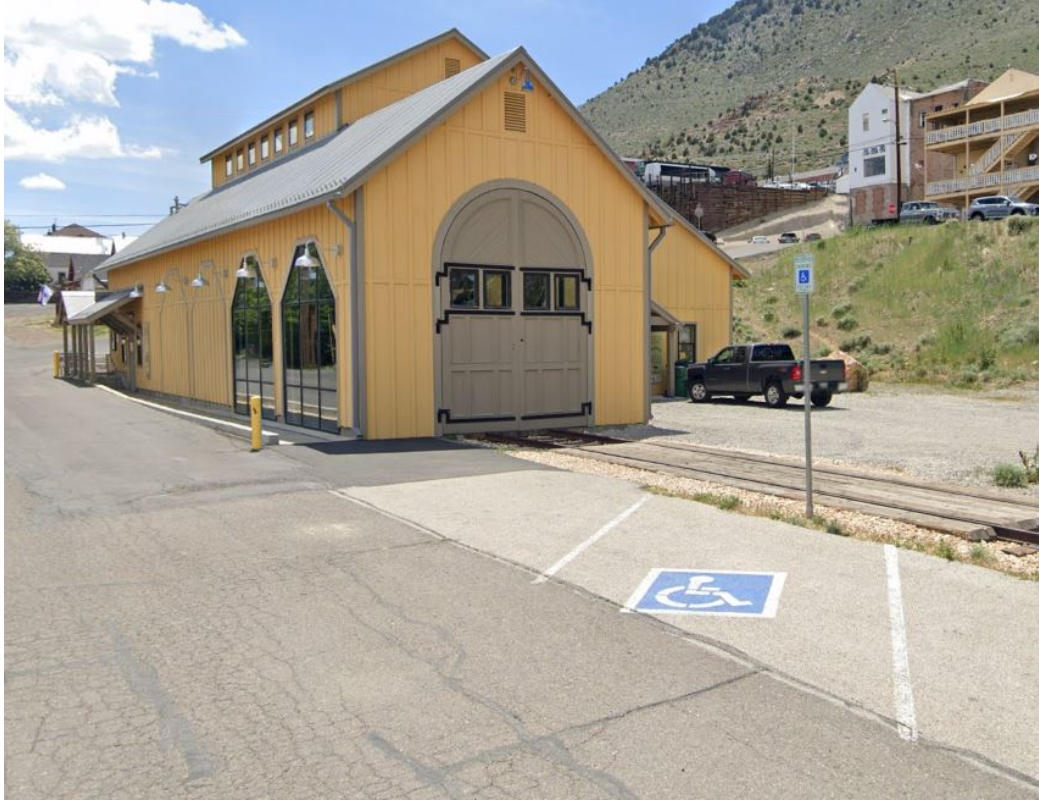
The ADA provides for accessibility to sites and services for people with physical limitations. The existing ADA parking space does not entirely meet the requirements of the code. This project provides funding to bring the existing ADA parking space up to code including removal of the asphalt and replacement with concrete, updated signage, re-striping, re-grading and any other necessary upgrades. The 2018 IBC, ICC/ANSI A117.1, NRS 338.180 and the most current version of the ADA Standards for Accessible Design were used as a reference for this project.

Comstock Office Building Site - Site #9840
Description: View of Site and ADA Parking Upgrades.

PRIORITY CLASS 1 PROJECTS**Total Construction Cost for Priority 1 Projects: \$16,200****Currently Critical****Immediate to Two Years****ADA PARKING SPACE UPGRADE****Project Index #: 9840ADA1****Construction Cost \$15,700**

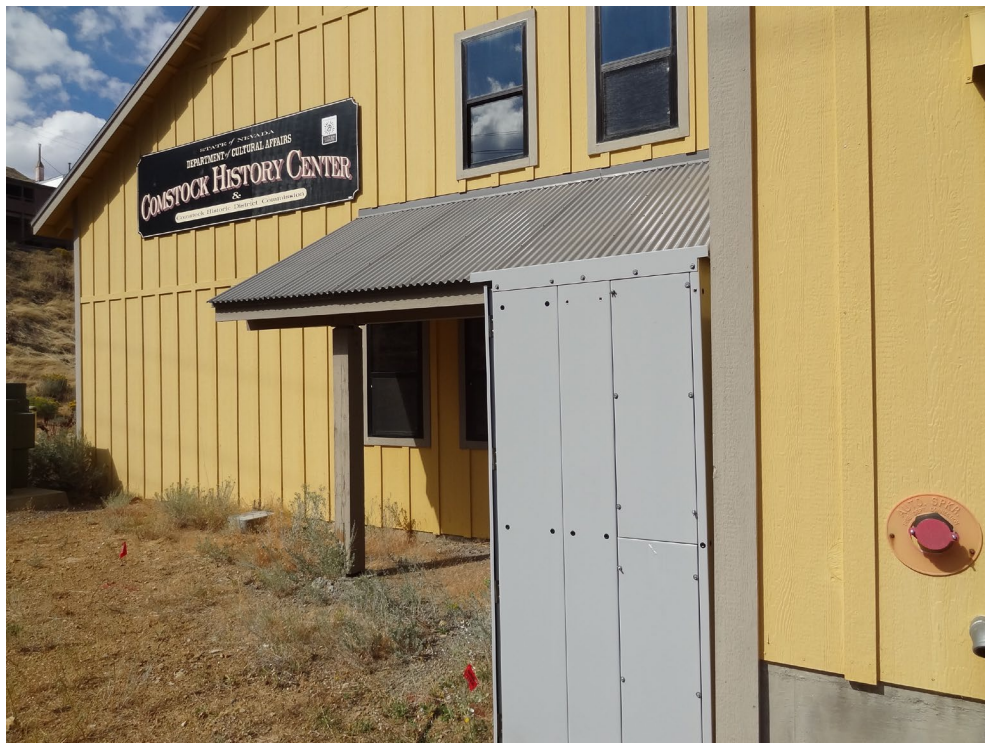
The site on the south side of the building has significant weed buildup and is a fuel source for fire. Accumulated leaves and dry vegetation at the base of structures create a significant fuel path to structure fires. This project would provide for the removal and disposal of the weeds and debris around the structures on the site.

Comstock Office Building Site - Site #9840
Description: Combustibles Reduction & Weed Control.

COMBUSTIBLES REDUCTION FOR FIRE CONTROL**Project Index #: 9840SFT1****Construction Cost \$500**

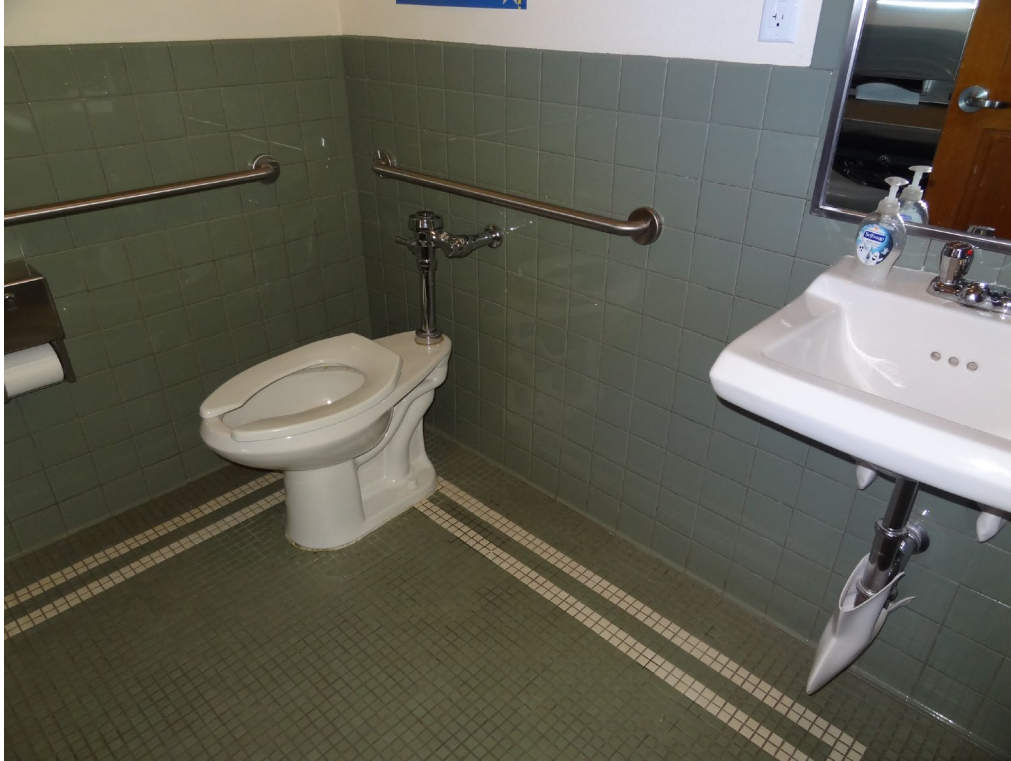
The ADA accessible restrooms are not fully compliant. The Women's restroom toilet flush handle is on the wrong side and both restrooms are missing a grab bar. A partial retrofit is necessary. This project would provide funding to bring the restroom into full ADA compliance. The 2018 IBC, ICC/ANSI A117.1, NRS 338.180 and the most current version of the ADA Standards for Accessible Design were used as a reference for this project.

Comstock Office Building - Building #1465
Description: ADA Restroom Upgrade.

PRIORITY CLASS 1 PROJECTS**Total Construction Cost for Priority 1 Projects: \$7,500****Currently Critical****Immediate to Two Years****ADA RESTROOM UPGRADE****Project Index #: 1465ADA1****Construction Cost \$2,500**

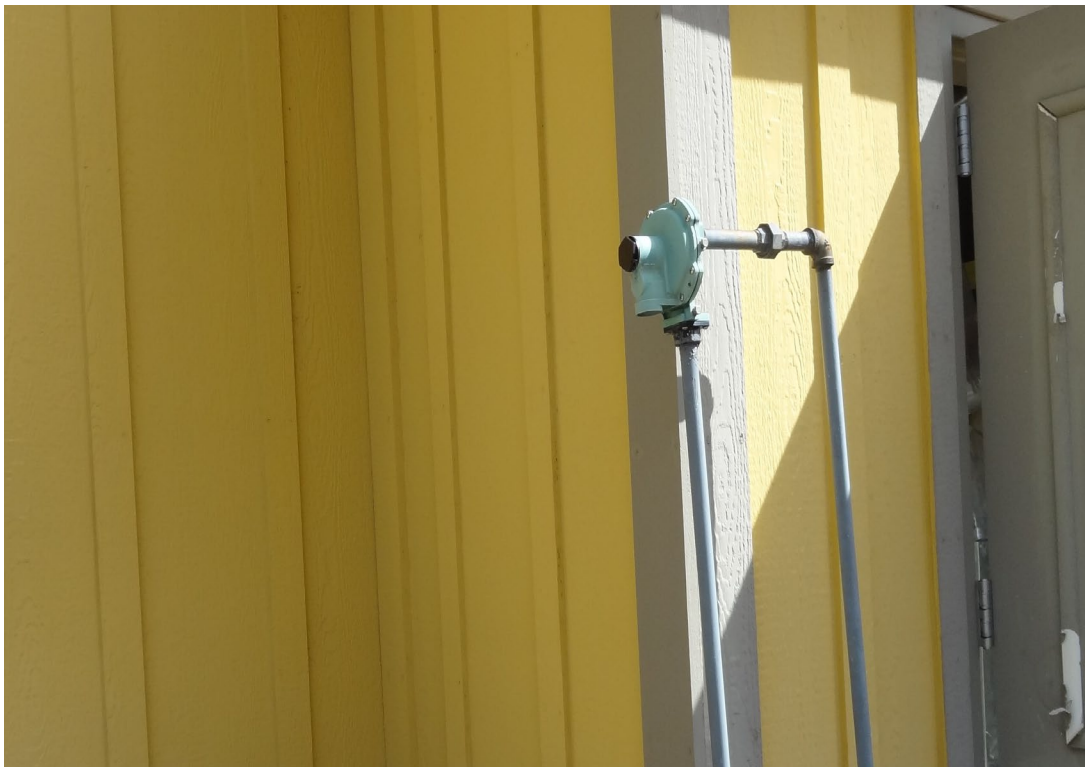
Comstock Office Building - Building #1465
Description: Seismic Gas Valve Installation.

SEISMIC GAS SHUT-OFF VALVE INSTALLATION**Project Index #: 1465SFT1****Construction Cost \$5,000**

This project would provide for the installation of a seismic gas shut-off valve on the main gas service piping prior to entering the building. Alternately, for propane services, consider installation at the tank if the tank feeds multiple buildings. This estimate is based on the manufacturer Pacific Seismic Products or approved equal, equipped with the optional Model MS remote monitoring switch (to be interfaced with the direct digital control system and/or with an audible alarm). The gas piping immediately adjacent to the seismic gas valve shall be secured to the building utilizing unistrut channel bracing.

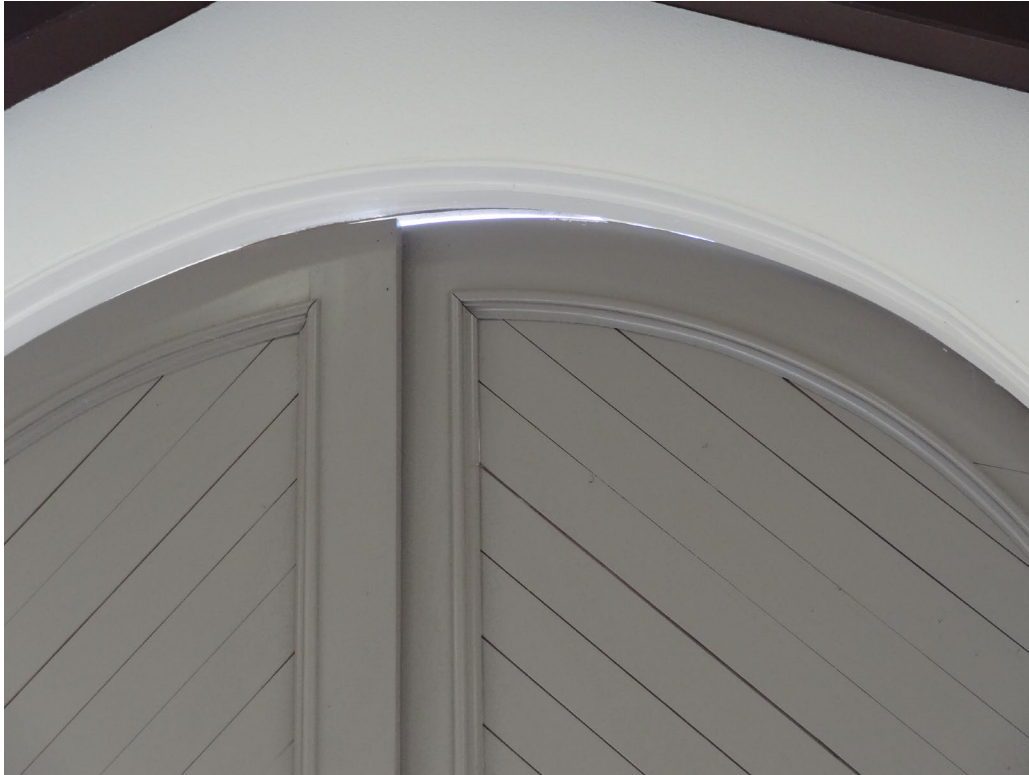
The large exterior doors that allow the historic train to roll into the building are failing. The hinges that secure the large pair of wooden doors no longer hold the doors plumb and tight in the opening. It requires several personnel and additional mechanical means to operate the doors. The doors no longer shut completely or seal resulting in large gaps where water, air, dust, and insects can pass freely. This project would provide for funding a complete refurbishment of the existing doors.

Comstock Office Building - Building #1465
Description: Exterior Train Door Repair/Rebuild.

PRIORITY CLASS 2 PROJECTS**Total Construction Cost for Priority 2 Projects: \$92,100****Necessary - Not Yet Critical****Two to Four Years****EXTERIOR TRAIN DOOR REPAIR / REBUILD****Project Index #: 1465EXT3****Construction Cost \$8,000**

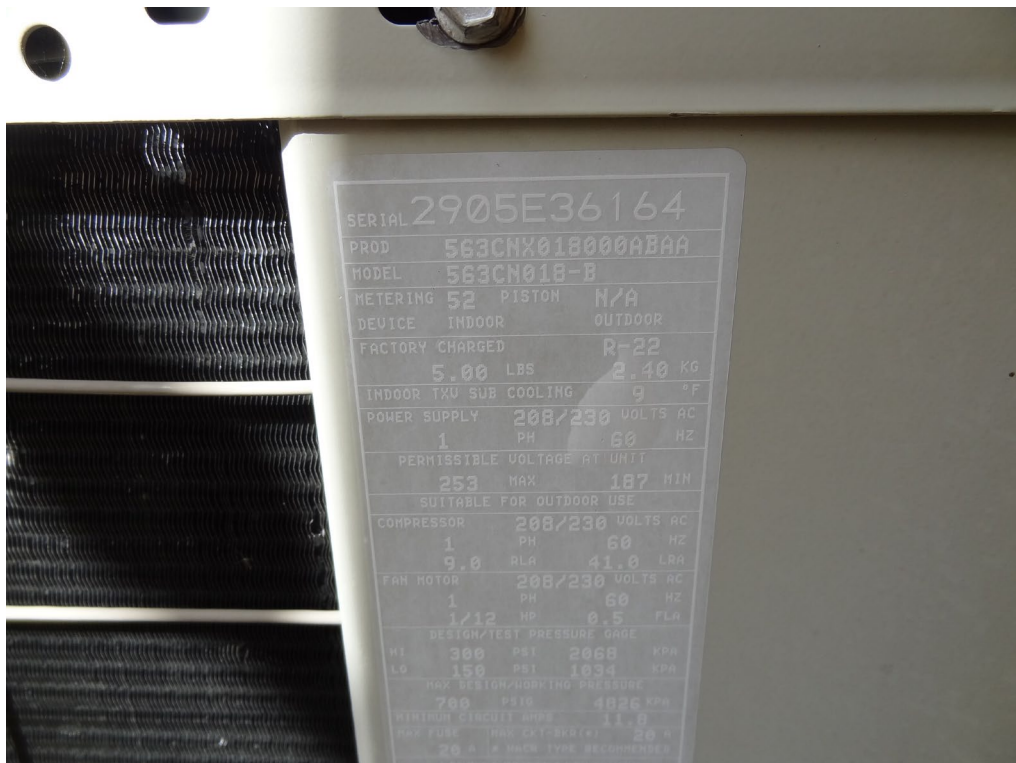
The HVAC system is original to the building and should be scheduled for replacement. It is not energy efficient and the R-22 refrigerant in the cooling system is no longer EPA compliant and its production is mandated to be phased out completely by January 1, 2020. This project would provide for installation of a new HVAC system and cleaning of the existing duct work and grilles. This project includes removal and disposal of the existing HVAC system and all required connections to utilities.

Comstock Office Building - Building #1465
Description: HVAC Equipment (R-22) Replacement.

HVAC EQUIPMENT REPLACEMENT**Project Index #: 1465HVA1****Construction Cost \$42,000**

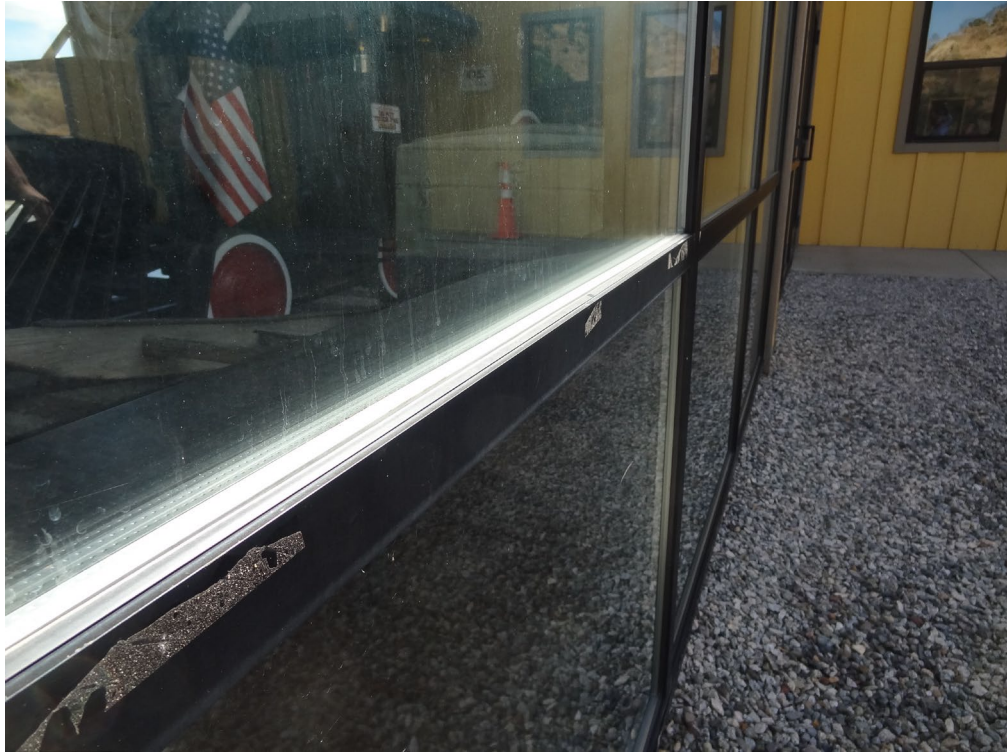
There are four sets of exterior aluminum storefront glazing systems that appear to be original to the building. They are damaged from age and general wear and tear and are a constant maintenance problem. This project would provide for the replacement and installation of four new exterior aluminum storefront glazing systems. Removal and disposal of the existing storefronts is included in this estimate.

Comstock Office Building - Building #1465
Description: Storefront Glazing Replacement.

STOREFRONT GLAZING SYSTEM REPLACEMENT

Project Index #: 1465EXT2
Construction Cost \$38,400

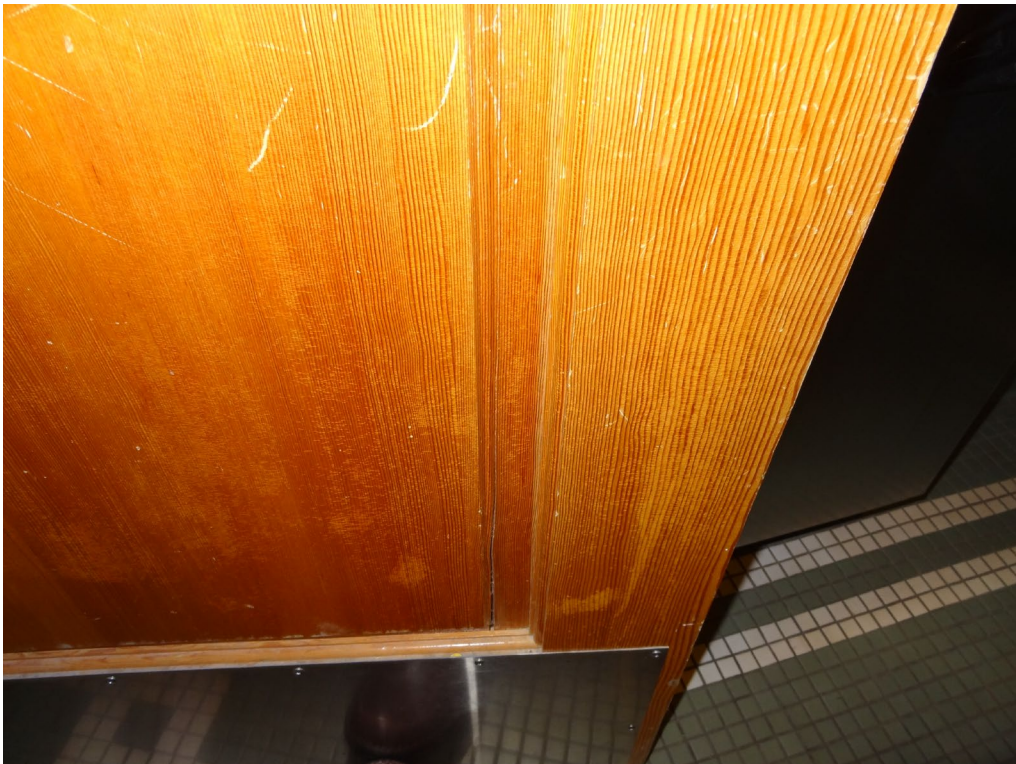
The interior doors in this building are damaged due to warping and cracking. This project would provide for the installation of new interior doors including lever action door handles, hardware and paint. Frames are not included in this estimate. Removal and disposal of the existing doors is included in this cost estimate.

Comstock Office Building - Building #1465
Description: Interior Door Replacement.

INTERIOR DOOR REPLACEMENT

Project Index #: 1465INT2
Construction Cost \$3,700
