DEPARTMENT OF ADMINISTRATION
STATE PUBLIC WORKS DIVISION
FACILITY CONDITION ASSESSMENT

PROPERTY PORTFOLIO REVIEW PROJECT ADDENDUM

9850 - MUSEUM ADMINISTRATIVE SITE 708 N CURRY ST CARSON CITY, NV 89703-3915 CARSON CITY COUNTY

SURVEY DATE: 05/09/2024

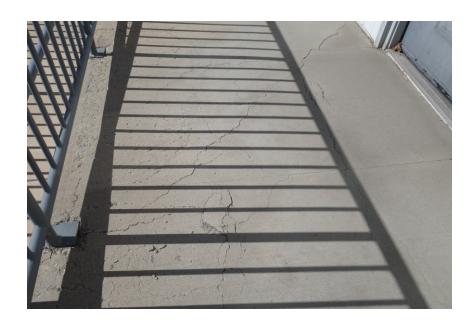
2028-SFT-8: EXTERIOR STAIR & LANDING REPLACEMENT

Replace the exterior concrete landing and stair at the residence entry due to extensive cracking and settlement, which presents a trip/fall hazard and has compromised the guard/handrail anchorage. Estimates are: Landing - 6'x8' (48sf), 6-step stair, 20 LF handrail.

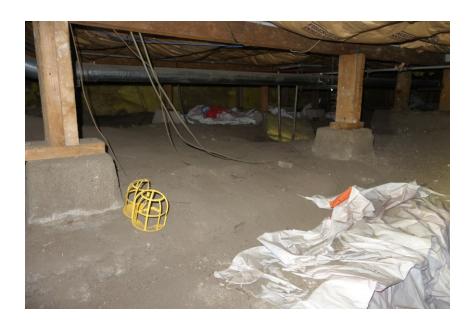
NEW SAFETY ISSUES - 10/6/2025 2028-SFT-1:SEISMIC SURVEY

This building is a historic wood framed structure on an old concrete foundation consisting of a perimet This historic, wood-framed building appears to rest on an older concrete foundation with a perimeter stem wall and interior posts and piers. The stem wall and piers appear cracked and deteriorated, and the wood framing appears not to be properly anchored to the concrete.

Because the structure predates modern seismic codes (1970s), a comprehensive structural evaluation of seismic performance is

recommended in accordance with ASCE 41. This is a visual survey only; conditions and anchorage require confirmation by a licensed structural engineer. Any costs for potential seismic retrofit are excluded from this estimate.

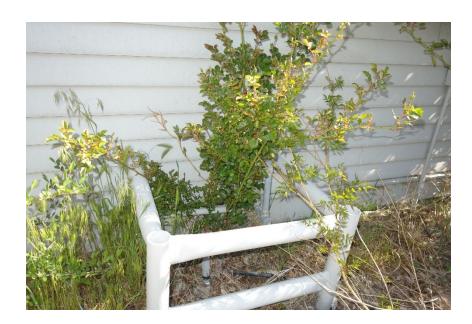
2028-SFT-7:SEISMIC GAS SHUT-OFF VALVE INSTALLATION

The gas is currently shut-off.

This project would provide for the installation of a seismic gas shutoff valve on the main gas service piping just prior to entering the building. This estimate is based on the manufacturer Pacific Seismic Products or approved equal, equipped with the optional Model MS remote monitoring switch (to be interfaced with the direct digital control system and/or with an audible alarm). The gas piping immediately adjacent to the seismic gas valve shall be secured to the building utilizing unistrut channel bracing.

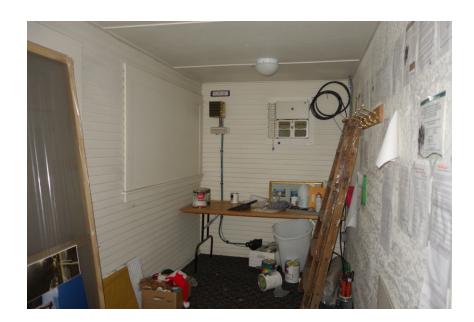
2028-INT-2:INTERIOR CLEANUP & TOILET DECOMMISSIONING

The water is currently shut off.

Perform a one-time interior cleanup of the storage areas: remove trash/debris, sweep/vacuum, wipe surfaces, and treat for odors/pests as needed. In the restroom, remove the existing toilet (bowl and tank), cap the closet flange with a mechanical test plug and install a blank cover plate; isolate and cap the water supply, and patch flooring/finish at the former fixture location. Maintain

utilities in "off" position and post "Non-potable/Out of Service" signage.

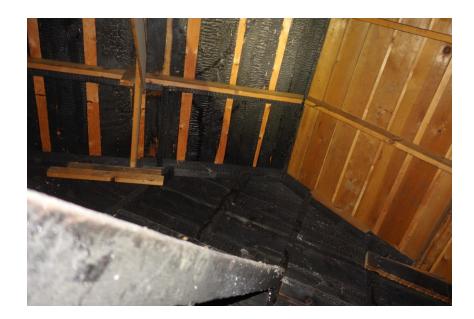
2028-STR-2: ATTIC FIRE DAMAGE ASSESSMENT

During a visual survey, evidence of prior fire appears on attic trusses, interior roof sheathing, and the interior face of a gable end. Charring/delamination and heat exposure appear to be present on select members. The extent of damage and residual structural capacity cannot be confirmed without professional evaluation and limited destructive testing.

Estimate: 4 hours at \$225/hr for a Structural Engineer.

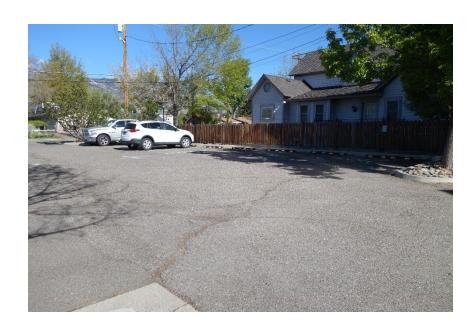
9850-SIT-2: SLURRY SEAL ASPHALT PAVING

The pavement maintenance is currently Carson City's responsibility even though the State owns the property. This project is for information only. The cost is \$0.

It is important to maintain the asphalt concrete paving on the site. This project would provide for minor crack filling and slurry sealing of the paving in the parking lot. Striping and signage including updated ADA parking requirements are included in this estimate. This project should be scheduled on a 5 year cyclical basis to maintain the integrity of the paving and prevent premature failure. 15,000 square feet of asphalt area was used to generate this estimate.

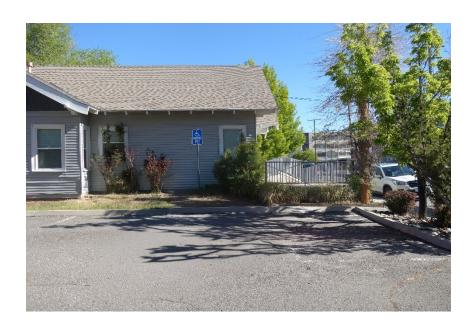
9850-SIT-3: ADA ACCESSIBLE ROUTE

The building is currently used solely for storage and is not open to the public; therefore, ADA upgrades are not recommended at this time under the program-access approach. The ADA accessible route from the parking to the building is not compliant and part of the route is the sidewalk in front of the building to the ramp and stairs.
