FACILITY CONDITION ASSESSMENT REPORT FOR: NORTHERN NEVADA CORRECTIONAL COMPLEX DEPT OF PUBLIC SAFETY

SITE #: 9851 DPS TRAINING FACILITY SITE

Survey Date: 1/10/2023

Distribution Date: 4/22/2024

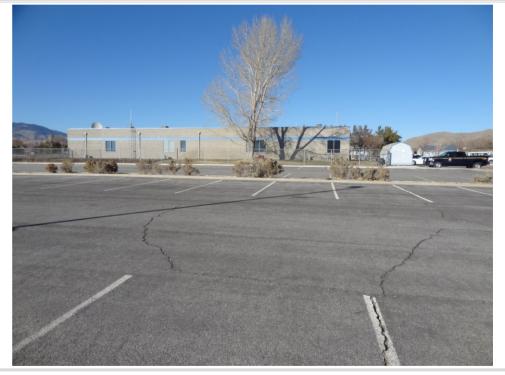
SLURRY SEAL PAVING

The site paving was re-sealed in 2022. It is important to maintain the asphalt concrete paving on the site. This project would provide for minor crack filling and slurry sealing of the paving site wide including access roads and parking areas. Striping is included in this estimate. This project should be scheduled on a 4 - 5 year cyclical basis to maintain the integrity of the paving and prevent premature failure. 40,000 square feet of asphalt area was used to generate this estimate.

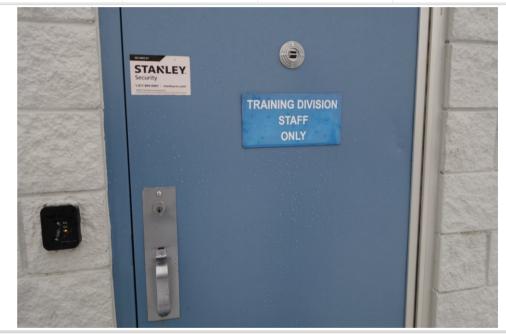
ACCESS CONTROL REPLACEMENT

The existing access control system is failing and has reached the end of its useful life. Card readers intermittently fail to read. A complete replacement of the hardware and software is recommended including the card readers.

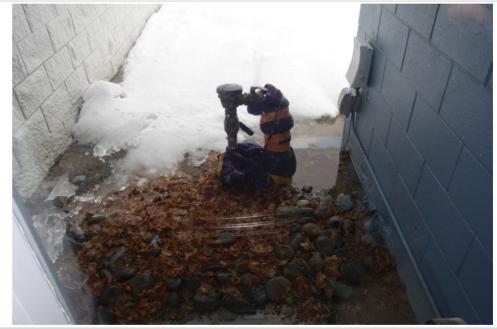
REPAIR ROOF SCUPPER DOWN SPOUTS

The existing down spouts at the roof scupper locations terminate right at grade and / or were missing the last section. The downspout at the front entry is completely missing allowing wind driven rain hit the adjacent walls and window glazing. Significant ponding occurs against the foundation at the front entry during each precipitation event. This project would provide for repair of the existing down spouts, install catchments at the point of downspout discharge and a means to drain the precipitation away from the building. This will require re-grading the landscape areas surrounding the building to facilitate the removal of the surface water.

This project or a portion thereof was previously recommended in the FCA report dated 12/01/2011. It has been amended accordingly to reflect conditions observed during the most recent survey date of 1/10/2023.

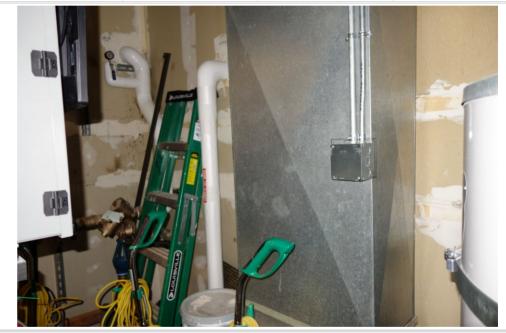
COLD AIR INFILTRATION REPAIR

The main hallway outside of the Utility Room is very cold and drafty during the winter season. The cause is oversized outside air ducting that is currently being used to provide combustion air to the natural gas fired water heater. The ducting provides a free path of outside air into the Utility Room and flows into the hallway. This project would fund the replacement of the existing water heater with a sealed combustion water heater in which the combustion and exhaust are directly ducted outside by the use of a concentric vent roof penetration. Cap and seal the existing combustion air ducts

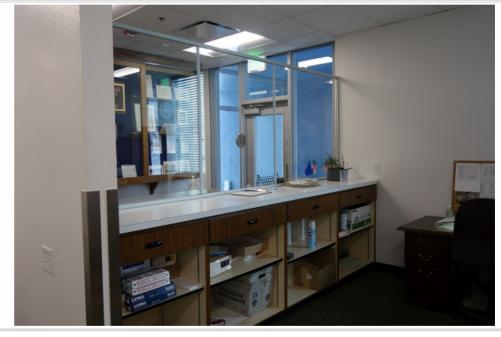
LOBBY SAFETY IMPROVEMENTS

The existing lobby safety measures protecting administrative staff appear inadequate. The existing Lexan barrier would not prevent a determined individual from entering the building. Physical improvements to the space are recommended including replacement of the casework, safety barriers and access control.
